Reply to: 2880 Geologic Services and Resources

Date: August 7, 1984

Subject: Land Stability of the Six Mile Ponds Area

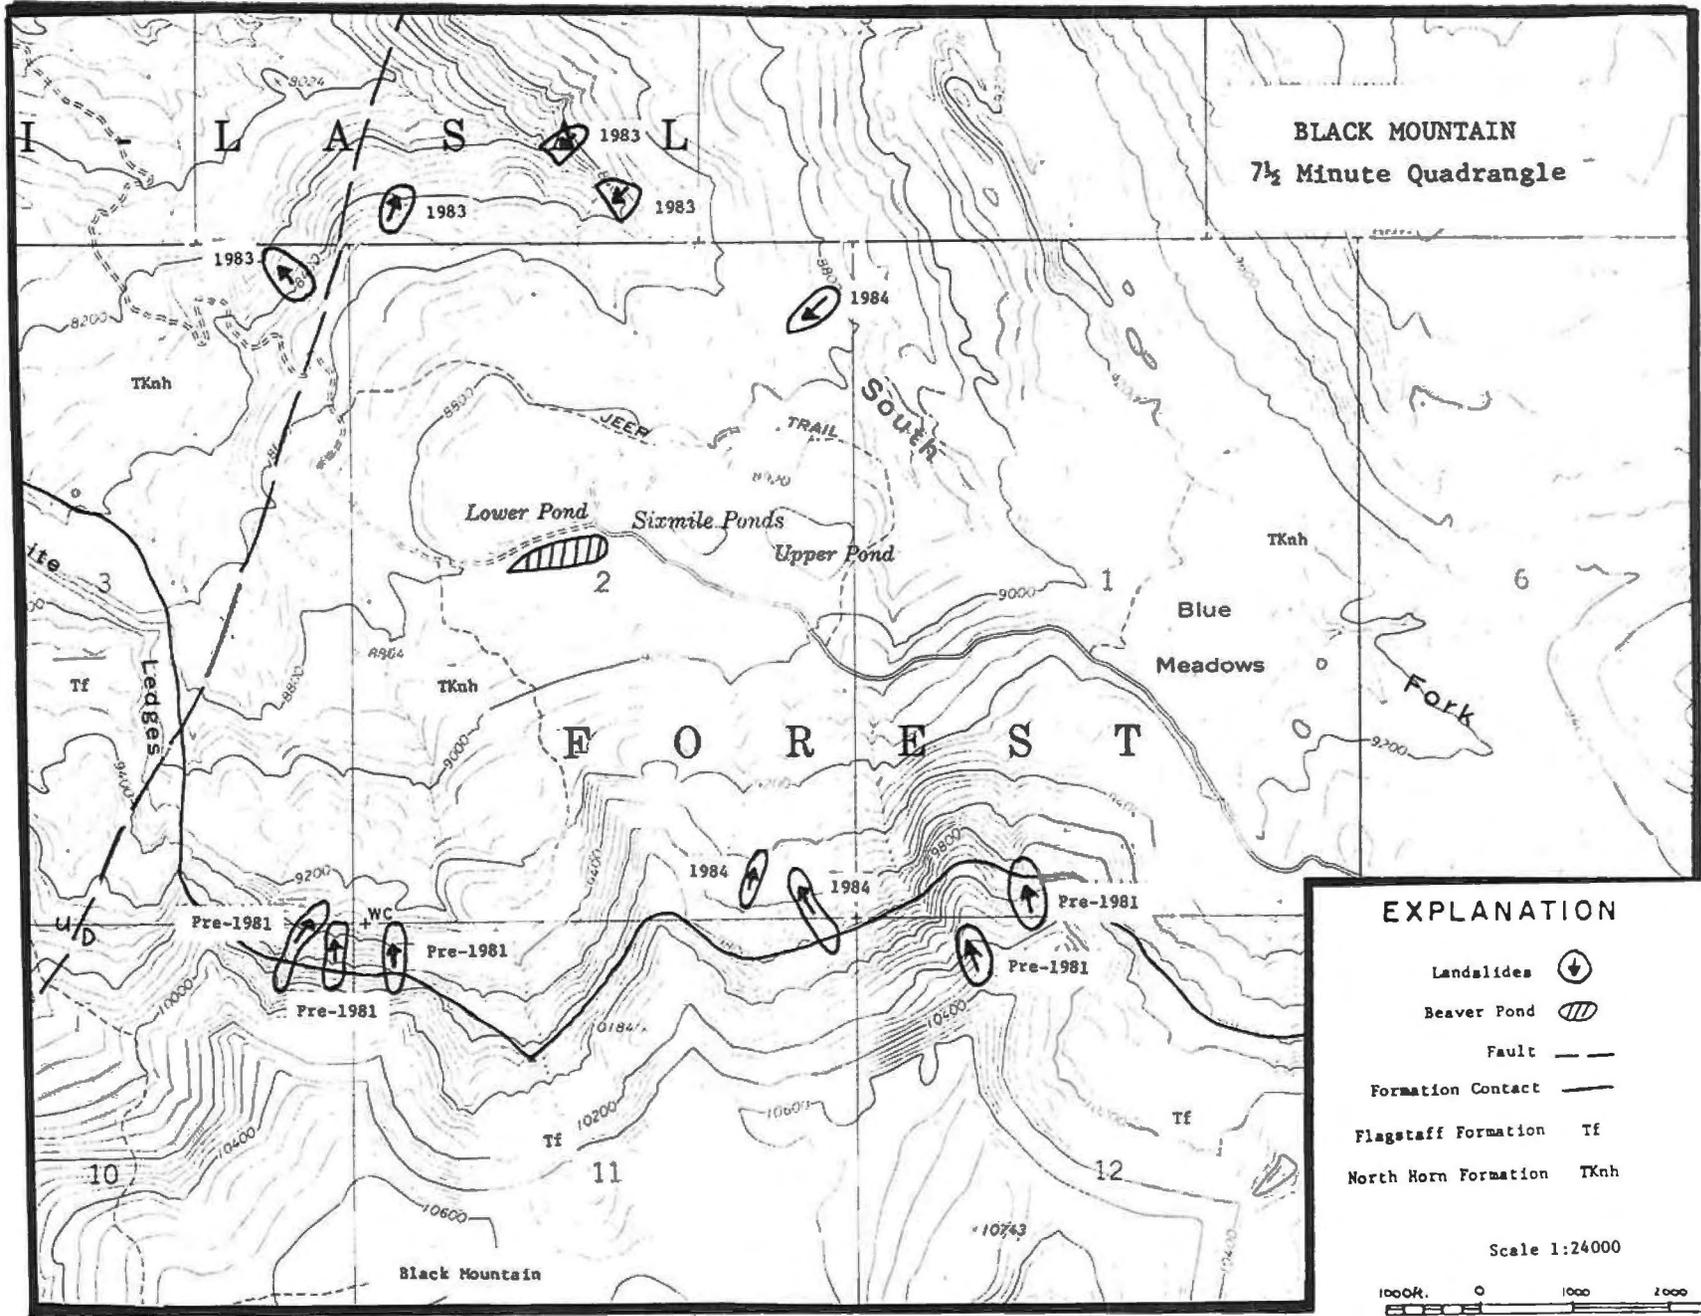
MAP 1

The subject area is located in the NE $\frac{1}{4}$ of Section 2, T19S, R3E (map 1). The dam associated with the Upper Pond failed and was subsequently breached in 1975. Reconstruction of the dam is now being evaluated for recreational purposes.
