Twelve Mile Canyon

Geologic Assessment
of the
Twin Lakes North and
South Landslide

by
Maureen McBrien, Geologist
Manti-LaSal National Forest

June 23, 1983

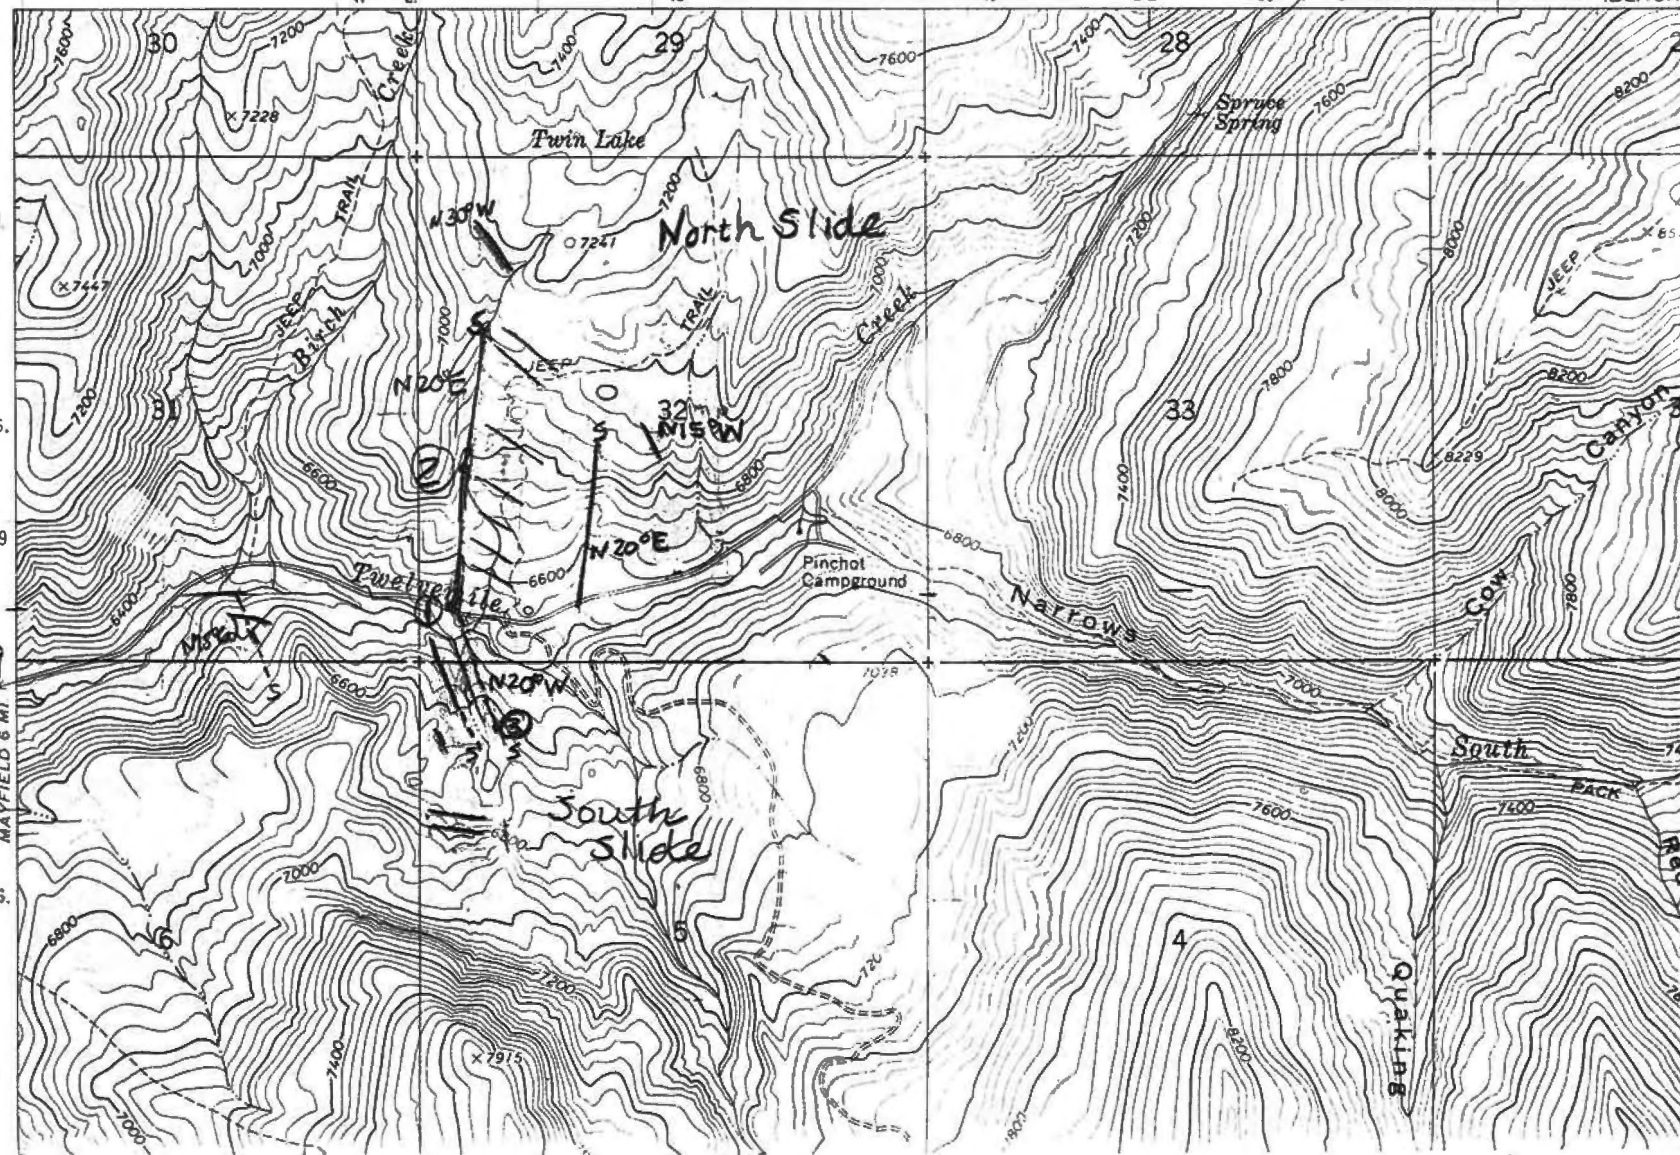
Twin Lakes
(North and South Slide)

The north paleolandslide is bounded to the west and east by a fault. The south slide is bounded by a fault on its east side. The active slides are smaller in extent than the topography indicates for the paleolandslides. New fissures are developing daily which indicate that the active land slide area is enlargening.

On June 5, 1983, Station 1 (See map 1) was set up near the toe and western flank shear of the slide to determine the approximate movement rate of the slide. Measurements were made until June 8, 1983. At Station 1 the landslide material was rotating downstream and compression features had destroyed the siting station. On June 6, 1983, a second station (Station 2, See map 1) was set up 3/8 of a mile north of the toe of the slide on the western flank shear during the construction of the diversion channel for the breaching of Twin Lakes. The second station was lost at 3:00 p.m., June 10, 1983.
