A Summary of the Sentinel Slide Project Zion National Park

Reoccurring landslides along the Zion Canyon Scenic Drive have required some creative solutions for maintaining a road in a location that is geologically active.

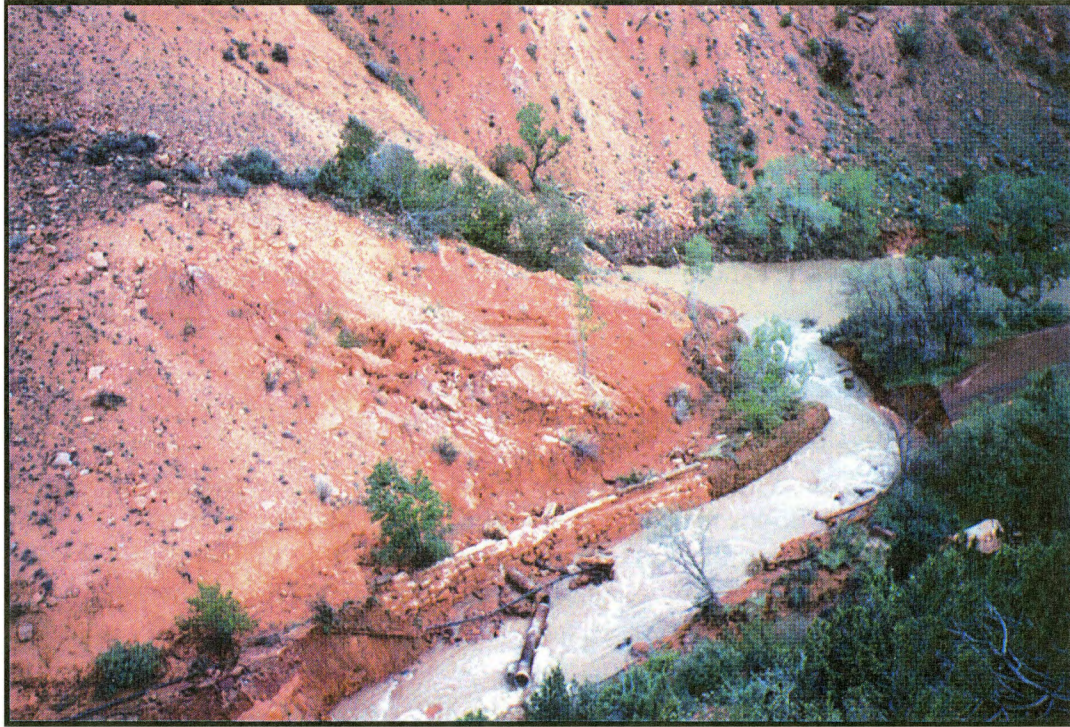
On April 12, 1995, about 110,000 cubic yards of rock and sand slid downward as mass, pushing into the channel of the North Fork of the Virgin River. A stream gauge downstream recorded an abrupt cessation of stream flow at 9:20 pm as the river had been dammed to a depth of about 15 feet. Campgrounds downstream were evacuated due to the risk of flooding if the dam breached abruptly. This did not happen, but in about 90 minutes the small lake behind the dam filled to the point that the roadway, now the lowest path for the water, acted as a spillway. About 600 feet of roadway was eroded away along with power, sewer and water lines.

Sentinel Slide shortly after slide movement on April 12, 1995. The river is now flowing in what used to be the road bed. It previously flowed on the west side of the stone retaining wall now visible on the far side of the river. The objects in the river bed are water, sewer and electric lines that had been buried in the road bed.

A temporary road passage was excavated in a few days, permitting emergency access to the lodge. Then during the winter of 1996 a 450-foot by 25-foot high retaining wall of concrete T-blocks¹ was constructed to support the road, a river channel capable of conveying a 100-year flood was excavated, and a rock buttress was added to the toe of the slide. The buttress is a dam of heavy basalt boulders at the toe of the slide, which act as a counterweight to reduce the risk of renewed sliding. The new road and channel had shifted 60 feet east around the slide debris.

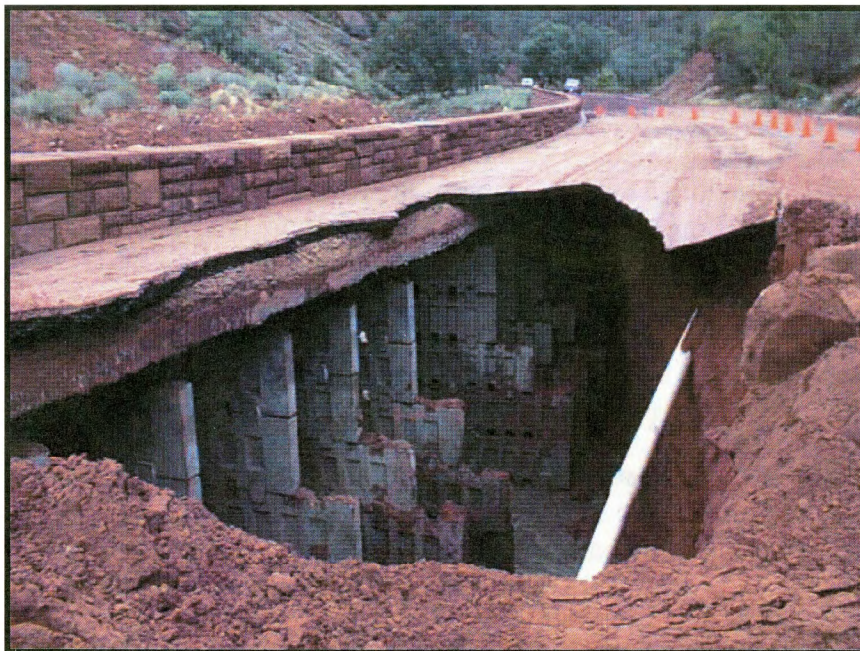
On September 11, 1998 a series of nighttime storms on already wet ground produced a flood of 4,500 cubic feet per second (cfs). This was a very short duration flood, rising sharply from 193 cfs at 8:45am to 4,500 cfs at about 10:00am, and then dropping to less than 1,000 cfs by noon. During that time the channel scoured down at least 6 feet, undermined the retaining wall and removed much of the gravel backfill. Depressions were observed in the road by 11:00am and a large sinkhole opened up in the roadbed minutes later. Later core drilling would document void spaces along the entire length of the wall.

Investigations showed that the wall had no provisions protecting it from channel scour. It was also found that the channel was so smooth, narrow and steep that it produced extreme water velocities and "supercritical" flow conditions that could move all but the largest boulders. More disturbing was the fact that a flood of this size has occurred on average every 12-15 years, far to frequent for damage of this magnitude to be tolerated.

Road Damage from scour under retaining wall and road during flood of September 1998.

A two-phased project was undertaken to repair the wall and correct the deficiencies. Phase I was the disassembly of the retaining wall, installation of a 20-foot deep secant pile wall (a curtain of overlapping 30" diameter holes drilled into the underlying slide debris and grouted with concrete) followed by reassembly of the retaining wall. It was accomplished during the winter of 1999. The piles are designed to provide protection from an additional 12 feet of channel scour.

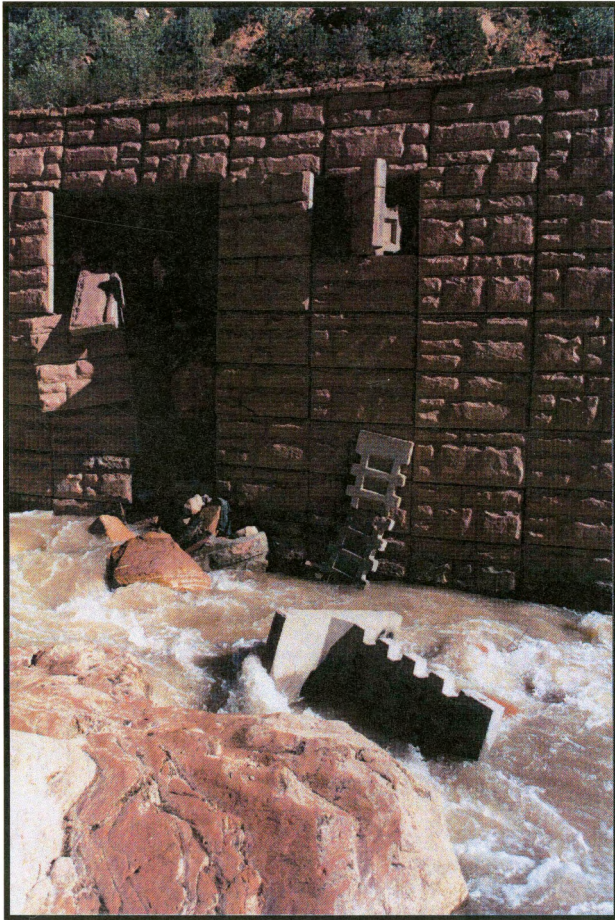
Damage to the retaining wall from scour during the September 1998 flood event.

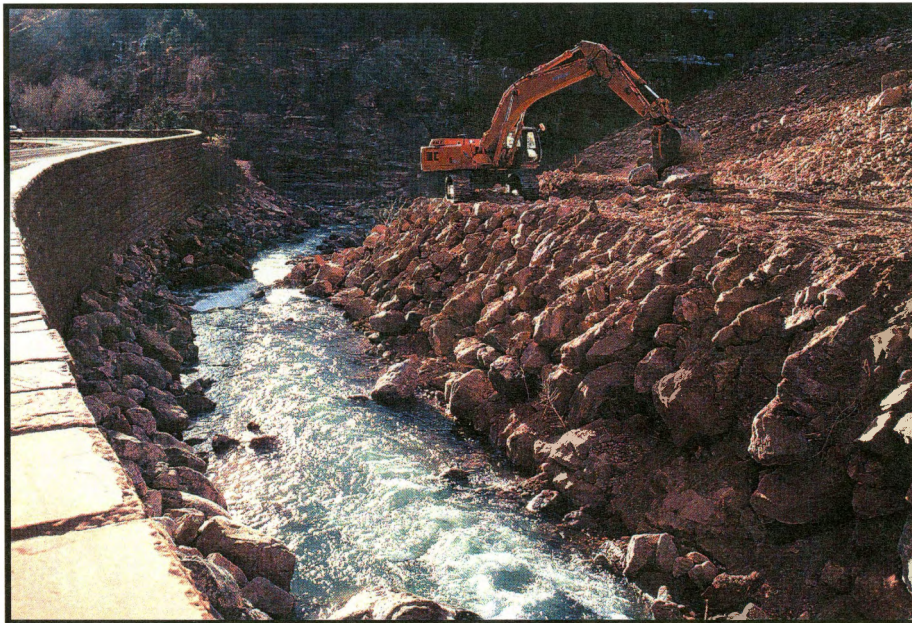
The widened channel conveyed floods in October and November 2004, and January 2005 fairly well. These are the first significant floods since the 1998 flood that damaged the retaining wall, and are of comparable magnitude. Scour of gravel bars upstream of the slide indicate that no pooling occurred. Two of the four drop structures were disrupted, but the boulders remain and continue to contribute to channel roughness.

Construction project to widen the river channel between the slide buttress and retaining wall in 2000. The approximately 40-foot wide channel was widened by an additional 20 feet, and boulder drop structures were added to increase channel roughness.

Phase II involved widening and increasing the roughness of the river channel to reduce flow velocities during floods. Initial modeling of a widened channel showed disappointingly little reduction in flow velocities, with peak velocities during a 100-year flood event reduced only from 33 feet/second to 27 feet/second. It was realized that without increasing channel roughness, flow was continuing to be supercritical (somewhat analogous to supersonic movement in air) and not taking advantage of the widened channel. Supercritical stream flow behaves as a jet of water passing quickly through the center of the channel, while expending little energy flowing around irregularities in the channel. In contrast subcritical flow swirls around channel irregularities expending a substantial amount of energy as turbulence. As a result, modeling of a rougher channel showed peak velocities reduced to about 16 feet/second.

In order to get an idea of how wide to make the channel, the width of the natural channel several hundred feet upstream of the slide was measured. It was found that channel width during a 25-year flood averaged 67 feet in a natural channel, and only 39 feet where constricted by the Sentinel Slide. It was also found that during floods the constricted channel pooled water upstream of the slide. This had the effect of causing the gravel and cobbles to drop out of the flow and widen the channel. It also raised the water surface elevation, which would provide additional energy for scour as the water descended through the narrow section. The pooled channel was nearly twice as wide as the natural channel for the same flows.

It was therefore decided to widen the channel 20 feet, while adding large rocks and drop structures to achieve a roughness similar to natural channels. Further widening would have been desirable to alleviate hydraulic concerns, but would have further reduced the safety factor for renewed movement of the slide. The project was implemented during the spring of 2000. It entailed removing the existing rock buttress in 15-foot segments, removing 20 feet of slide material, and then reconstructing the rock buttress. Drop structures made out of boulders and additional boulder clusters were placed in the channel to increase roughness.
