Reply to: 2880 Geologic Services and Resources

Date: August 7, 1984

Subject: Land Stability of the Six Mile Ponds Area

To: William H. Boley, Forest Engineer

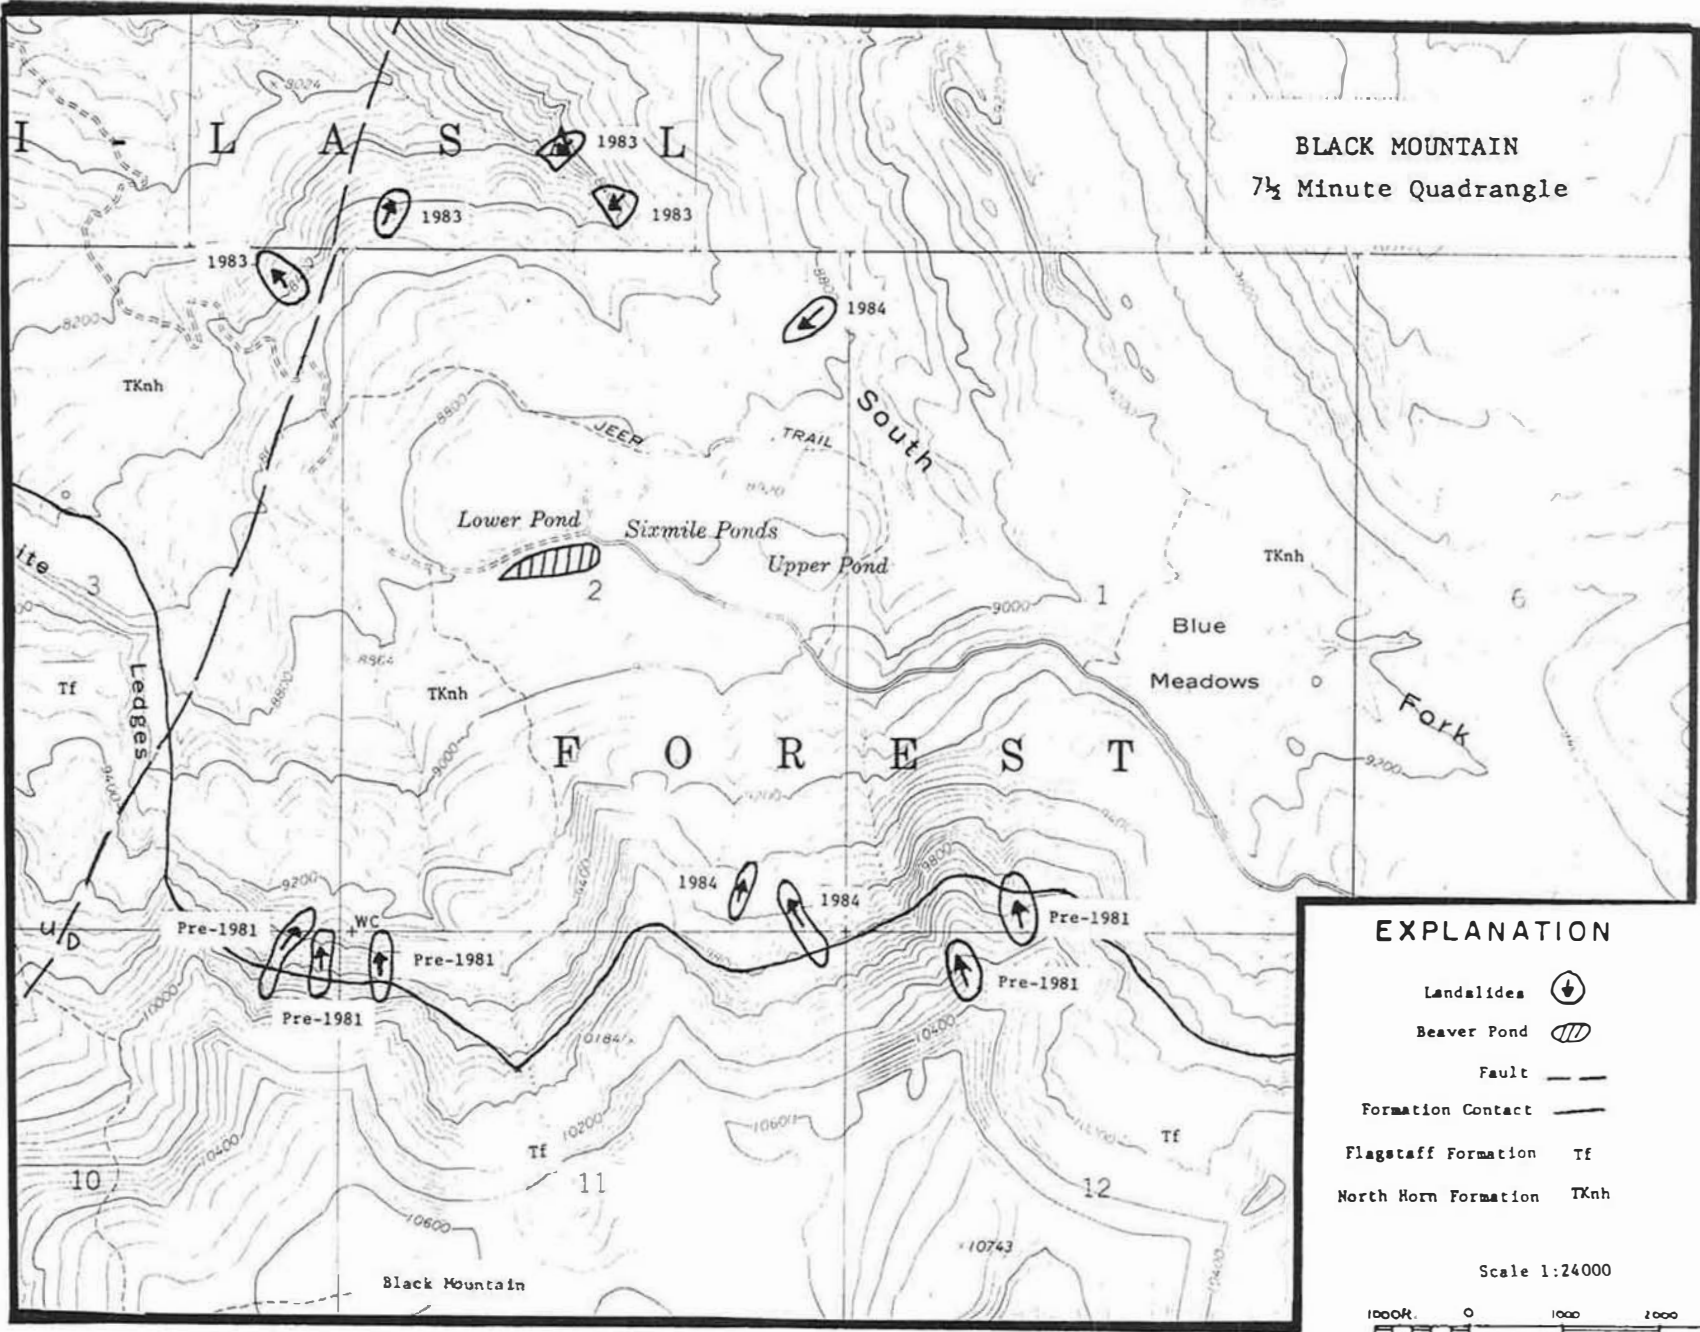
MAP 1

The subject area is located in the NE $\frac{1}{4}$ of Section 2, T19S, R3E (map 1). The dam associated with the Upper Pond failed and was subsequently breached in 1975. Reconstruction of the dam is now being evaluated for recreational purposes.
