Landslide Report

Attached are four "Mud and Flood" reports. The reports include information on land instability that Carter Reed and I observed in Twelve Mile Canyon and Manti Canyon.

## Mud and Flood Reporting Form

Mud and Flood Reporting Form

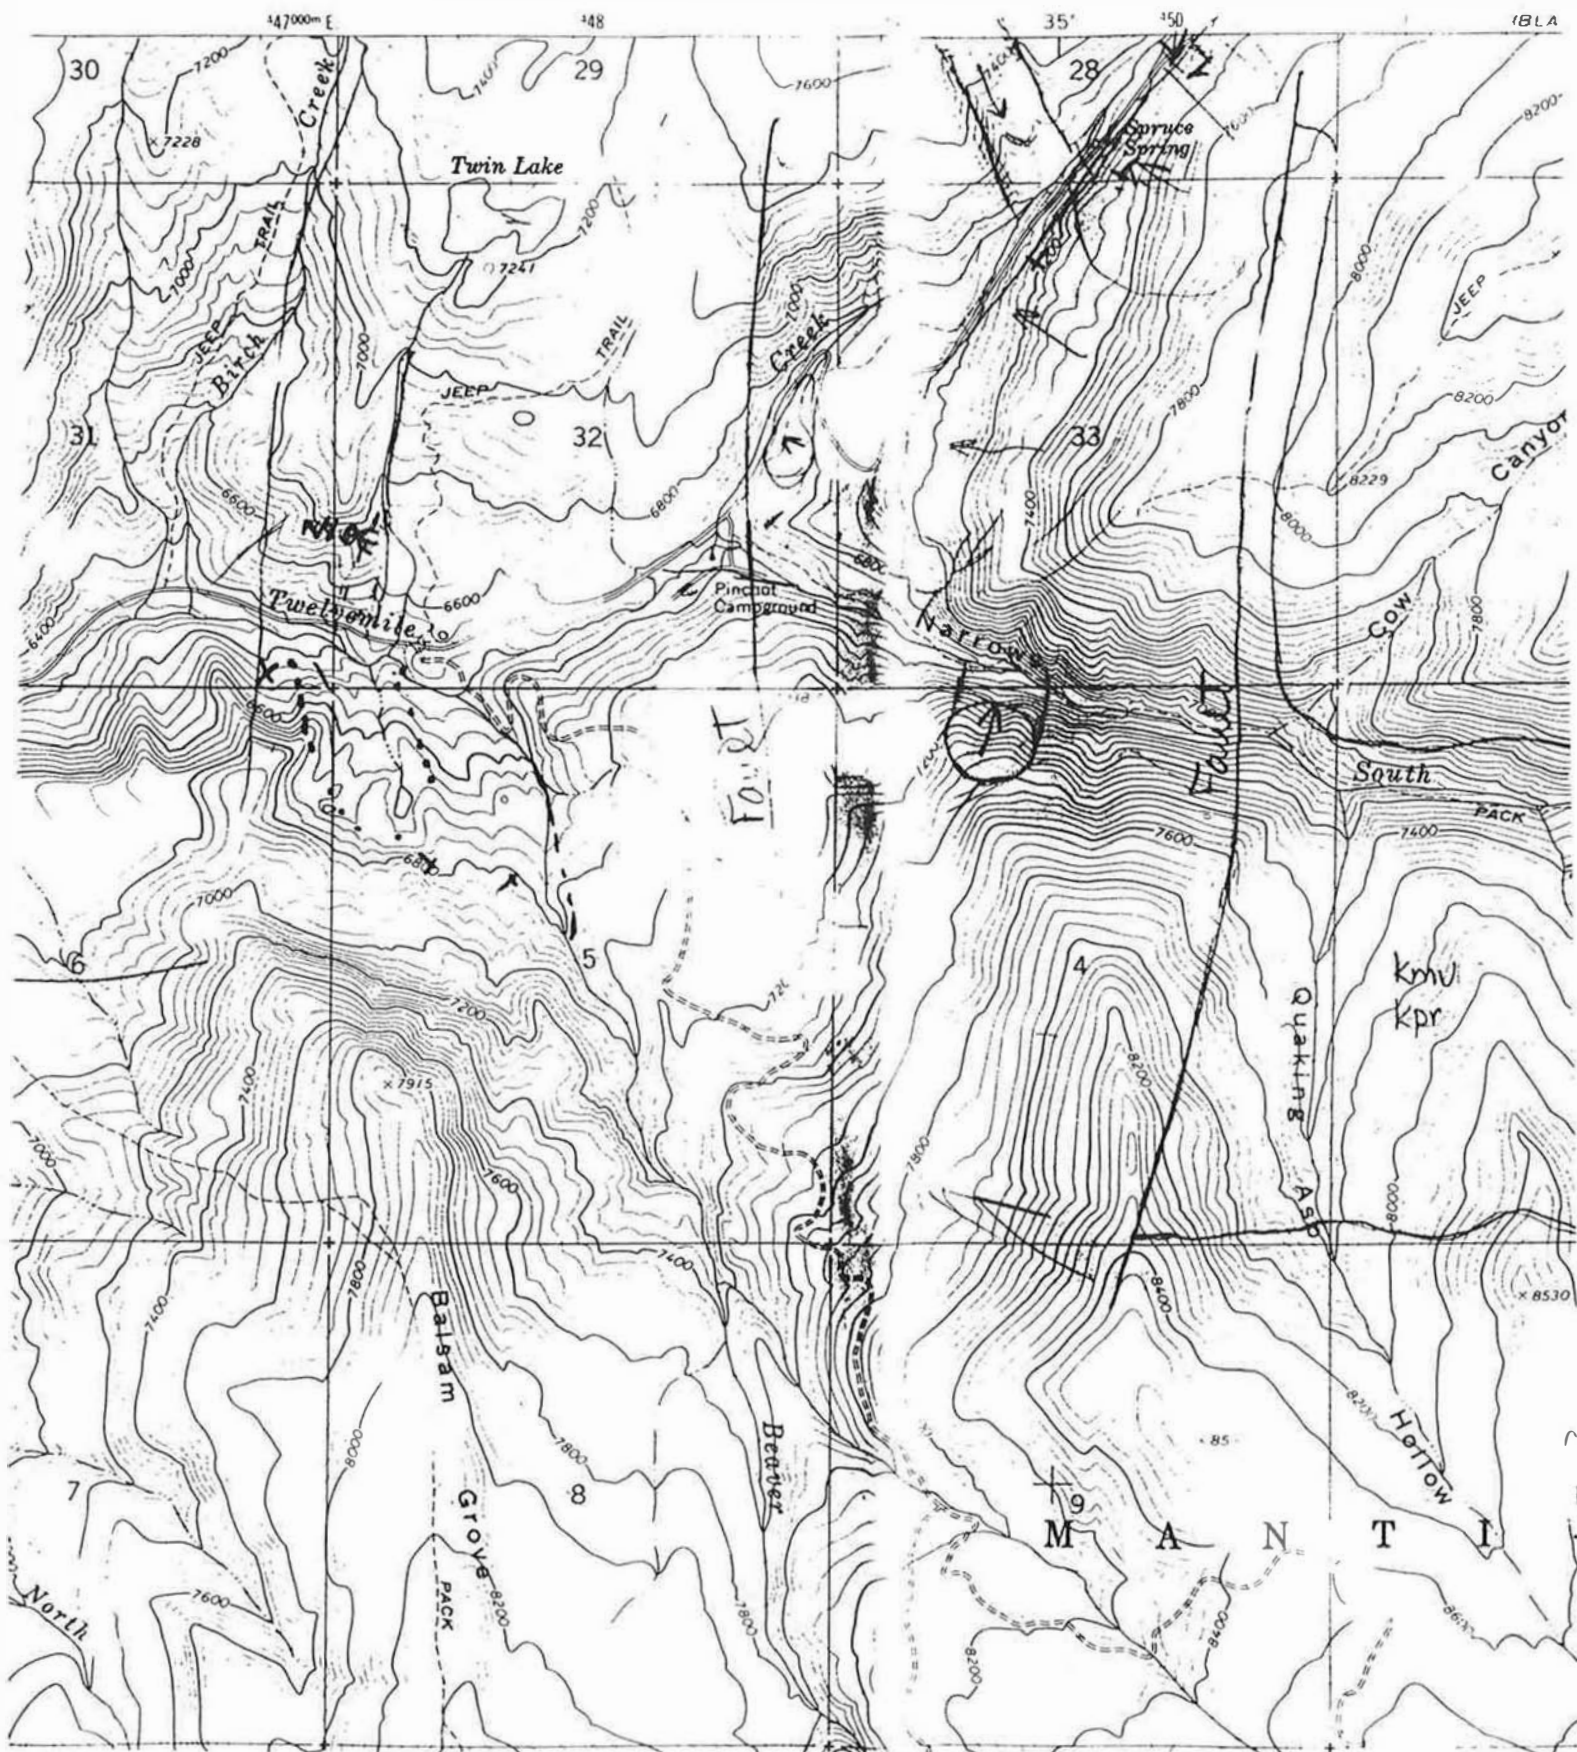
Topography Slopes of the North and South Forks of Twelve Mile Canyon

Legal Description Sec 32, 33, 28, 4, T19S, R 3E

See attached map - photos available

| <u>Date</u> | <u>Impacts</u> | <u>Forest Service Actions</u> |
|---|---|---|
| <p>5/24/83</p> <p>Carter Reed</p> <p>Fred Fitzgerald</p> | <p>Landslides along the southeast slope of the North Fork has upheaved, cracked and in a few locations covered the road. The area observed was between the switchback in the road above Pinchot CG - Spruce Spring and the next switchback to the north-east (Snowline). Pinchot CG was flooded due to sliding and flushing of water in the south fork and log jams. Photographs are available</p> | <p>F.S. made an attempt to rescue a private vehicle and a F.S. trailer trapped in the campground. A backhoe cleared the campground access road of a log jam. They were unable to get the truck or trailer free.</p> <p><u>Photographs in 1590 file</u></p> |

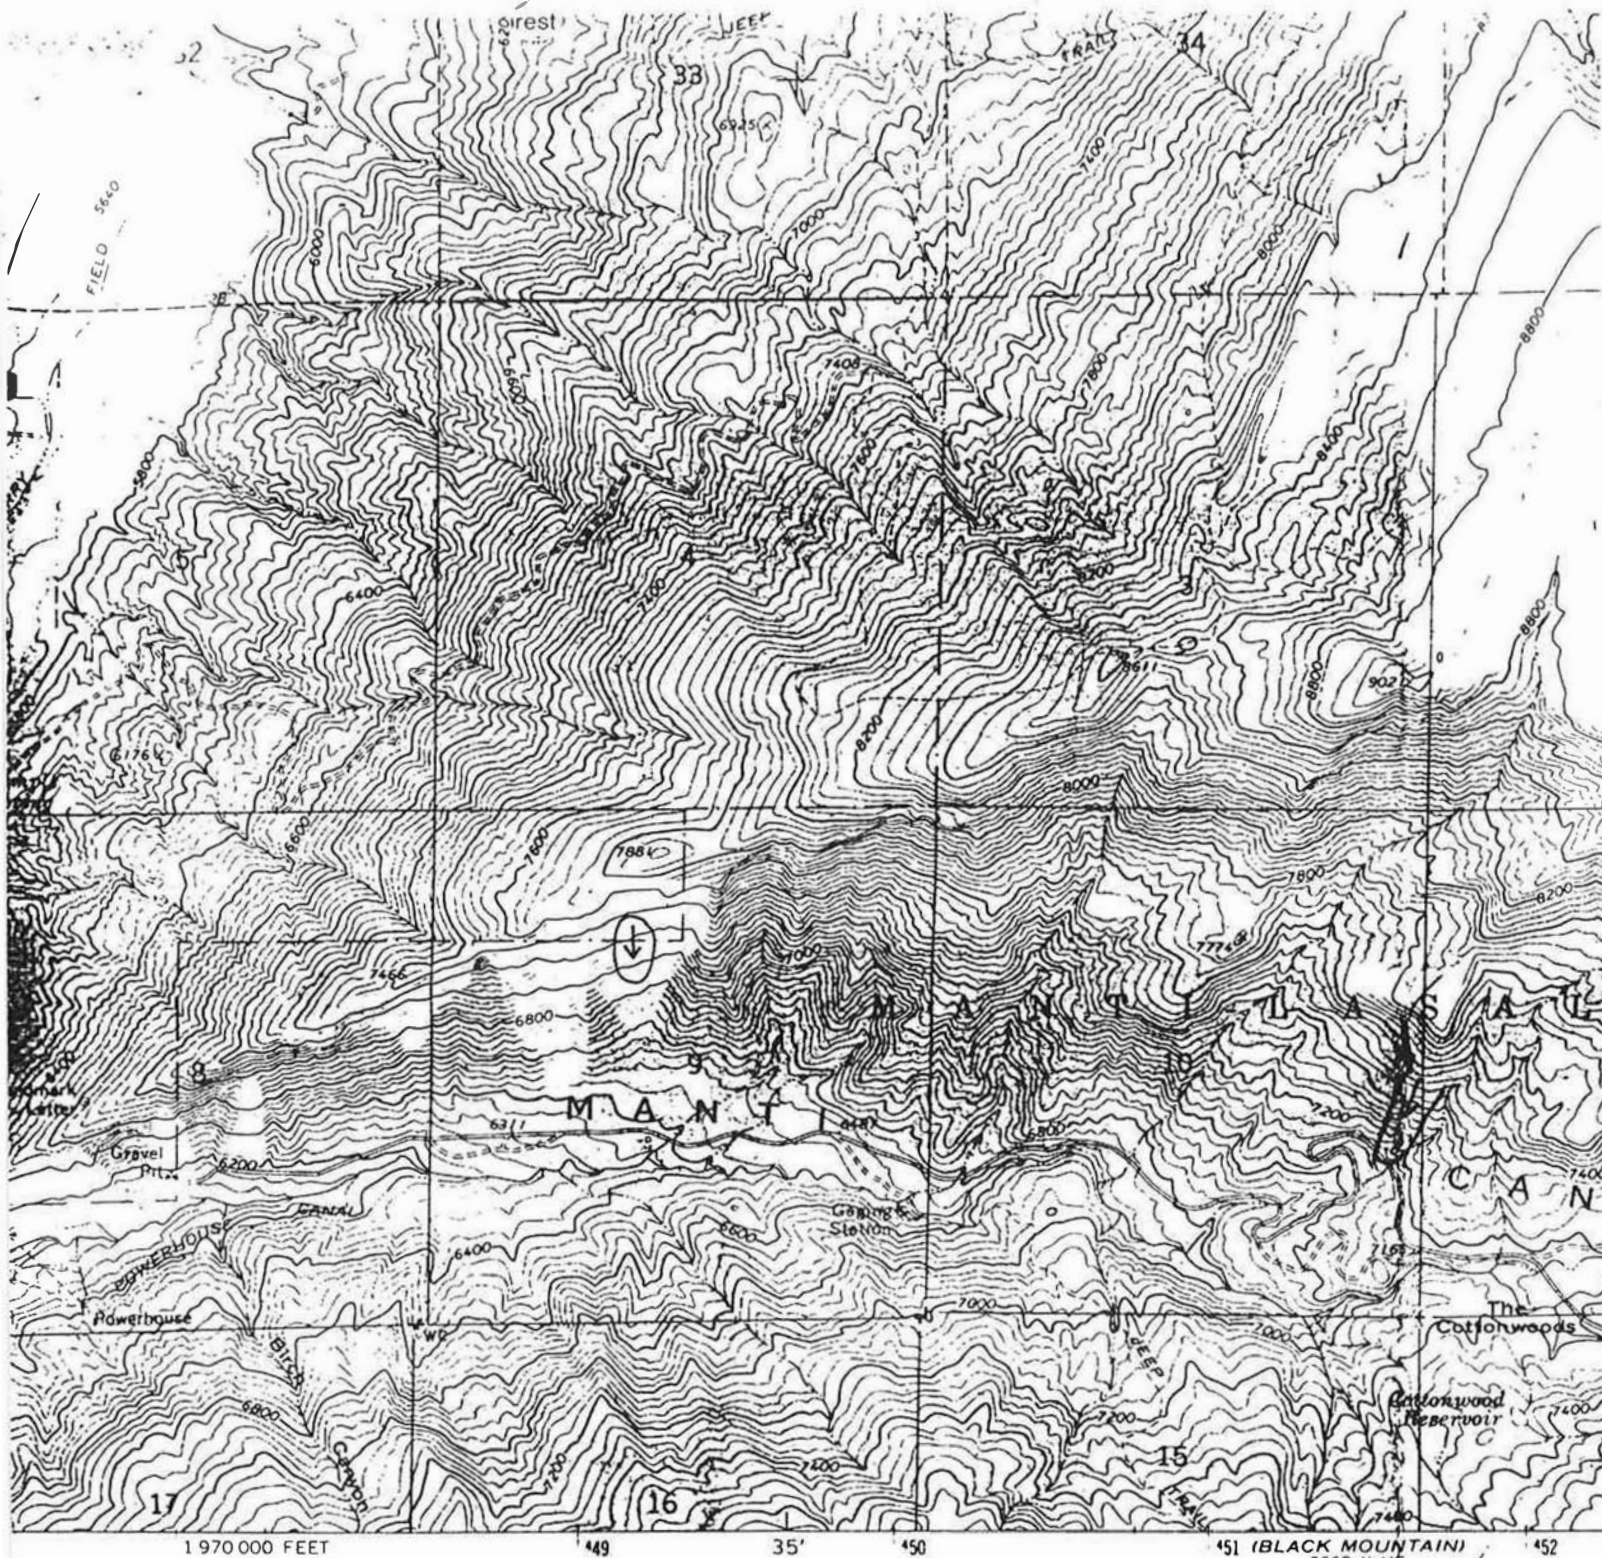
Type of Disturbance (i.e. mud flow, slump, etc.) landslide, - The North Slide area has been reactivated

Topography North slope of Mantí Canyon

Legal Description NE 1/4 SE 1/4 Sec 10, T18S, R3E

| <u>Date</u> | <u>Impacts</u> | <u>Forest Service Actions</u> |
|---|---|---|
| 6/3/83<br>Cauler Reed<br>Ed Carlson | The slide has covered the road making the road impassable for approx. 100' | None - the Mantí Canyon road is already closed to the public |
