Subject Twin Lakes North and South Landslide

Geologic Assessment
of the
Twin Lakes North and
South Landslide

by
Maureen McBrien, Geologist
Manti-LaSal National Forest

June 23, 1983

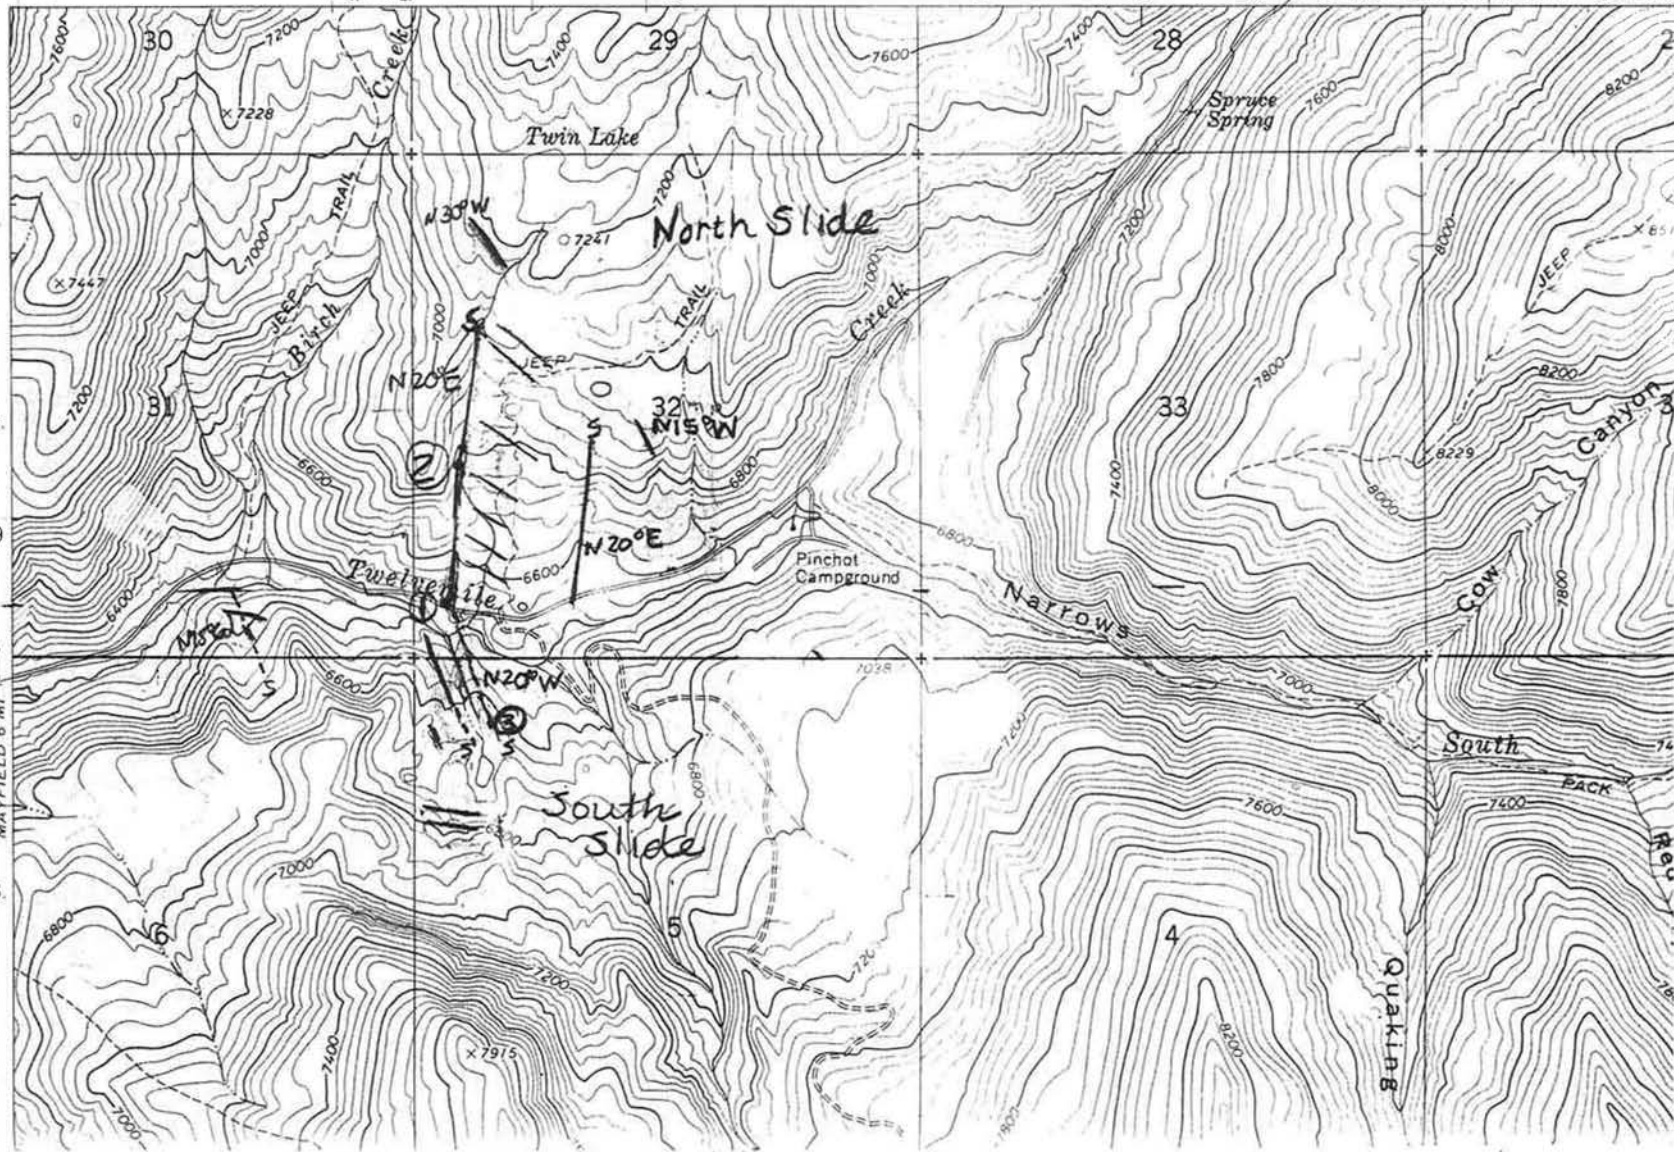
Twin Lakes
(North and South Slide)

The north paleo-landslide is bounded to the west and east by a fault. The south slide is bounded by a fault on its east side. The active slides are smaller in extent than the topography indicates for the paleo-landslides. New fissures are developing daily which indicate that the active landslide area is enlargening.

On June 5, 1983, Station 1 (See map 1) was set up near the toe and western flank shear of the slide to determine the approximate movement rate of the slide. Measurements were made until June 8, 1983. At Station 1 the landslide material was rotating downstream and compression features had destroyed the siting station. On June 6, 1983, a second station (Station 2, See map 1) was set up 3/8 of a mile north of the toe of the slide on the western flank shear during the construction of the diversion channel for the breaching of Twin Lakes. The second station was lost at 3:00 p.m., June 10, 1983.
