## Utah Geological Survey

<b>Project:</b> Geologic reconnaissance of the Zion Canyon landslide of April 12, 1995, Zion National Park, Washington County, Utah			<b>Requesting Agency:</b> Emergency Response
<b>By:</b> Barry J. Solomon	<b>Date:</b> 4-28-95	<b>County:</b> Washington	<b>Job No:</b> 95-08
<b>USGS Quadrangle:</b> Springdale East (73)

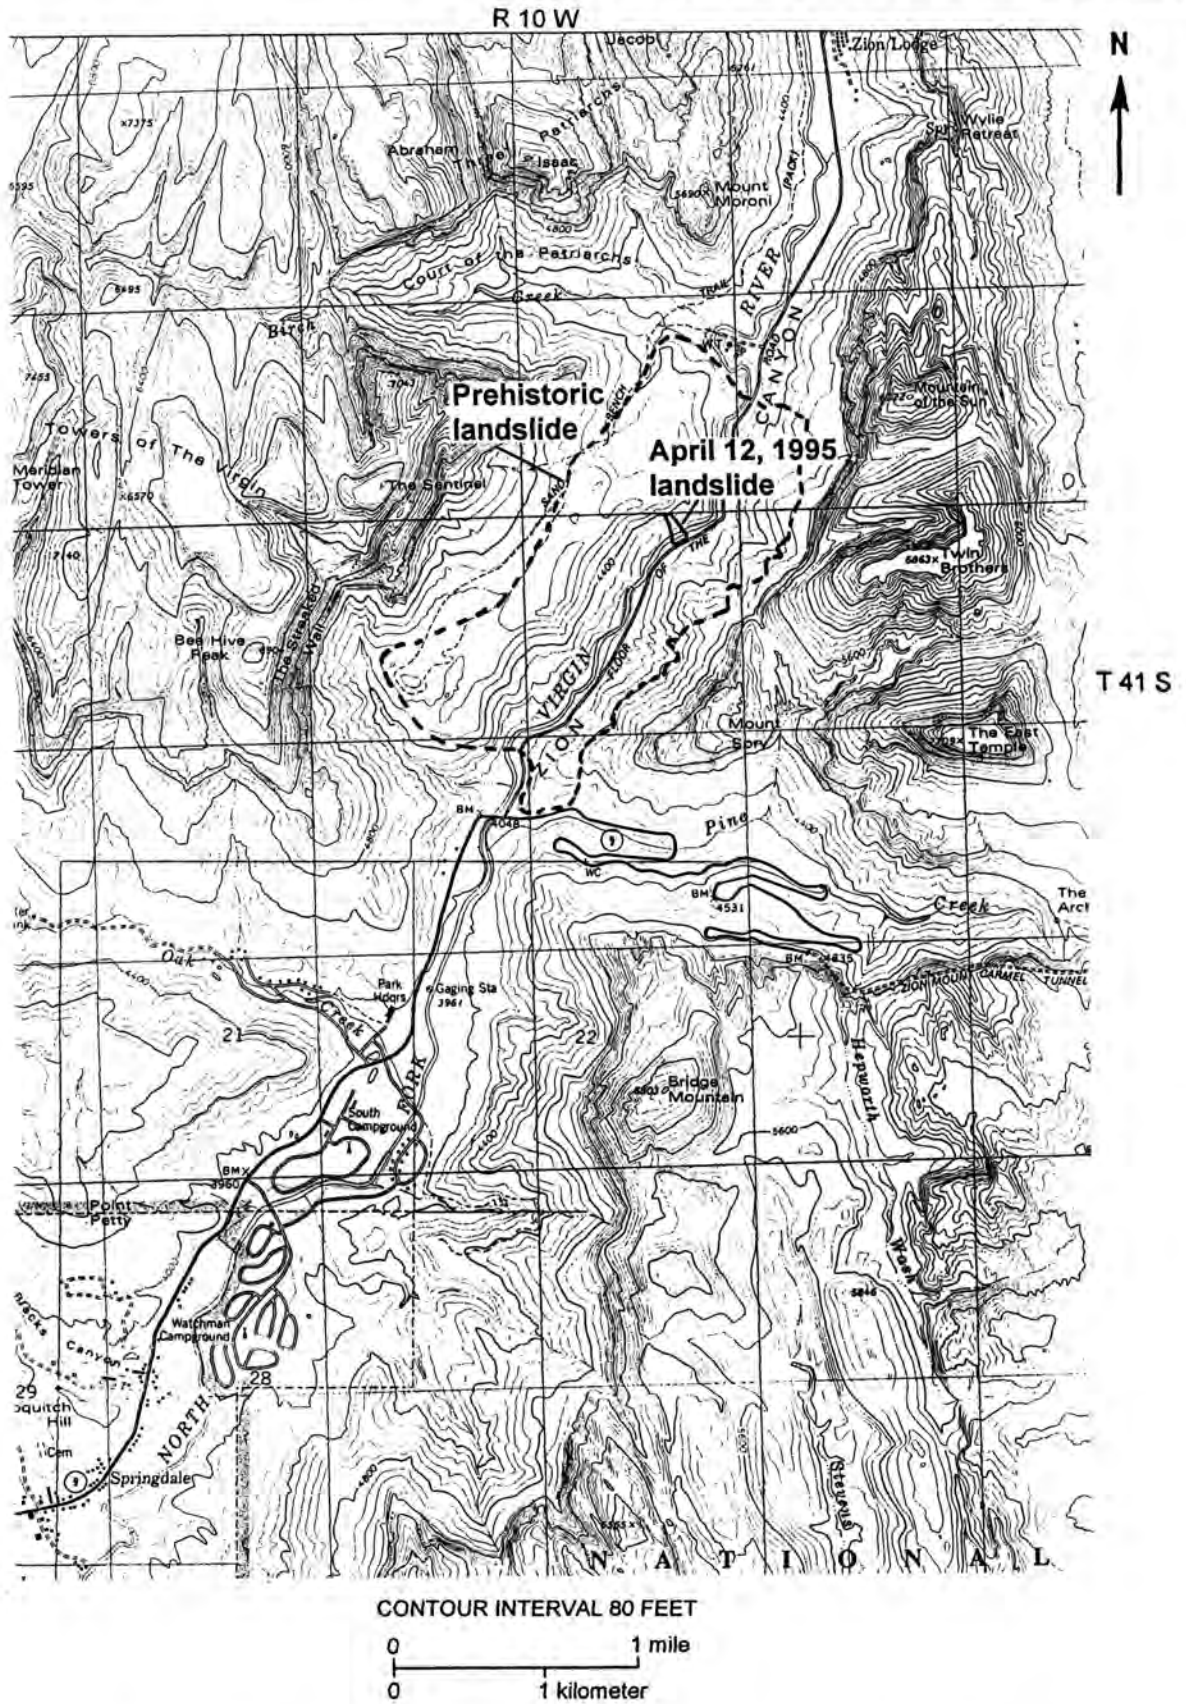
At about 9:00 p.m. on April 12, 1995, a landslide occurred on the west bank of the north fork of the Virgin River in Zion Canyon, Zion National Park (attachment 1). The landslide dammed the river and formed a pond about 20 feet (6 m) deep. About 1,000 campers were evacuated from the Watchman and South campgrounds downstream in case sudden dam failure initiated flooding. Drinking-water supplies were temporarily disrupted in the campgrounds and in the town of Springdale, 3 miles (5 km) south of the landslide. The river gradually cut around the toe of the slide and drained the pond, but caused no downstream flooding. As the river flowed around the slide it eroded the east river bank and washed out a 600-foot (180-m) section of the adjacent Zion Canyon Scenic Drive. The road was the only access for vehicular traffic to Zion Lodge, where more than 300 guests and lodge employees were stranded without water, sewer, electricity, or phone service. A one-lane, temporary road was cut into the slope on the east side of the river by park personnel for evacuation of the lodge, which was completed on the morning of April 14.

The landslide moved southeast from the face of Sand Bench, a 600-foot- (180-m-) high bluff at the base of a prominent sandstone cliff (attachment 1). The cliff rises another 2,200 feet (670 m) to an elevation of 7,043 feet (2,147 m) at the peak of The Sentinel. Prehistoric landslide deposits form the bulk of the bluff (Grater, 1945). A terrace on the upper surface of the bluff, part of the "high terrace remnants" identified by Coney (1959), developed in the late Pleistocene when the Virgin River was from 600 to 900 feet (180-270 m) above its present level.

The prehistoric landslide (attachment 1) detached from the face of The Sentinel and slumped beneath the terrace (Eardley, 1965), blocking Zion Canyon and creating an extensive lake (Grater, 1945). The canyon was first blocked about 4,000 years ago, an age determined by radiocarbon dating, measurement of varves in lake clays, and estimation of the rate of sediment transport in the river (Hamilton, 1979). The lake behind the prehistoric landslide dam was about 0.7 square miles (1.8 km<sup>2</sup>) in area and at least 350 feet (115 m) deep during its early years (Hamilton, 1979). A radiocarbon date of 3,600 ± 400 years B.P. on plant carbon from non-lacustrine silt above the lake beds indicates when the dam was finally breached by the lake waters.

Attachment 1. The landslide of April 12, 1995 and a generalized outline of the prehistoric landslide (modified from Hamilton, 1978) in Zion Canyon.
