**RED NARROWS LANDSLIDE  
US-6 SPANISH FORK CANYON  
M.P. 192.9**

**GEOTECHNICAL DIVISION REPORT**

**FIELD TRIP REPORT  
GEOTECHNICAL SECTION**

**Landslide Site Reconnaissance**

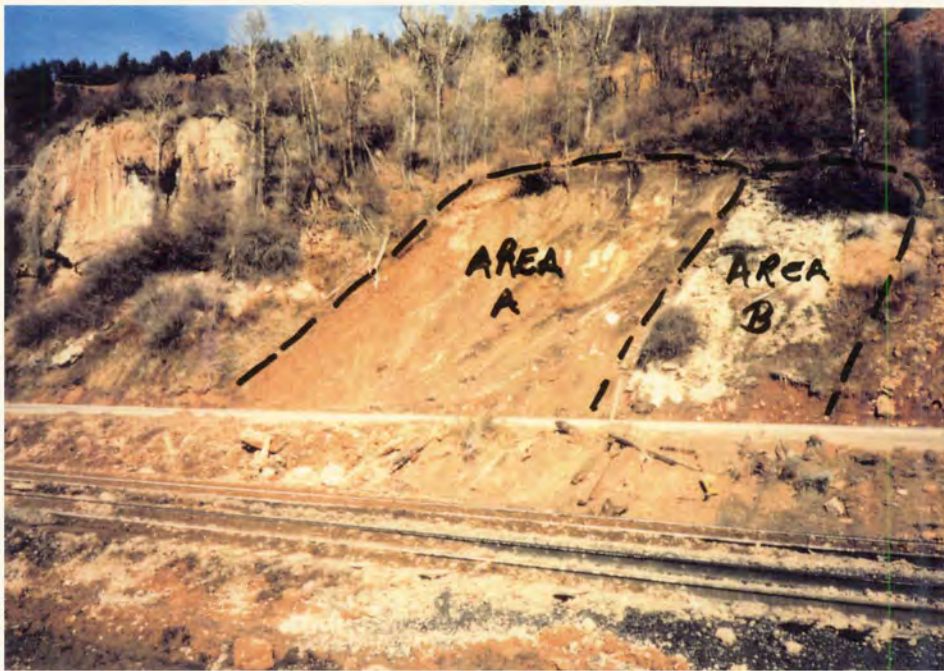
Area A and B  
before Area B  
was released

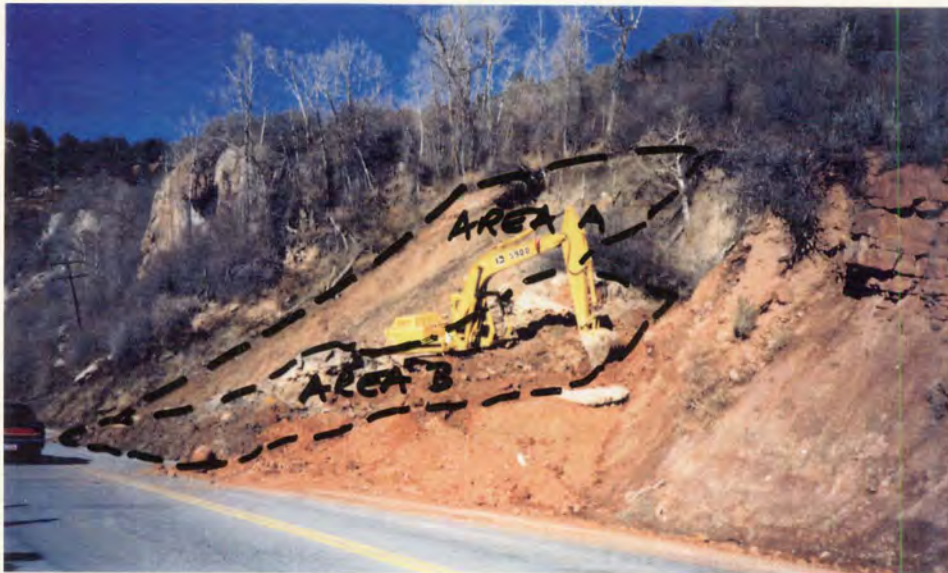
**COMMENTS:** On November 14, 1995 at 9:00 a.m. Region 3 mobilized a track hoe, the necessary support equipment, and the traffic control support to bring down the unstable material in a controlled, safe and restrained manner. The track hoe built access up to the unstable material and cautiously removed the "tufa cap rock" and undercut the toe which caused the release of the saturated material in Area B. The material came down at 11:35 a.m. (See photos page 1). The support equipment then removed the debris.

Area A and B  
after Area B  
was released

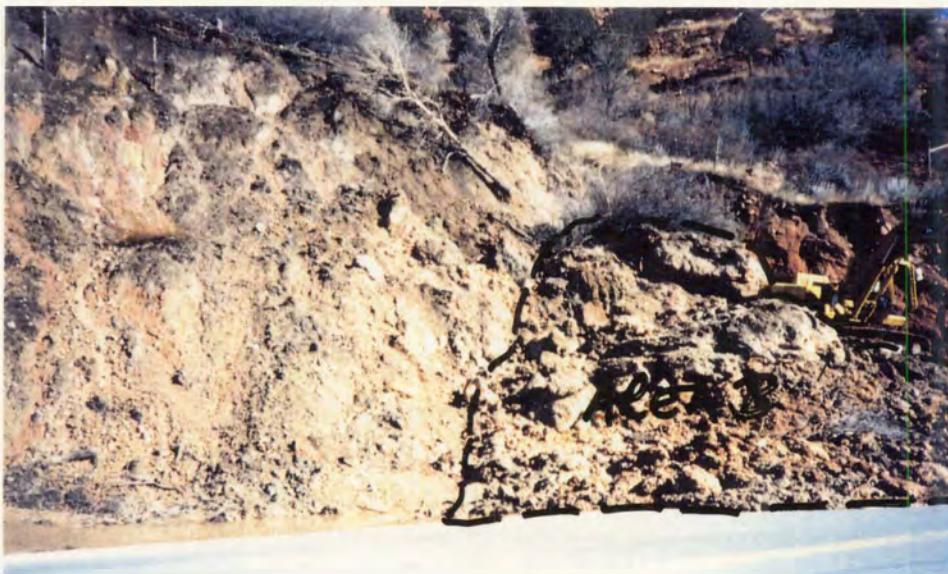
Area B after  
release

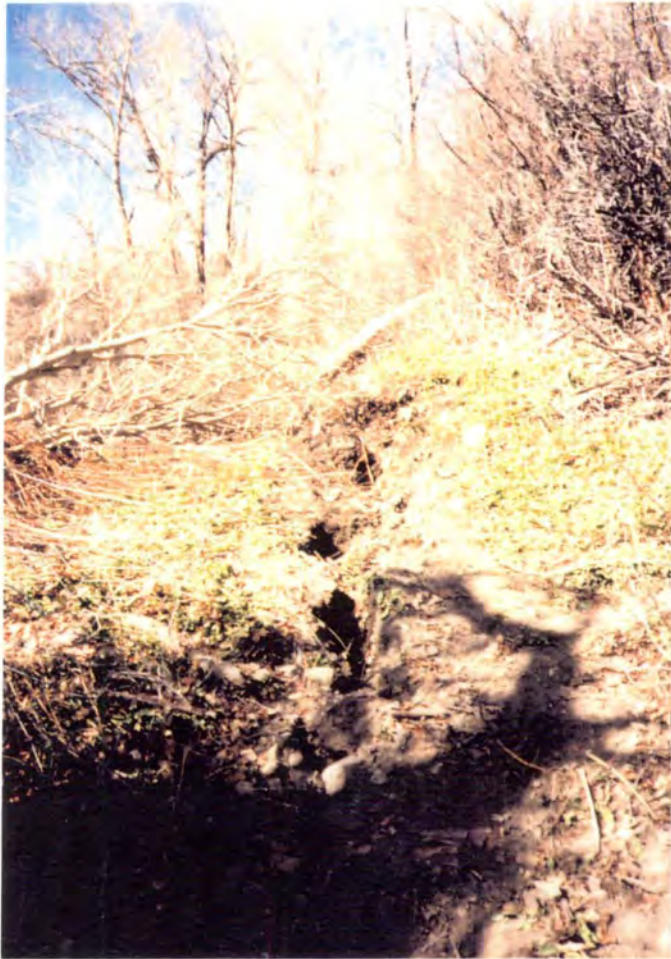
Open Crack above Area B  
before release

The second area of concern is directly east of the slide (Area B, Figure 1). This block will probably come down in the near future. The toe is currently undercut and the head scarp has a six inch wide crack. It is recommended that this area should be brought down mechanically before mother nature brings it down at an inconvenient time.

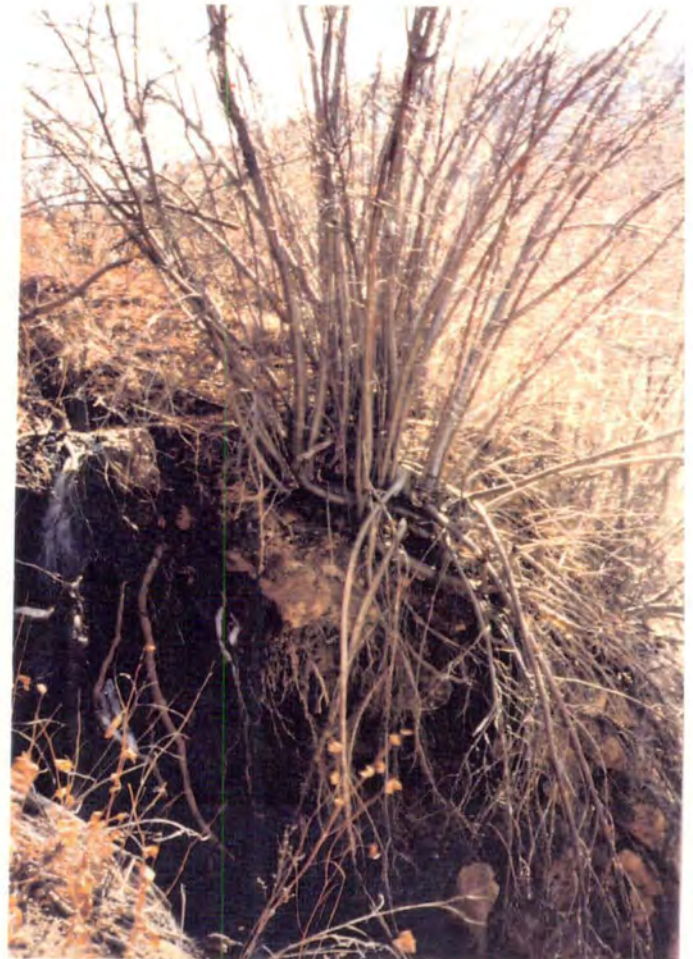
- 1) Water is coming in from above - see photo page 2.
- 2) Tufa deposits indicate a possible deep seated spring source and water could be coming directly into hillside.
- 3) Water could be collecting behind the self sealing tufa deposits and building up pressure.

Flowing water and Erosion above  
Area C

- 1) Track the water coming into the areas from above by using dye.
- 2) Monitor seismic activity for ground vibration. Several "micro slides" were noted as trains passed by, possibly adding to the liquefaction potential of the saturated soil.
- 3) Define subsurface contacts either through drilling or geophysical survey.
- 4) Accumulate the surface water coming into the area with collection basins and pipe the water past the cut slopes.
- 5) Horizontal dewatering holes might be warranted if water is coming from a spring source.
- 6) Removal of tufa deposits might allow water to migrate through the ground.

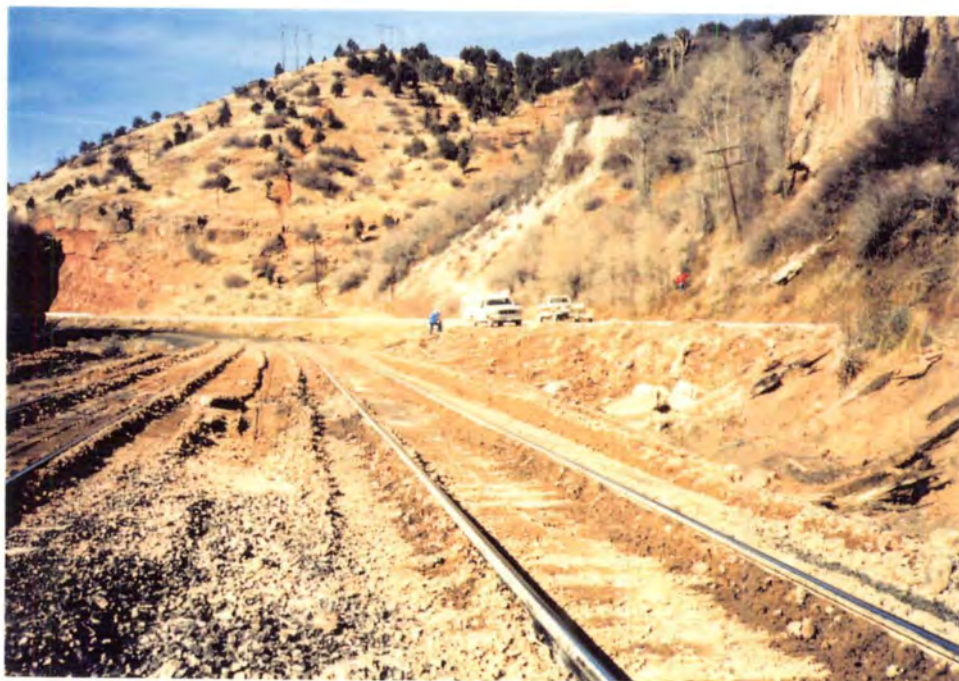
Area of Railroad tracks covered by  
the toe of the slide (After cleanup)

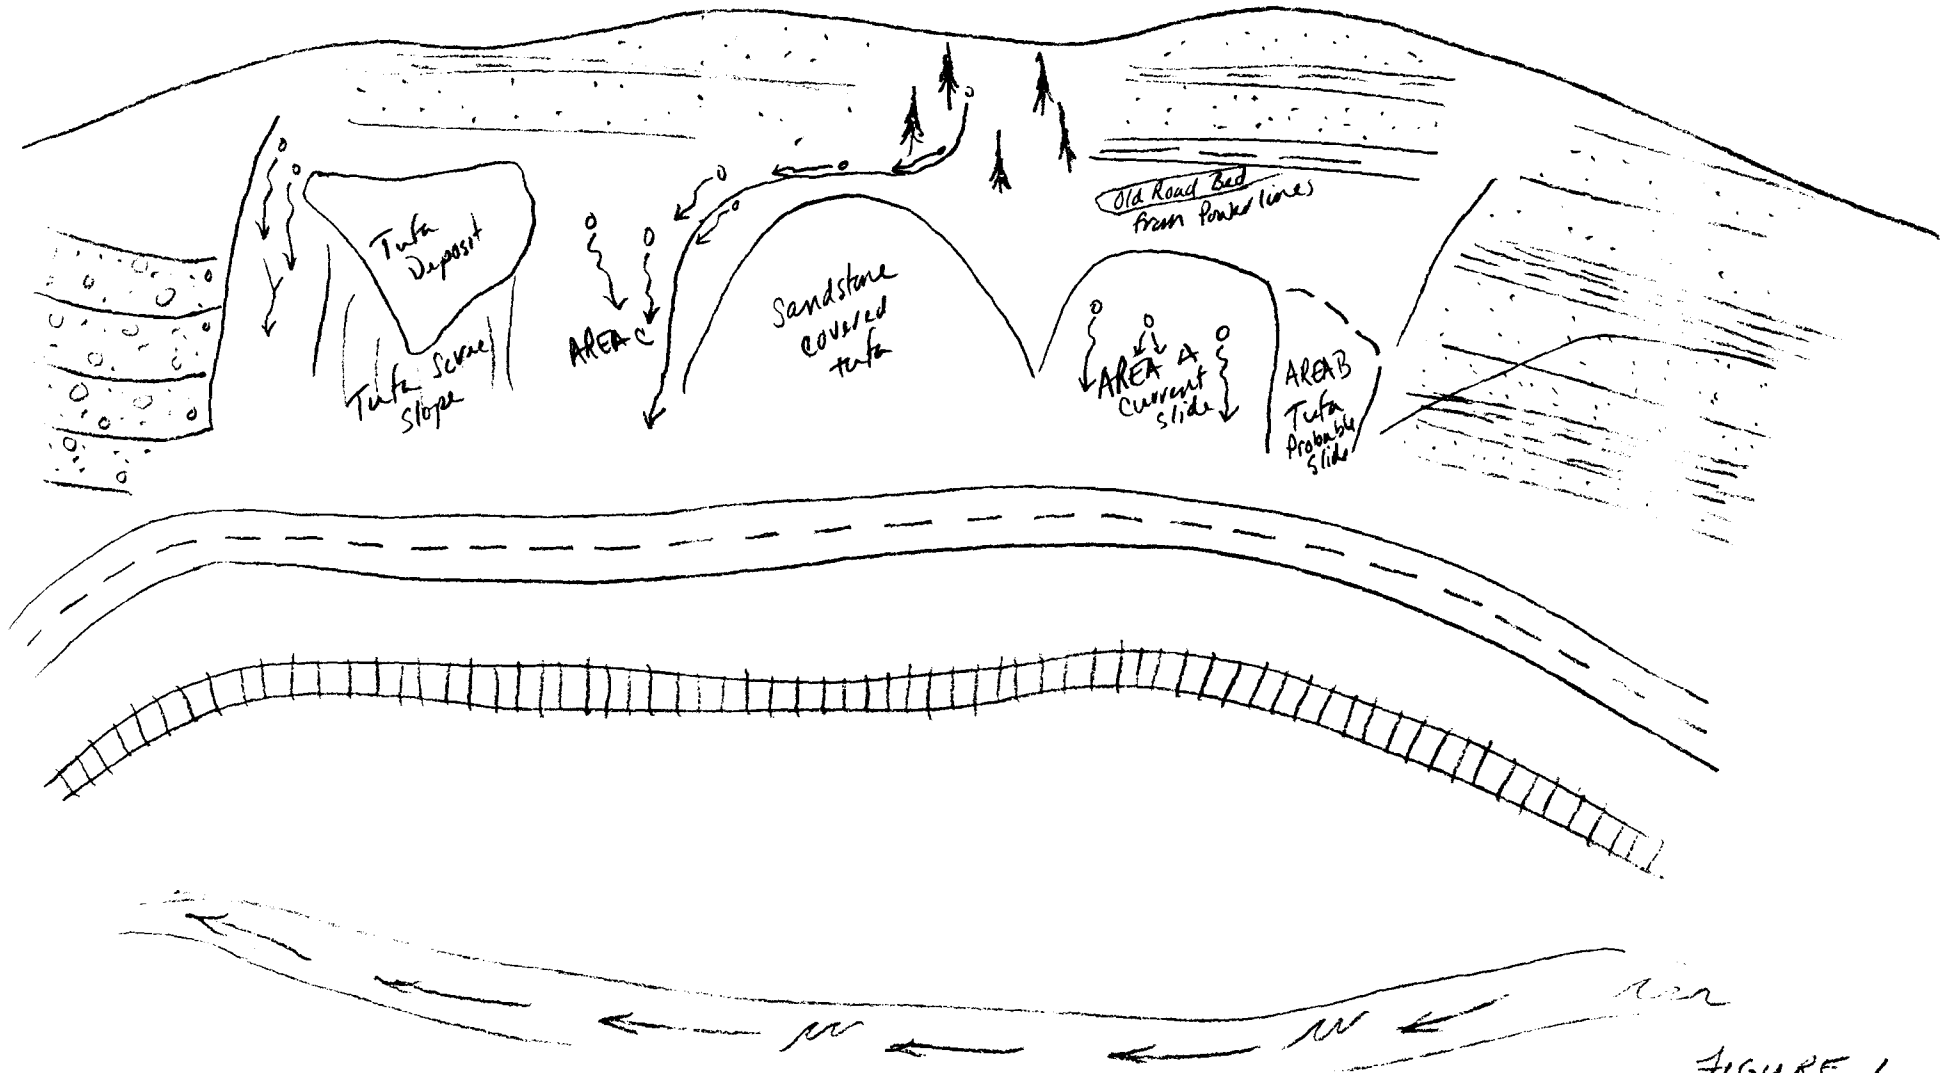
The area that slid on November 3 (Area A, Figure 1) is heavily saturated with water, currently seeping out of the scarp. Above the scarp, an old road bed, from power line construction, is collecting the water and saturating the ground below. The slide is approximately 100 feet wide and has a scarp 120 feet high. The material that has been removed consists of colluvium that was probably covered with a superficial layer of tufa. The face of the scarp appears to be rock and further slumping in the near future from this scarp is unlikely.

The third area of concern is west of the slide (Area C, Figure 1). This area has a large volume of water and field evidence of previous ancient small slides. The water source from the drainage is derived from the drainage to the east and is cross cutting the hillside and draining into Area C. At this time the area is stable, but the area should be monitored for cracking and care should be taken not to under cut the toe of the area.

**FURTHER INVESTIGATION:** Meet with Regional Engineer and maintenance personnel on site to formulate further investigations. The slide areas appear to be small, but drill holes would confirm the field observations. Horizontal dewatering holes might be warranted.

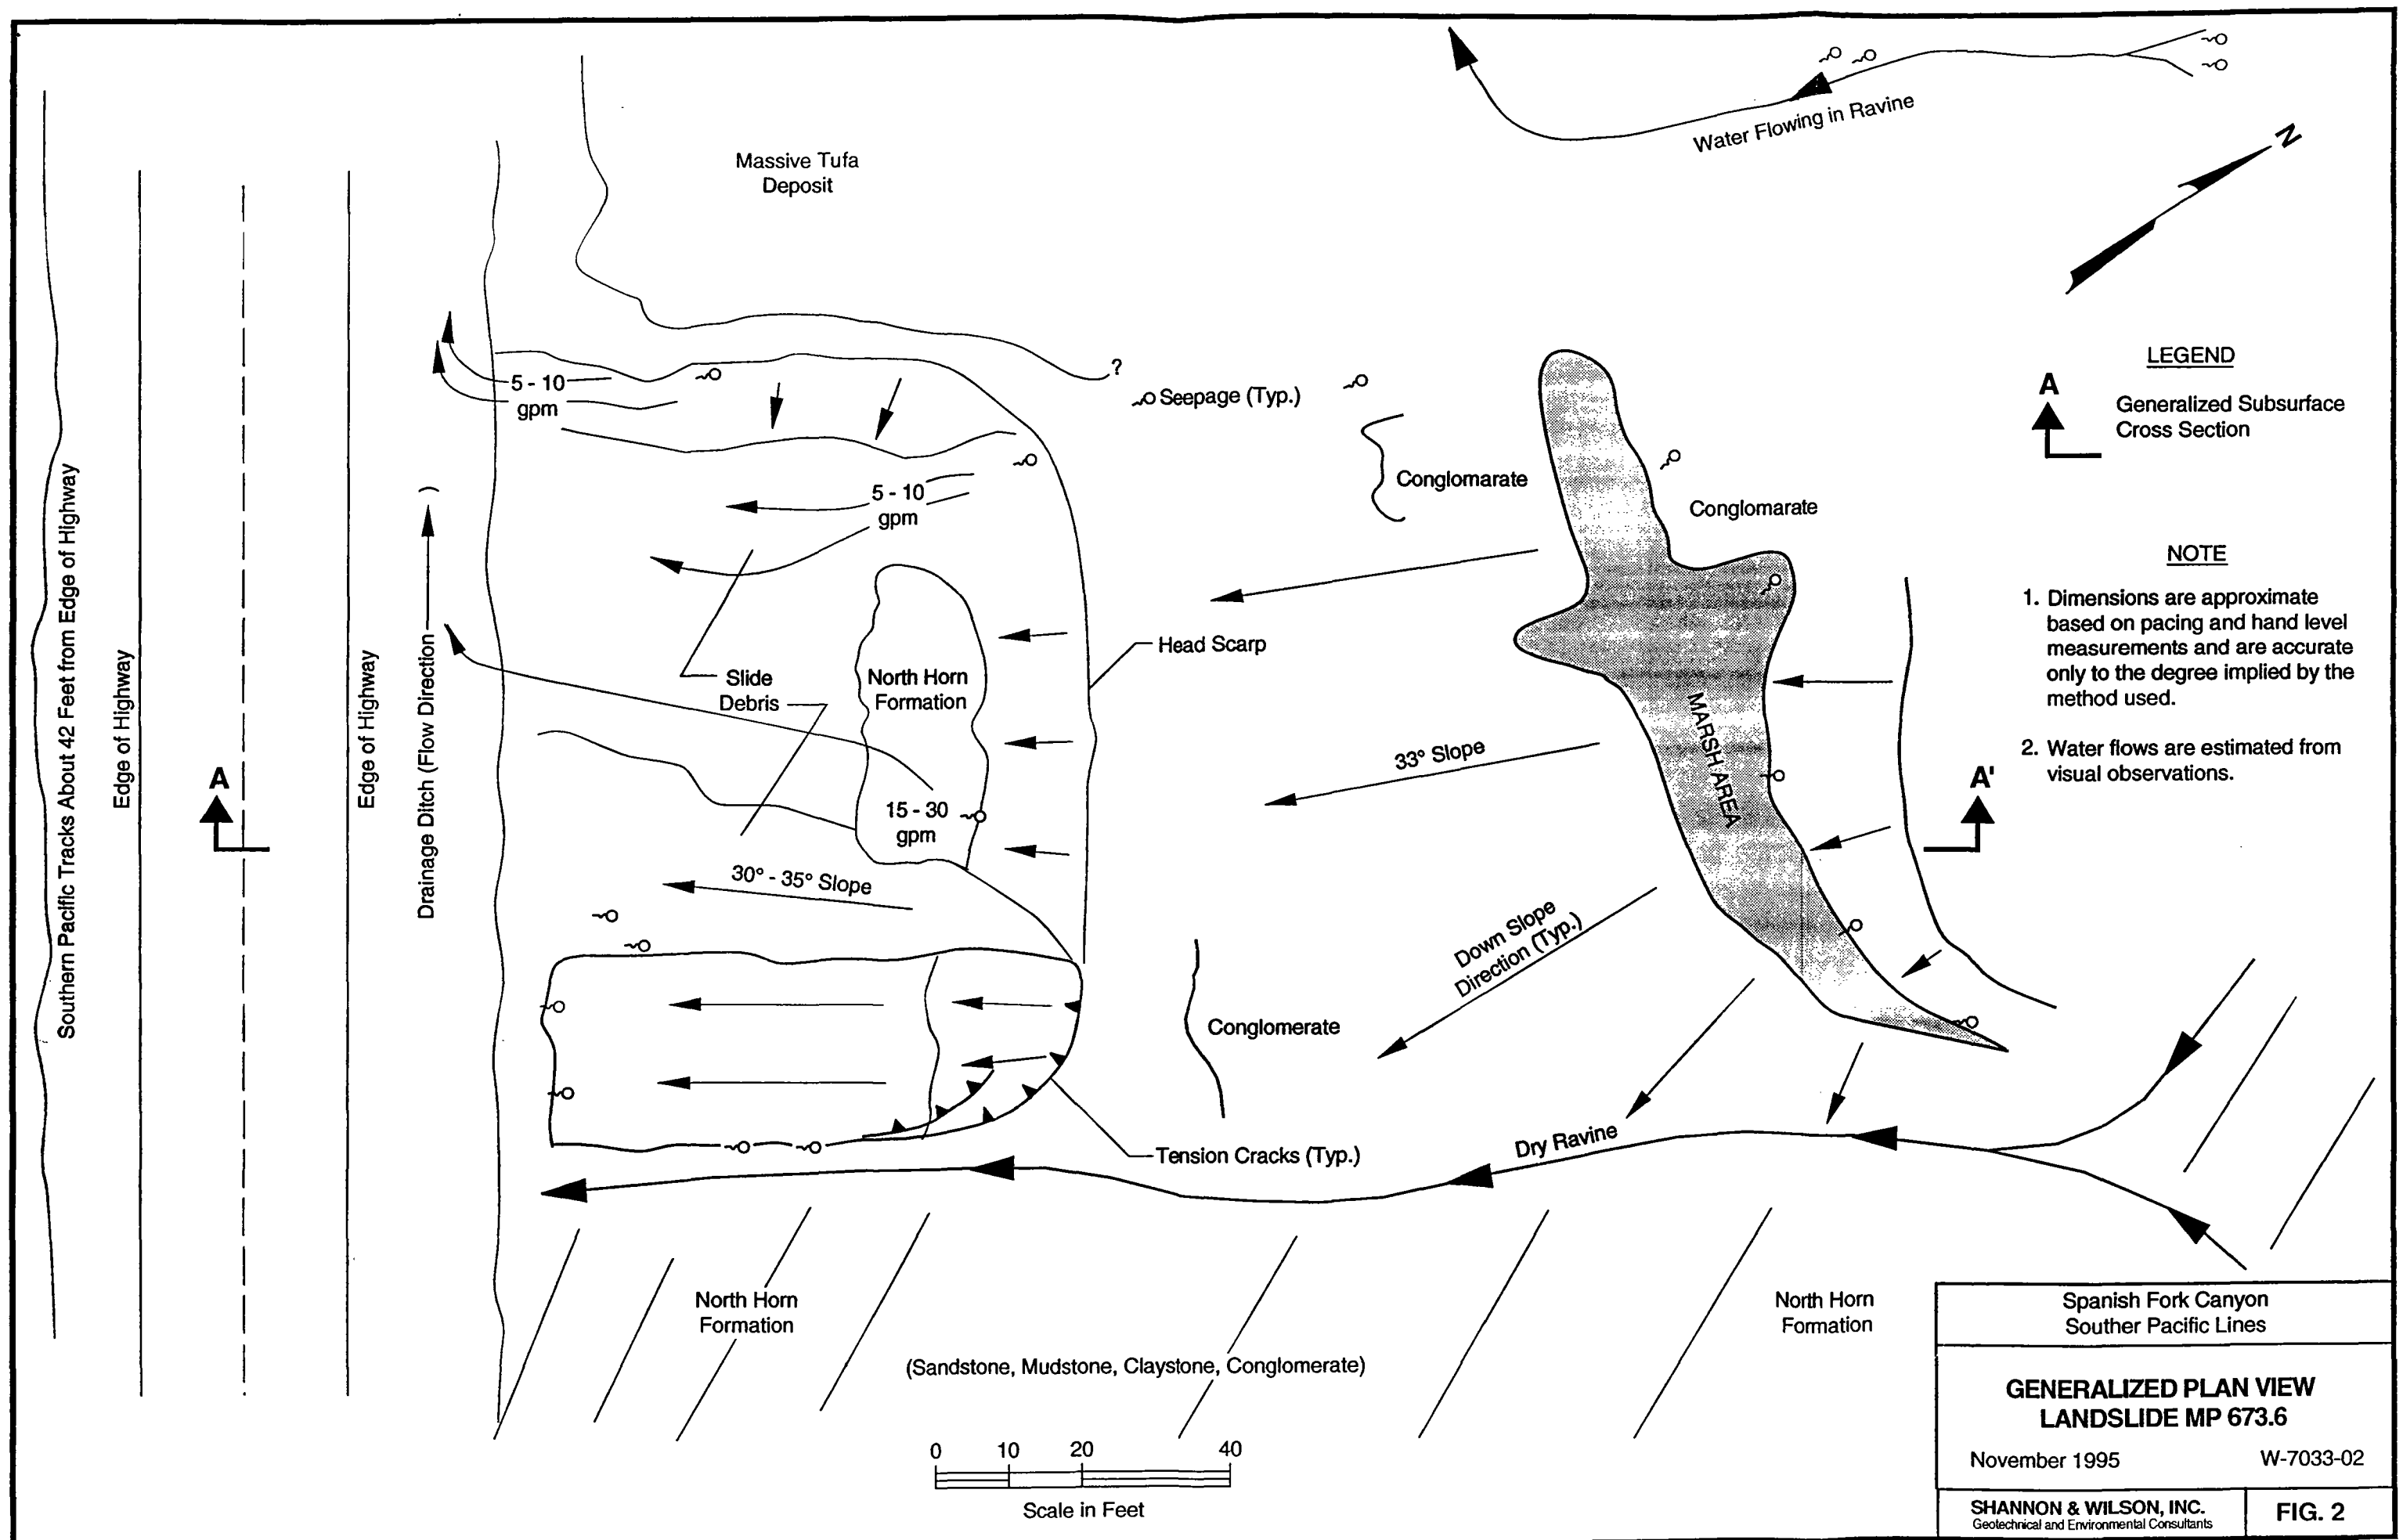
**GENERALIZED PLAN VIEW  
LANDSLIDE MP 673.6**

At the time of our site visit, the highway and railroad were cleared of debris and the drainage ditch at the toe of the cut slope had been reestablished. The length of the slide at the base of the cut slope is 80 feet long, measured east-west along the highway, and extends approximately 100 feet up the hill, measured from the assumed pre-existing toe of slope to the head scarp. The crest of the head scarp is approximately 55 feet vertical above the highway pavement. A generalized plan view and ground surface profile of the slide area are presented on Figures 2 and 3, respectively. These figures were developed from pace and hand-level surveys referencing existing site features and have a level of accuracy implied by the survey method used.

During our reconnaissance we observed a section of the cut slope along the east flank of the existing slide that has moved but not traveled with the main body of the slide. This slide mass is still hanging above the highway and railroad. Tension cracks are visible at the top of this slide mass that intersect the existing head scarp. This slide mass is approximately 27 feet wide (measured along the highway), and has an estimated volume of about 500 cubic yards. Seepage was observed on the soil surface along both flanks and along the toe of slope.

1. that the Utah Department of Transportation remove the potential slide material on the eastern flank of the existing slide.
2. that the Utah Department of Transportation assess the potential for progression of the existing slide up slope and to submit their report to Southern Pacific Lines for review and comment.
3. that the Utah Department of Transportation install a drainage system in the bench up slope from the slide to divert water away from the slide area.
4. that until items 1, 2, and 3 are completed to the railroads satisfaction, install a slide fence between the railroad and Highway 6. The slide fence should be designed so that a mud flow such as that which occurred recently will trigger the system and warn approaching trains that the track is obstructed. Specifically,

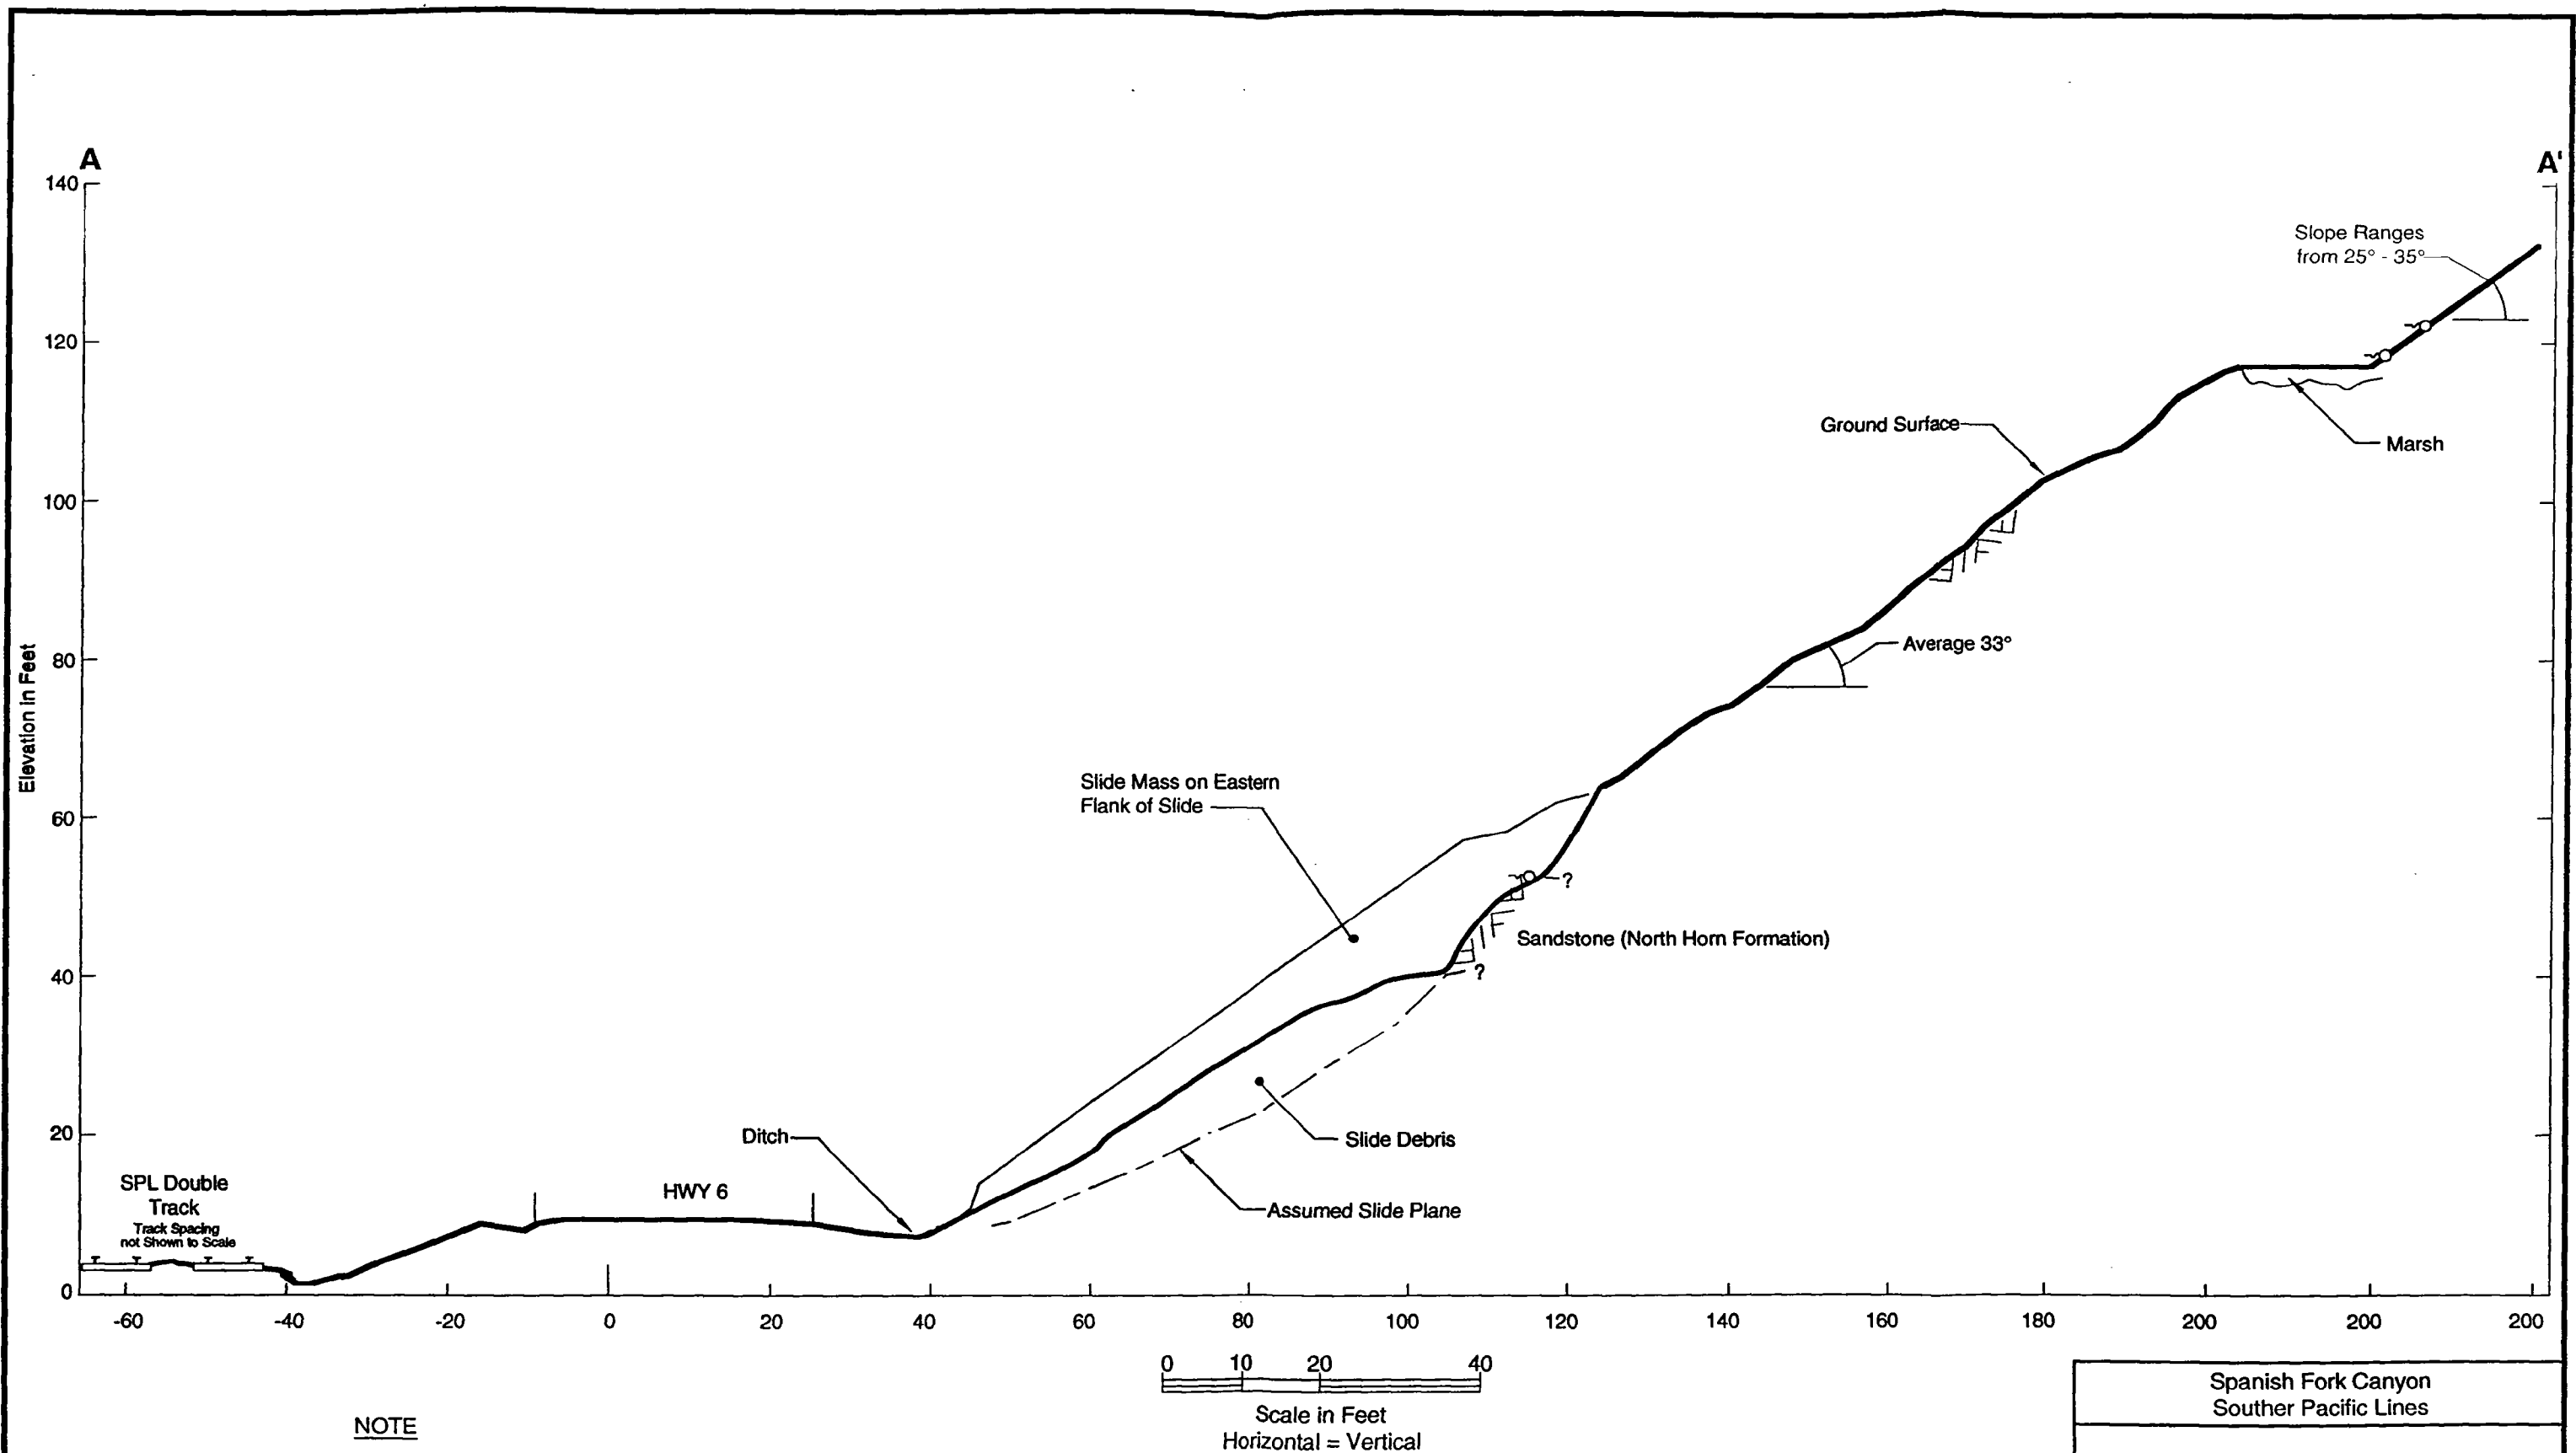
**Generalized Profile A-A'**

We understand that the slide occurred on Friday morning, November 3, 1995, at about 10 a.m. and originated in the highway cut slope on the north side of Highway 6 as shown on Figure 3. The railroad was reportedly cleared of slide debris by the afternoon on 3 November 1995 and train service through this area resumed at approximately 4 p.m.

The existing ground surface in the area of the head scarp ranges from near vertical to overhanging. Slide debris on the lower portion of the slide area slope at 30 to 35 degrees measured from the horizontal. Sandstone of the North Horn Formation crops out in the upper half slide and top of rock is located about 12 feet below the crest of the head scarp. The sandstone was observed in the eastern two-thirds but not in the western one-third of the slide area. Numerous seeps were observed in the slide area, and we estimated that the total combined flow at 20 to 50 gallons per minute. Seeps were observed throughout the vicinity of the slide, with the largest seeps observed in the upper portion of the slide at the contact of the sandstone and overlying soil.
