## INTERIM GEOTECHNICAL REPORT

● MANTI CANYON NORTH SLIDE  
STABILITY STUDIES

● DEBRIS DAM FOUNDATION  
INVESTIGATIONS

SEPTEMBER 1976

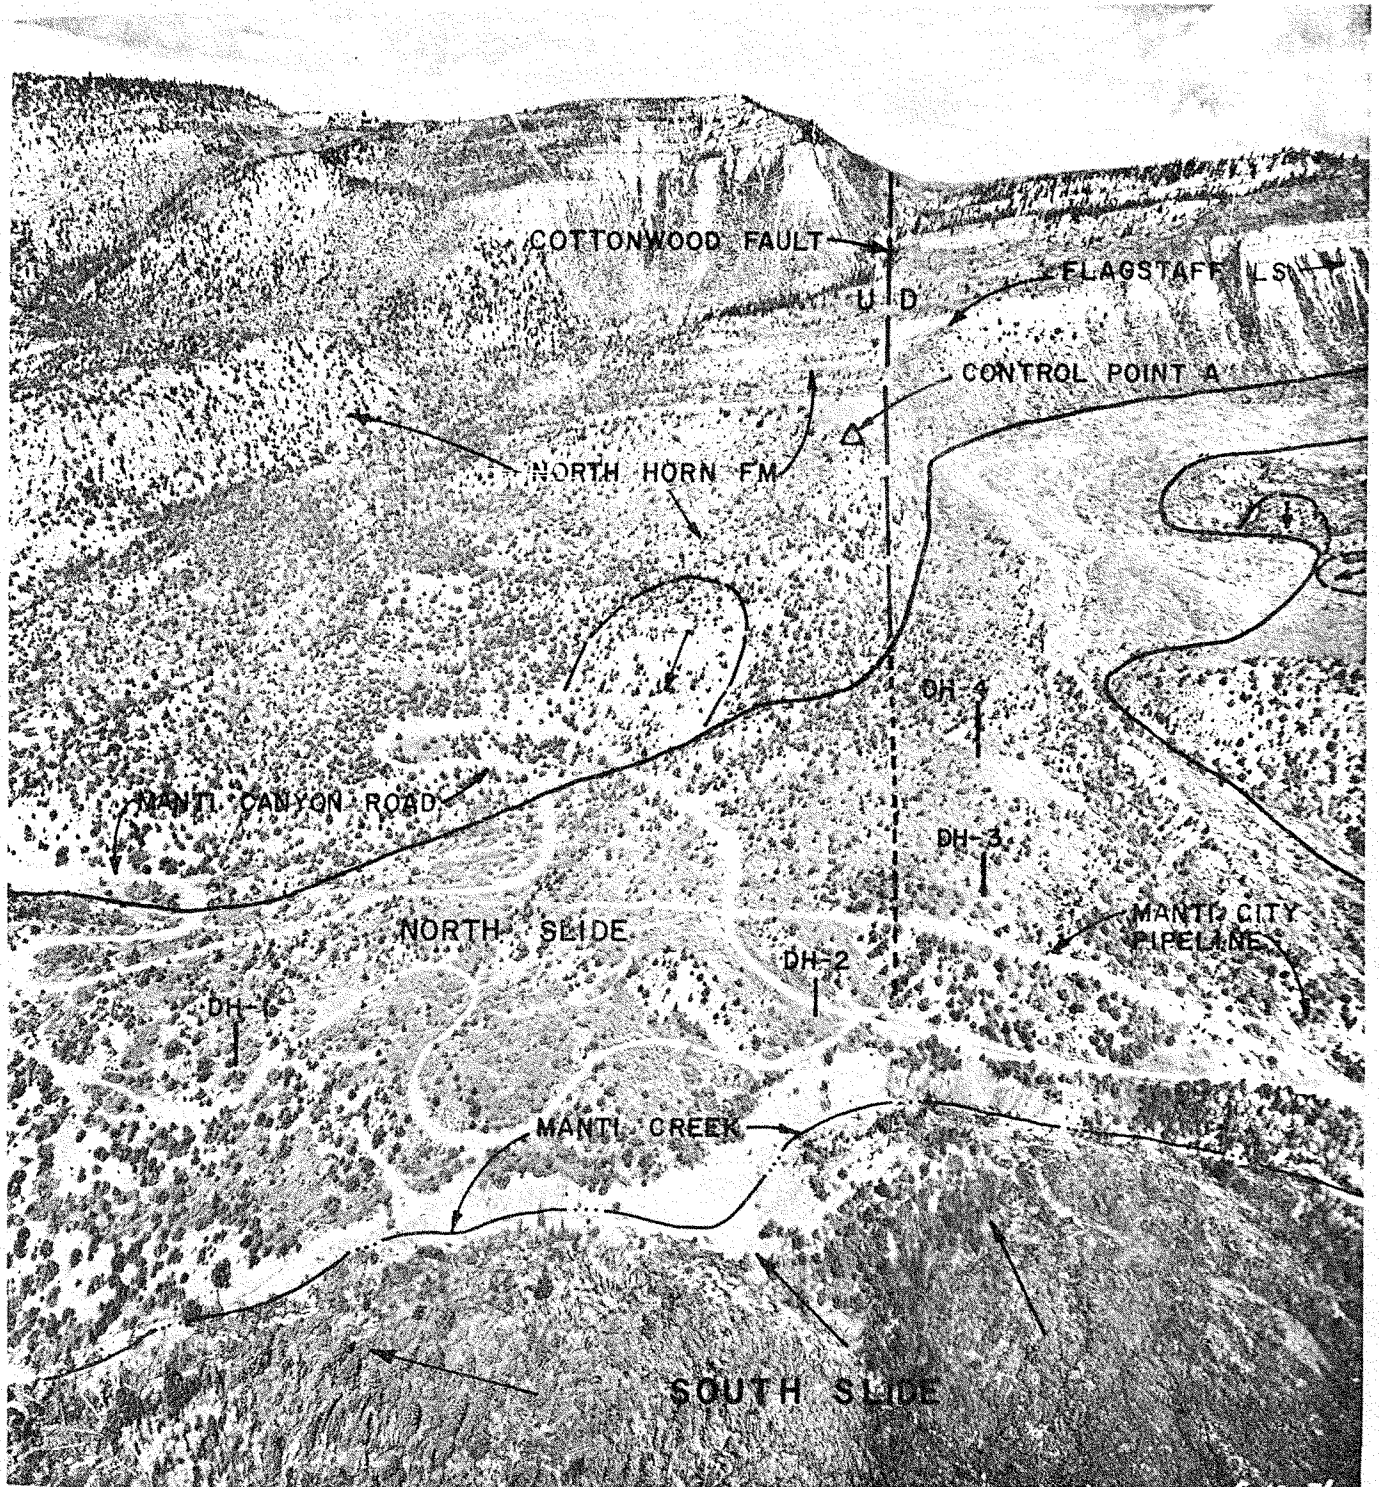
PHOTO 1 - PORTION OF NORTH SLIDE

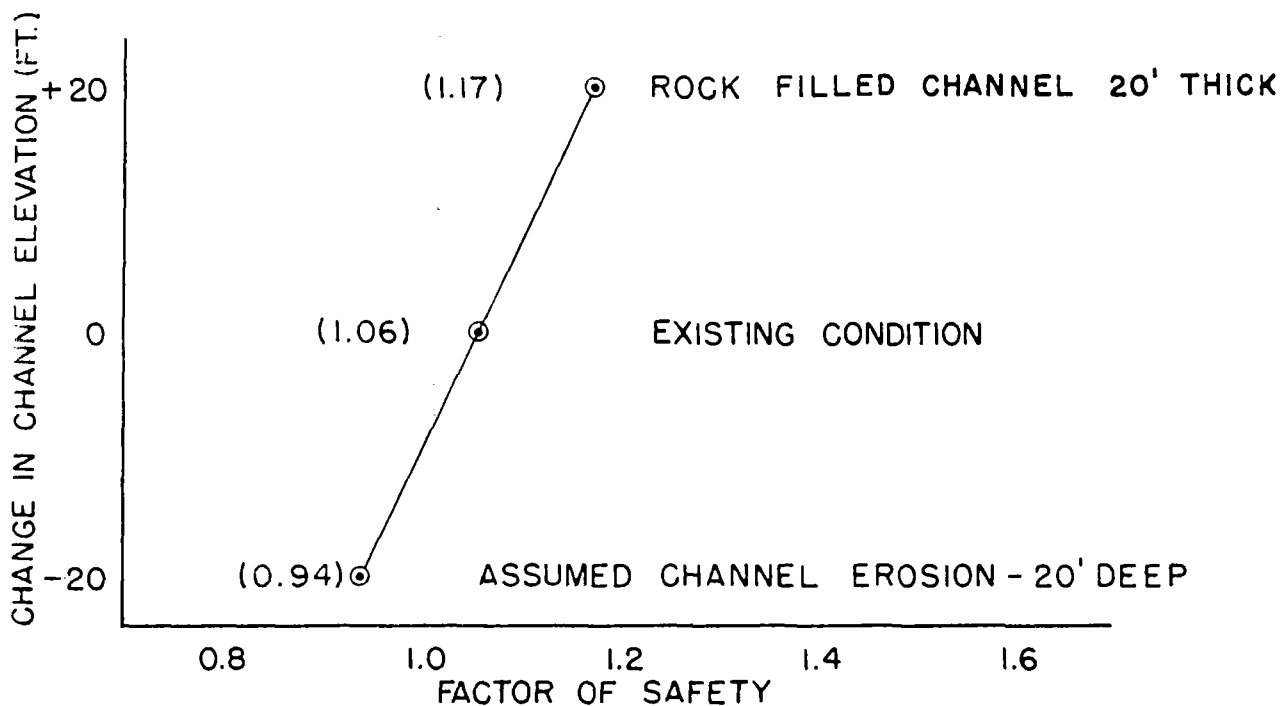
FIGURE 2-4 — FACTOR OF SAFETY OF NORTH SLIDE  
BISHOP STABILITY ANALYSIS — SEC. 2

The critical factors of safety for the three conditions of analyses are shown on Figure 2-4. The computed critical or minimum factor of safety for the existing condition (F.S. of 1.06) is very close to 1.0 and again, as in Section 1, the factor of safety could be slightly below 1.0.

The factor of safety for the eroded channel in Section 2 is 0.94. This value indicates that further erosion of the channel would induce slip circle failure.

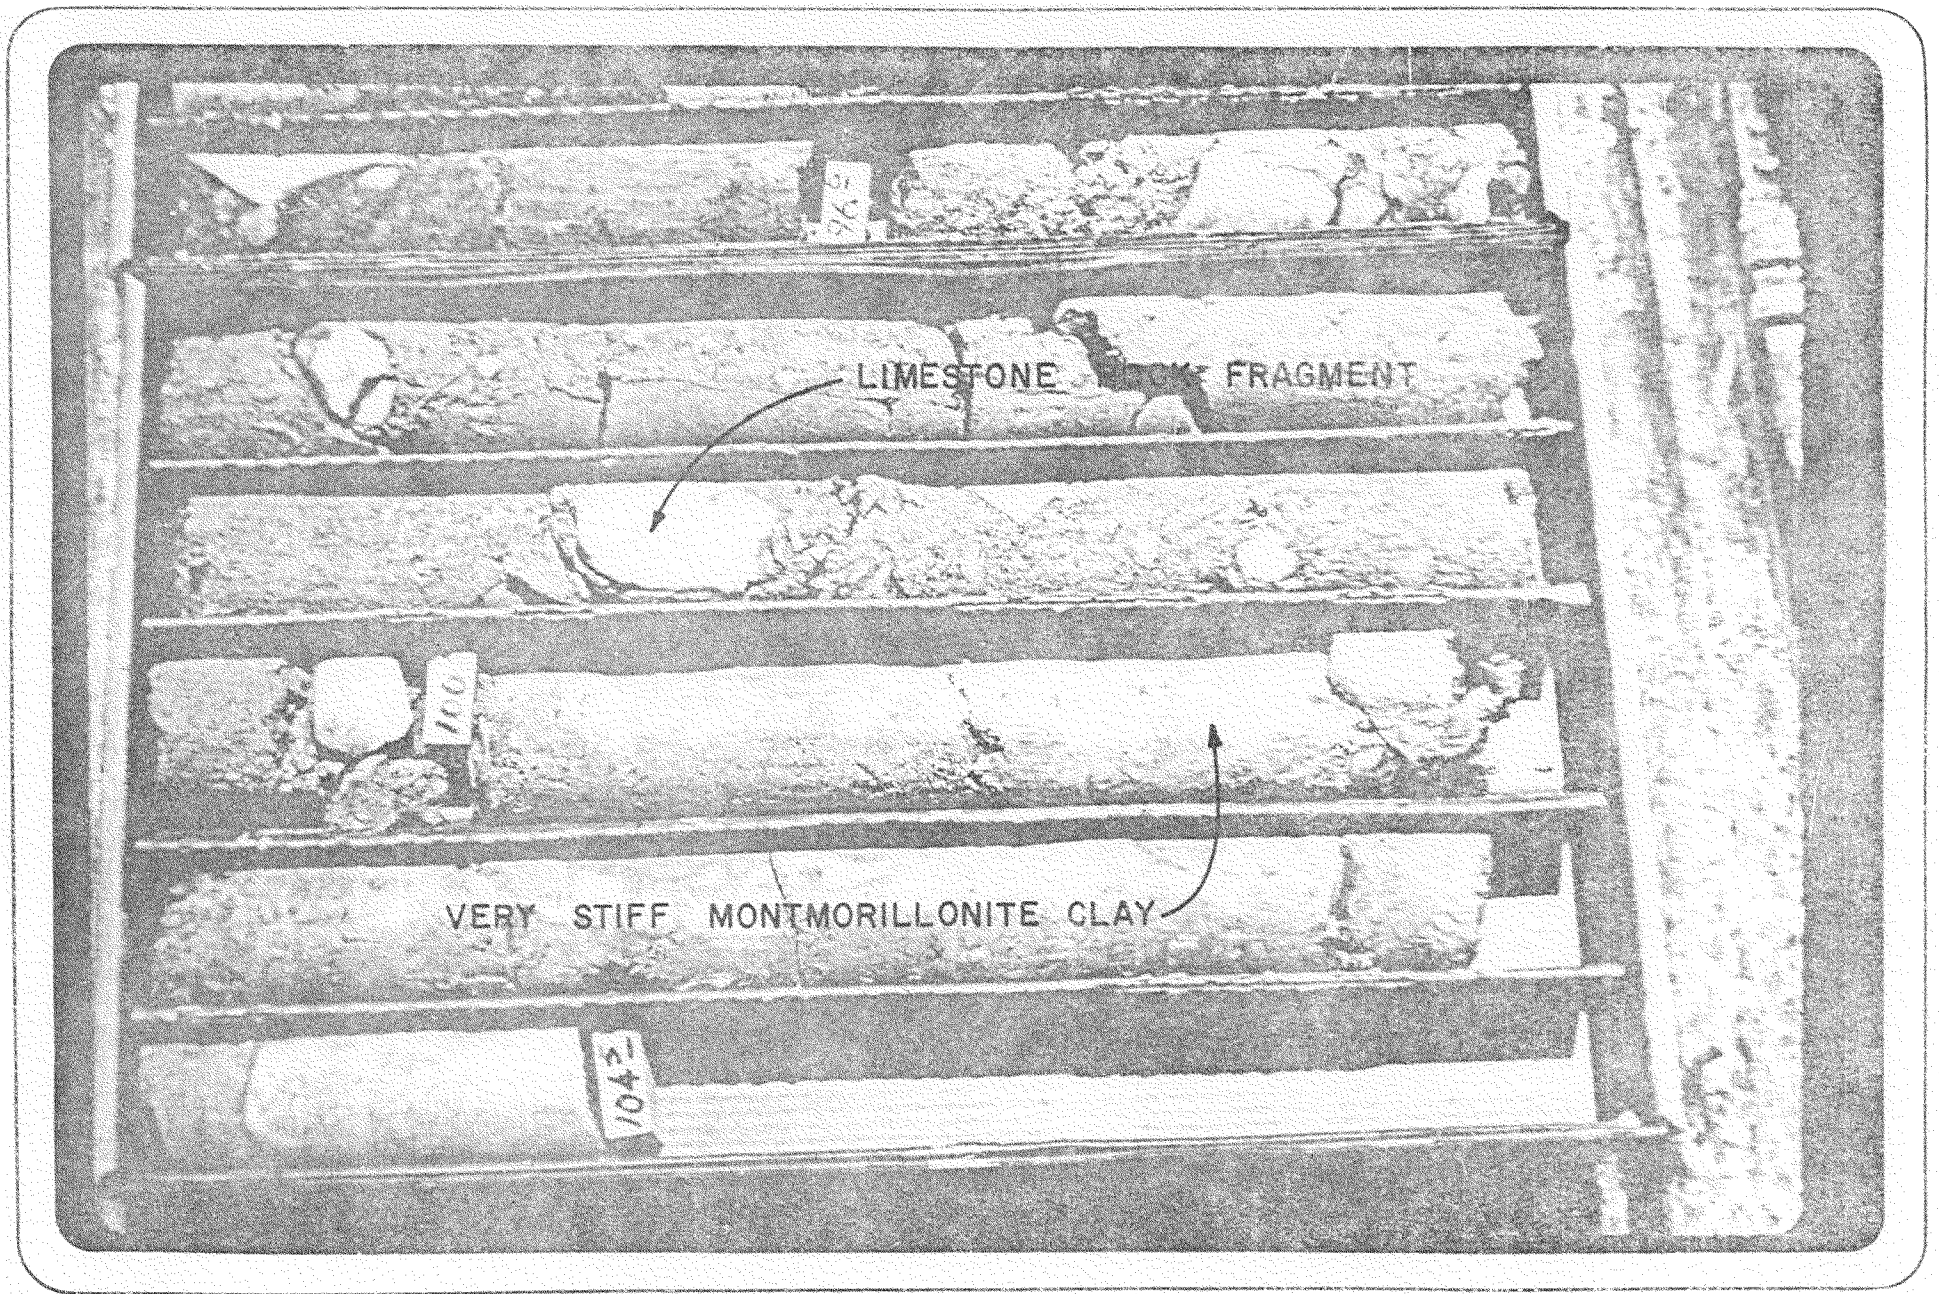
PHOTO 2 — TYPICAL DENSE GLACIAL TILL DH-1 95' TO 104'

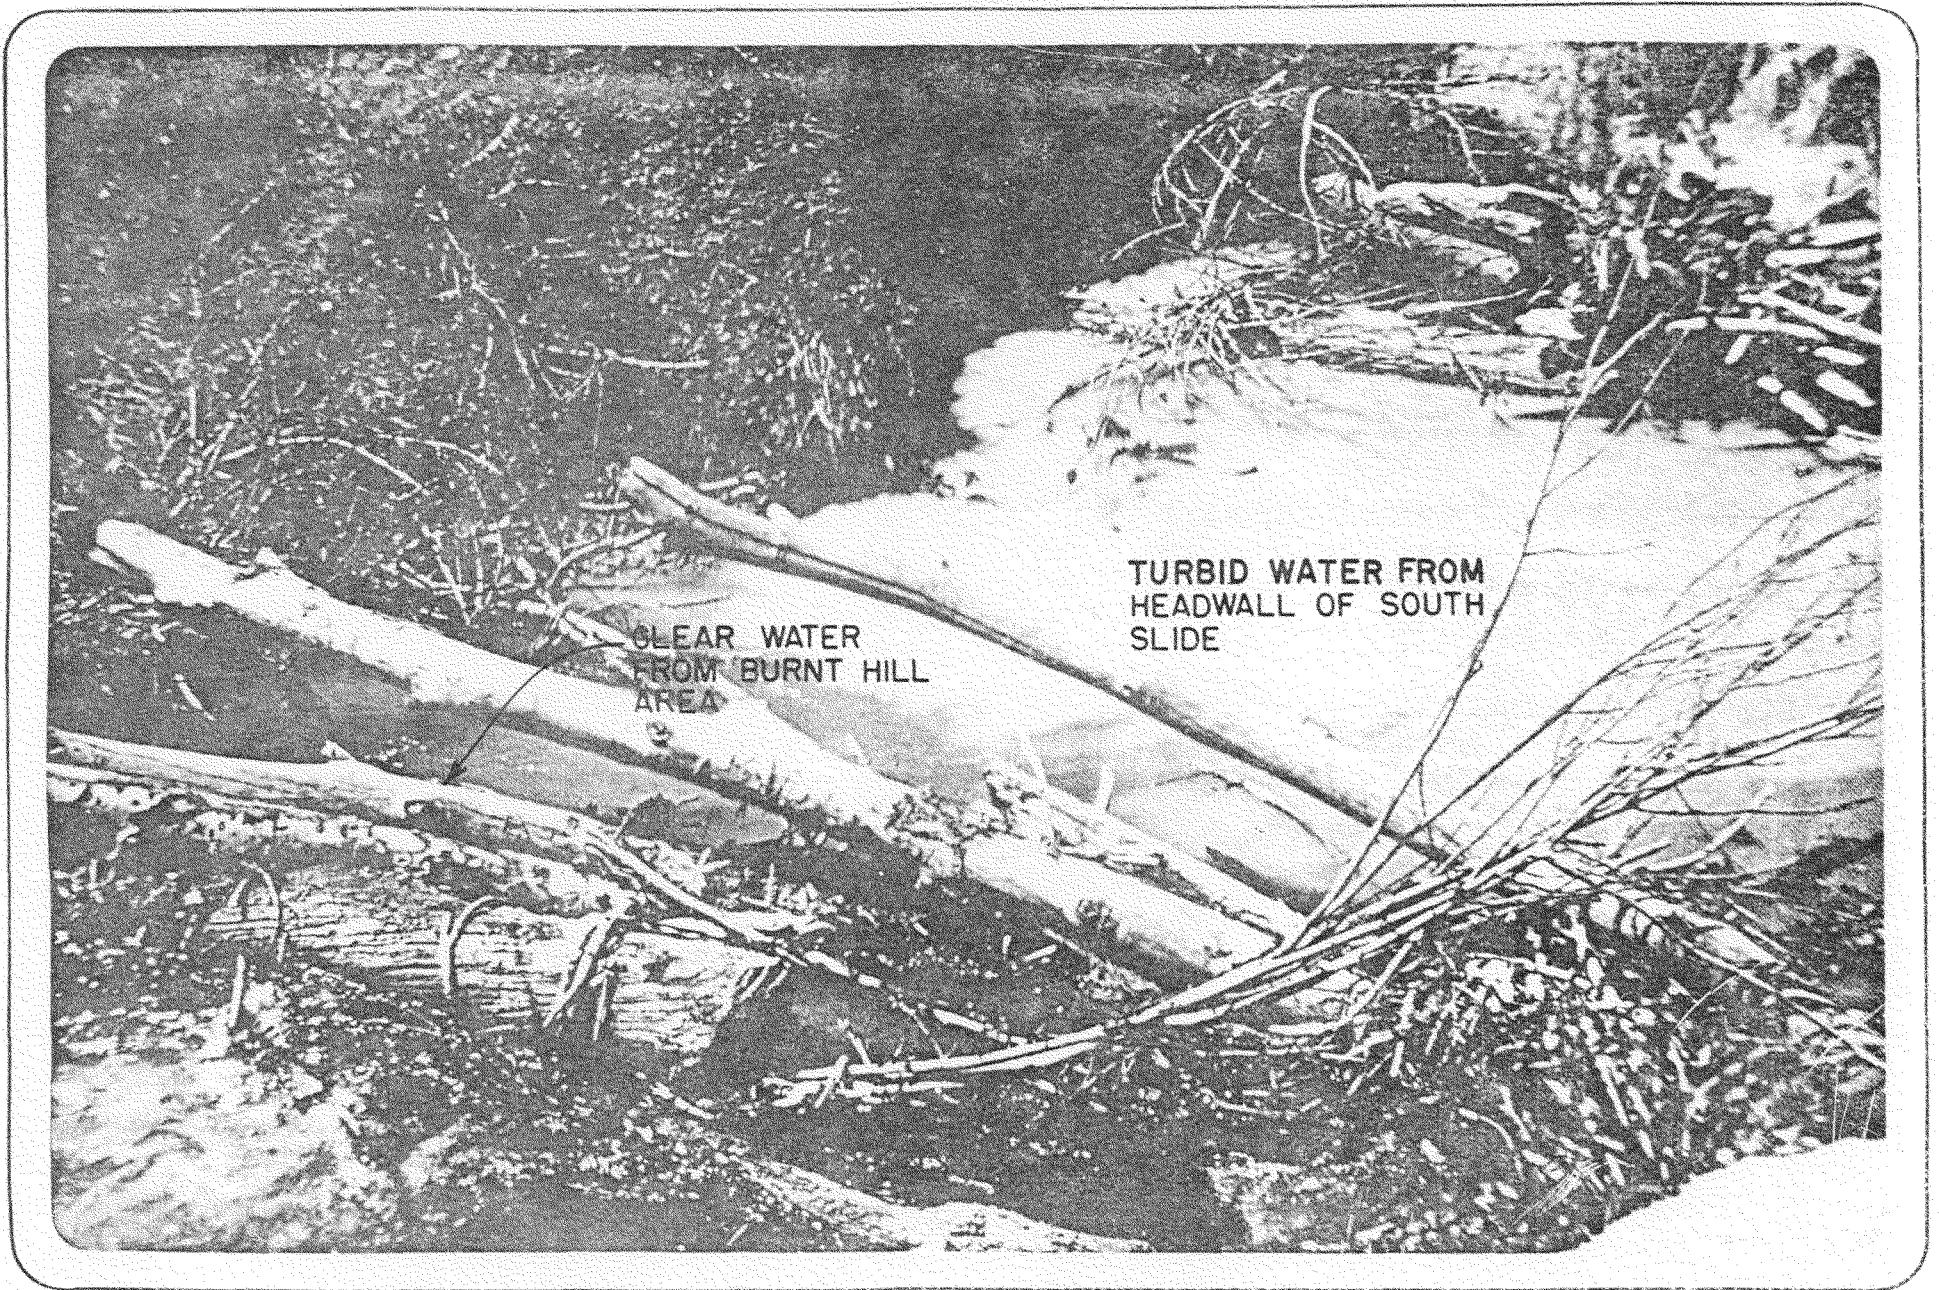
PHOTO 3 — MIXING OF CLEAR WATER FROM BURNT HILL FORK AND TURBID WATER FROM THE SOUTH FORK OF COTTONWOOD CREEK

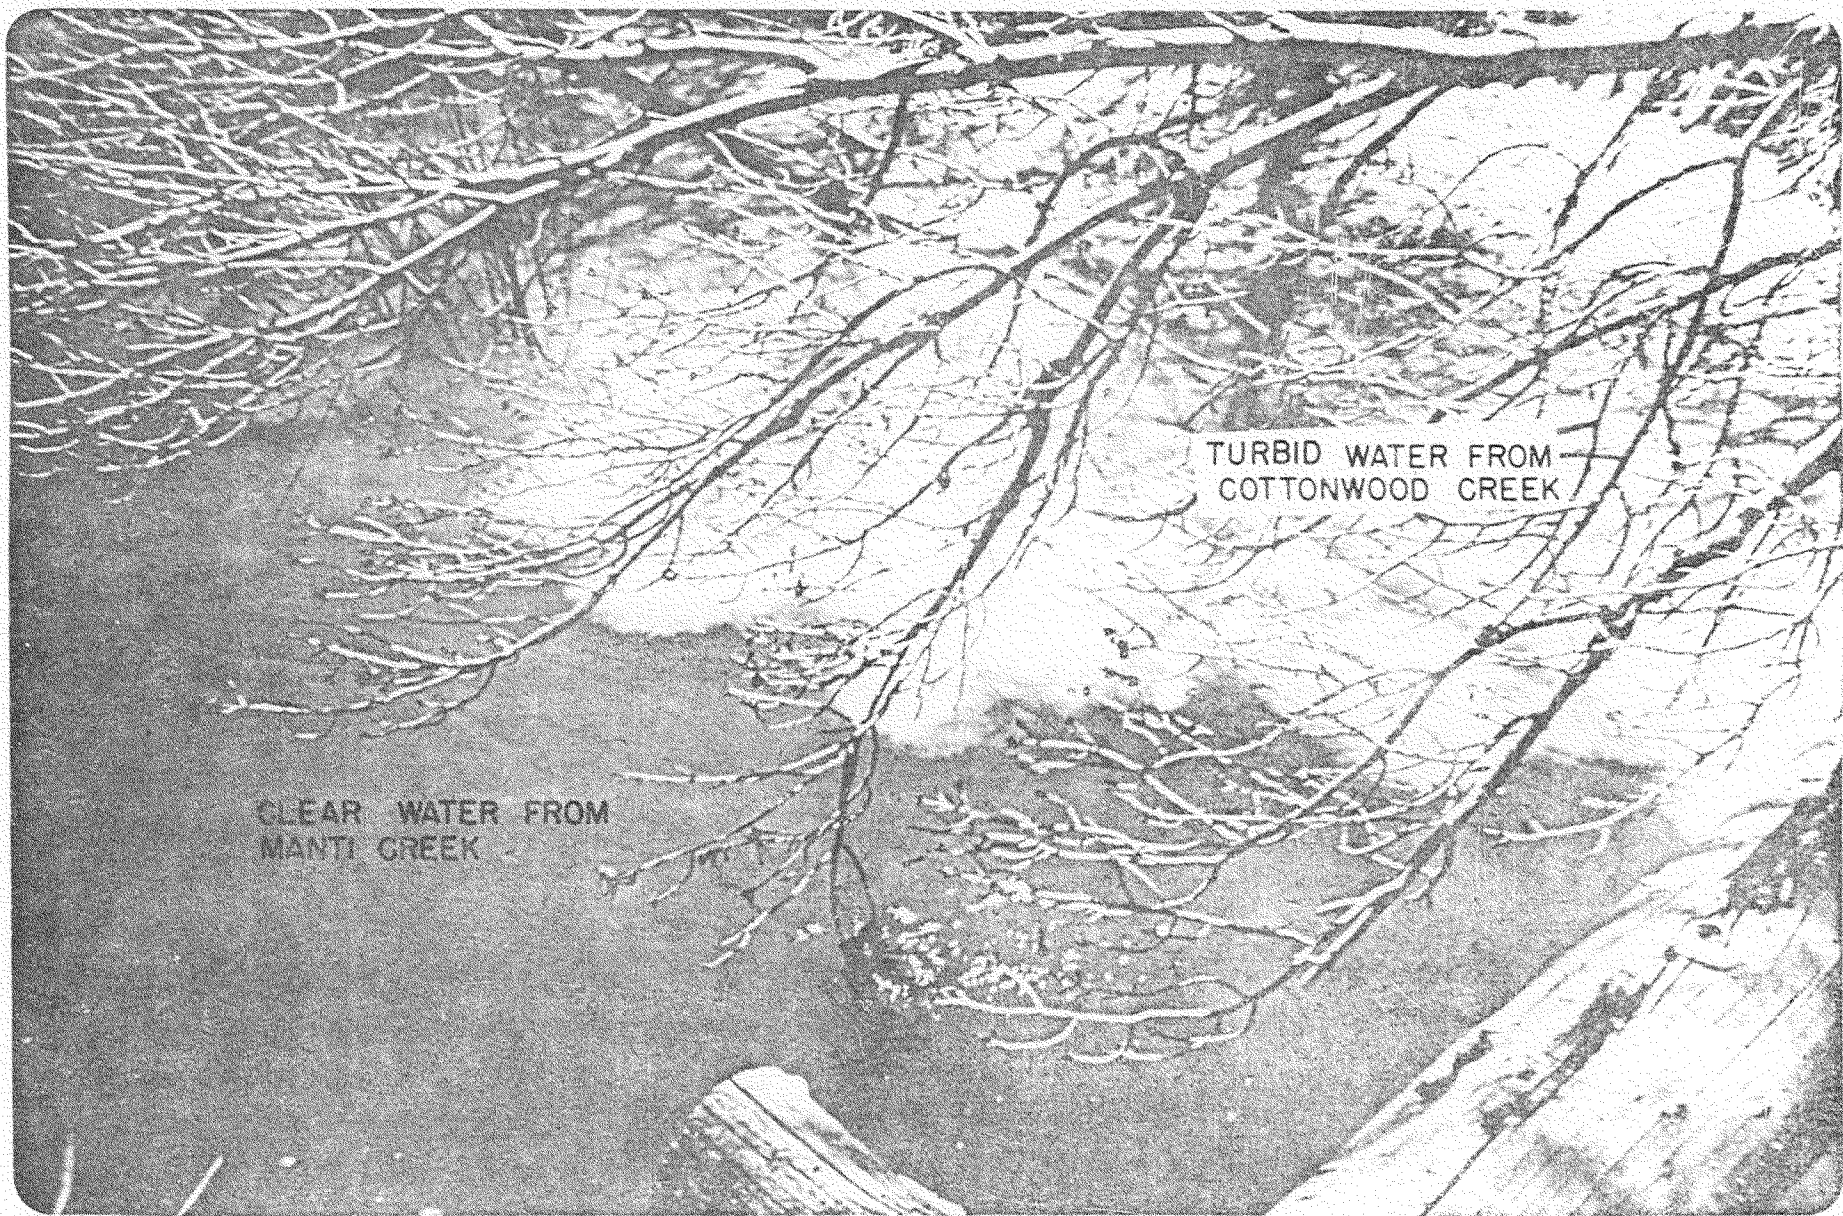
CLEAR WATER FROM  
MANTI CREEK

TURBID WATER FROM  
COTTONWOOD CREEK

PHOTO 4 - CONFLUENCE OF MANTI CREEK AND COTTONWOOD CREEK  
SHOWING MIXING OF CLEAR AND TURBID WATERS

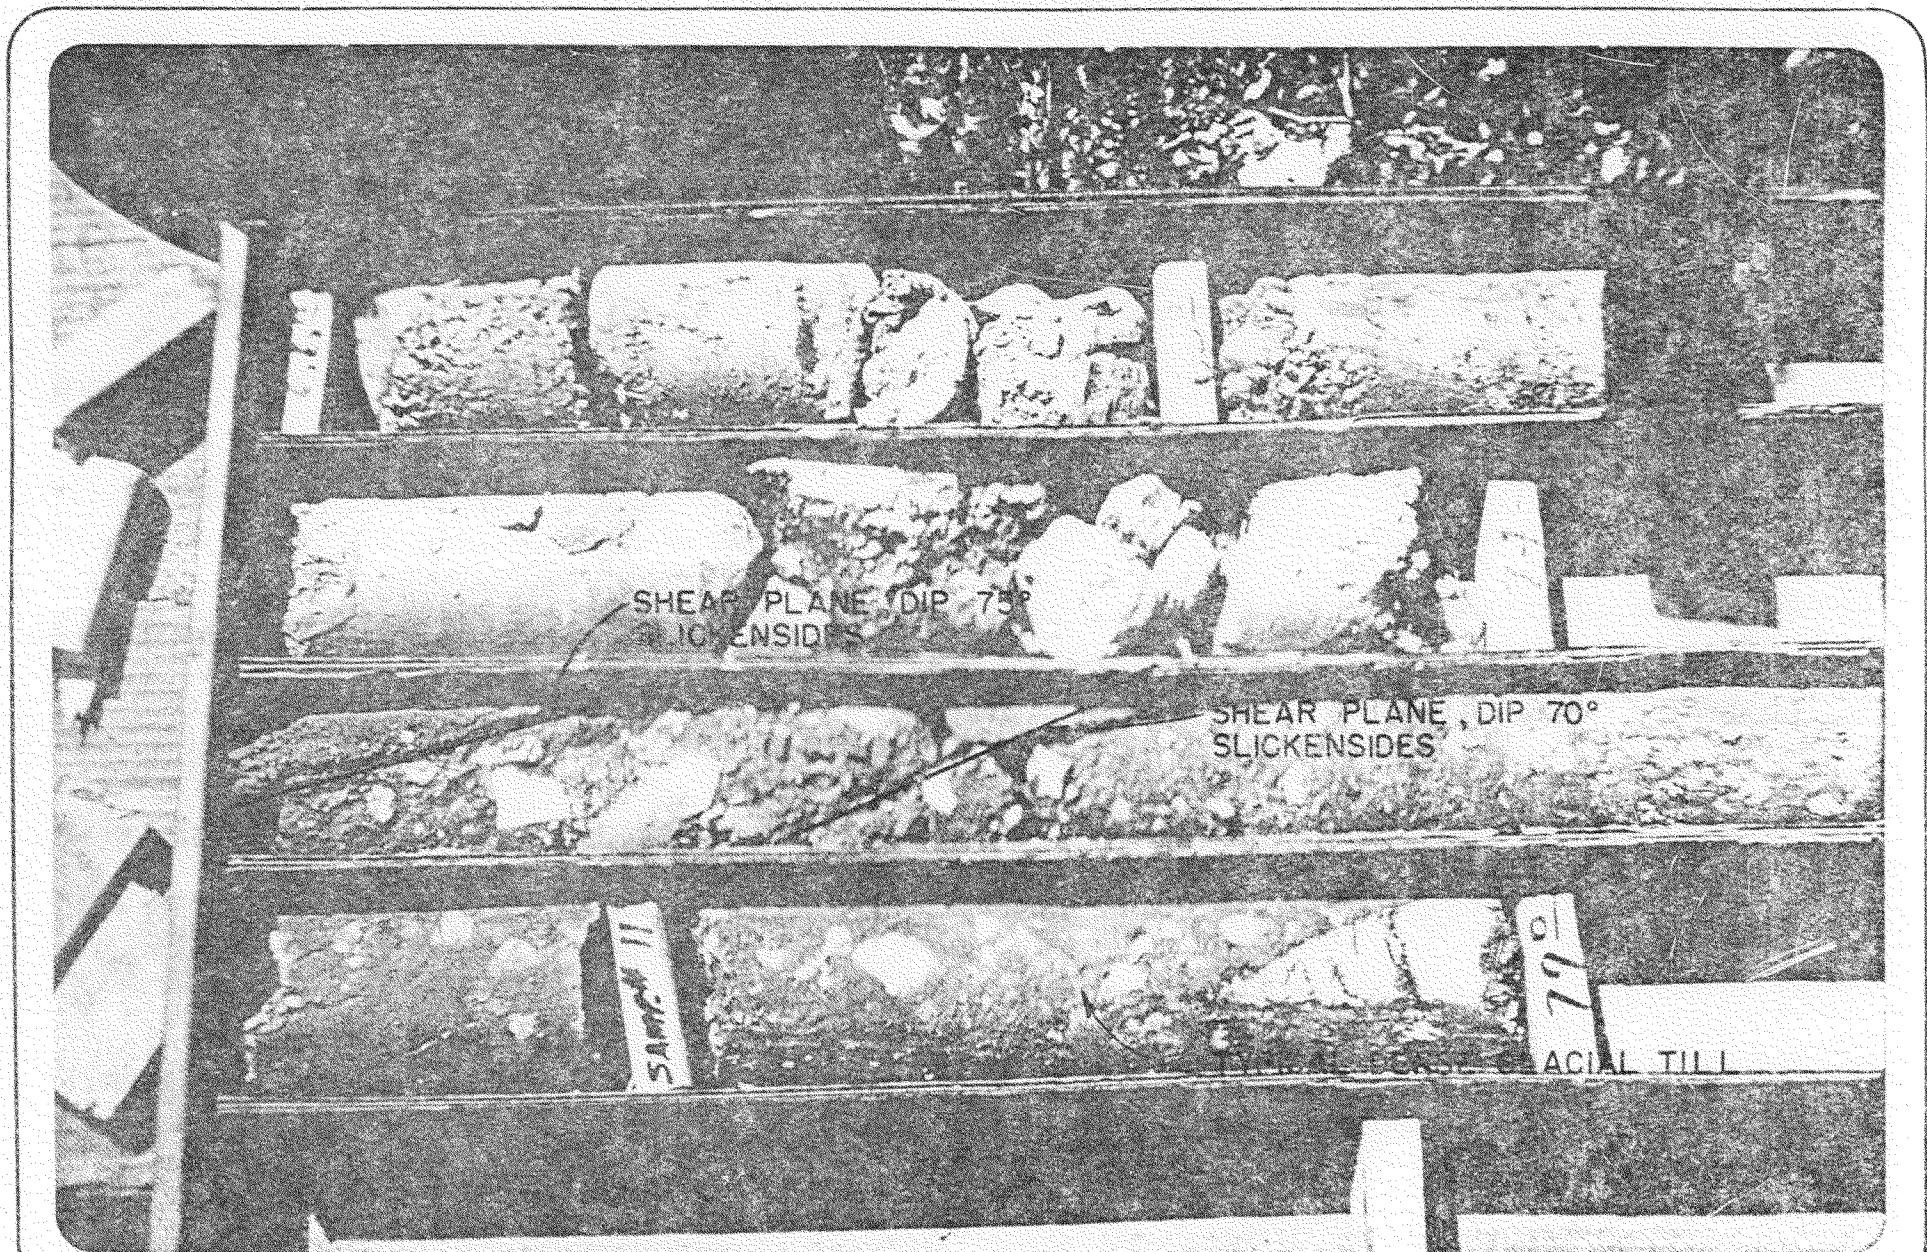
Several small shear zones and shear planes were noted in the drill core obtained from exploratory holes (see Drill Logs and Exhibits 3, 4 and 5). Photo 5 shows two shear planes at the depth of 75.0 feet in DH-2. The shear zones are characterized by dark gray and bluish gray sandy clay

with natural moisture up to 23%, and numerous irregular discontinuous slickensided surfaces. Dip of the shear planes range from 16<sup>0</sup> to 80<sup>0</sup>. The shear zones result from local differential settlement and slumping during glaciation or slow plastic deformation similar to soil creep. Several dark gray clay shear zones can be seen in the bank of Manti Creek near DH-2. These zones are approximately 1 foot thick, irregular and discontinuous.

PHOTO 5 - GLACIAL TILL, NC CORE FROM DH-2  
SHOWING SHEAR PLANES

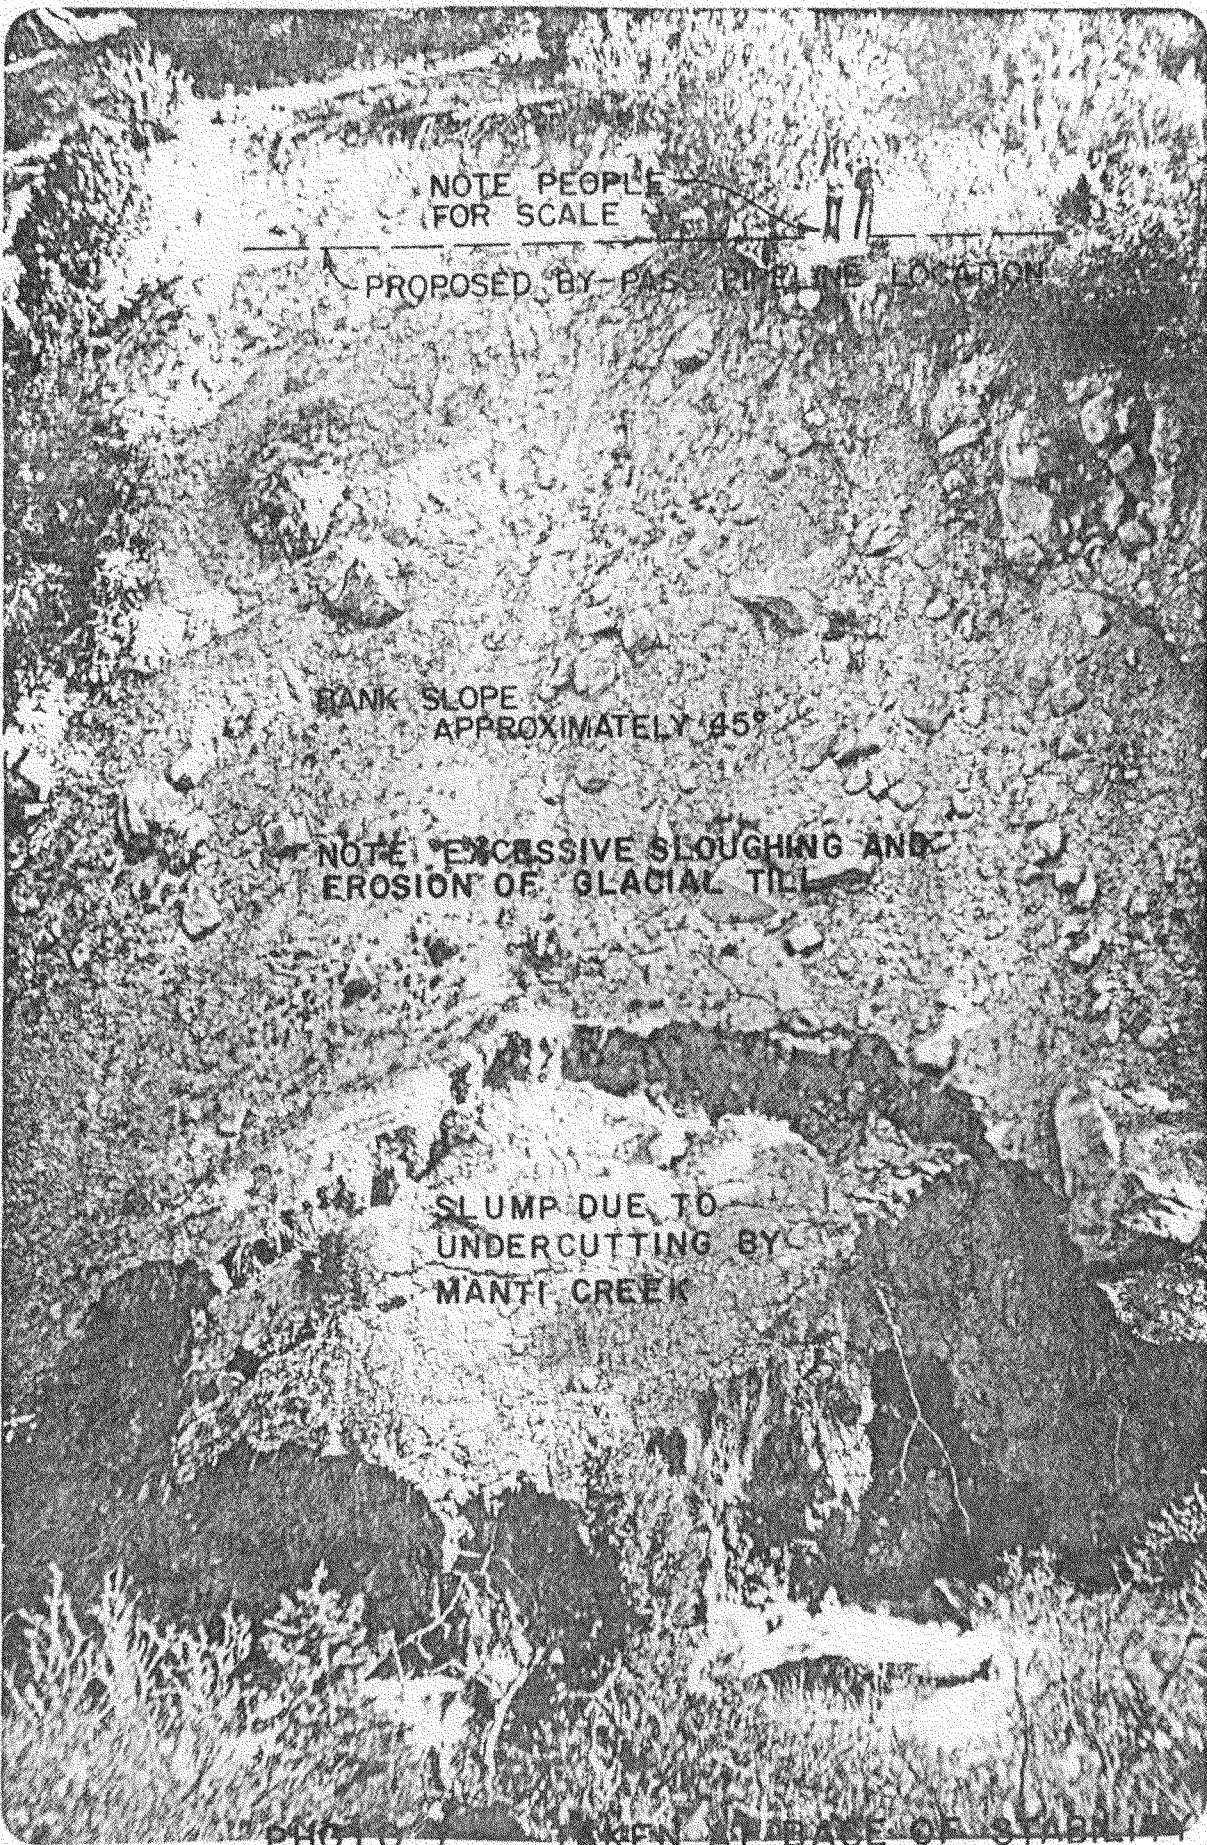
PHOTO 7 TAKEN AT BASE OF STABILITY  
SECTION 2

3. Stability of Section 2 - Section 2 was chosen because the toe of the slope is being eroded by Manti Creek (see Photo 7). A failure in this section would remove the Forest Service road and the proposed by-pass pipeline and the City of Manti's water pipeline (see Exhibit 12).

SLUMP DUE TO  
UNDERCUTTING BY  
MANTI CREEK

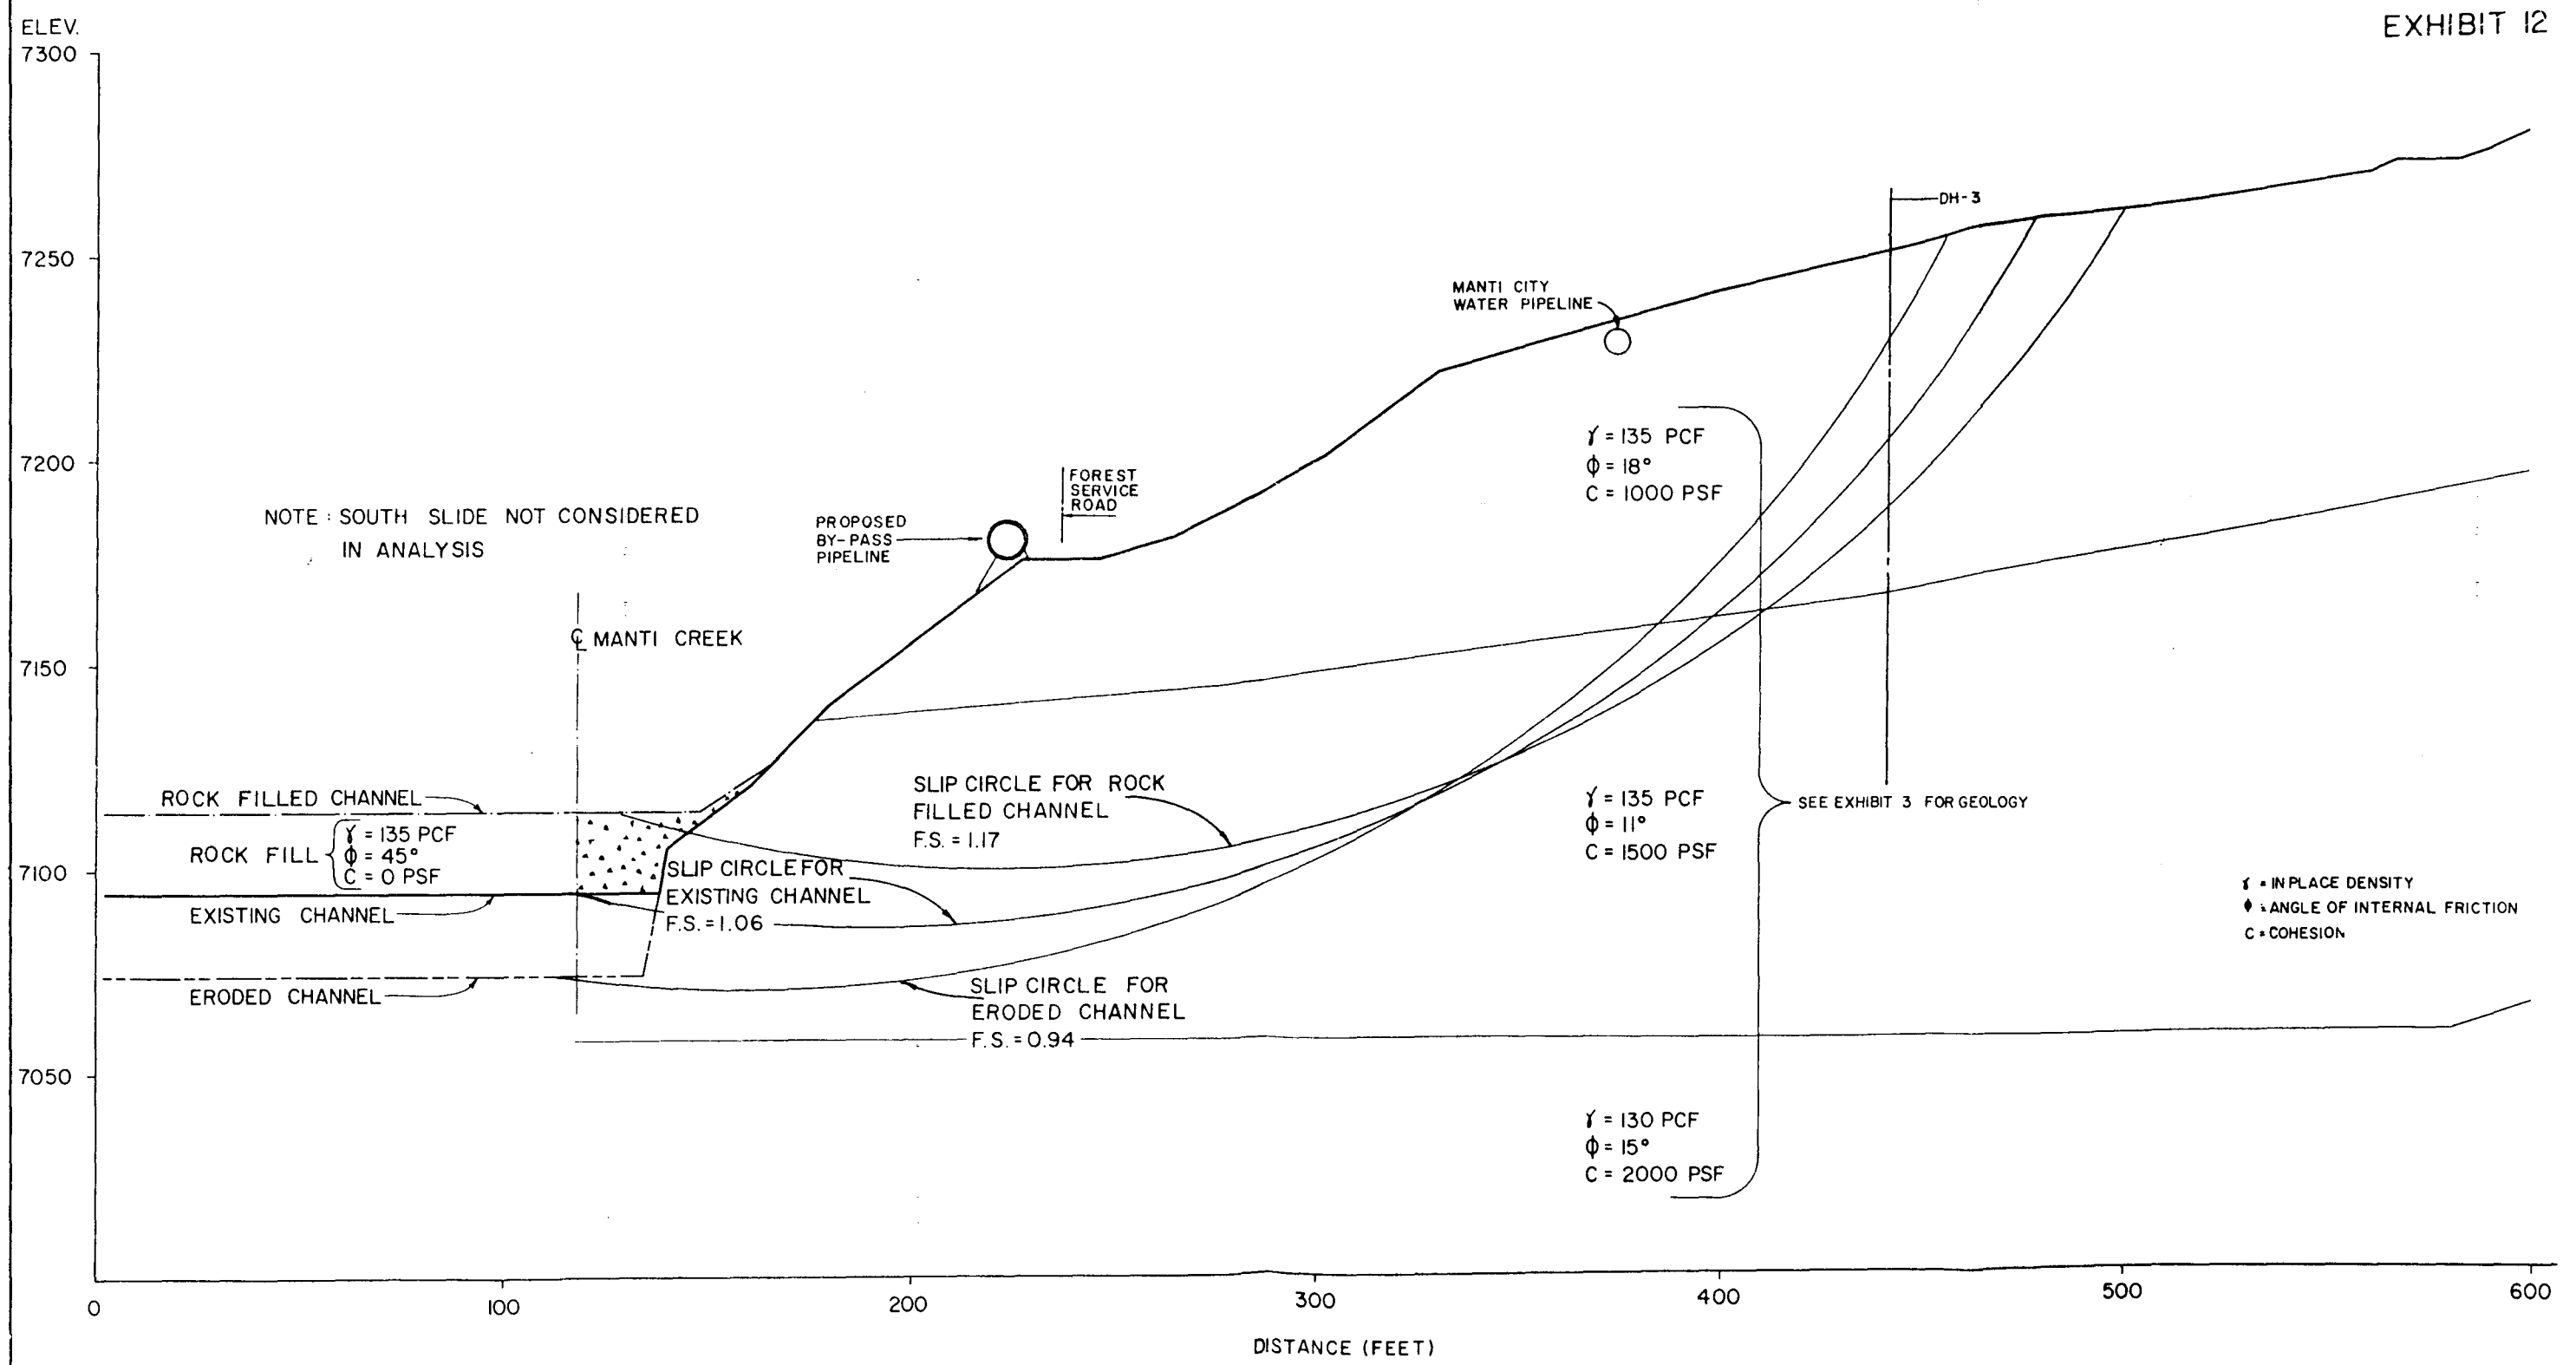
### NORTH SLIDE STABILITY ANALYSIS SECTION 2

SLIP CIRCLE FOR ERODED CHANNEL  
F.S. = 0.94
