December 14, 1984

TO: Steve Wilde
FROM: Ben Everitt
SUBJECT: Report on Spillway Excavation at
Smith and Morehouse Dam

UGMS HAZARDS SECTION

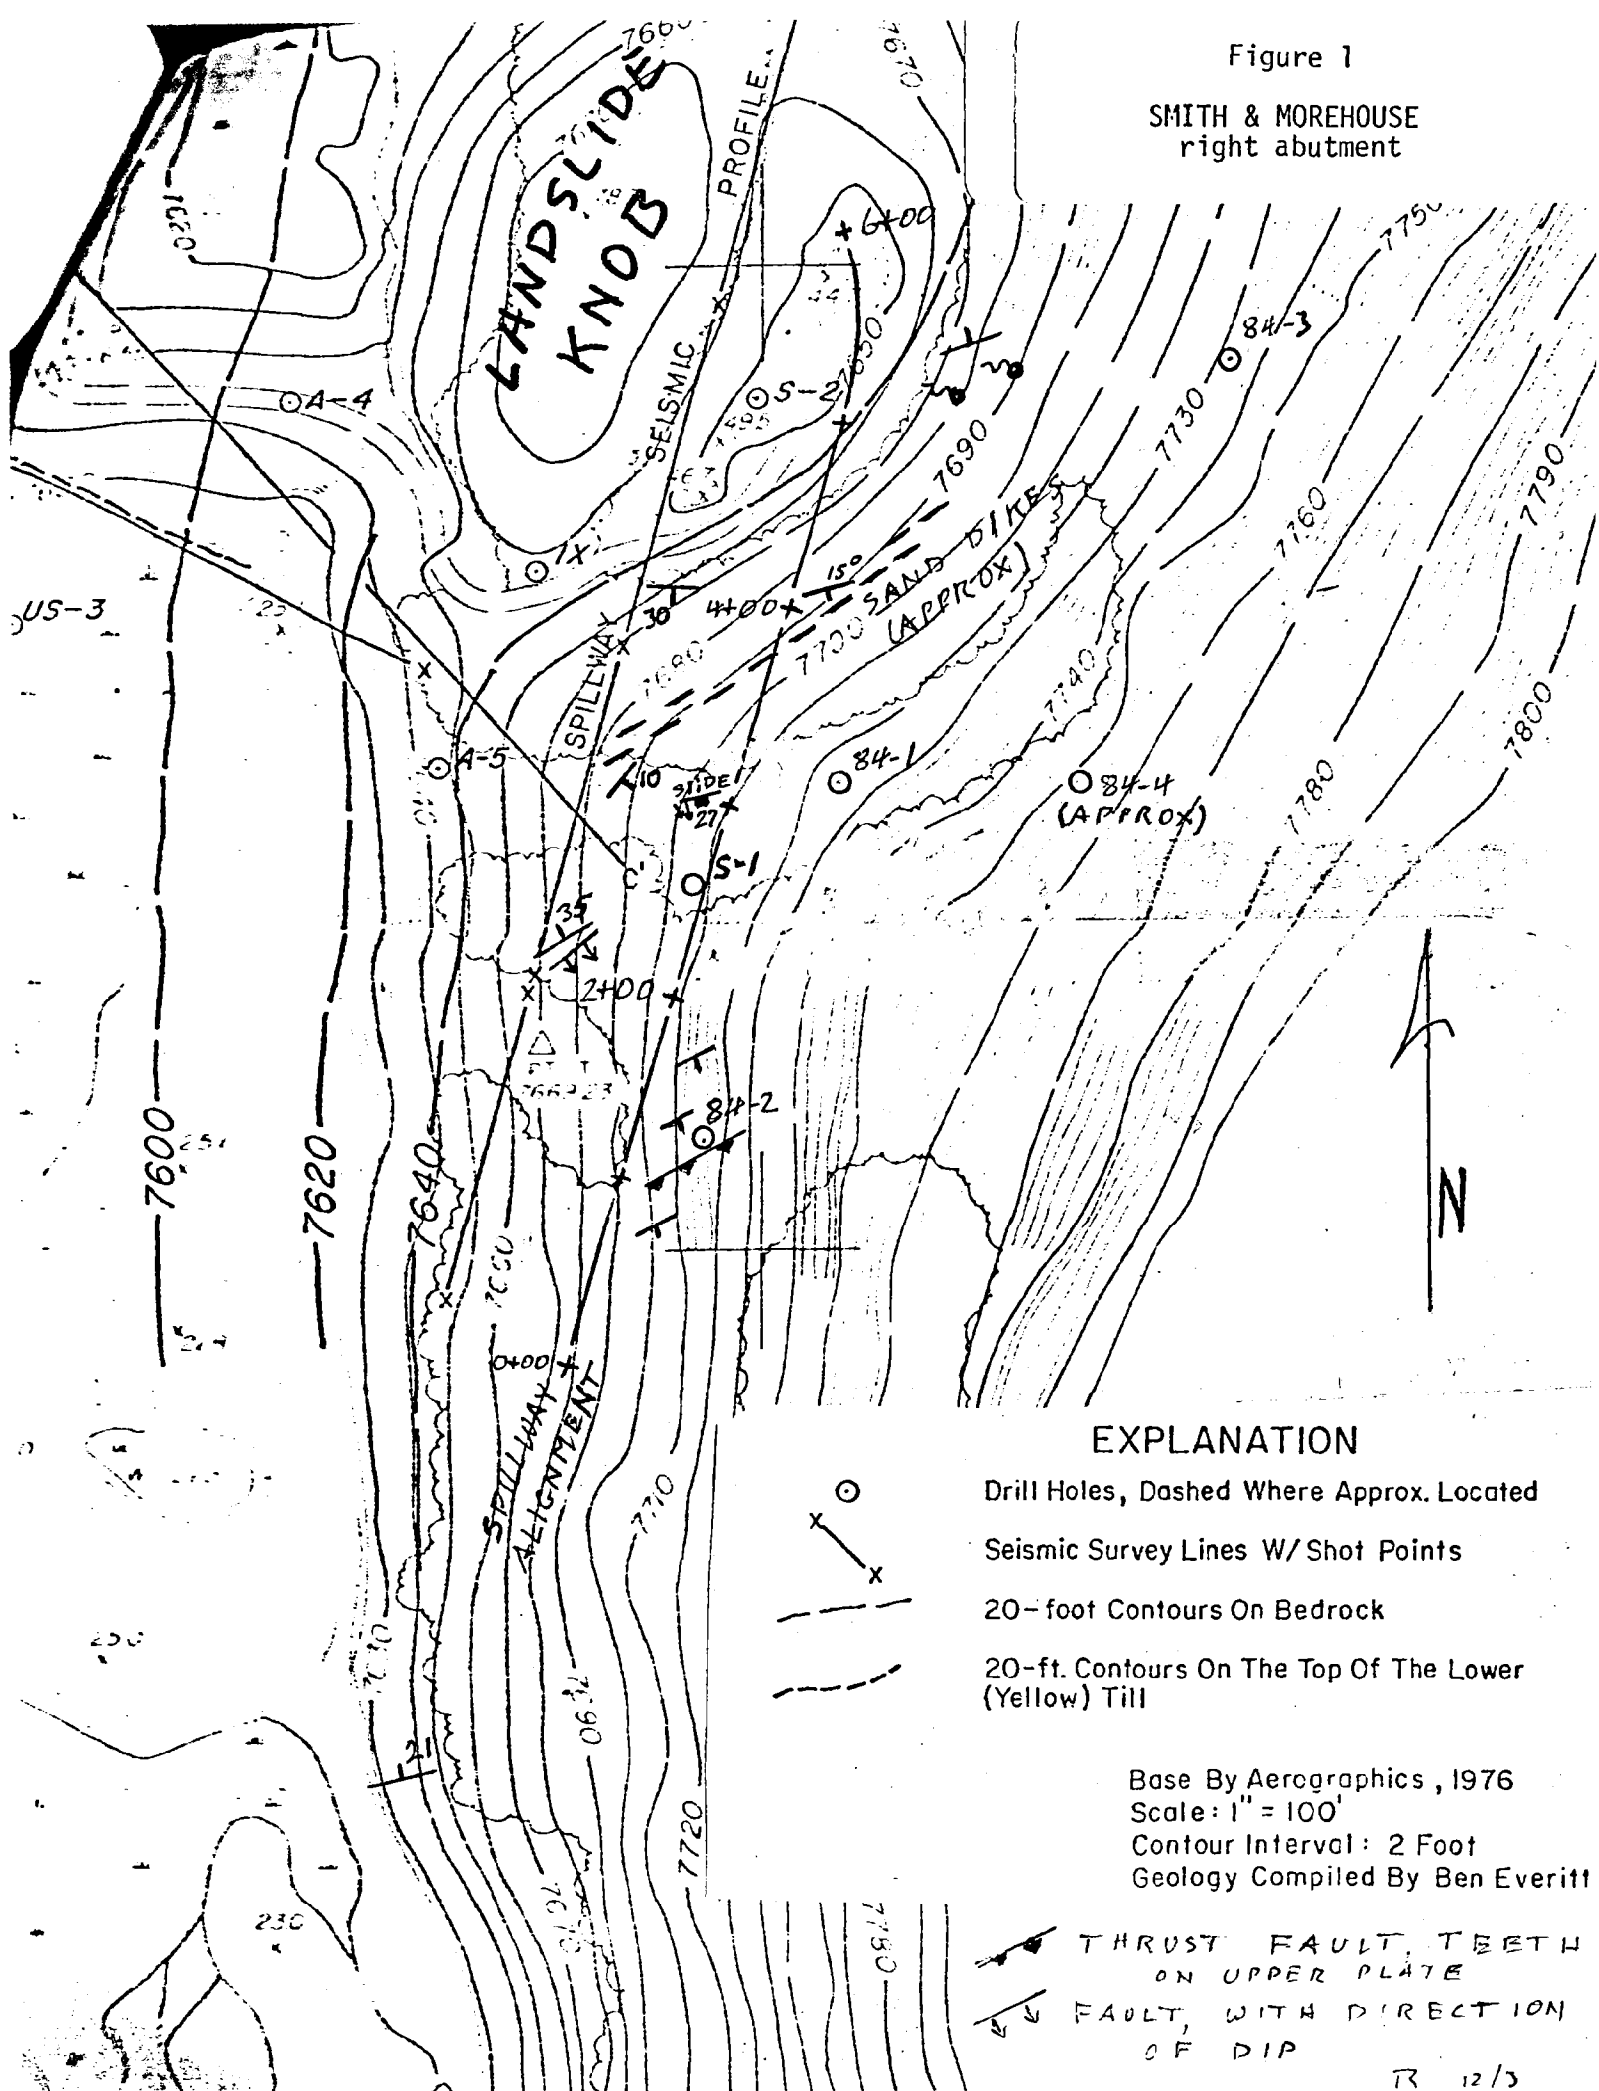
Figure 1

Drill hole 84-3 of the current series (Figure 1) spudded in hard limestone and recovered nearly 100% of core for 90 feet. The interval from 91-94 feet recovered 8 inches of black organic muck containing some spongy peat, confirming the existence of a massive deep landslide in the right abutment and spillway area.

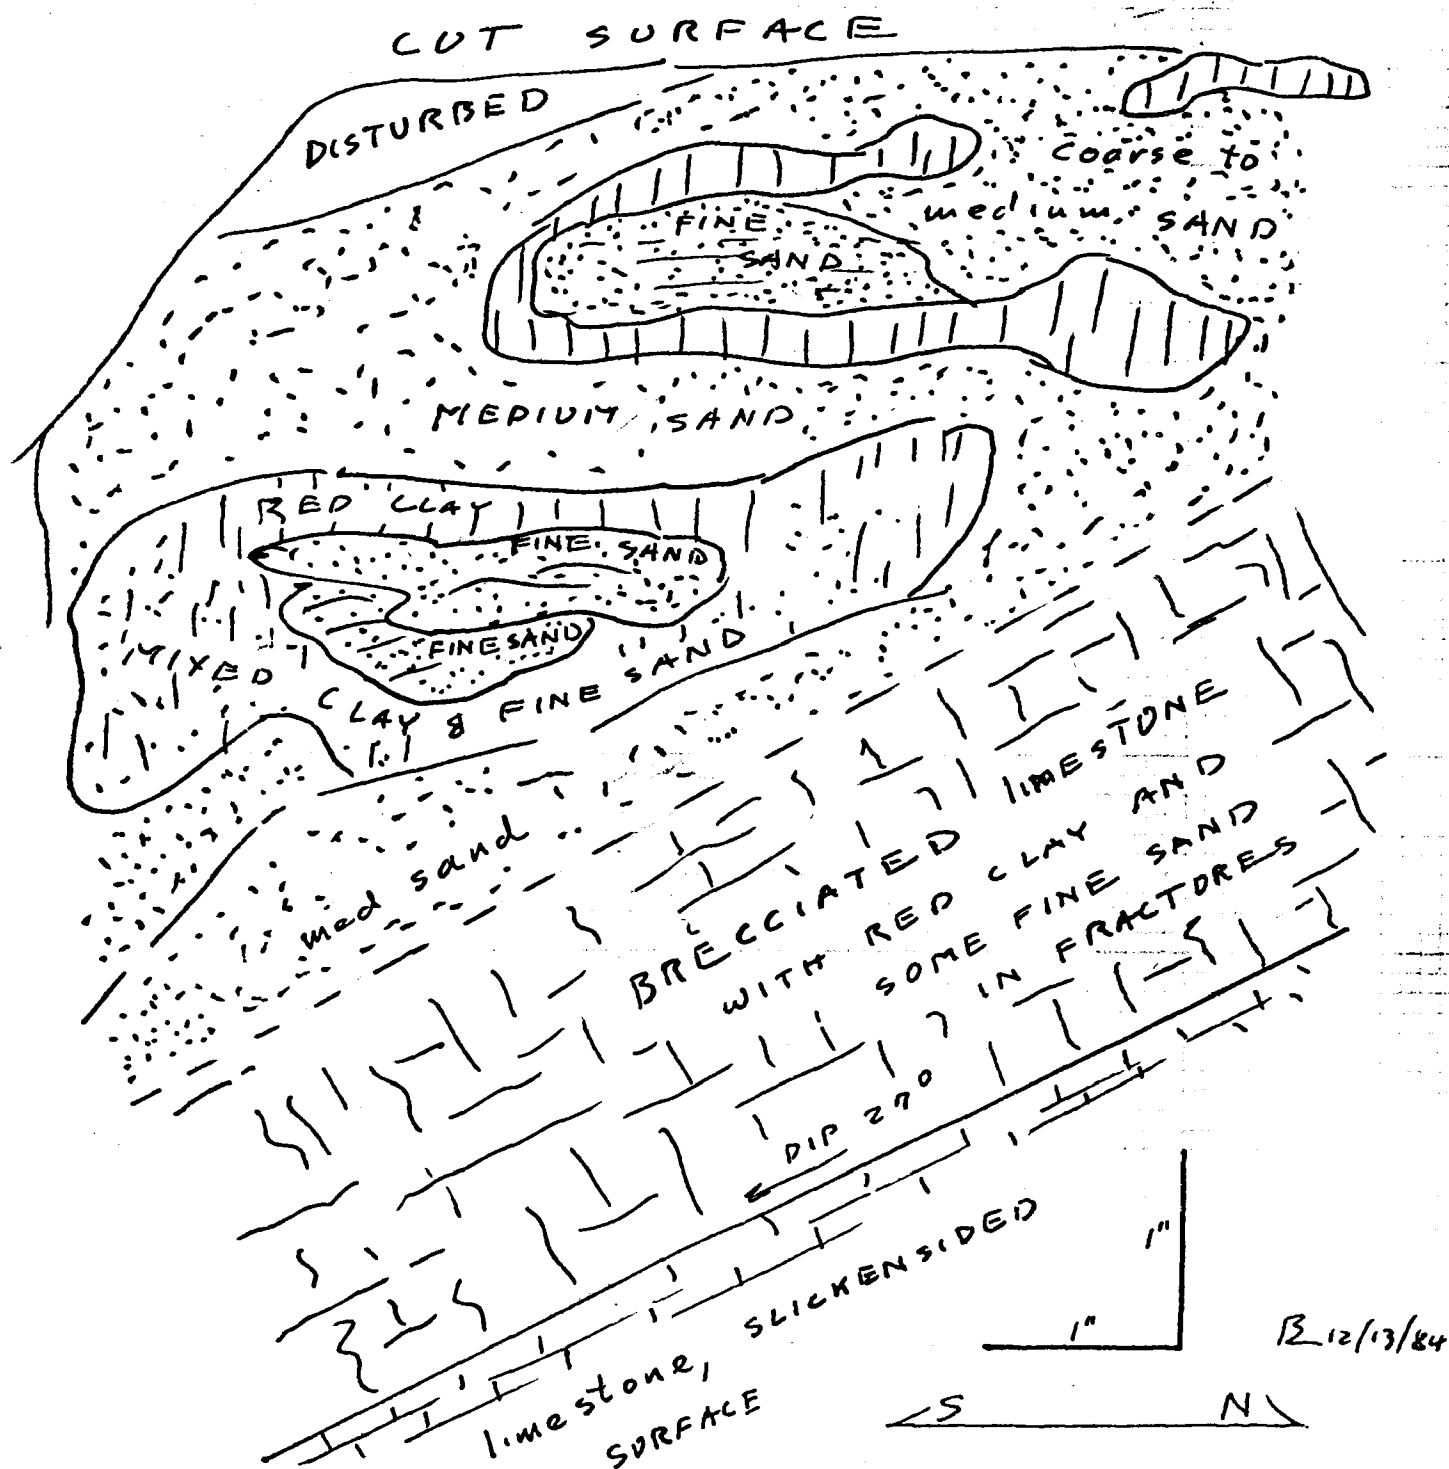
SKETCH TO SHOW STRUCTURE
 IN SAND SEAM, SMITH AND
 MOREHOUSE SPILLWAY CUT STA. 3+00 @ EL. 84
 VERTICAL SECTION

The sand seam at 3+00 and elevation 84 inspected on December 5, dips gently southeast, into the hillside. It is composed of beds of sand, silt, red clay, clayey sand, and limestone breccia oriented parallel to the seam (Figure 2). The footwall of the seam is a hard flat surface of limestone, probably a bedding plane, but not definitely identified as such. The surface is polished in spots and has at least two sets of scratches, one plunging down dip (S 20° E) and the other slightly east of down-dip.

Overlying this slip surface is a 1-2" layer of brecciated gray limestone mixed with a small amount of reddish sand and clay. The breccia crumbles easily into sharp angular fragments; some fracture surfaces bear a thin coating of red clay.

Overlying the breccia is an irregular zone up to 4" thick of finely interbedded fine sand, silt, and red clay. Boundaries between these units are sharp and emphasized by color differences. Unlike the vertical sand seam, sand rather than clay forms the edges. The finely layered sand and clay shows evidence of shearing with compression parallel to the sand seam. The shearing may be due to excavation.

The one good exposure of sheared sediment occurred only 6" below the excavated cut surface (Figure 2); the observed shearing was probably the result of excavation.
