UGMS HAZARDS SECTION

August 14, 1985

SUBJECT: Laketown Project

This is to report on two recent trips to Laketown, Utah, to inspect the existing reservoir and sites for proposed new reservoirs.

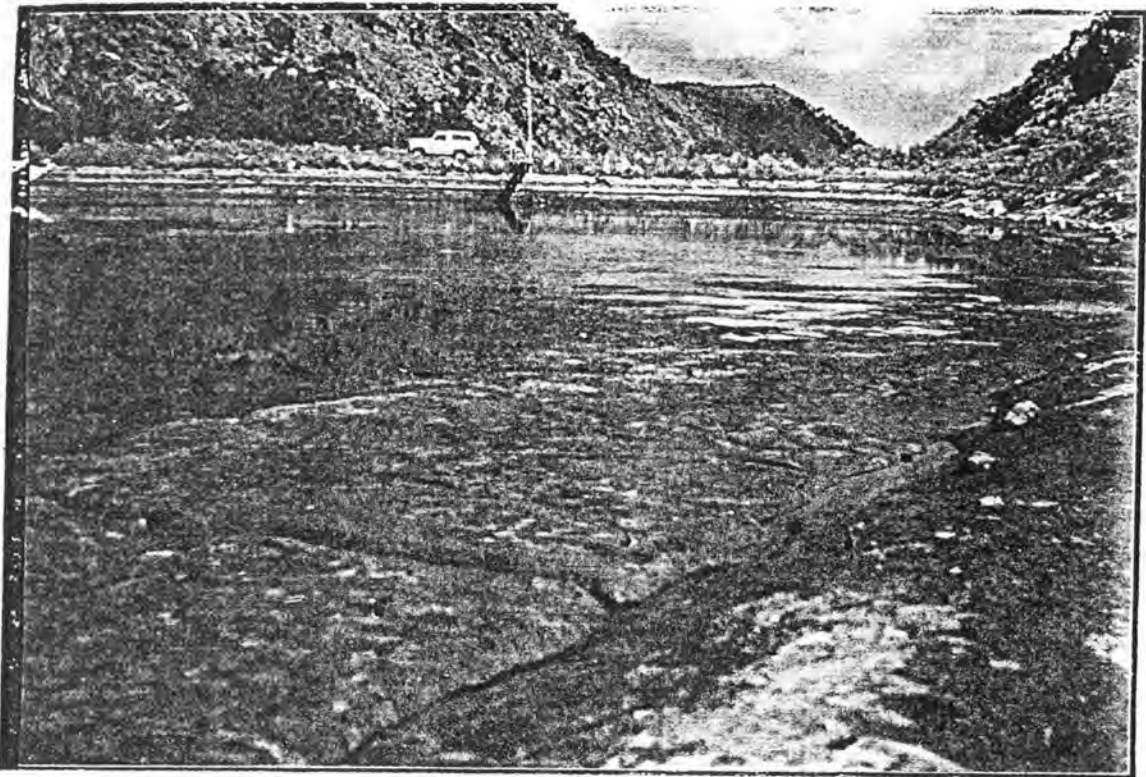
Figure 2. Ground cracks in the reservoir basin, view downstream

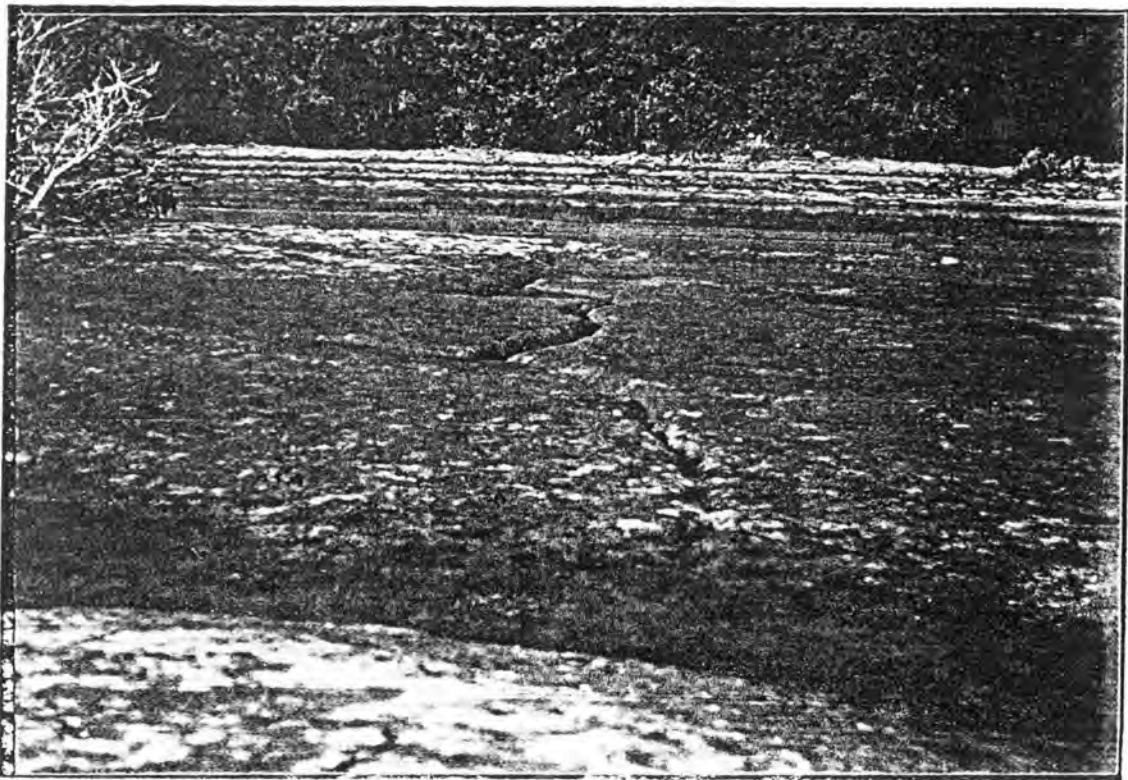
Figure 3. The cross-valley cracks are sinuous, and are not associated with broad ridges or depressions.

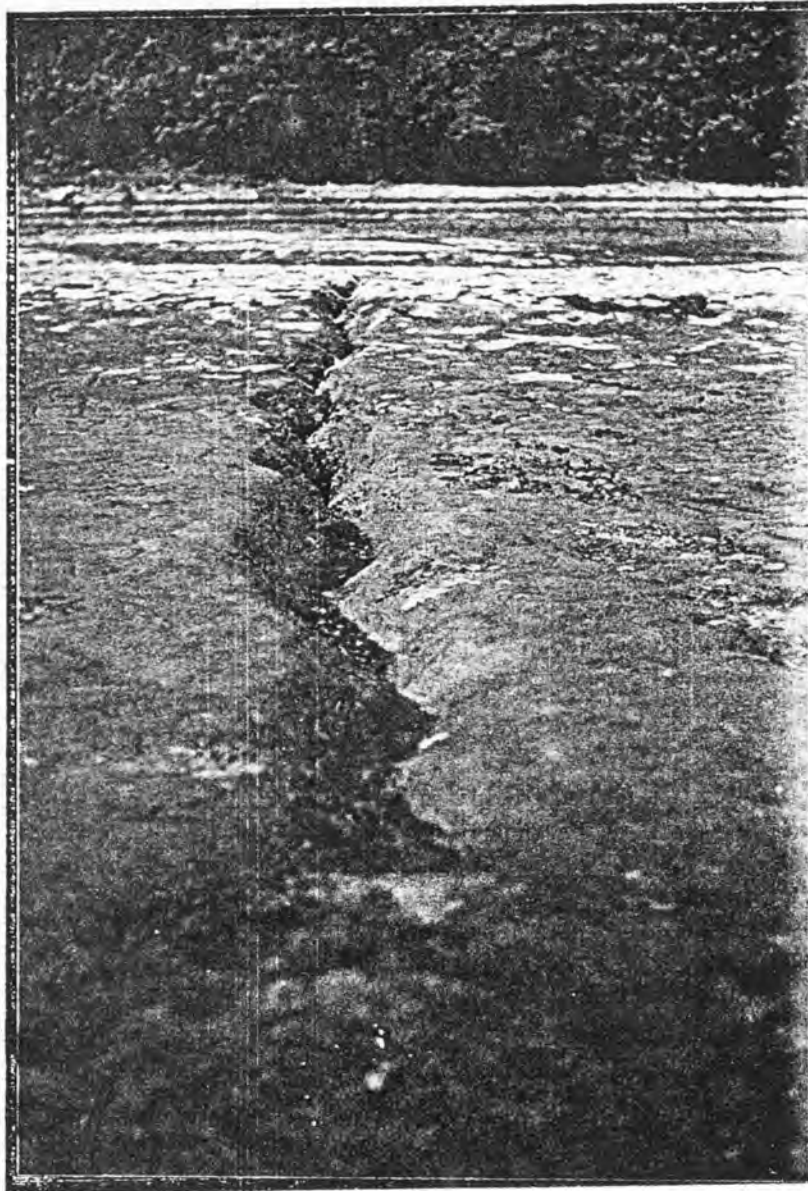
Figure 4. Fresh cracks are open to 1 inch and are taking water

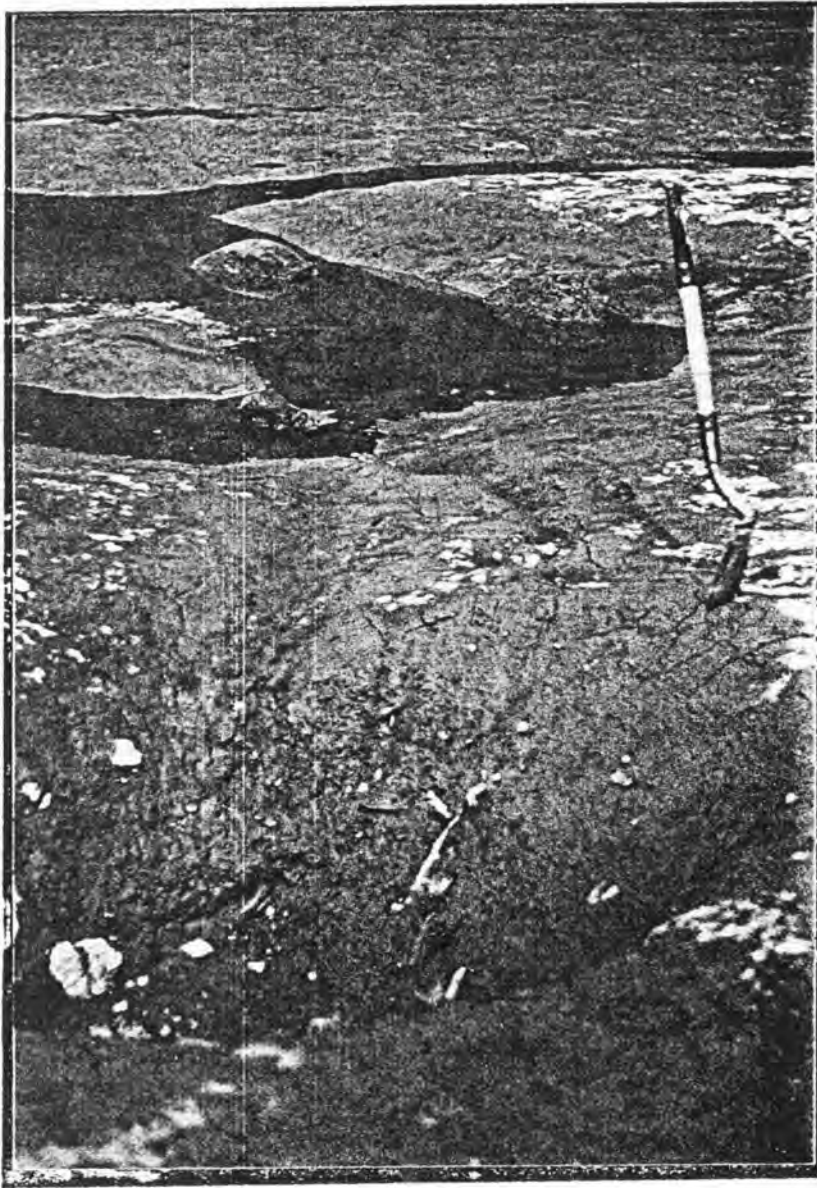
Figure 5. The largest of the sink holes, near the intersection of two ground cracks, is 5 feet wide and 3 feet deep, with the bottom 2 feet below water level in the reservoir.
