UTAH DEPARTMENT OF TRANSPORTATION

DATE: October 31, 1980

SUBJECT: I-15-4(18)188 - Scipio to Sevier River
Subsurface Investigations for Sinkhole Problem

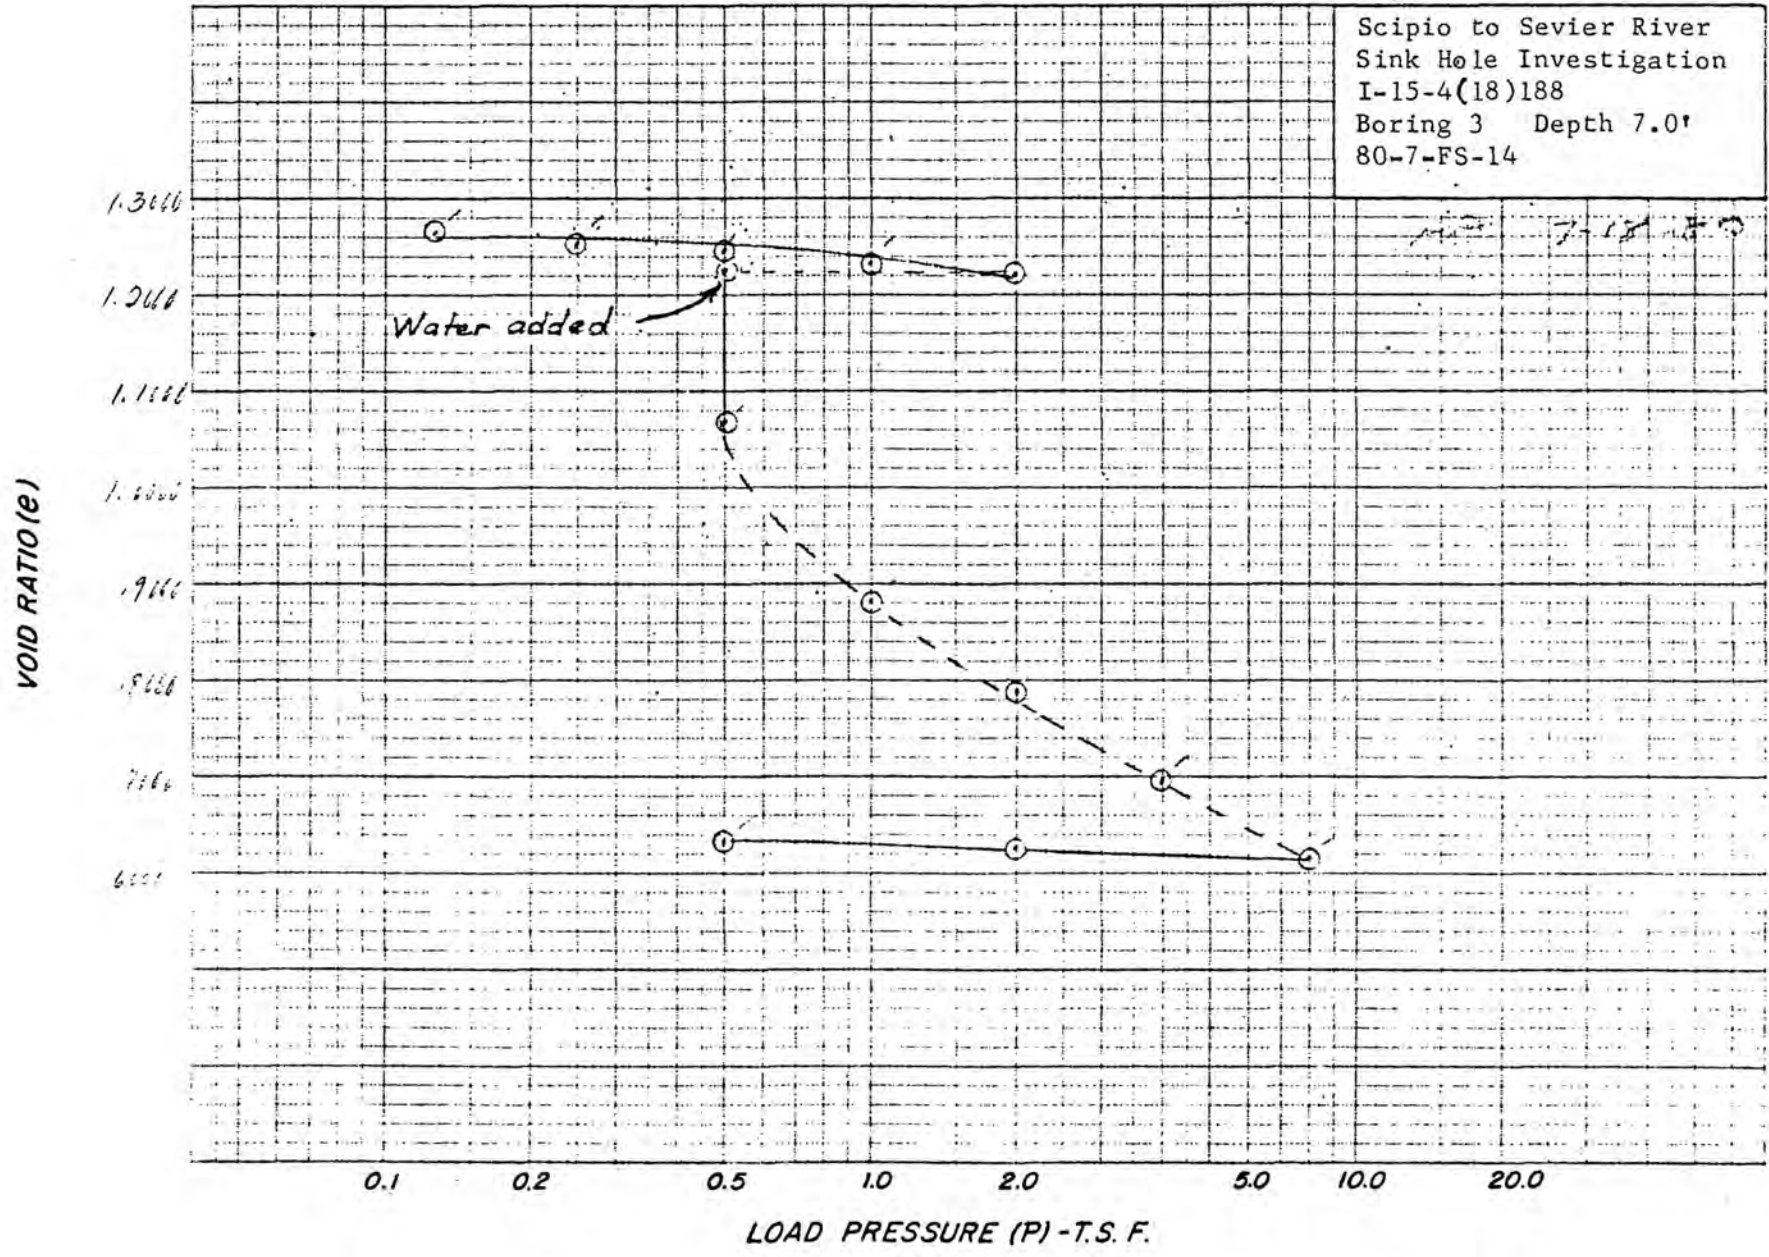
Scipio to Sevier River
Sink Hole Investigation
I-15-4(18)188
Boring 3 Depth 7.0'
80-7-FS-14

Copies of the void ratio vs. log of pressure curves from the consolidation/collapse tests are also attached. In general, these tests show that all samples tested except those from drill hole 1 are susceptible to collapse on contact with water. The samples from hole 2 and those from 19 feet or deeper in holes 4 and 5 are moderately collapse-susceptible and only when subjected to higher than in-situ pressures. It can be seen from the test curves that the collapsible soils at field moisture conditions have considerable strength to resist deformation from pressure but lose this strength and are easily compressed after saturation with water. Several of the specimens were found to be highly susceptible to collapse as shown by immediate reduction in void ratio or volume on contact with water (eg. Test Hole 5 at 7 feet). The wet unit weights of the collapse-susceptible silts are also much lower than normal for soils with similar grain size distribution.
