# LANDSLIDES IN THE BORAH PEAK, IDAHO EARTHQUAKE OF 1983

David K. Keefer, Raymond C. Wilson, Edwin L. Harp, and Elliott W. Lips  
U.S. Geological Survey  
Menlo Park, California

This report describes landslides and related ground-failure effects that were observed after the earthquake. Observations were made from a small fixed-wing aircraft on October 31 and November 8 and on the ground from October 30 to November 9. Ground-based field studies included automobile traverses over most roads in the epicentral region and traverses of selected areas on horseback or on foot.

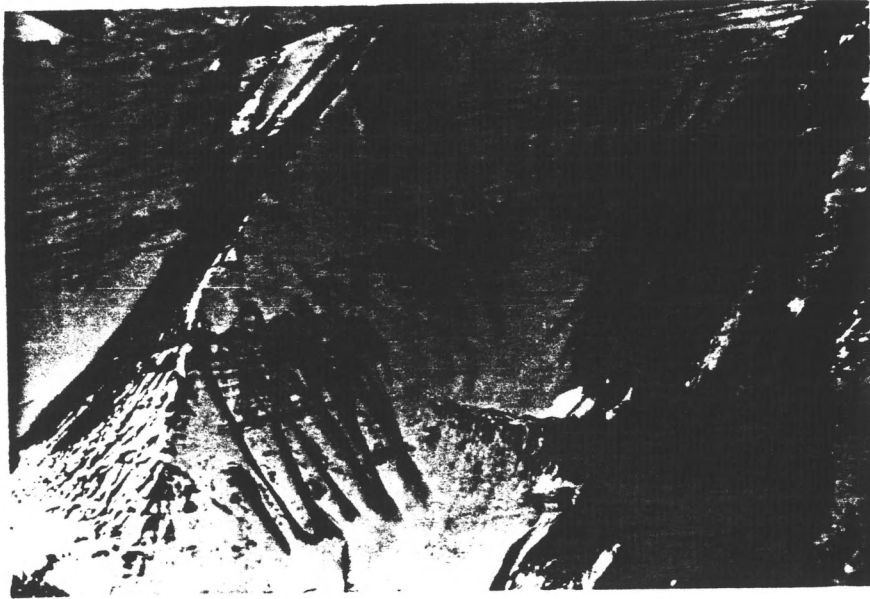
The areas with the most numerous rock falls and rock slides were the glacial cirques on eastern flank of Grouse Creek Mountain, at the heads of Rock Springs and Dead Cat Canyons. We observed several dozen small rock fall and rock slide deposits, which consisted of trails of boulders and finer debris a few dozen meters long, a few meters wide, and probably less than 2 meters thick. These landslides originated on steep, in some cases near-vertical, slopes in Mississippian limestone, calcareous siltstone, and sandstone of the Middle Canyon, Scott Peak, South Creek, and Surrett Canyon formations. Typical rock fall and rock slide deposits are shown in Figure 3.

Figure 3. Oblique aerial view of rock falls and rock slides on the eastern flank of Grouse Creek Mountain in the Lost River Range. Deposits of earthquake-induced rock falls and rock slides are dark-toned trails overlying snow in left and central parts of photograph. Longest trails are about 100 m long. Medium-gray deposits to right of snow-covered area are pre-earthquake talus deposits.

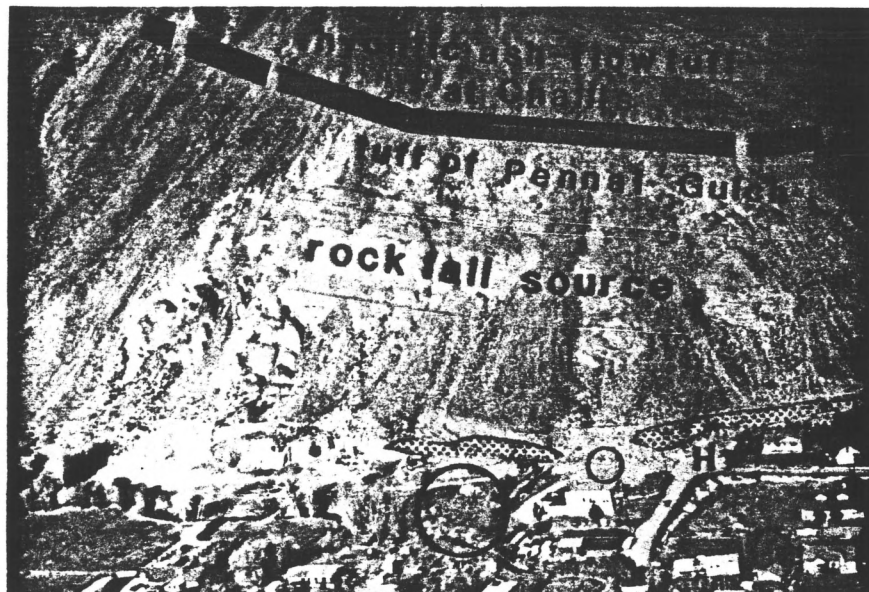
Several dozen boulders up to 3 m in diameter fell at Site I, which is shown in Figure 4. The boulders fell approximately 100 m from a hillside with an average inclination of  $35^\circ$  and localized near-vertical cliffs. Boulders

Figure 4. Oblique aerial view northward toward Site I in Challis showing rock-fall source, geologic contact (dashed where approximate), earthen embankment (dotted areas), house damaged by rock fall (H), and areas of visible rock-fall deposits (circled). Boulder causing damage to house was removed before photograph was taken.

bounced and rolled as much as 70 m across the gently sloping ground at the base of the hillside. Other boulders came to rest behind an artificial earthen embankment approximately 5 m high at the base of the hillside, and a few boulders apparently bounced over this embankment.

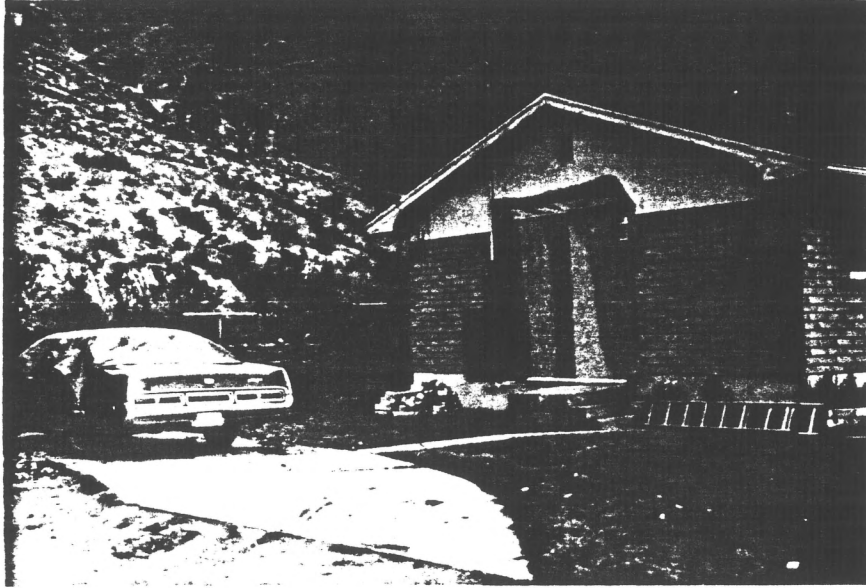
One of the largest boulders, which weighed an estimated 10 metric tons, bounced into a house less than 10 m from the base of the hillside (Figure 5). The boulder impact moved the house superstructure several centimeters, cracked the cement steps, and smashed into the doorway through which a resident had fled a few moments earlier (Idaho Falls, Idaho, Post-Register, Oct. 31, 1983, p. A-9). The house remained on its foundation. Boulders at Site I also damaged two automobiles (one visible in Fig. 5), dented the metal roof of a garage, and partly blocked a street (Fig. 6) and a parking lot.

Figure 5. House and automobile damaged by rock fall at Site I in Challis. Boulder crashed into doorway of house, now covered by plywood, and moved house superstructure several centimeters. Boulder removed before photograph was taken.

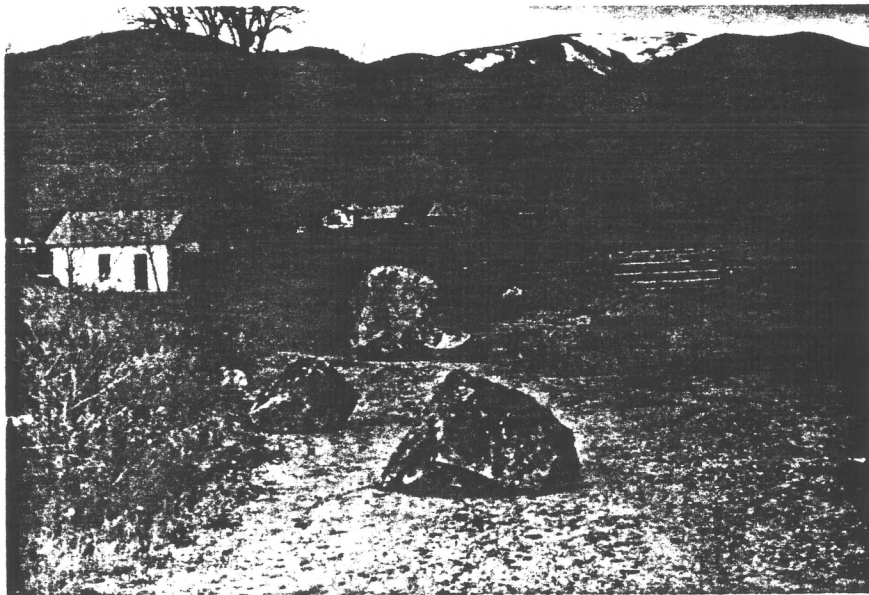
Figure 6. Boulders dislodged by earthquake partly blocking road at Site I in Challis.

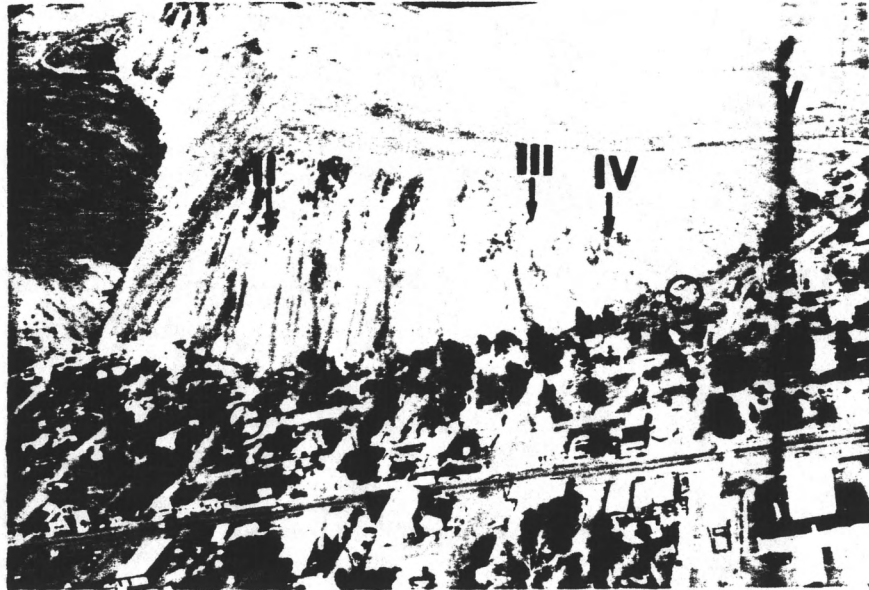
The largest boulder we observed in Challis (Fig. 11) fell from a promontory (Site IV in Figure 7) that contained many conspicuous open joints. The boulder, 8 m in diameter and weighing an estimated 50 metric tons, contained painted letters or high-school-class numerals on 3 sides, showing at least 3 edges were exposed prior to the earthquake. This boulder fell and slid approximately 50 m and came to rest a few meters from the base of the slope. Several smaller boulders also fell at this site during the earthquake.

Earthquake-induced rock falls also occurred at several other sites in and near Challis. At Site V (Fig. 7) cobbles and small boulders fell through the

Figure 7. Oblique aerial view northward toward Sites II, III, IV, and V in Challis. Arrows point to rock-fall sources; circles show locations of rock-fall deposits visible in photograph. Hillside in Figure 7 is just east of hillside in Figure 4.

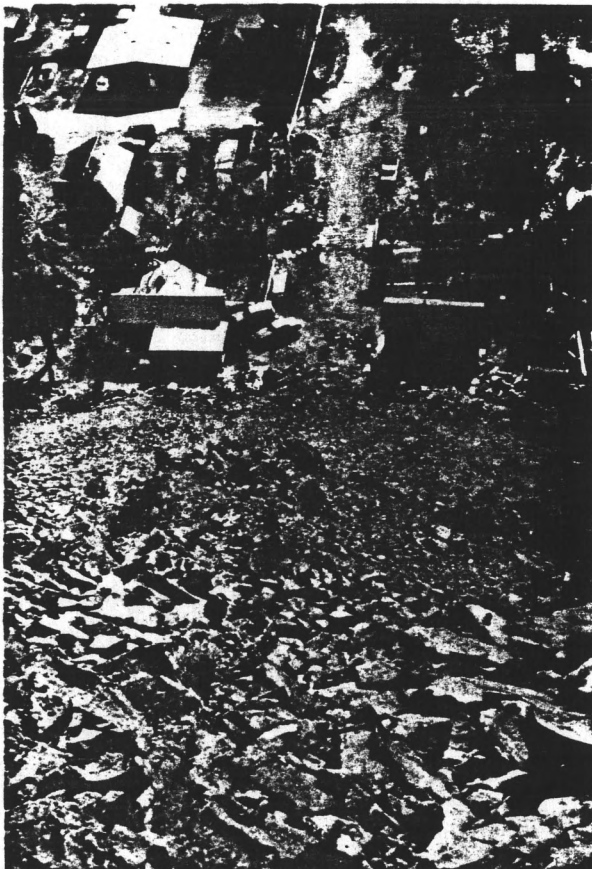
Figures 8 and 9 show the source, path, and resting place of the largest boulder that fell at Site II (Fig. 7). This boulder, which was detached from a near vertical cliff just above a talus apron, bounced and rolled approximately 100 meters down the 35° talus slope. At the base of the slope the boulder bounced between two houses and smashed a garbage can; bounced again and hit some fence posts; bounced four more times and cracked the planks of a small wooden bridge; then rolled into the front yard of another house, crashed into an apple tree, and crushed a corner of the porch before coming to rest less than 3 m from the front door (Fig. 9). This boulder is 3.3 m in diameter and weighs an estimated 20 metric tons. It traveled 70 m from the base of the steep talus slope. Figure 8 shows that, had the boulder followed virtually any other path from its source, it would have caused significant damage to one or more houses.

Figure 8. View from source of rock fall at Site II in Challis. Arrows show visible boulder-impact marks. Largest boulder removed before photograph was taken.

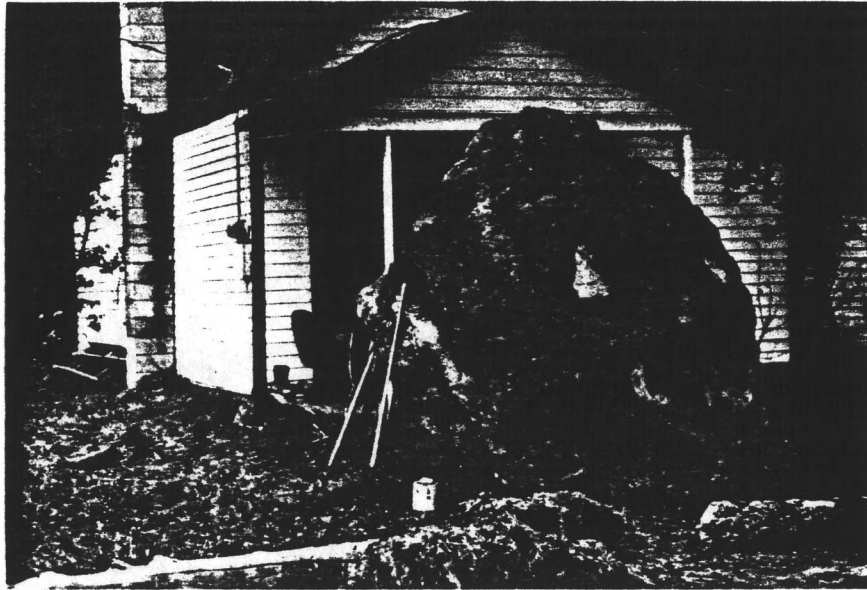
Figure 9. Largest boulder dislodged by earthquake at Site II in Challis. The decorations were added the day after the earthquake.

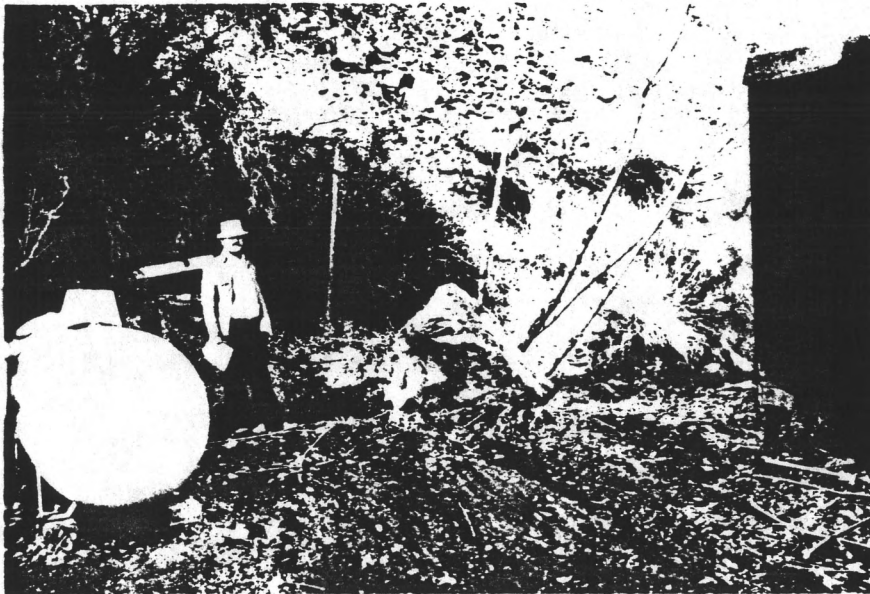
Figure 10. Boulder from rock fall at Site III in Challis. Boulder bounced across creek, landing between propane tank and trailer (right edge of photograph), before rolling part of the way back down the creek bank.

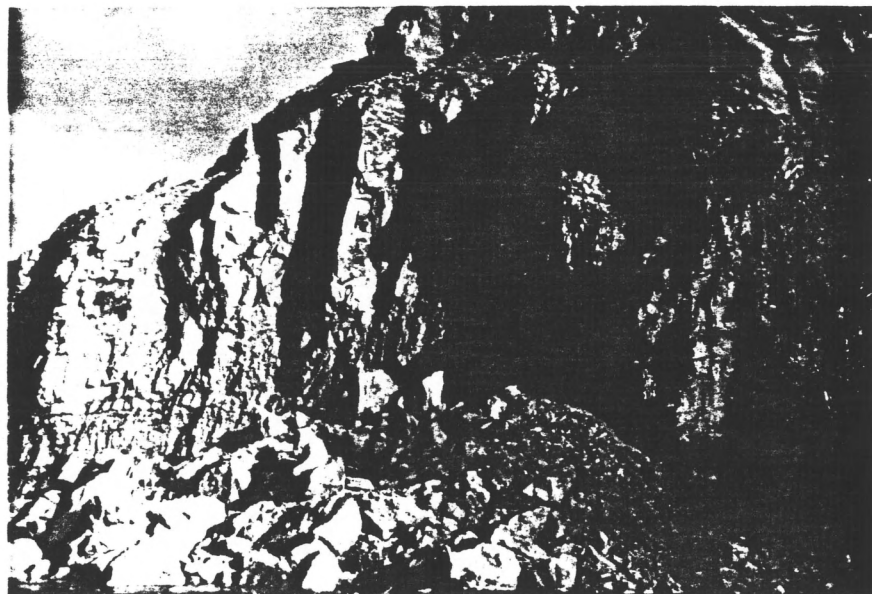
Figure 12. Largest observed rock fall triggered by earthquake, adjacent to Salmon River at Birch Creek. Volume of rock fall is about 10,000 m<sup>3</sup>.

A rock fall of about  $10,000 \text{ m}^3$ , the largest one we observed that was caused by the earthquake, occurred on a near-vertical cliff adjacent to the outside of a meander (Fig. 12). The rock fall involved both massive and thin-bedded tuffs of the Challis Volcanics (Rember and Bennett, 1979a). Bedding dipped into the slope, but angular blocks were detached along two sets of conspicuous, near vertical joints.

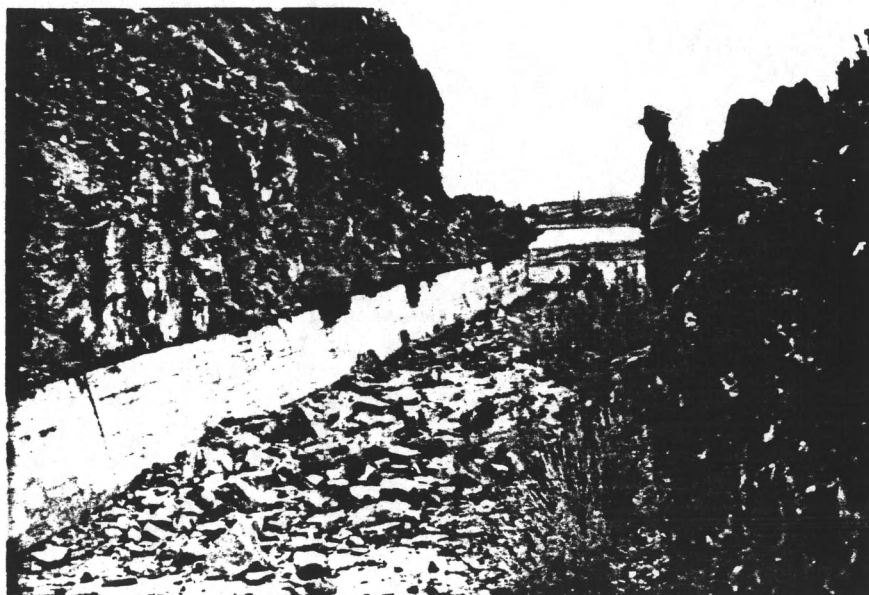
Falls from an east-facing slope deposited approximately 200 m<sup>3</sup> of rock in the Mackay Dam spillway, but this rock constituted only a small obstruction (Fig. 13). The source of the rock fall was a highly fractured, partly altered, limestone of the White Knob Limestone (Mississippian to Permian) (Nelson and Ross, 1969). The source slope was 80 m high and had an average inclination of 40°.

Figure 13. Rock-fall deposit in spillway at Mackay Dam.

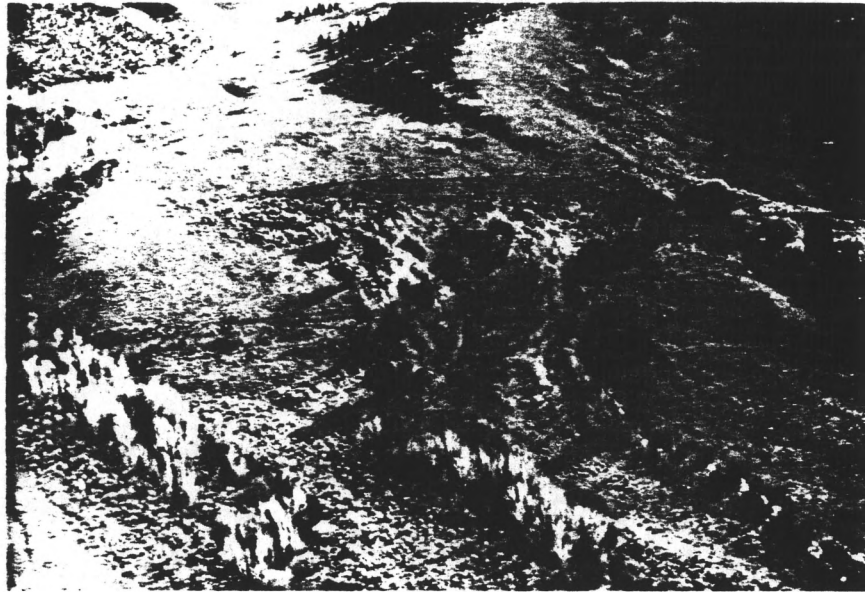
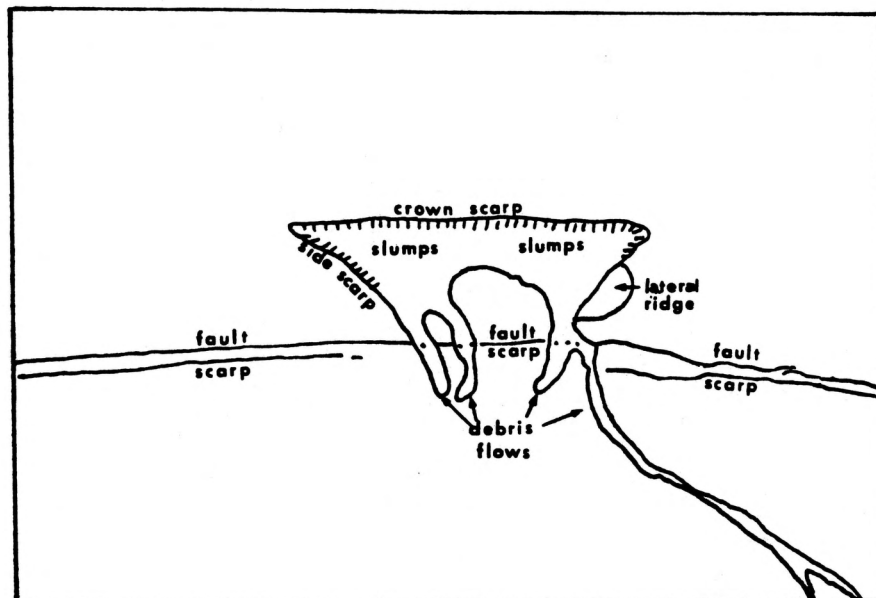
Figure 14. Complex rotational slump-debris flow at Birch Springs.

The arcuate crown scarp of the landslide was approximately 250 m long and up to 5 m high (Fig. 15). Upslope from the scarp was a zone of crown cracks subparallel to the scarp. For approximately 50 m downslope from the scarp, the landslide mass consisted of a jumble of back-rotated slump blocks (Figs. 14 and 15), some of which had partly disintegrated and produced small debris flows. The zone of slumps was bounded on the right flank (facing downslope) by a scarp and on the left flank by a lateral ridge of landslide material up to 2 m high (Fig. 14b).

The landslide material was progressively more disrupted downslope, and the distal part of the landslide consisted of four debris flows several hundred meters long (Fig. 14). The debris flows were complex, with numerous lobes, blocks of less fluid material, and islands of undisturbed ground around which the debris had flowed. These debris flows were bounded in part by complex lateral deposits and had toes a few tens of centimeters high.

Figure 14a. Oblique aerial photograph eastward toward Birch Springs slump-debris flow.

Figure 14b. Line drawing of same area as in Figure 14a, showing main features described in text, including crown scarp, area of slumps, side scarp, lateral ridge, main debris-flow deposits, and fault scarp (dotted where covered by debris-flow material). Crown scarp is approximately 250 m long.

Factors probably contributing to initiation of this landslide include the presumably low strength of the saturated colluvium, temporarily elevated pore-water pressures caused by strong earthquake shaking near the fault, and (or) changes in ground-water flow due to the faulting.

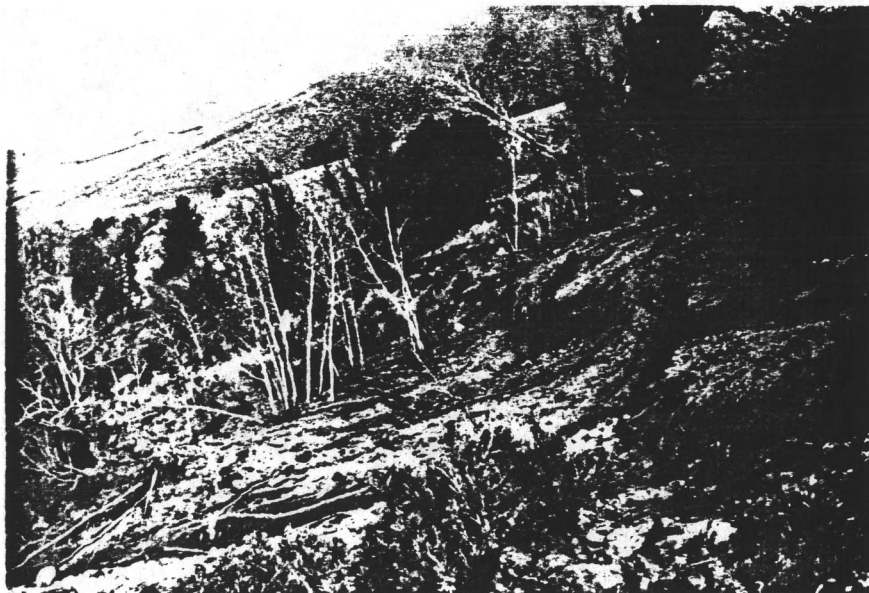
Figure 16. Birch Springs slump-debris flow. View northward showing debris-flow material lapping over fault scarp.

Debris lapped over the fault scarp 200 m downslope from the crown (Fig. 16), showing that debris-flow movement took place after rupture on the fault. The morphology of the debris flows and splash marks at least 1.2 m above the surface on trees suggest that the debris flowed rapidly, at least several tens of meters per hour.

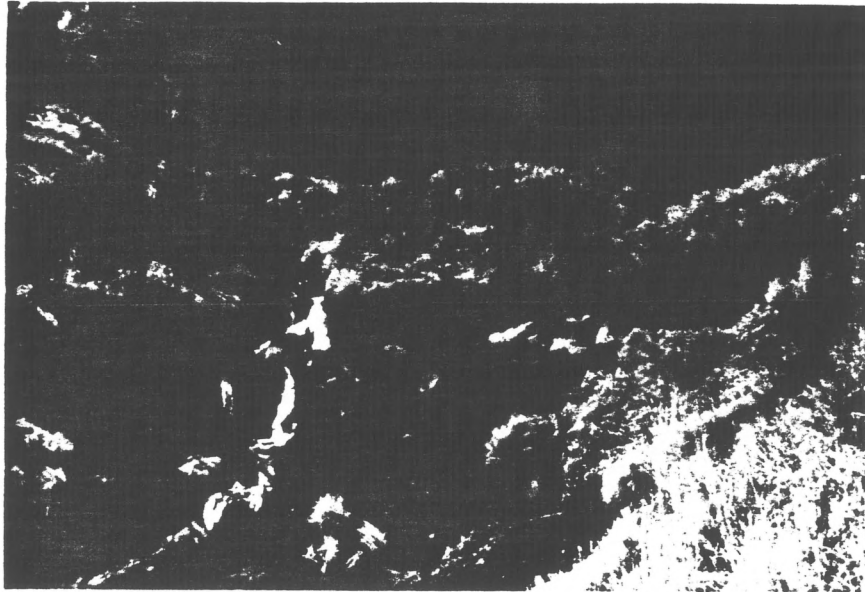
The source of the mud flow was a 10-m-thick deposit of colluvium, derived from rocks of the Copper Basin Formation (Nelson and Ross, 1969; Betty Skipp, oral communication, Nov. 4, 1983). When we examined the source area (Fig. 18) on November 4, 1983, we noted that a mass of this colluvium 200- to 300-m long had been removed by landslide movement, providing the material for the mud flow. The presence of small rotational slump deposits on and near the 10-m-high crown scarp (Fig. 18) suggests that the colluvium moved initially in a retrogressive series of rotational slumps. Lobate lateral deposits of mud-flow material are present less than 200 m downstream from the crown scarp. The proximity of these deposits to the scarp suggests that the slumps disintegrated into mud flows in a short distance. This rapid disintegration was probably partly due to the high water content of the material. The mud flowed more than 3 km down the valley of Lupine Creek on an average gradient of less than 8°, spreading out to cover most of the flood plain (Figs. 19 and 20). The mud flow broke numerous trees and even near its distal margin, 3.5 km from its source, was sufficiently powerful to snap aspen trees more than 20 centimeters in diameter.

Figure 18. Crown scarp of Lupine Creek mud flow. Blocks of sod-covered (light-toned) earth on scarp are deposits of small slumps. Light-toned streak on left-center of scarp marks course of stream with flow that increased after earthquake. Note human figure above right end of scarp for scale.

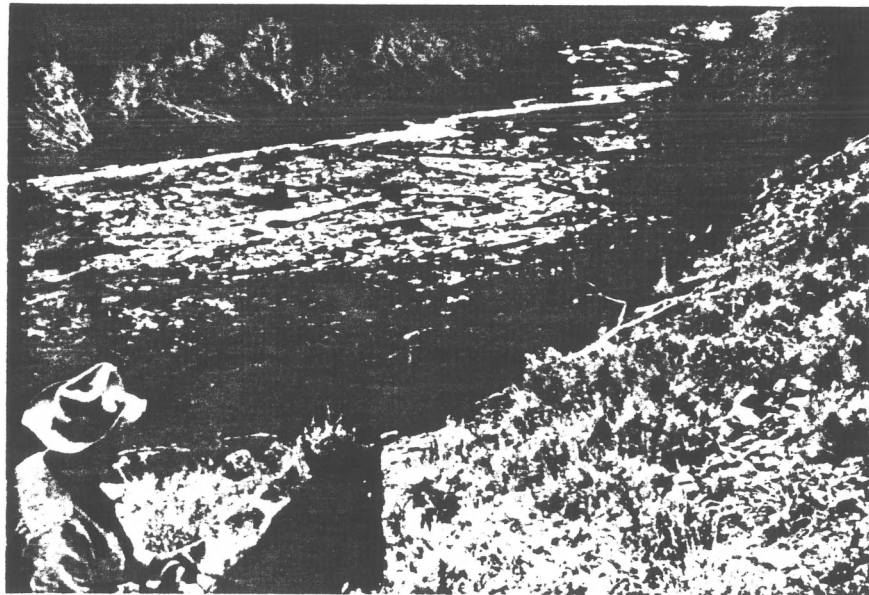
Following the earthquake, a large complex mud flow occurred in the valley of Lupine Creek. The deposit of this mud flow contained an estimated 200,000 m<sup>3</sup> of material and covered virtually all of a 3.5-km-long stretch of the Lupine Creek flood-plain to an average depth of about 50 cm. The mud-flow material was a black organic-rich silty sand containing some clay and gravel and many trunks and limbs of trees broken by the mud-flow movement. Where sampled near the toe, the inorganic matrix was 15% by weight gravel, 41% sand, 30% silt, and 14% clay (Fig. 17). The water content of matrix sampled on November 4, 1983 was 108%<sup>1</sup>; the water content was probably greater when the mud flow was moving.

Figure 19. Mud-flow deposit (dark-toned area) in Lupine Creek valley, containing numerous trunks and limbs of trees broken by mud-flow movement.

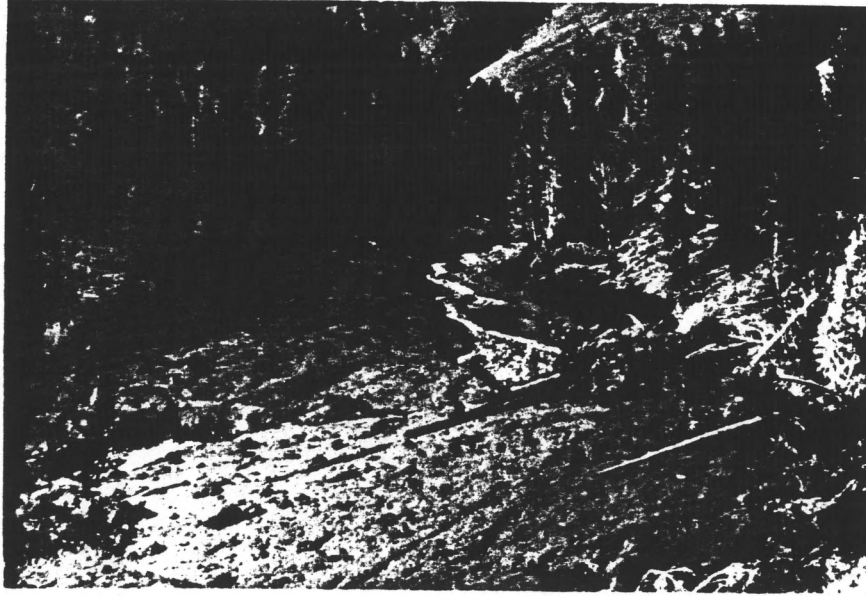
Figure 20. Mud-flow deposit (medium- to dark-toned area) covering the Lupine Creek flood-plain.

springs in the valley and observed that the flow in Lupine Creek was at least triple the pre-earthquake flow. The mud flow was thus probably caused by saturation of the colluvium owing to increased surface and subsurface water flow due to the earthquake.

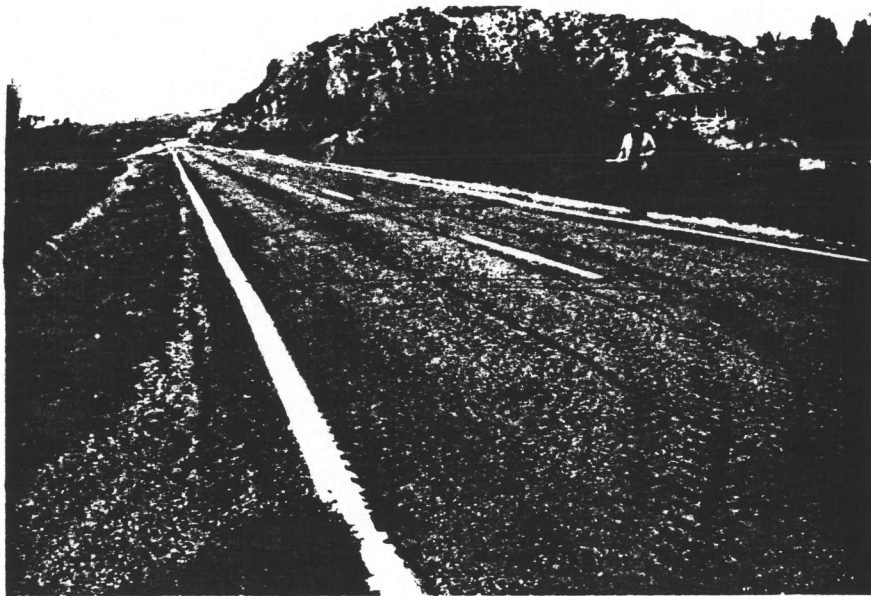
Figure 21. Cracks in shoulder and pavement of U.S. Highway 93 at Sportsmen's access. View northeast.

U.S. Highway 93 at this locality is on a 12-m-high man-made embankment composed of cobbly fine-sand fill built on the flood plain of the Big Lost River. Longitudinal cracks were present along both shoulders, and longitudinal and oblique cracks disrupted the pavement (Fig. 21). Material on the western shoulder settled and moved horizontally to the west a few centimeters, but much of the roadway and eastern shoulder moved 10 to 20 cm horizontally toward the east. Eastward movement likely predominated because both the road surface and the natural ground surface beneath the embankment sloped toward the east and because water flowed in an unlined canal along the east side of the embankment, presumably creating soft foundation conditions.

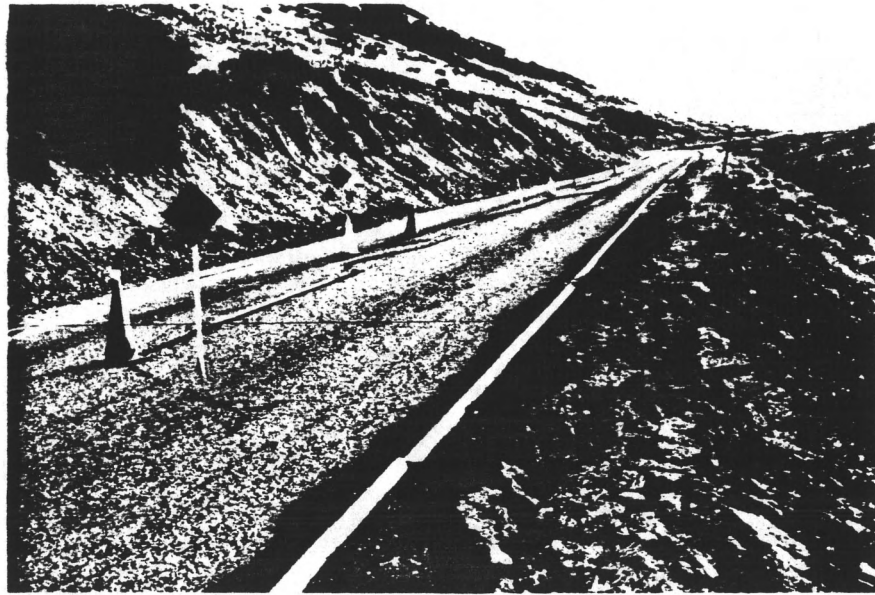
A slump approximately 20 m wide disrupted the highway pavement and west shoulder of U.S. Highway 93 (Fig. 22). The southbound lane and part of the northbound lane of the highway moved several centimeters westward, and fill in the shoulder west (downslope) of the pavement was cracked into blocks several centimeters on a side. The highway is on a cut-and-fill slope, and the crown of the slump appeared to be at or near the boundary between cut and fill.

Figure 22. Slump at Willow Creek Summit along U.S. Highway 93. Material on shoulder broken into blocks by slump movement. View south.
