Report No. UT-03.01

UTAH ROCKFALL HAZARDS INVENTORY Phase I

**By: Robert T. Pack, Ph.D., P.E.
Ken Boie**

**Utah Department of Transportation
Research Division**

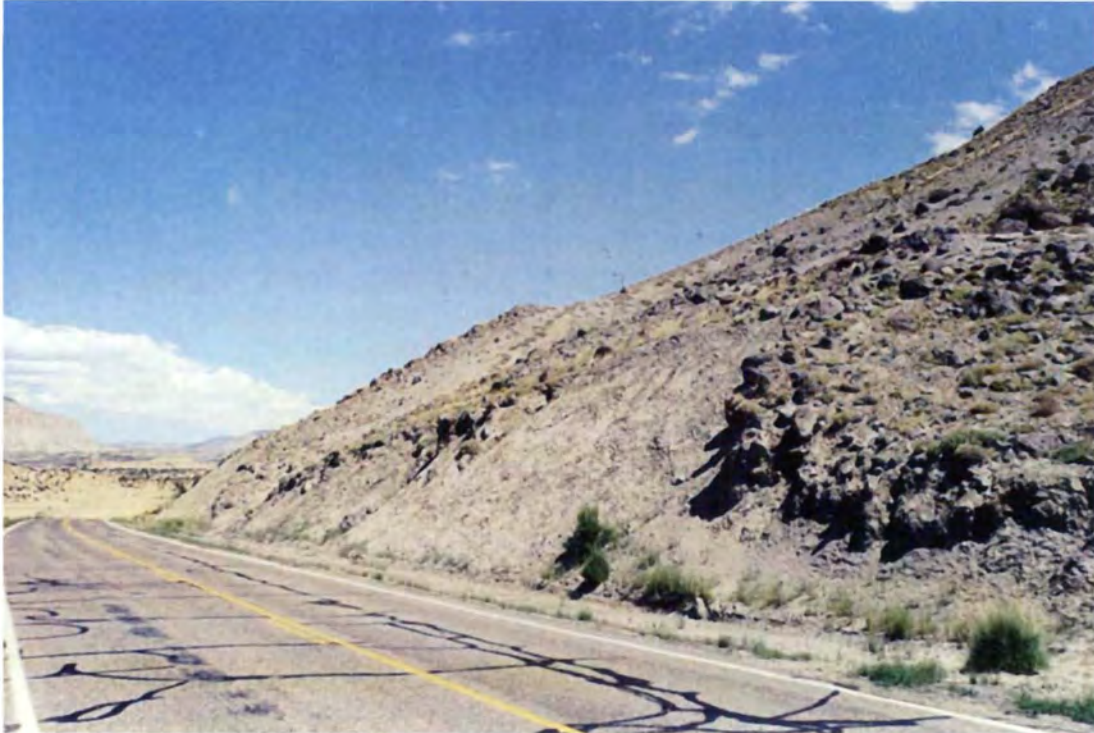
Figures 3 through 6 are photographs of representative slopes in categories A through C. The C slope given in Figure 3 is located in the jurisdiction of the Emery Maintenance Station in central Utah. The slope angle for this site is relatively low and is cut through a sedimentary rock unit (shale or mudstone) that is subject to moderate weathering. The upslope portion of this rockfall site has evident rounded boulders likely from an upslope alluvial or conglomerate source. The lower portion of the slope poses no risk to the roadway, save for small soft sediment sloughs where the upslope material might represent a low risk. However, because of the large roadside ditch and the low slope angle, this slope was given a C rating.

Figure 3. C-rated slope near Emery, Utah.

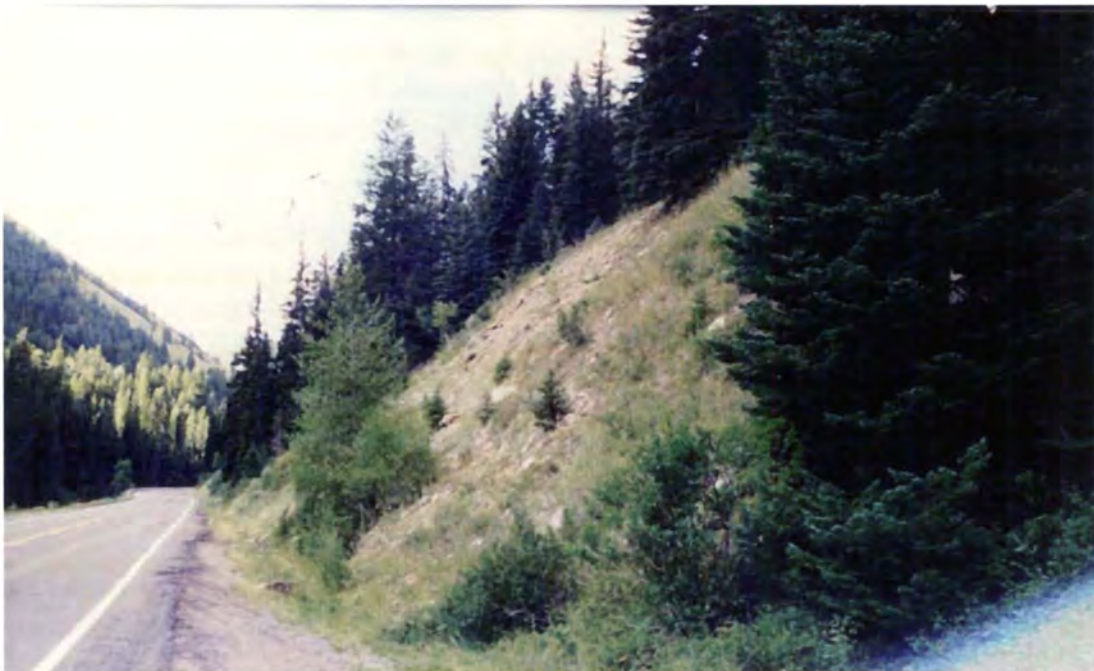
Two B-rated slopes have been included as examples. Figure 4 is from the Huntington Maintenance Station located in the Uinta Mountains while Figure 5 is from the Colton Maintenance Station. These two photos were chosen because they illustrate two very different B-rated slopes. The site in Figure 4 is what might be envisioned as a typical B slope. This cut is surrounded by heavy forest and has abundant plant cover on the slope itself. The presence of rock slabs on the slope surface indicates some possibility for rock sliding despite the plant cover and relatively low slope angle. In the background, it is apparent that there is a relatively modest berm area. This slope was given a B rating because of the small ditch/ berm area combined with the presence of slabs that could potentially slide on the slope face and reach the roadway. Figure 5 also shows a B-rated slope. This slope has both vertical and laid-back rock faces cut through multiple sedimentary rock-types. Differential weathering is apparent in two of the three layers shown. On first glance, this slope might seem to warrant an A rating but on closer inspection, the width of the ditch area indicates very effective catchments for debris (both slough and boulders evident in the ditch). This is also borne out by the modest amount of rockfall reported on the road over the years. This slope demonstrates the effect of well sized catchments on this preliminary rating system. This slope may have significant cleaning requirements to maintain its B status.

Figure 4. B-rated slope near Huntington, Utah.

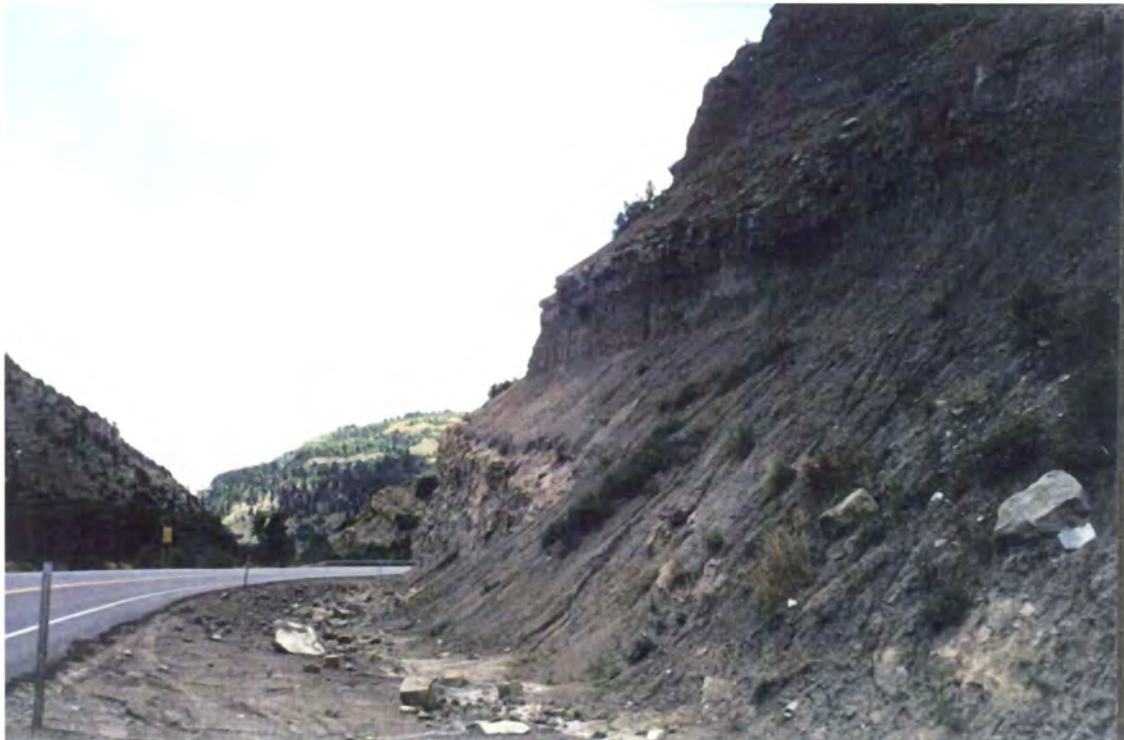
Figure 5. B-rated slope near Colton, Utah.

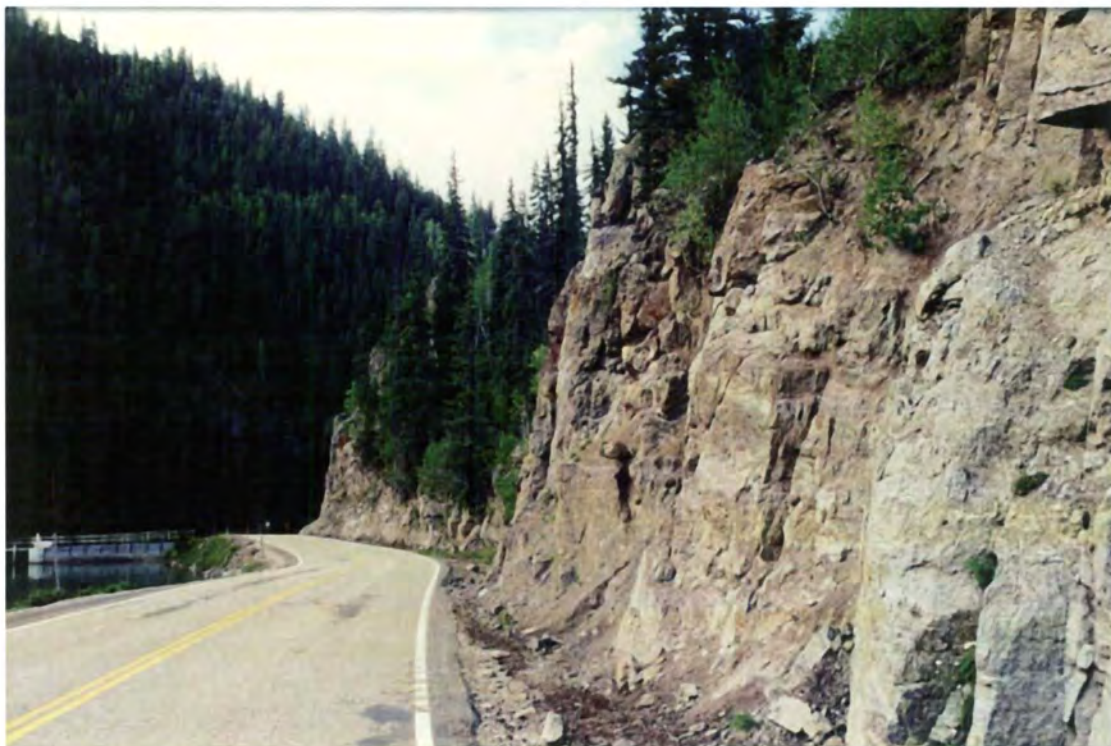
Figure 6 is a typical A-rated slope. This cut located in the Beaver Maintenance Station jurisdiction is a representative A-rated slope for several reasons. The catchment ditch area is inadequate in both width and depth to catch the size material weathered from the rock face. While the face itself is not extremely high and has good cover on top, the sizes of the blocks that are weathering from the cliff face are large and easily capable of reaching the road surface. Final contributing factors to instability on this face evidenced by vegetation are (1) the potential effects of saturation due to relatively high rainfall and (2) the potential effects of seasonal freeze-thaw action during the spring thaw.

Figure 6. Near-vertical A-rated rock cut in the Beaver Maintenance Station.
