**RECONNAISSANCE STUDY OF THE APRIL 12, 1995,
LANDSLIDE IN ZION CANYON,
ZION NATIONAL PARK, UTAH**

Robert L. Schuster and Gerald F. Wiczorek
Branch of Earthquake and Landslide Hazards
U.S. Geological Survey

U.S. Geological Survey Administrative Report

May 2, 1995

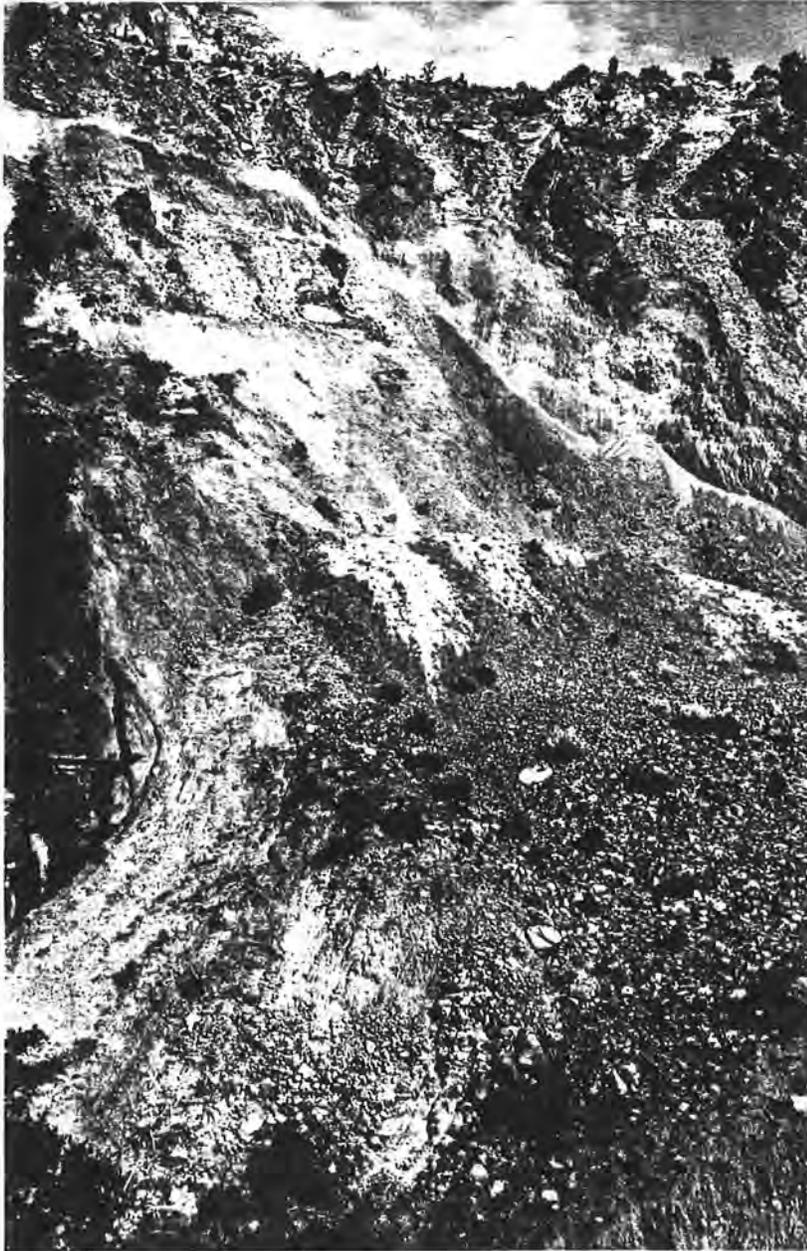
The current landslide (figs. 3 and 4; volume approx. 300,000 yd³) seems to be similar to the 1923 and 1941 events. It occurred in broken-up rock (Navajo sandstone and Kayenta formation) at the edge of the old slide block that forms the west valley wall of Zion Canyon (fig. 1). It can be classified as a debris slide (Varnes, 1978). The slide consists of two blocks of debris separated by an intermediate scarp. The materials exposed in the flank of the upper main scarp are rock fragments in a sandy gravelly matrix (fig. 5) derived from the rock units disrupted by the prehistoric sliding. It measures about 700 ft along the river and approximately 900 ft (horizontal distance) from the head of the slide to its toe in the river. The elevation difference between the top of the headscarp and the toe of the slide at the river is about 550 ft.

The probable cause of the 1995 landslide consists of two elements: (1) saturation of shale and mudstone layers within the old landslide mass and (2) toe erosion by the river along the base of the old slide mass. Heavy precipitation and resulting high runoff during the winter of 1995 contributed to both of these elements. Cumulative precipitation measured at Zion Park Headquarters for January, February, and March 1995 totaled 15.22 in., almost equaling the average annual precipitation of 15.23 in. for the period 1928-1980 (Hamilton, 1992). This high amount of precipitation probably raised the water table within the remnant of the old slide mass and in the saturated shale and mudstone layers within the Springdale member; however, the majority of the slide mass appeared to be dry. A seep was observed at the SW margin of the lower block of the landslide, probably from the sandstone unit of the Springdale member which outcrops at the margin of the landslide and possibly extends beneath the landslide. Because of elevated pore pressures, the shear strength of these

landslide materials was reduced. The reduced shear strength, combined with erosion at the base of the canyon wall due to fairly high river levels during the spring, led to the landslide.

Figure 3. Looking upslope at the April 12, 1995, debris slide. Main scarp is visible in the upper center of photograph and rocky landslide deposit is visible in the lower center.

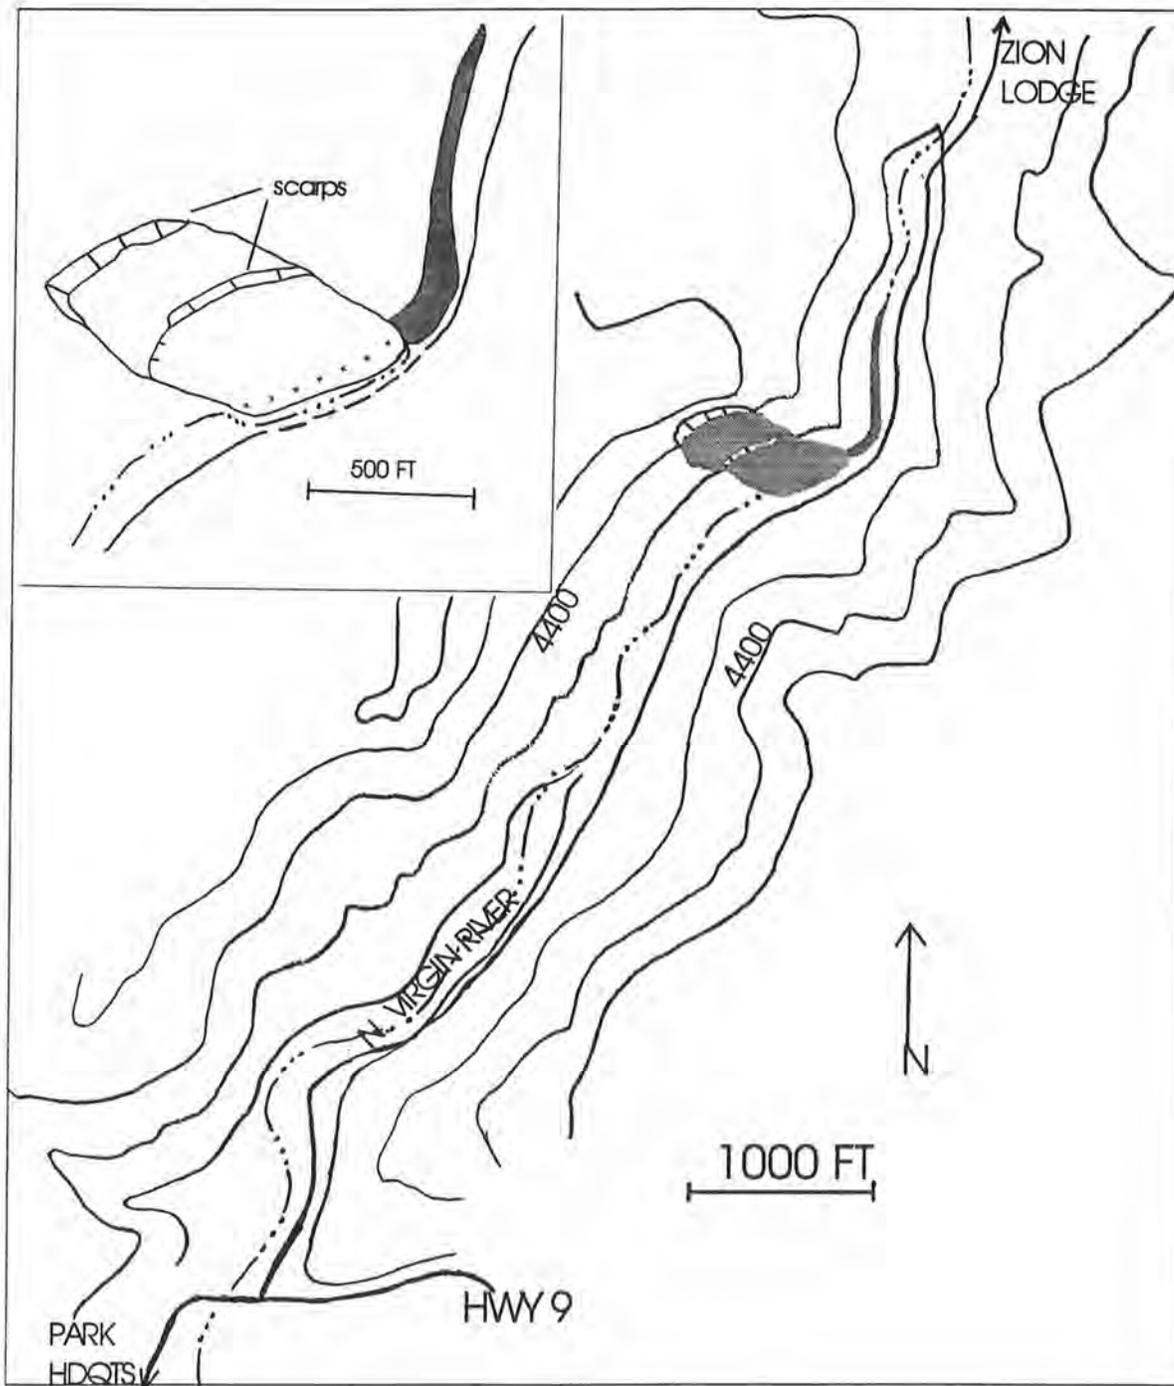
Figure 4. Map of Zion Canyon showing size and shape of the April 12 debris slide and the impoundment (shaded area) that remained behind it after partial breaching on April 12, 1995. Inset shows enlarged diagram of landslide and the location of the original channel of the Virgin River (dotted line). Contour interval is 160 ft.

This plan will necessitate moving the river from its current channel back to a position approximating that of the pre-landslide channel (fig. 2). This will require minor excavation into the toe of the current landslide to relocate the river. The cut slope should be analyzed

for slope stability by NPS geotechnical engineers. Both sides of the future river channel (the cut in the toe of the slide and the riverward face of the highway fill) will be protected from erosion by geogrid or gabion walls faced with a 6-ft-thick section of rip rap. A possible option would be to place the entire new highway structure on an erosion-resistant subgrade consisting of boulders larger than 1 ft in diameter.

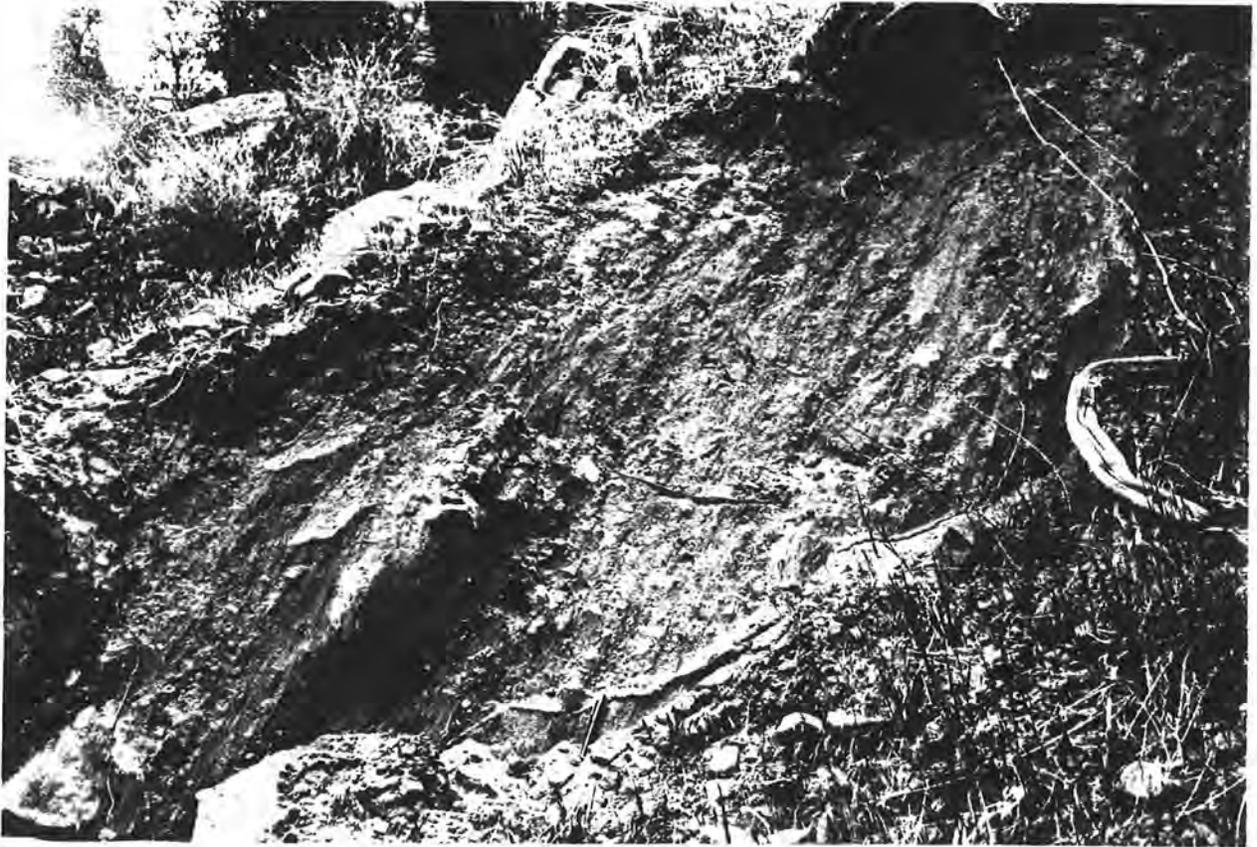
Figure 5. Scarp along right flank of upper slide block. Slope of ground surface (upper left) is about 30°. Steeply inclined striations indicate direction of movement of about 3.5 ft. The scarp exposes rock fragments in a sandy gravelly matrix derived from the rock units disrupted by prehistoric sliding. Pencil (lower center) indicates approximate scale.

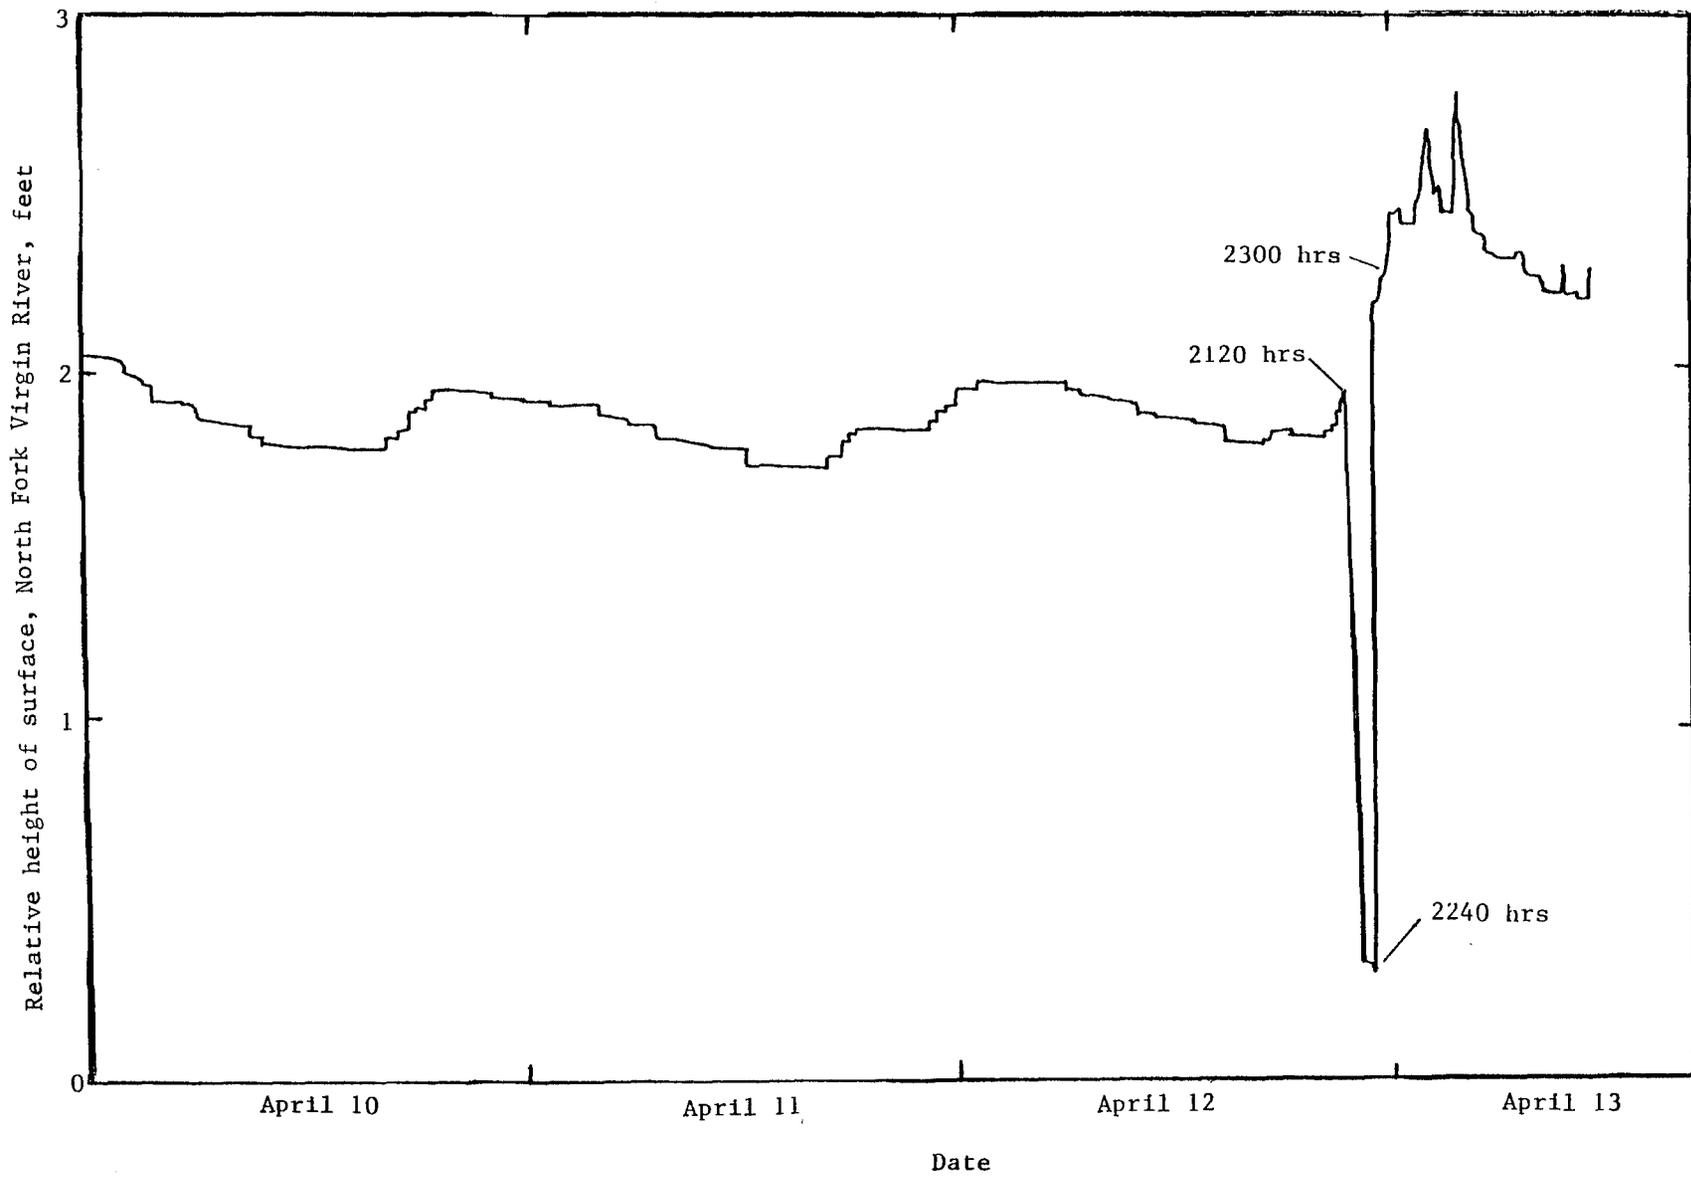
12, 1995. By means of a hydrograph (fig. 6) of river flow taken at a gaging station near Park Headquarters, about 1 mi downstream, we estimate that partial failure of the landslide dam occurred in about 1 1/2 hr. In this partial failure, the upper 10 ft of the approximately 25-ft-high dam was removed by erosion, resulting in a flood crest of only about 1 ft at the gaging station. However, the flood immediately downstream from the dam must have been several times as great. It did considerable damage to the canyon highway for a couple of hundred yards downstream, removing the pavement and eroding large gullies in the subgrade (fig. 7). No damage was caused at the campgrounds in the vicinity of Park Headquarters or in the city of Springdale, about 2 mi downstream.

Figure 6. U.S. Geological Survey hydrograph on the North Fork Virgin River for April 11-13, 1995. This hydrograph is from a gaging station located near Park Headquarters approximately 1 mi downstream from the landslide (fig. 1).

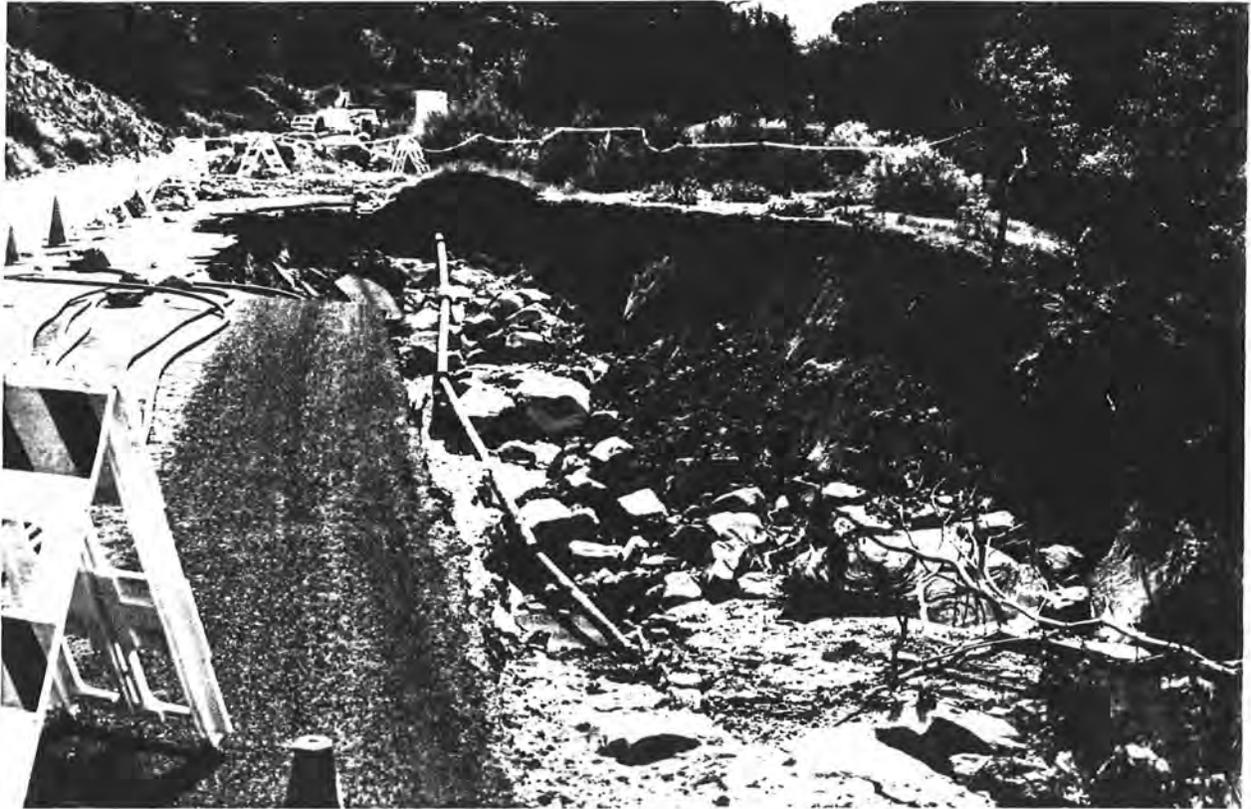
Figure 7. Erosion damage to Zion Canyon highway downstream from the landslide as a result of flooding due to partial failure of the landslide dam.

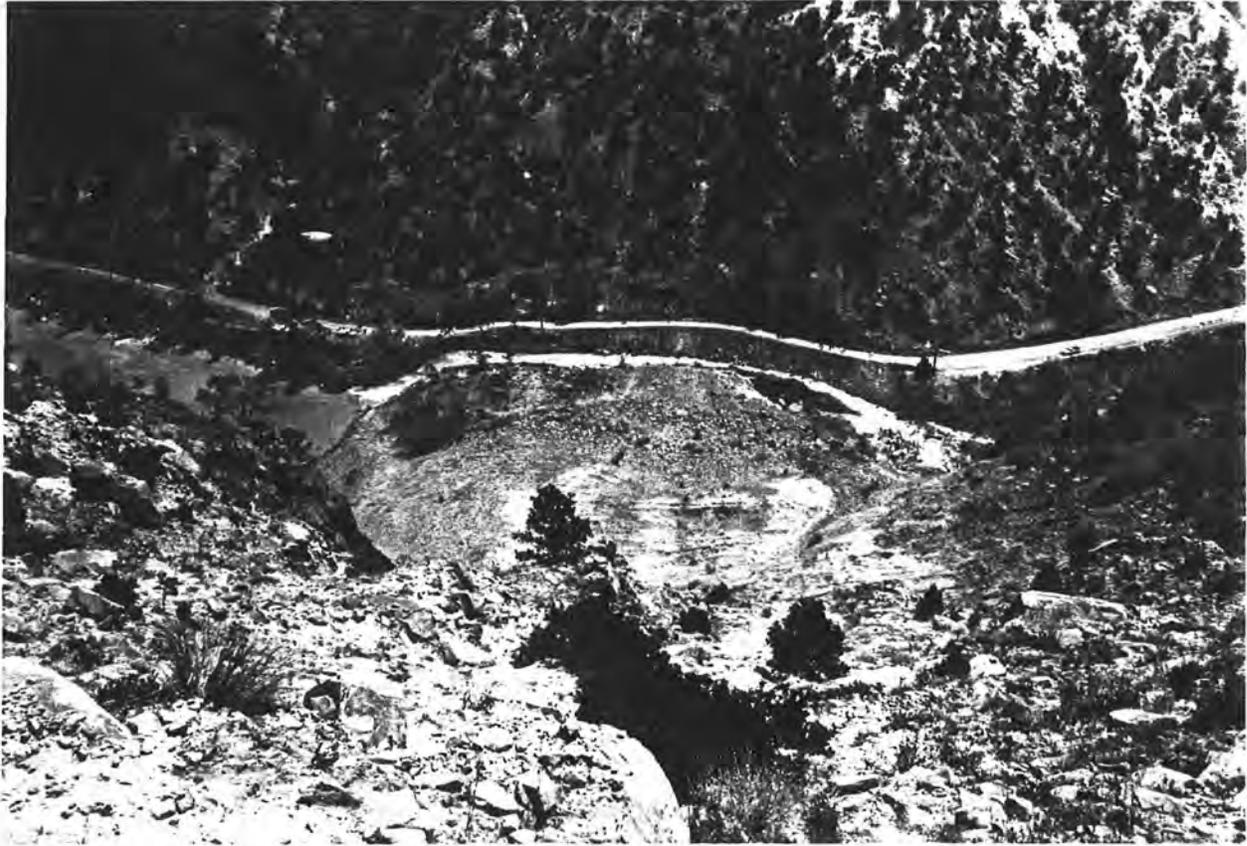
Figure 8. View looking downslope along the April 12 landslide from the top of the main scarp. The North Fork of the Virgin River has been displaced by the landslide against the east wall of the canyon where an emergency road has been cut into the slope. The remnant of the impoundment behind the landslide dam can be seen to the left. Vehicles along the road provide scale.
