LIQUEFACTION GENERATED BY THE 1983 MOUNT BORAH, IDAHO, EARTHQUAKE

T. L. Youd, E. L. Harp, D. K. Keefer, and R. C. Wilson

U.S. Geological Survey

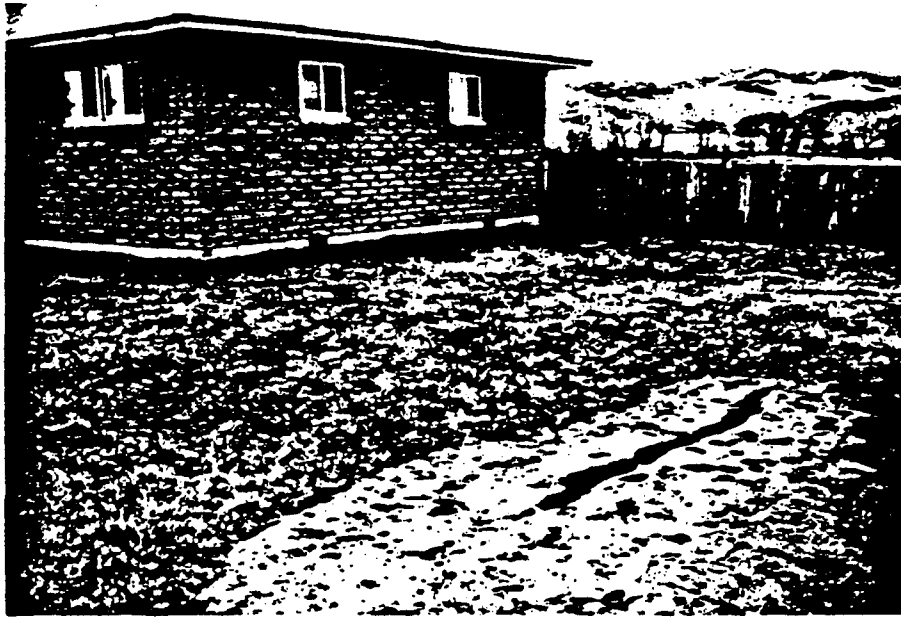
Fig. 2(a)

About 3 mi northwest of Makay Reservoir and 6 mi southeast of the southern terminus of fault rupture a lateral spread developed on a low terrace near the Big Lost River (Site 1 on Fig. 1). A curved zone of fissures and sand boils marked the head of the spread, and passed beneath a house, barn, and adjacent ranch yards (Fig. 2). The fissures were as wide as 1 ft with scarps as high as 1 ft. Sand boil deposits, as wide as 8 ft., were composed of gravelly sand with pebbles up to 1 in diameter. Grain-size distribution curves for samples from two sand boils at this site plus curves for samples from sand boils at other sites are given in Fig. 3. The foundation of the house was constructed of small spread footings with wood pillars beneath the interior of the structure and a perimeter footing with concrete-block wall

Fig. 2.--Structures at Site 1 damaged by lateral spreading: (a) damaged house with sand boil deposit on front lawn; (b) foundation at back of house where slippage of 5 in between blocks accommodated lateral displacement that occurred beneath structure; (c) Steel framed barn that was astride fissured zone and pulled apart at the base by about 1 ft.

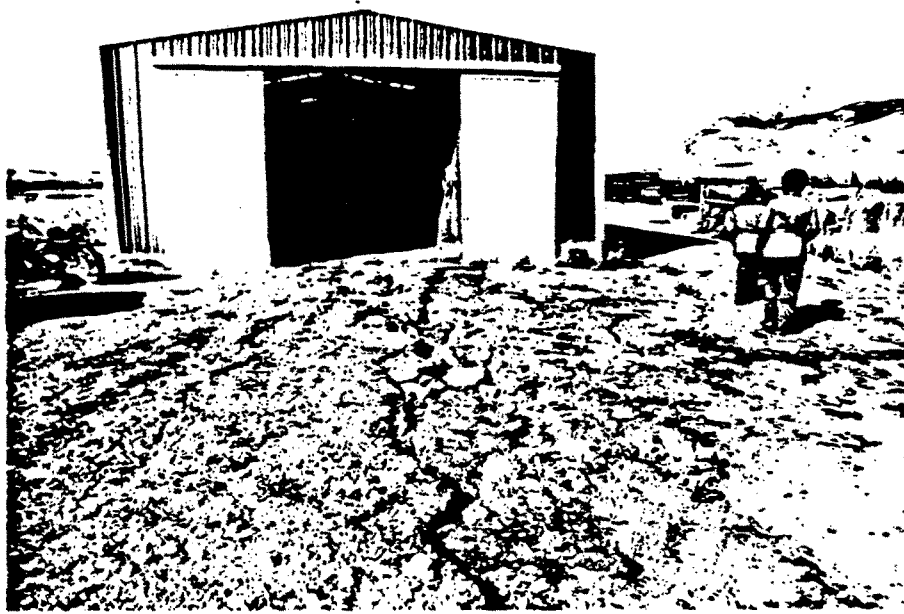
Fig. 2 c)

Eastward from the house, the fissures passed beneath a steel-frame barn with a dirt floor. The fissures gave the floor the appearance of having been plowed (Fig. 2C). The horizontal displacement widened the doorway by about 1 ft at the base and distorted the frame. The fissures continued eastward from the barn where they disrupted roadways and passed beneath a haystack yard. A wire fence enclosing the yard was pulled apart by 30 in.

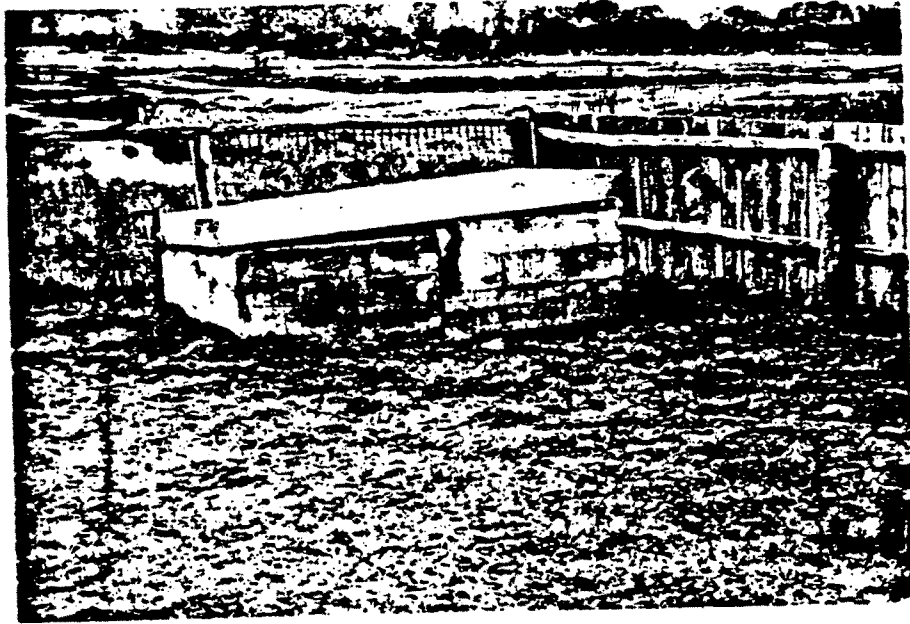
About 50 ft behind the house, a water tank and pump were housed in two separate, but adjacent concrete boxes that extended from about 2 ft above to about 4 ft below ground surface. Liquefaction during the earthquake caused the box containing the pump to buoyantly rise 3 in while the more heavily loaded box, containing the filled water tank, remained in place (Fig. 4).

Fig. 4.--Concrete boxes housing well pump and water tank; the lighter box containing the pump buoyantly rose 3 in due to liquefaction of surrounding soil.

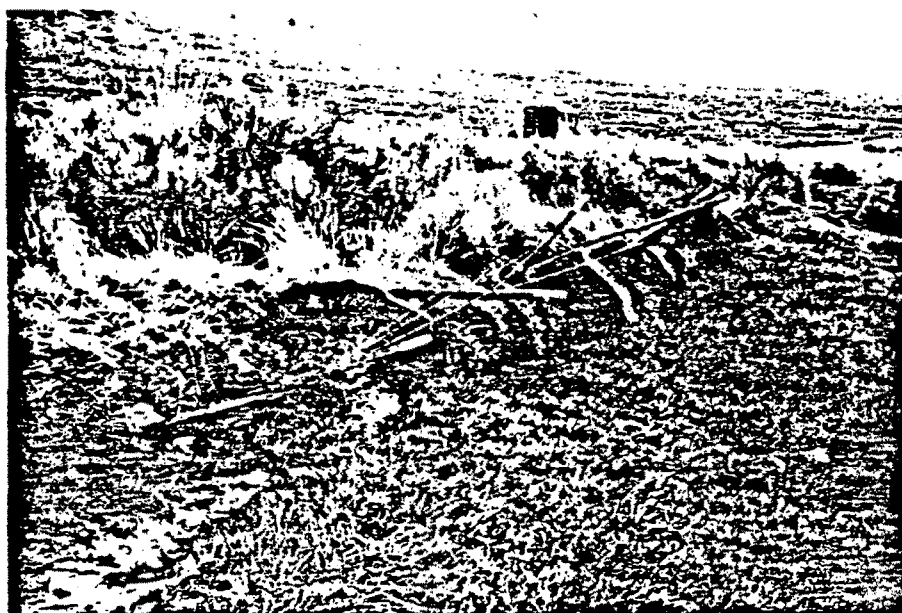
spreading movement. The thrusting generated buckles and scarps in the marsh sod as high as 4 ft (Fig. 7). Sand boils erupted at several localities along the fan-marsh interface and at a few localities on the fissured surface. Sand boils were more common at mouths of draws where the ground slope is more gentle than along steeper fan fronts. Small, permanent springs also flow out of margins of the fans in several places.

Fig. 7.--Buckled and overturned sod in toe of lateral spread mapped on Fig. 5. This disruption occurred below damaged section of Highway 93 where fissures above highway and lateral displacement of highway was greatest.

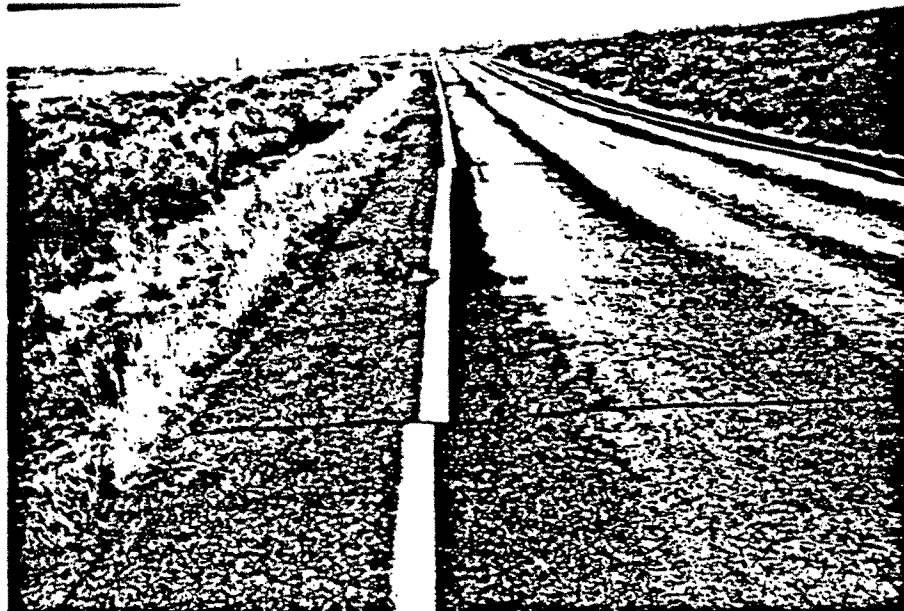
hazardous driving conditions, but did not block the roadway. The roadway and underlying ground were also also displaced at least 4 ft downslope across the middle part of the section. This displacement created a gentle concave curve in the road (Fig. 9). Sand boils erupted along cracks in the barrow pit on the up hill side of the road, on the alluvial fan surface between the road in the marsh, and along the toe of the spread.

Fig. 9.--Displacement of Highway 93 south of Whiskey Springs due to lateral spreading.

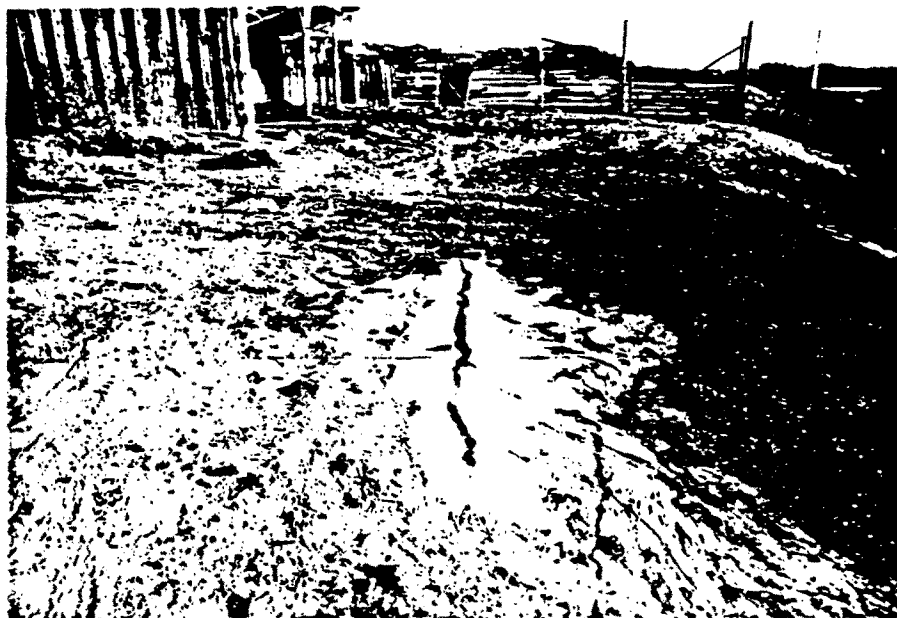
A few hundred sand boils erupted in a 2,000-ft-long and 500-ft-wide zone that extends eastward from Hooper Lane across a flat terrace a few hundred ft north of the Pahsimeroi River ^{Site 5,} (Fig. 1). The zone is 16.5 mi north of the fault rupture. The only house on the east side of Hooper Lane lies within the zone of sand boils; the house was undamaged eventhough several boils erupted within a hundred of feet of the structure. A few boils also erupted in a field west of the house across Hooper Lane. The largest sand boil deposits were about 6 ft across; most deposits, however, were about 2 ft across; and the smallest contained only a few thousand grains of sand (Fig. 13). All of

the deposits were composed of medium-grained white sand. In many instances the sand boils erupted along small fissures that were as wide as 4 in. These fissures formed an arcuate pattern that seemingly outlined a lateral spread with incipient southward movement. Immediately south of the zone of sand boils, the ground surface drops to a 4-ft-lower terrace which is covered by marsh grass. Not a single sand boil that we could see erupted through the grassy surface, although several sand boils erupted near the northern margin of the terrace and a few erupted within a small stream that flows across the terrace. This observation is consistent with the behavior noted in the Thousand Springs Valley and further suggests that thick marsh grass inhibits the eruption of at least small to moderate size sand boils.

Fig. 13.--Sand boil deposit typical of hundreds that occurred in a 1,500-ft-long zone in the Pahsimeroi valley.
