Memorandum

UTAH DEPARTMENT OF TRANSPORTATION GEOTECHNICAL DIVISION

SUBJECT: Site Visit June 9, 2011
Brown Park Road – Jesse Ewing Canyon
Federal Aid Project STP-1364(4)15

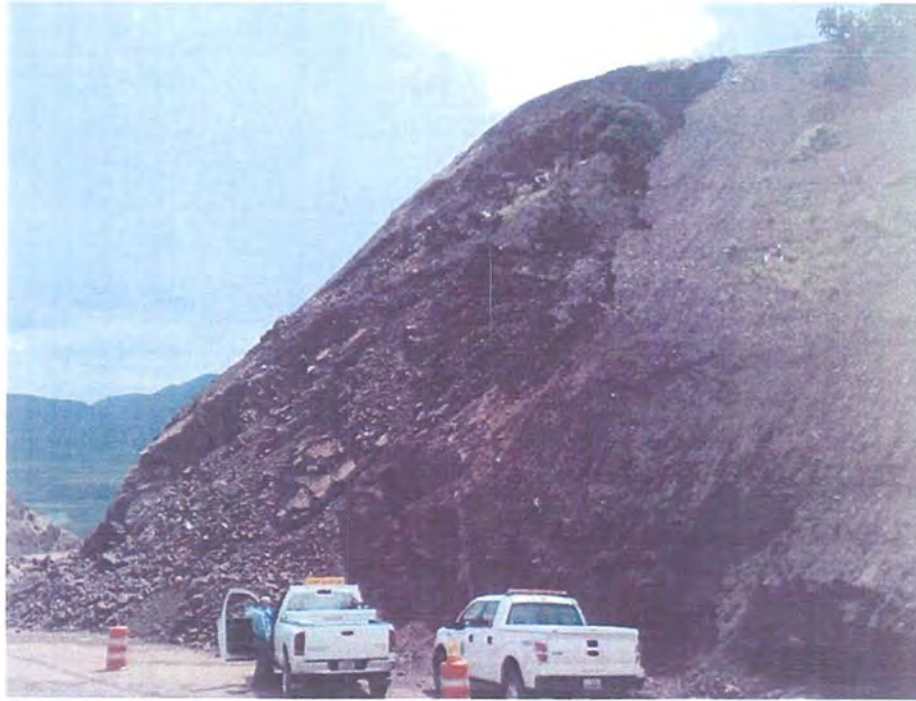
At about project Station 396+00 a rock slide was observed that extends to the top of the cut slope (Photo 1). The slide debris reportedly blocked the all of the southbound and part of the northbound lanes earlier in the week. The slide is about 150 ft and 50 ft wide at the base and crest of the cut slope, respectively. The slide materials consist of dark red-brown shale/mudstone and sandstone. Near the head scarp rock appeared highly fractured and broken into gravel and cobble-size pieces. Lower on the slope, large blocks of rock were visible in the slide debris and a bedding plane discontinuity appeared to daylight on the slide rupture surface near the right flank (Photos 2 and 3). The dip and dip direction of the discontinuity ranged from 30 to 40 degrees and 58 to 70 degrees, respectively. Measurements of slope inclinations with a hand-held clinometer were made at about 30 degrees (1.7H:1V) on the unaffected natural slope adjacent to the north of the slide. The cut slope adjacent to the south of the slide was measured at about 45 degrees (1H:1V) on the upper $\frac{3}{4}$ of the slope and about 60 degrees (0.5H:1V) on the lower $\frac{1}{4}$ to the slope. A 20-inch-diameter Questar natural gas pipeline is located about 100 ft horizontal distance back from the top of the rock cut slope.

Photo 1. Rock slide at approximately Station 396+00 blocking southbound lane.

Based on preliminary observations, it appears that the most feasible method of stabilizing the rock slide is to cut the slope back to a flatter inclination. Because of the potential for decreasing stability, removal of the rock slide material above the road is not recommended until a design slope can be established. The design civil engineer (Civil Science) and geotechnical engineer (American Geotechnics) should be consulted to determine the slope geometry and quantities for the repair of the cut slope.

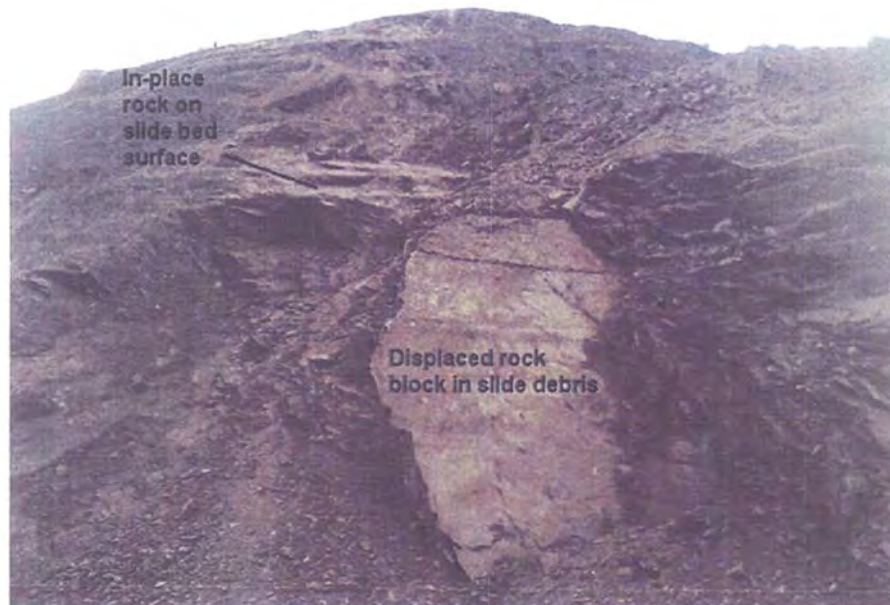
Photo 2. Facing slide with displaced block below in-place rock with apparent discontinuity intersecting cut slope surface.

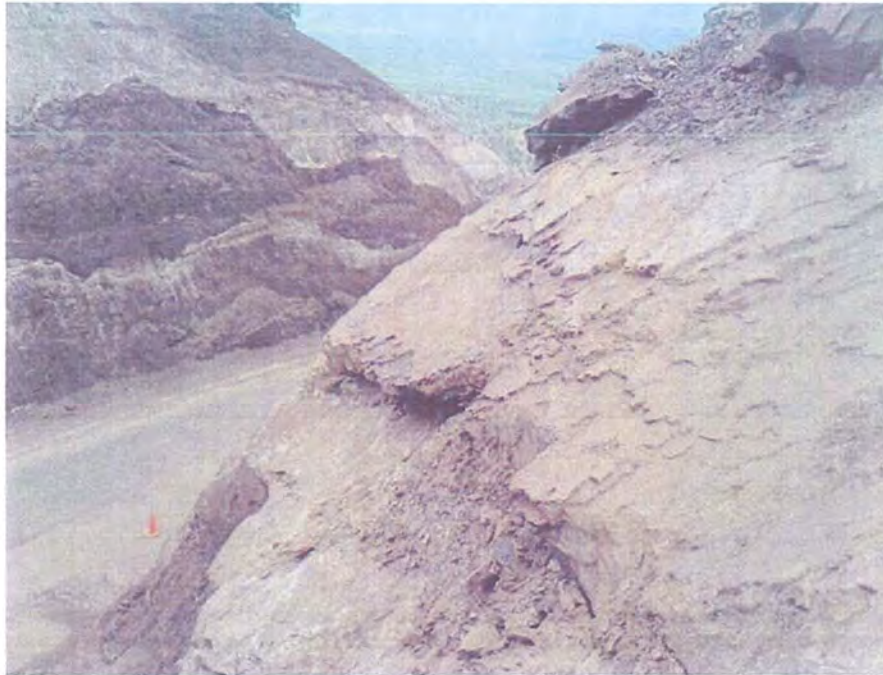
Photo 3. Close up of bedding plane discontinuity in mudstone dipping at 30 to 40 degree to the northeast (58 to 70 degrees bearing).

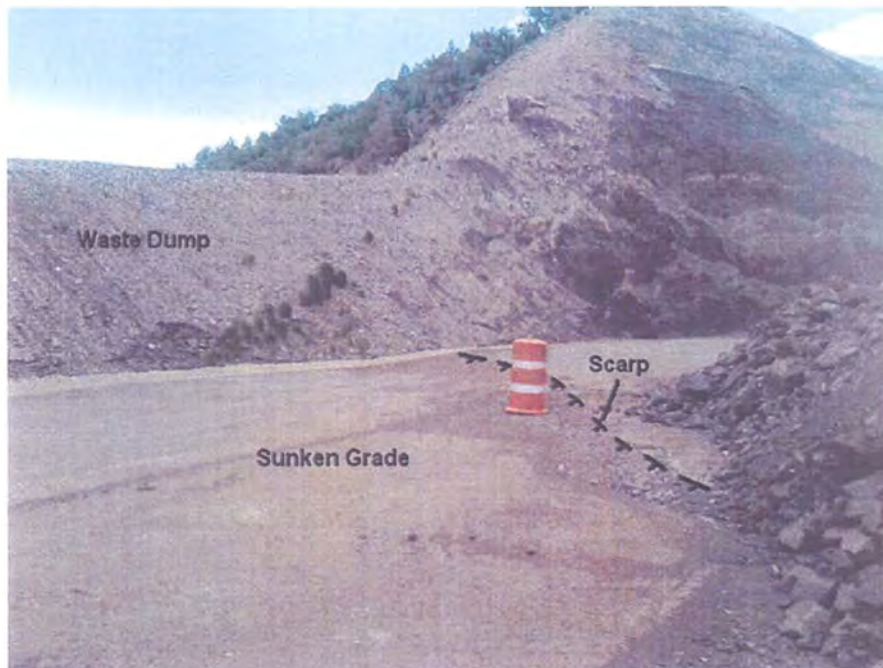
Photo 4. Scarp and sunken grade (down to lower left) in pavement near toe of rock slide at about Station 397+00.

A scarp and slightly sunken grade is visible in the pavement at about Station 397+00 (Photo 4) and a companion scarp was observed about 225 ft to the north. It appears that a waste dump was constructed on the downhill side of the road between about Station 394+50 and 397+00. The scarps and sunken grade appears to correspond to the approximate limits of the waste dump; however, tension cracks are visible in the pavement for an additional 250 ft beyond the northern edge to about Station 392+00 (Photo 5). It is not clear if movements above and below the road are related.

The cracks in the pavement should be monitored to obtain additional information about the magnitude and rate of movement below the road. If movement continues, additional explorations and studies would be necessary to develop a design for stabilization.

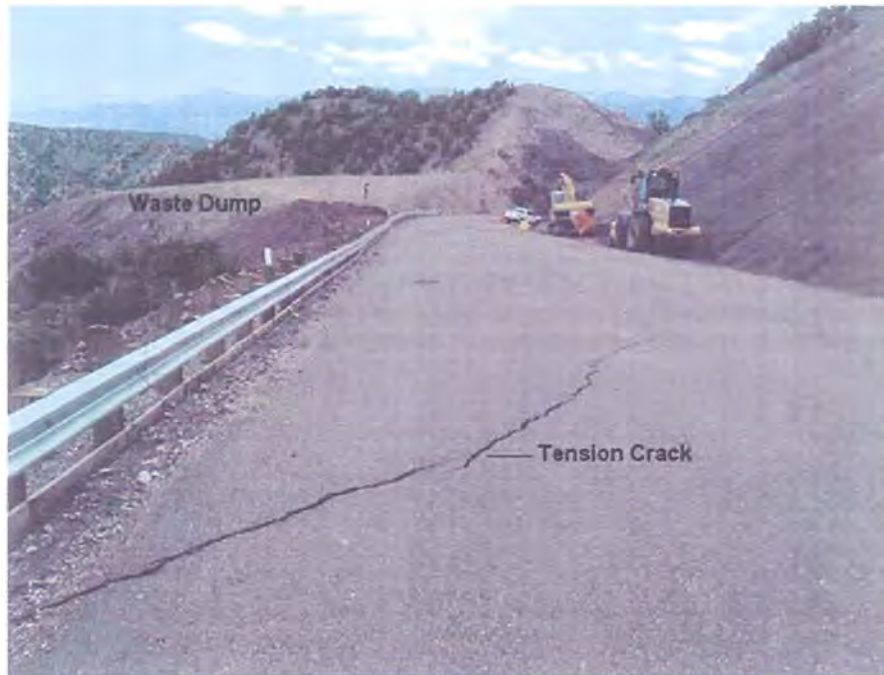
Photo 5. Facing south at about Station 392+00. Tension crack in foreground and waste dump in background.
