**ZION-MOUNT CARMEL HIGHWAY
SWITCHBACK LANDSLIDE FIELD TRIP GUIDE
ZION NATIONAL PARK, UTAH**

**34TH NORTHWEST GEOTECHNICAL WORKSHOP
SPRINGDALE, UTAH**

October 23, 2008

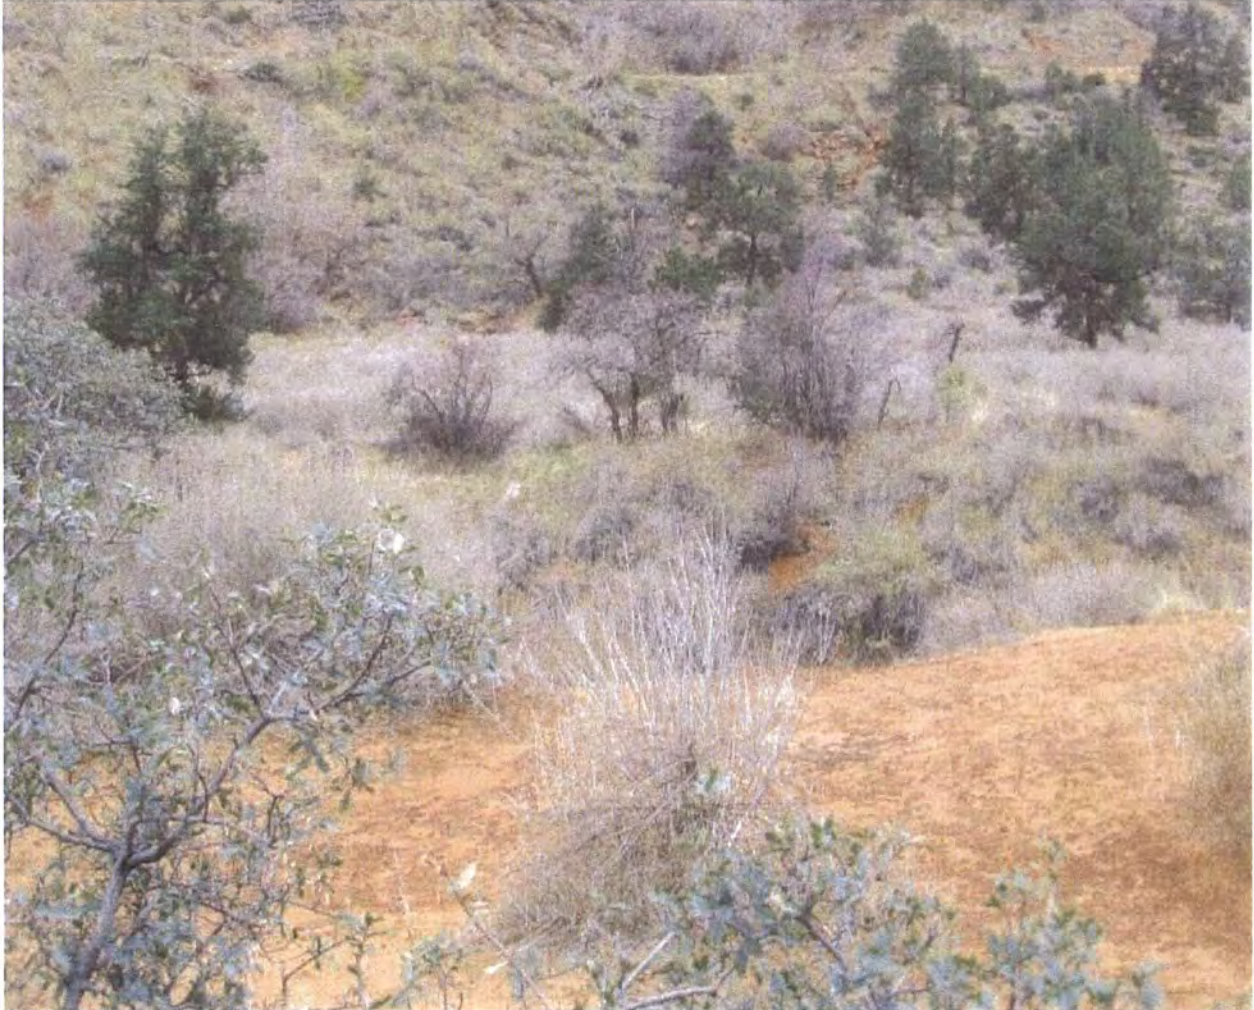
Figure 2: Recent eolian features are apparent within the project limits.

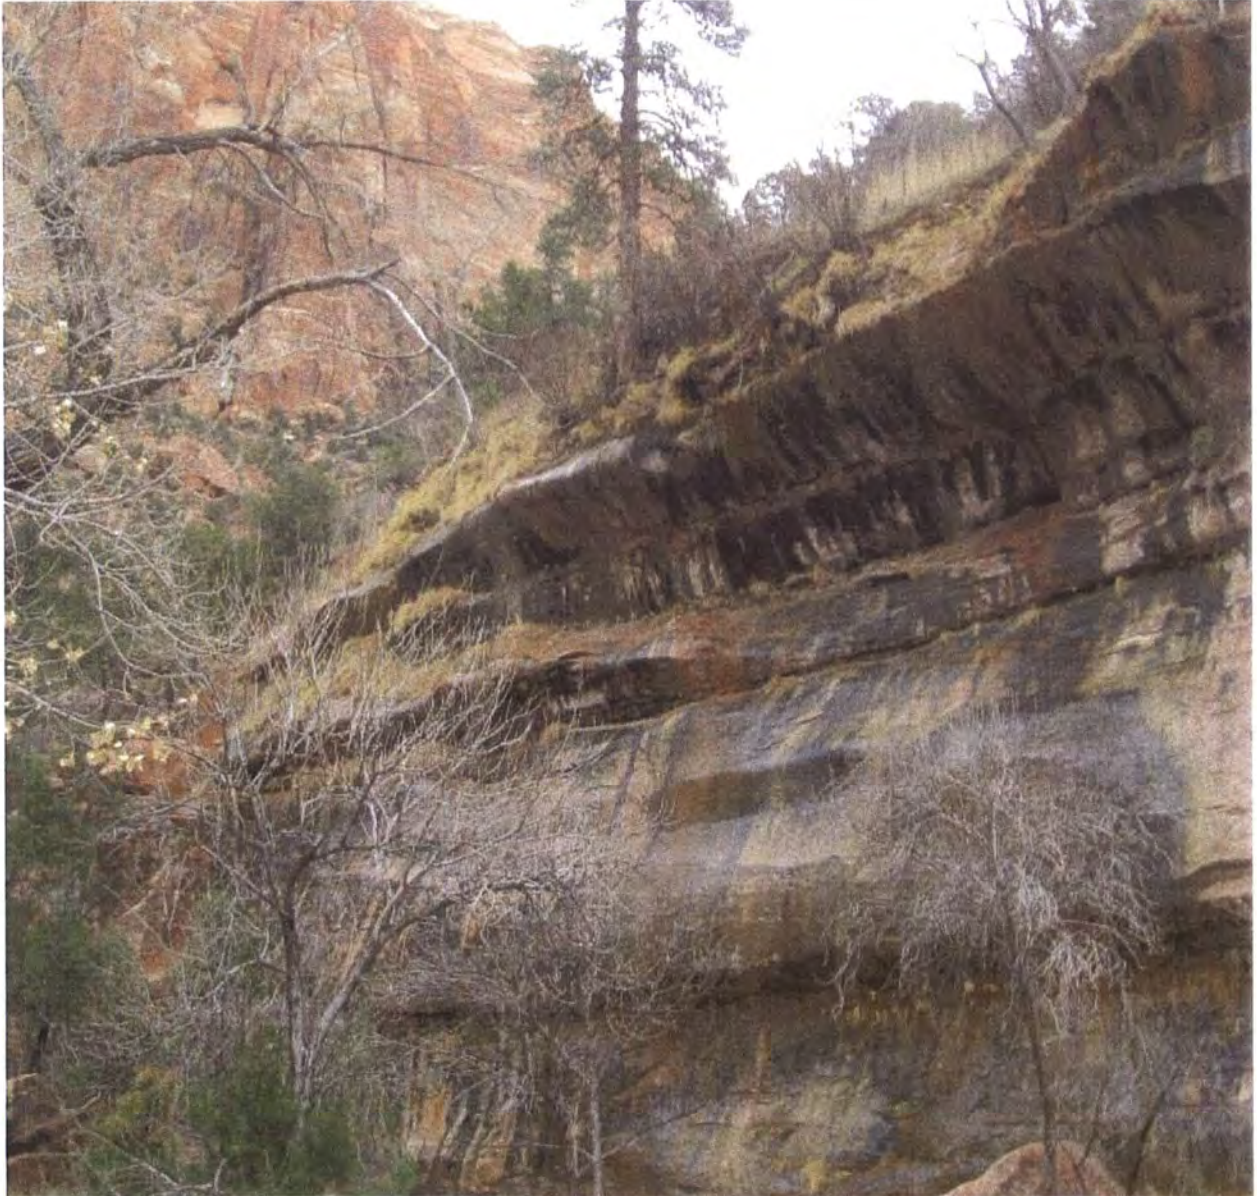
Groundwater seepage was observed below the project area, forming seeps just above the bedrock contact, in an area with relatively heavy vegetation (Figure 3). Groundwater most likely moves along the bedrock-overburden interface, flowing from the steep canyon wall beneath the project area to the Pine Creek drainage.

Figure 3: Groundwater seepage was observed forming seeps just above the bedrock contact, below the project area.

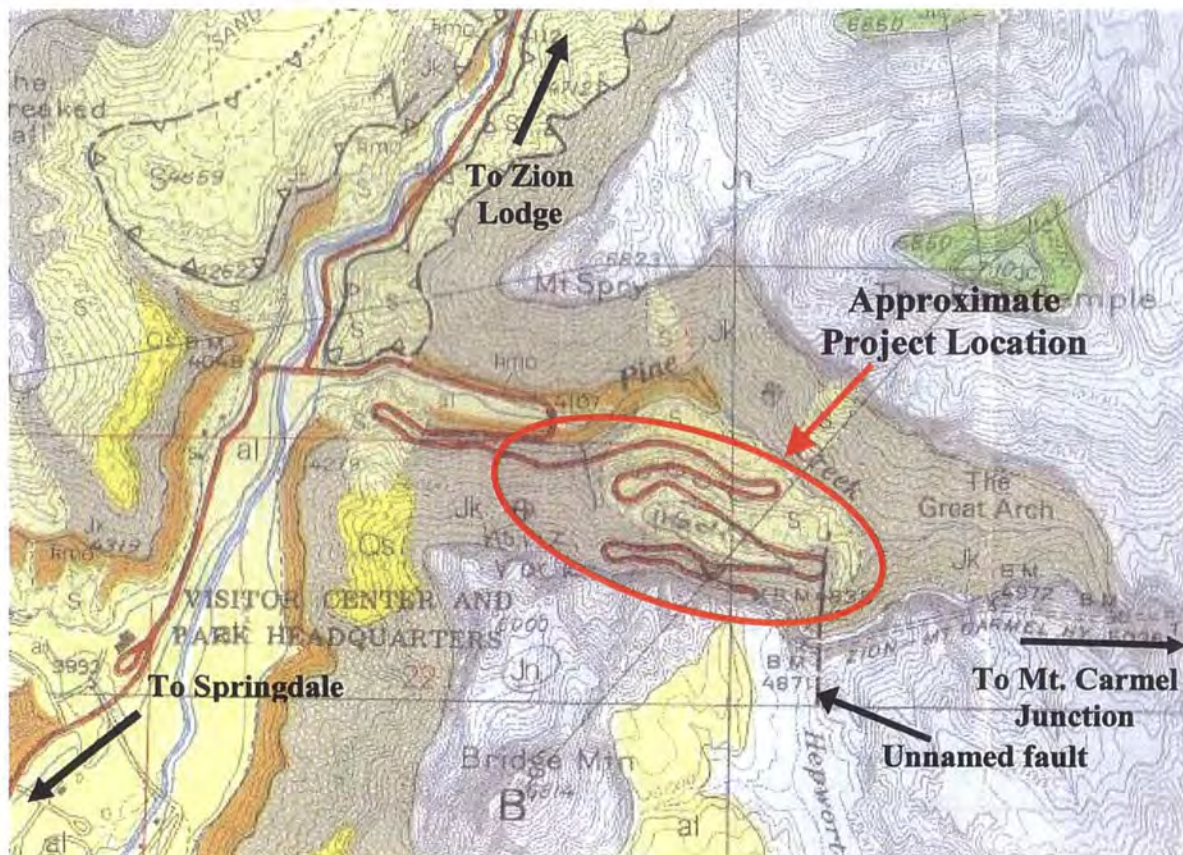
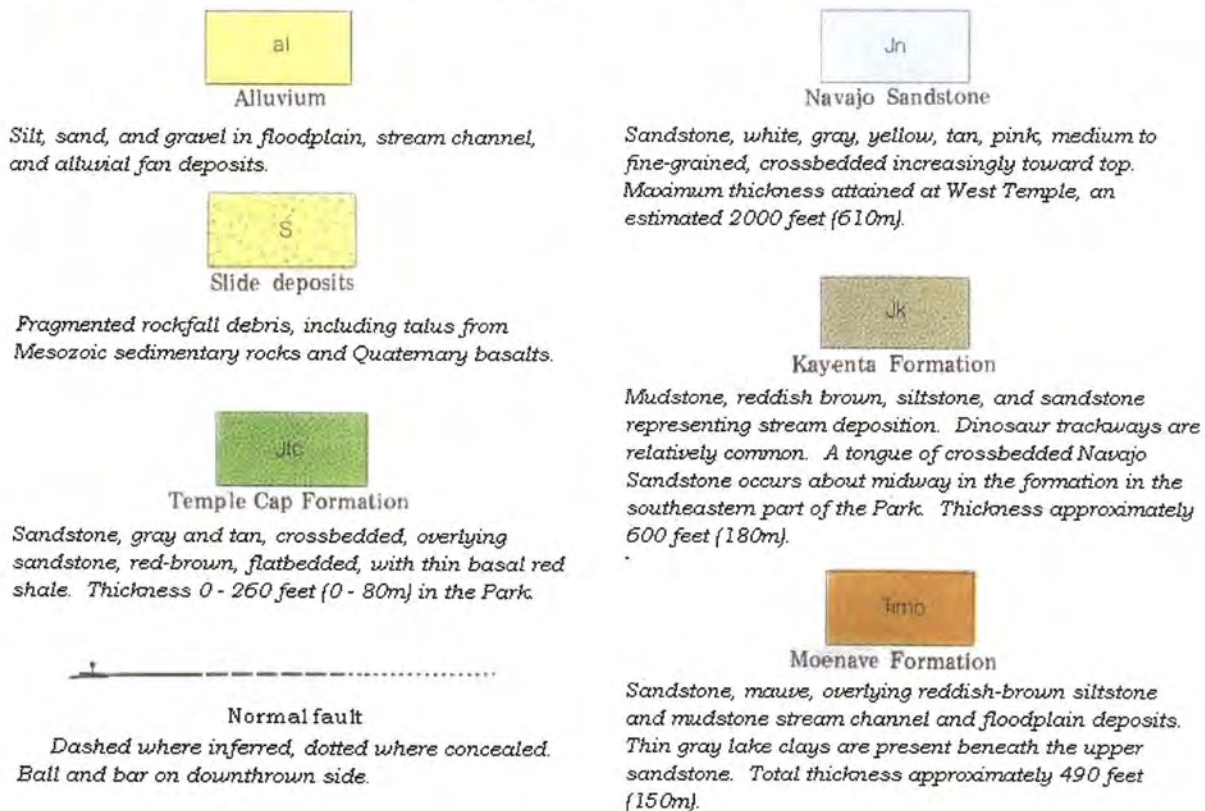
Figure 4 –Localized Geologic map (from Hamilton, 1978)

published geologic mapping (Hamilton, 1978). An unnamed normal fault is mapped near the east end of the project area (Figure 4 and Appendix A); movement here may have resulted in weaker materials and an even greater susceptibility to failure. A geologic map of the project site, with bedrock and surficial material descriptions, is shown in Figure 4.

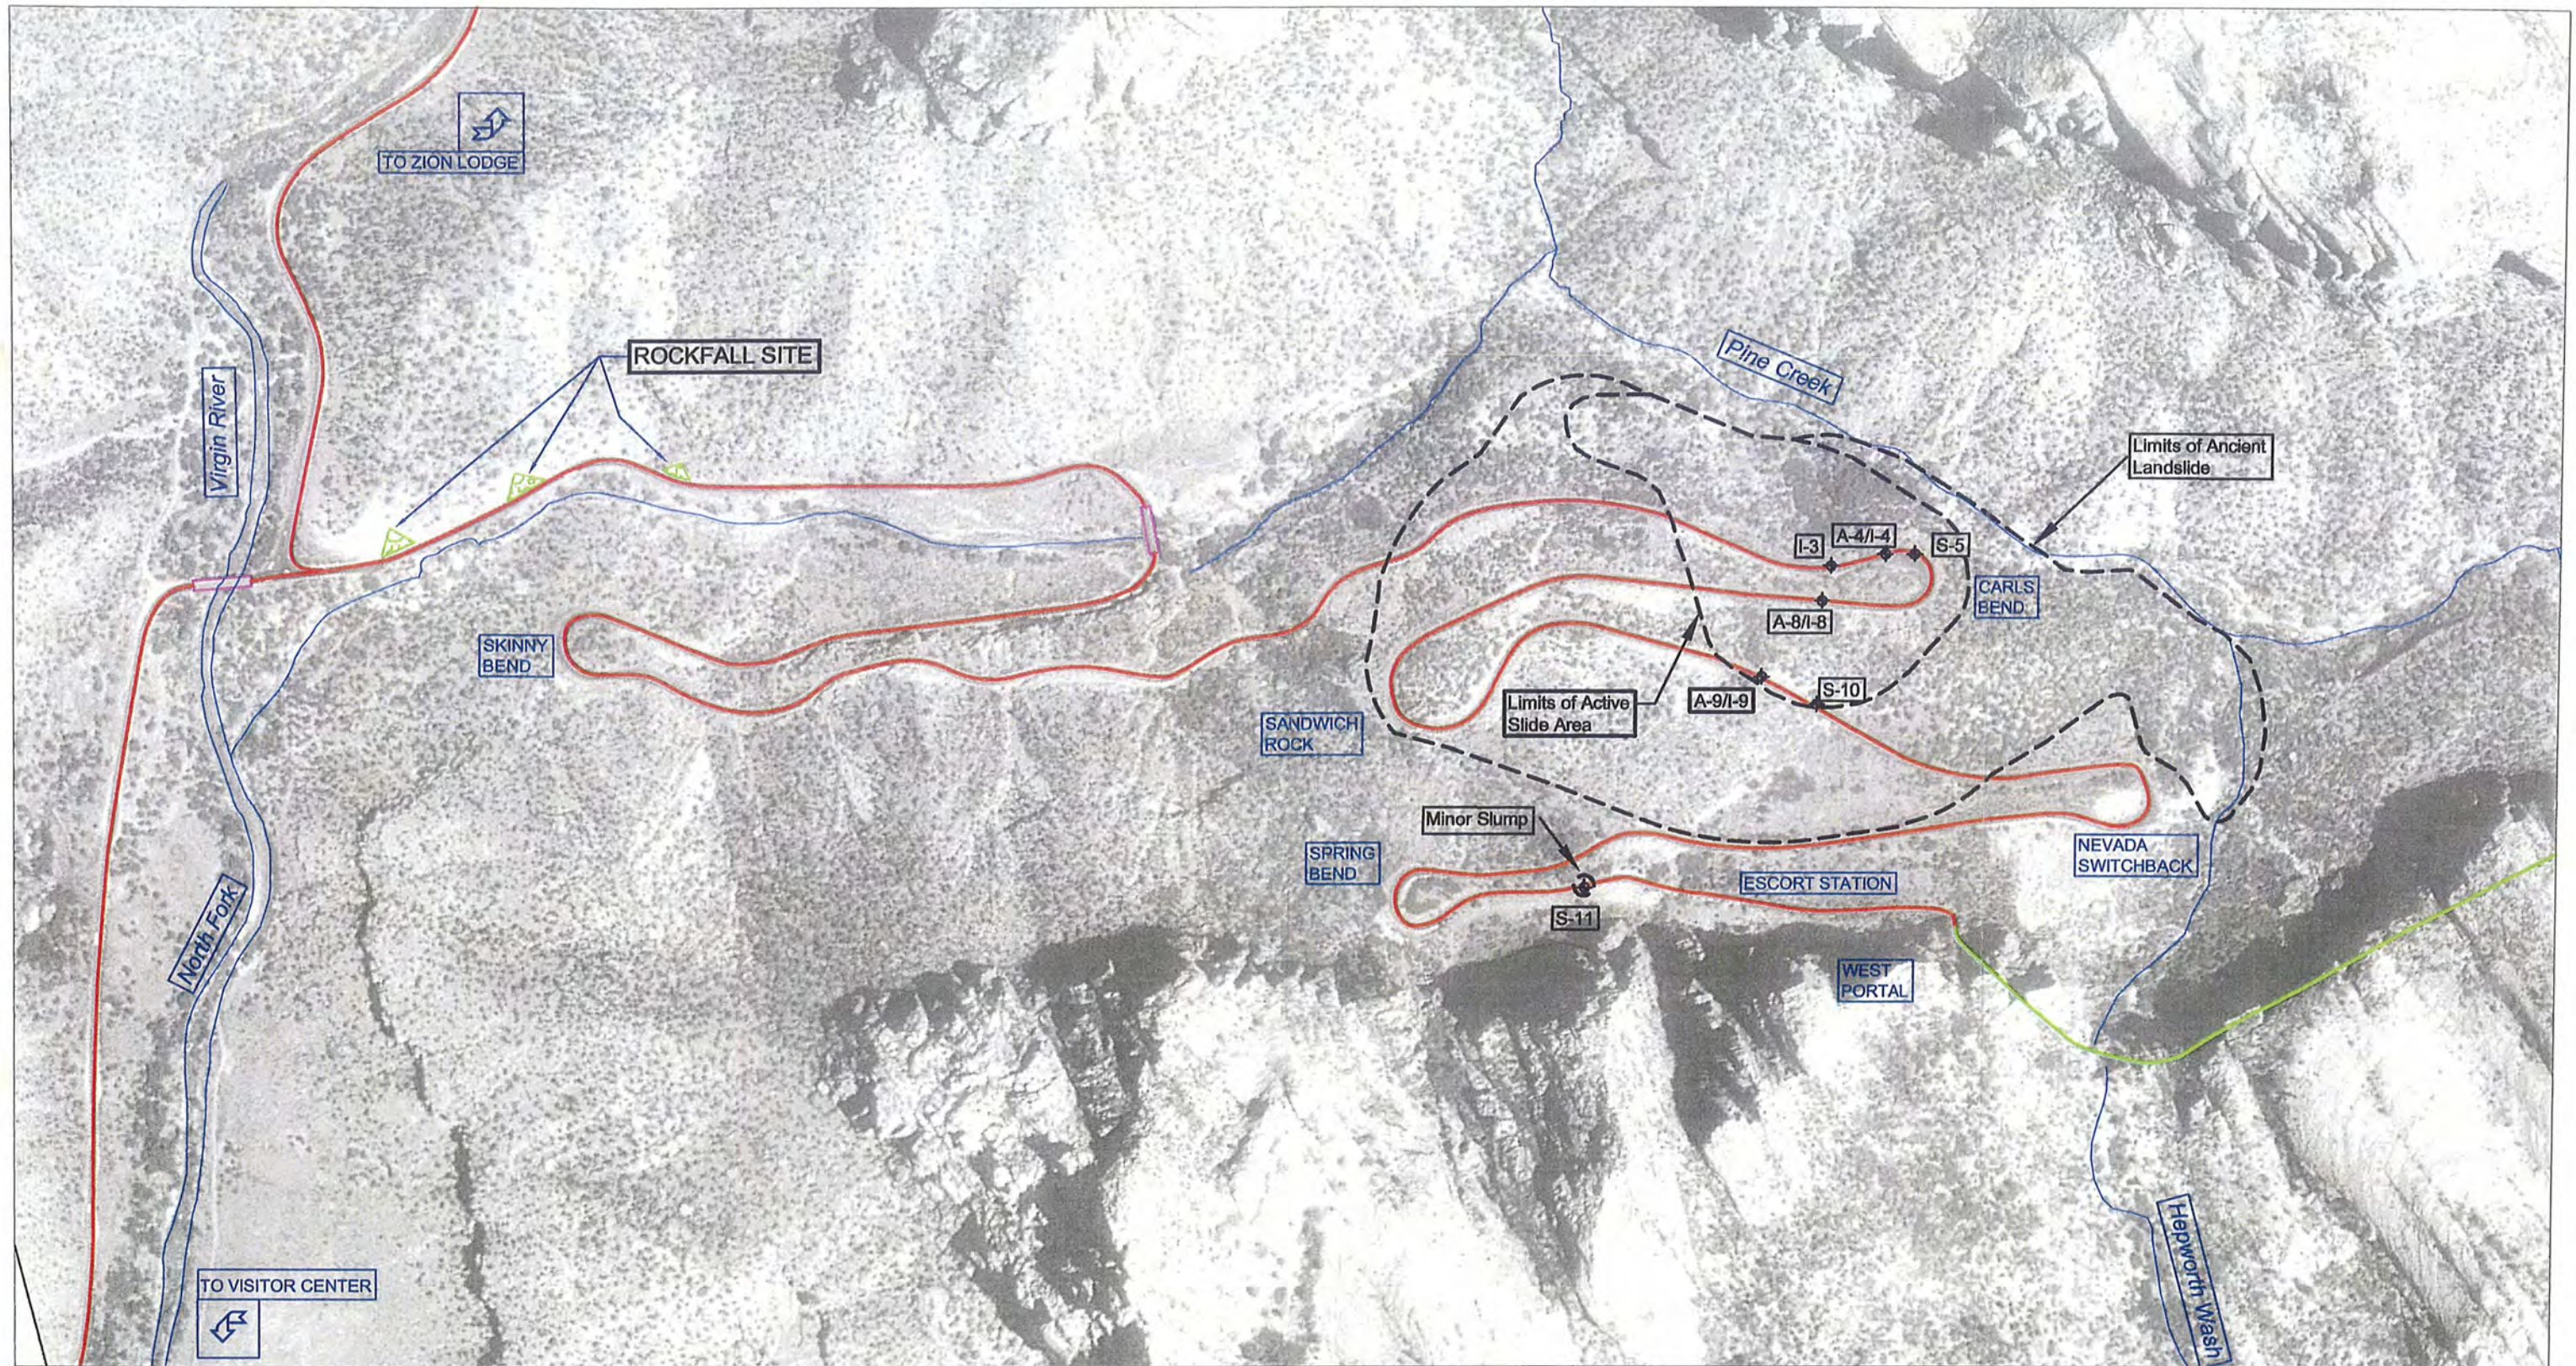
Figure:
A-1

of a landslide. Bedrock outcrops at the margins of the landslide consist of red and reddish-brown sandstone, with rounded exposures and a moderate amount of joints. Bedding orientation in the area surrounding the project site is nearly horizontal. Identified landslide scarps and boundaries are shown in Appendix A-1.
