INDEPENDENT GEOTECHNICAL PEER REVIEW HOOVER SLIDE SECTION PROVO CANYON

US-189: WILDWOOD TO
DEER CREEK STATE PARK

JULY 18, 2001

**INDEPENDENT GEOTECHNICAL PEER REVIEW
SR-189 HOOVER SLIDE SECTION, PROVO CANYON
WILDWOOD TO DEER CREEK STATE PARK**

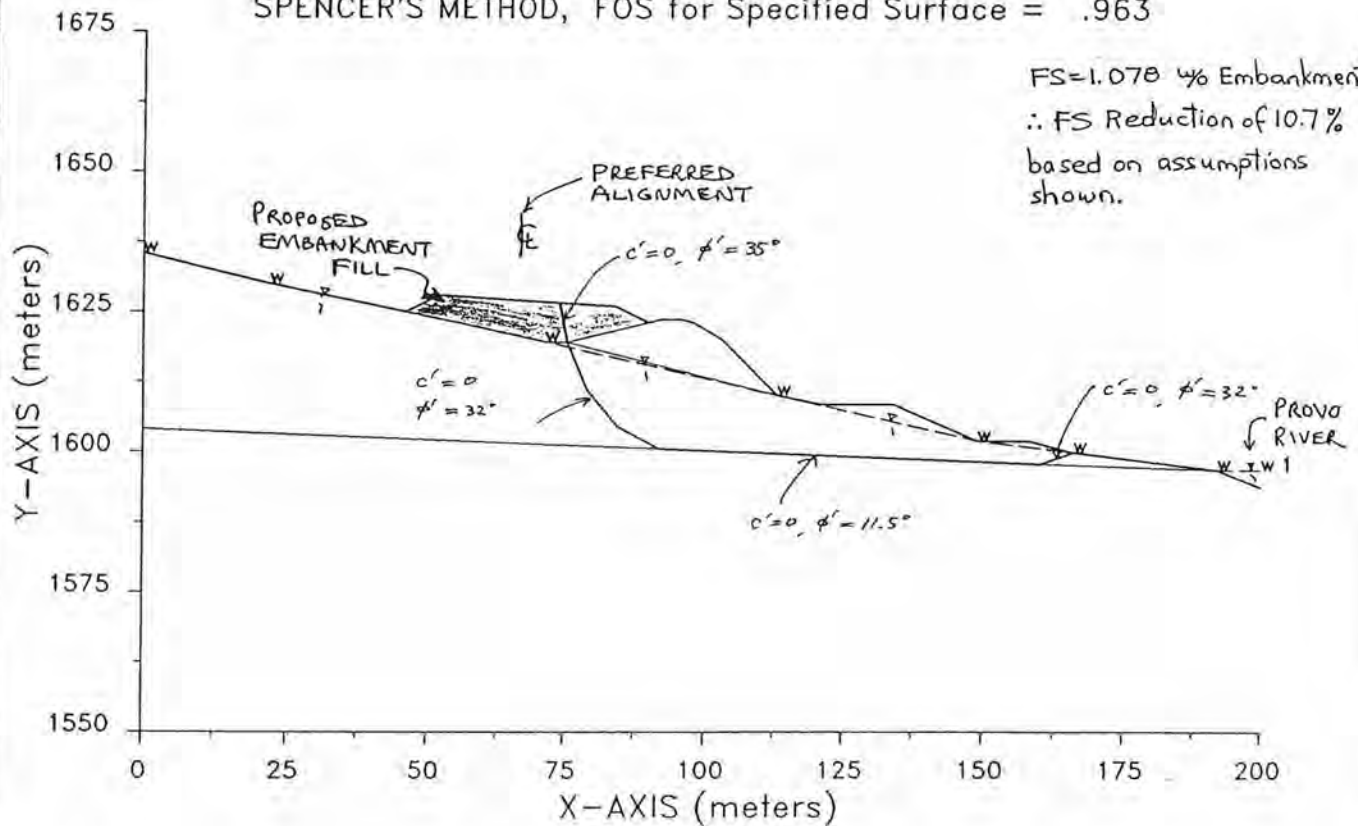
The preliminary analyses demonstrate that slope stability could decrease if an earthfill embankment is placed upslope of the existing highway. Decreases in the Factor of Safety of up to 11 % were calculated. If the existing Factor of Safety is marginal, i.e. less than 1.2, instability could result from embankment placement. The likelihood of instability would increase if the embankment foundation were subjected to critical groundwater conditions in an extremely wet season. Figure 5 presents a representative conceptual stability analysis cross section, with assumed parameters.

SPENCER'S METHOD, FOS for Specified Surface = .963

FS=1.078 w/ Embankment
∴ FS Reduction of 10.7%
based on assumptions
shown.
