November 16, 2015

Subject: Potential rockfall boulder Emergency Response, Goosenecks State Park, San Juan County, Utah.

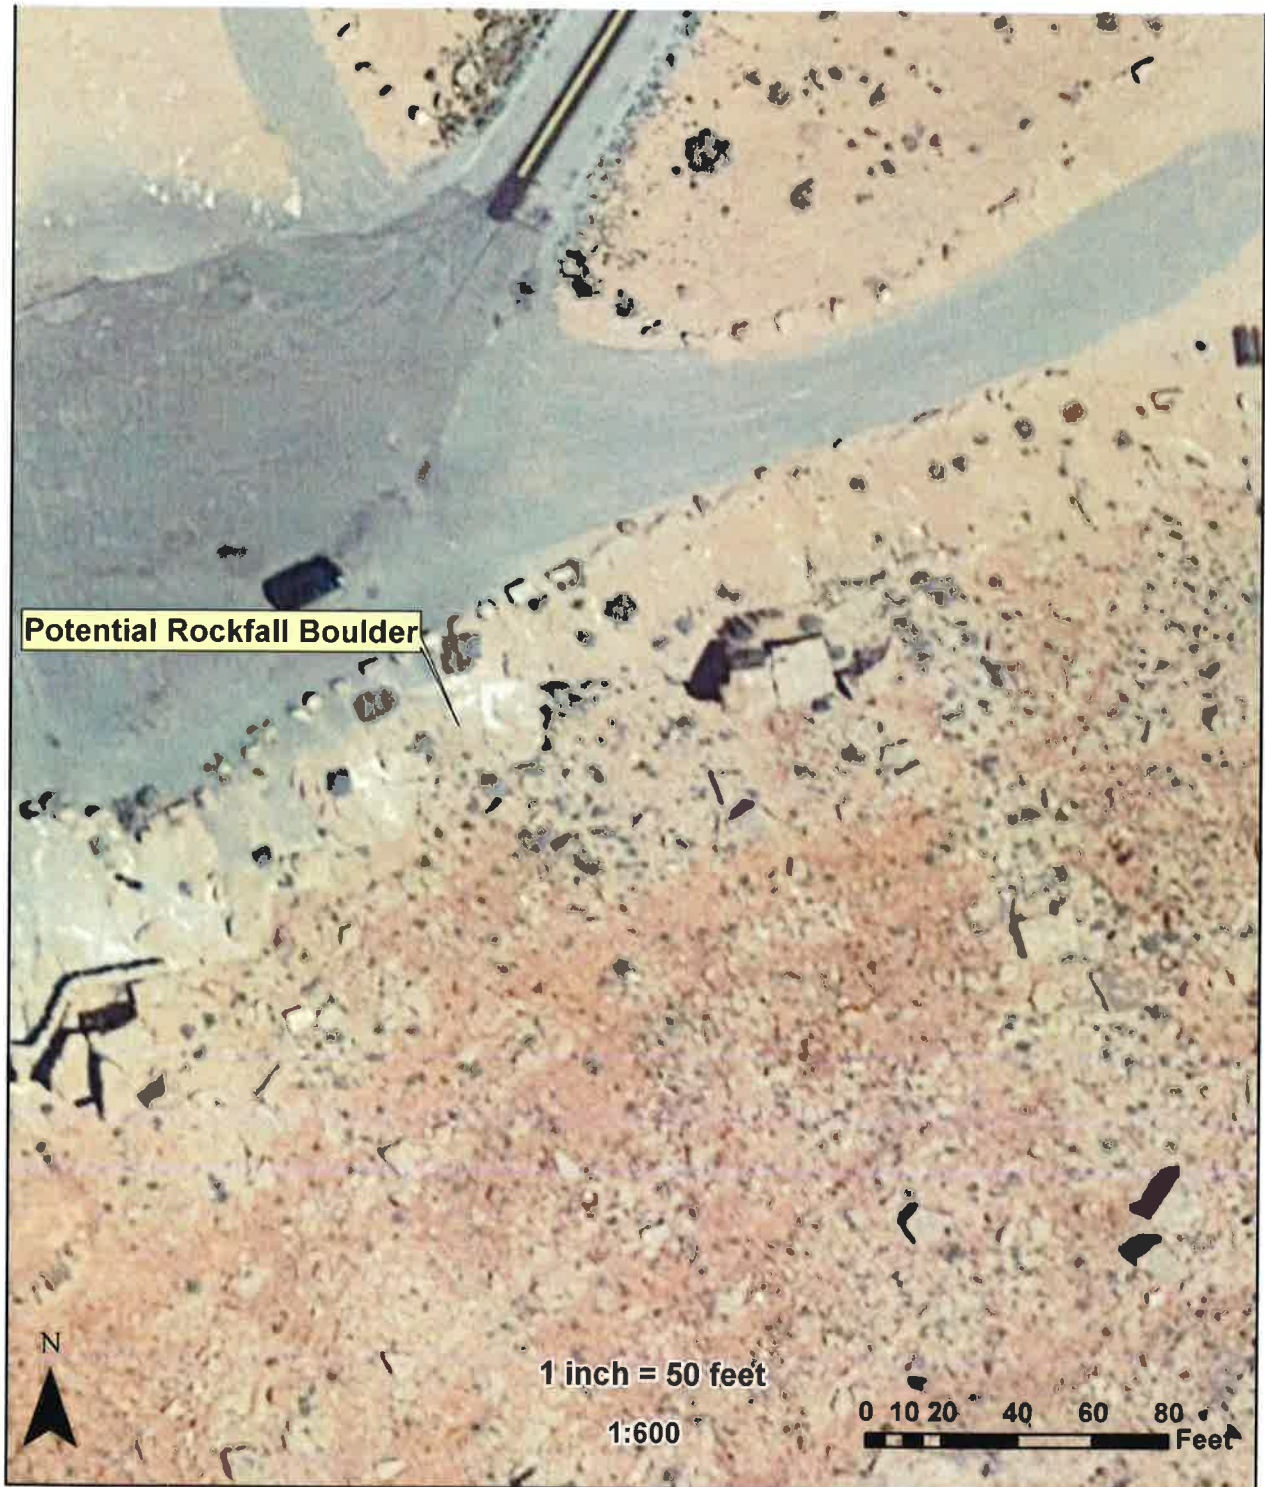
I enjoyed meeting you and Mark Bond on November 4, 2015, to discuss the potential rockfall boulder at Goosenecks State Park (figure 1). Your staff did a great job of recognizing movement, implementing monitoring, and seeking professional advice on this potential rockfall boulder. This letter is a summary of my observations and recommendations from my field visit.

The potential rockfall boulder is detached from the cap rock and has started tipping outward and possibly sliding onto the slope below. The monitoring point that Mark established documents the boulder movement relative to the adjacent cap

Figure 1. Location of potential rockfall boulder at Goosenecks State Park.

- Continue movement monitoring on the potential rockfall boulder, particularly after precipitation events. If the movement continues or the movement rate increases, restrict access around the boulder to protect park visitors.

- Install warning signs that would notify park visitors of potential loose, unstable rocks.
- If the potential rockfall boulder presents an unacceptable risk, a rockfall mitigation company could stabilize the boulder (similar to rockfall along highways) to reduce the risk.
