G-321
LANDSLIDE SURVEILLANCE
OF
LAKE POWELL

UPPER COLORADO REGION

DECEMBER 1980

Geology Report No. G-321
Field Work and Report
by D. Grundvig

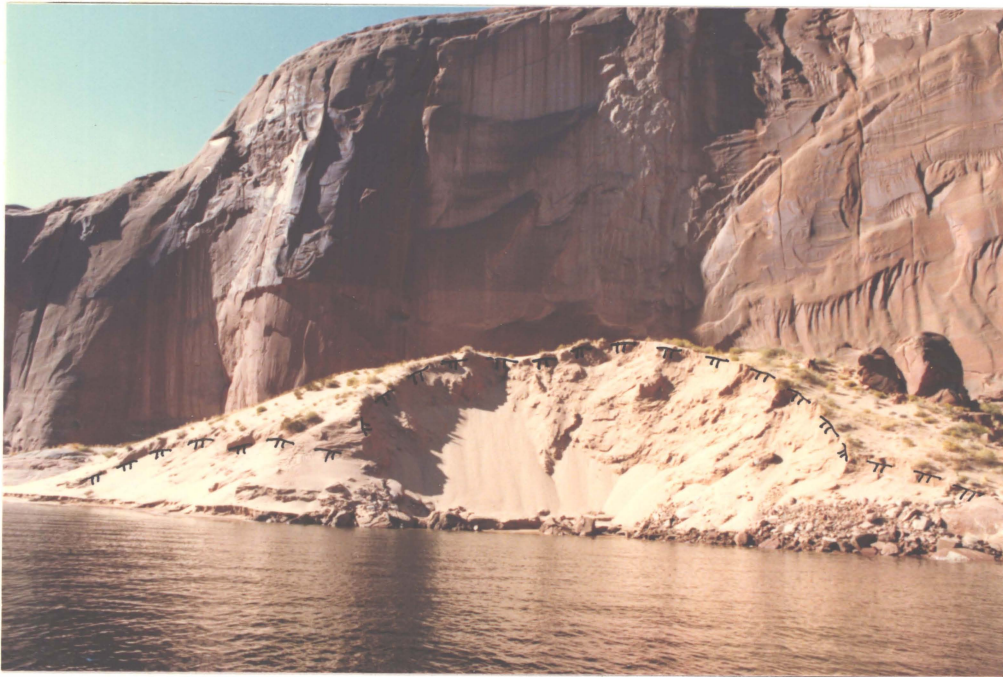
SITE 1: Active failure located about $\frac{1}{4}$ mile south of Gunsight Pass. Sand deposit is approximately 200 feet long and 50 feet high. Note absence of high water mark.

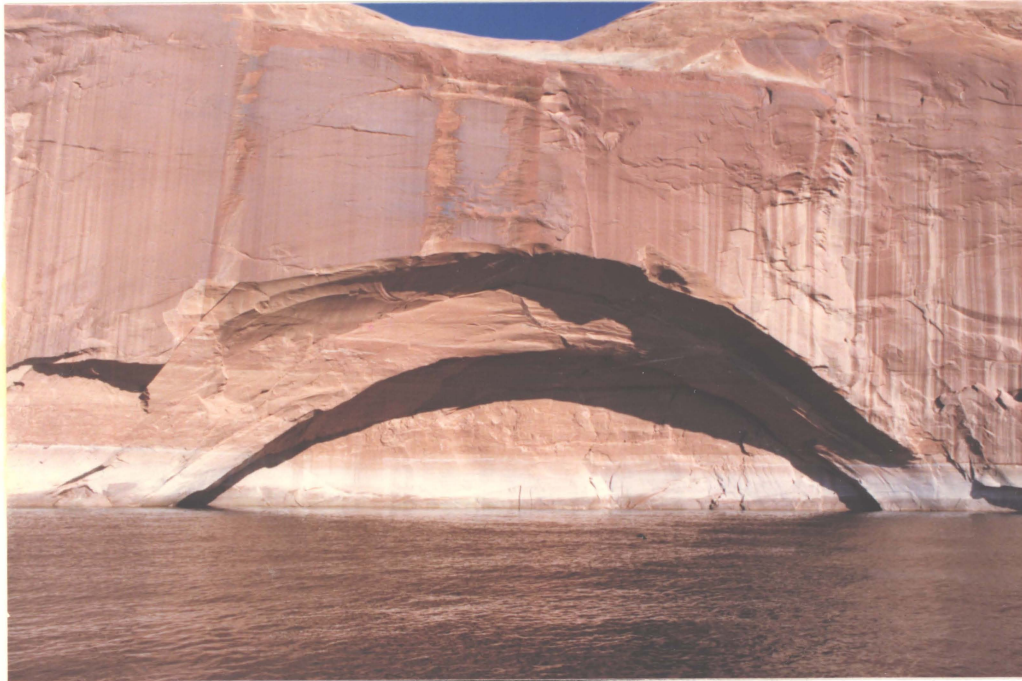
SITE 2: Site of recent arch collapse in Padre Bay. Presence of open cracks parallel to the arch indicate that additional slab failures may occur in the near future.

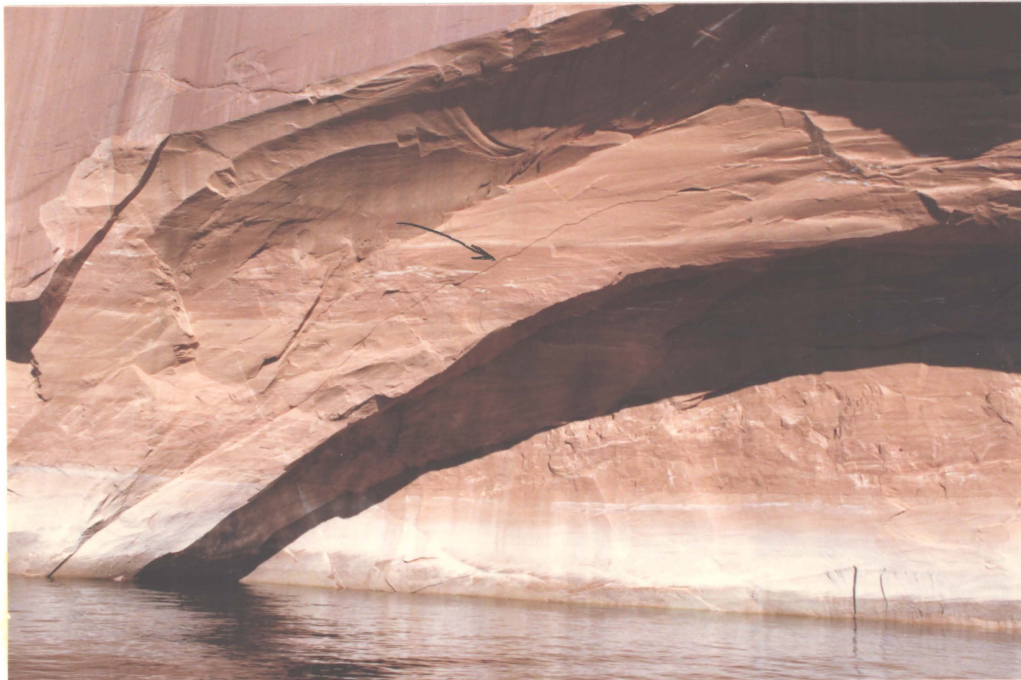
SITE 2: Closeup of open crack (indicated by arrow) Slab is separated from the wall of the cliff by an open vertical crack. Slab dimensions are approximately 60 feet by 20 feet by 10 feet.

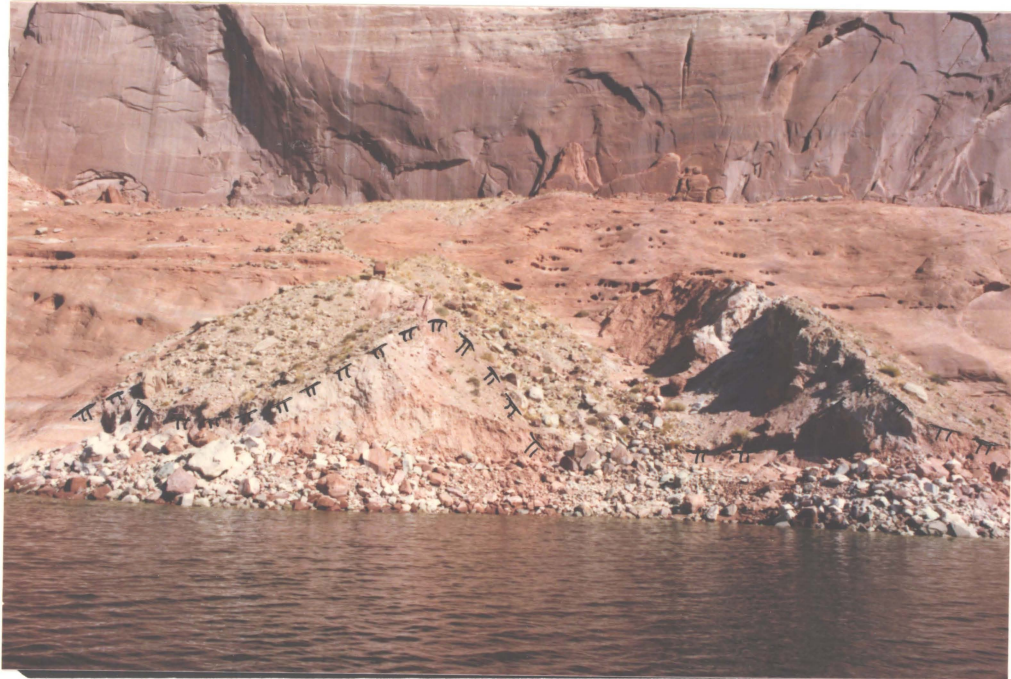
SITE 3: Active talus failure on Kane point. Wave action has caused sloughing and oversteepening of the slope. Talus slope is approximately 200 feet long and 60 feet high.

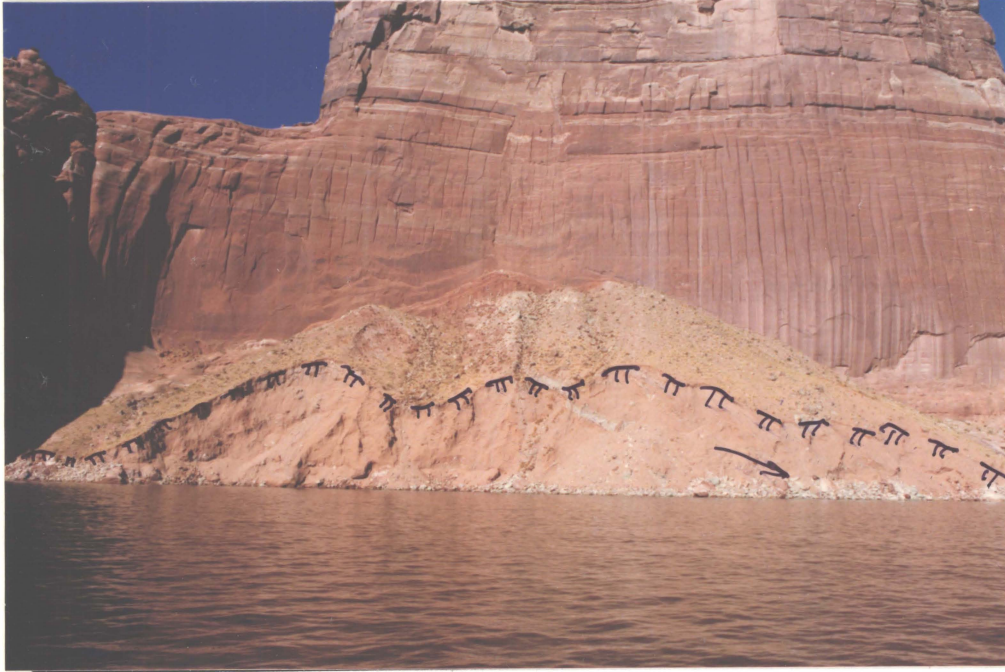
SITE 4: Active sand and talus failure in Last Chance Bay. High water mark (indicated by arrow) is 15 feet above the reservoir. The sand and talus deposit is approximately 600 feet long and 130 feet high.

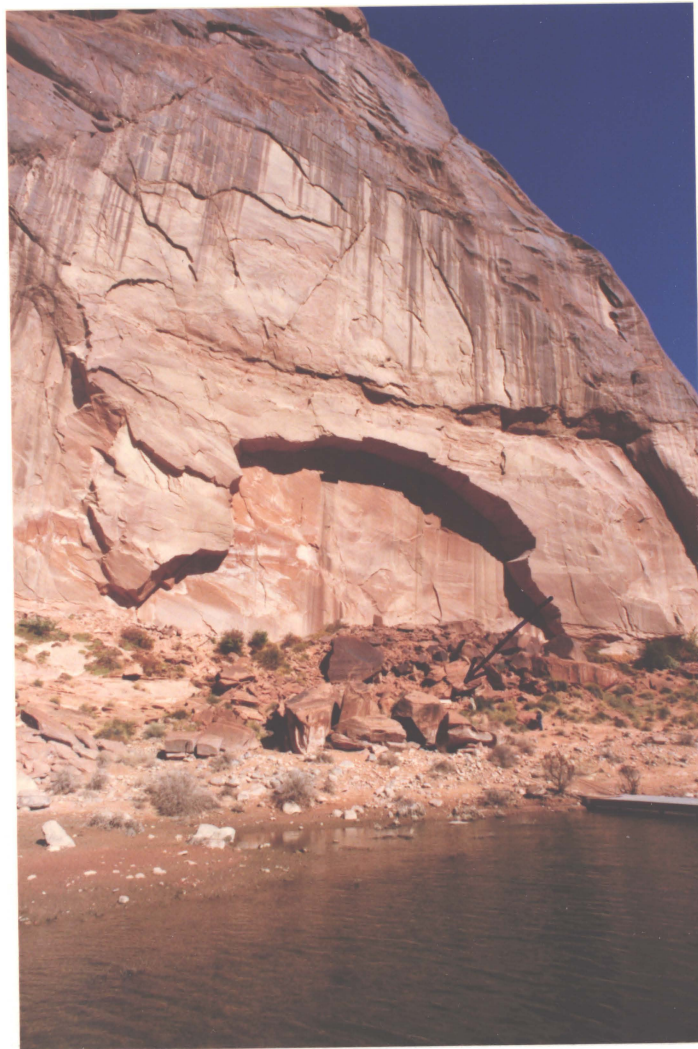
SITE 5: Rainbow Bridge National Monument. Visitors' rest area (indicated by arrow) located among large blocks resulting from slab failure. Location of bench and presence of open cracks and fresh breaks in the wall have combined to create a hazardous situation which could result in serious injuries or death of visitors if a rockfall should occur.

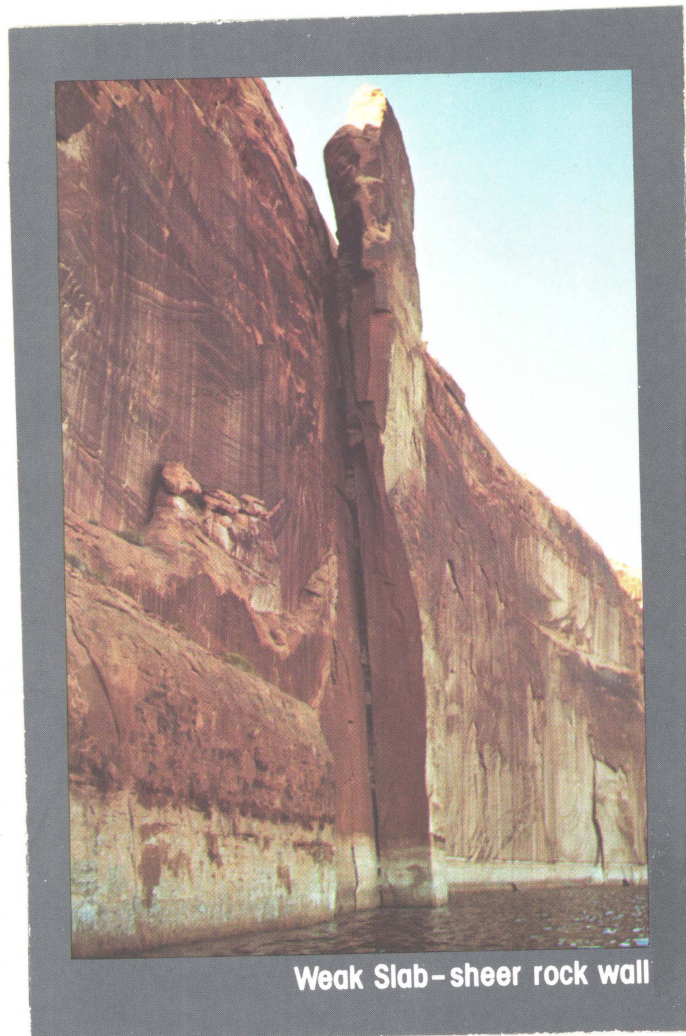
SITE 7: Pillar developed in Navajo Sandstone. Pillar extends approximately 240 feet above the reservoir and is approximately 30 feet wide and 20 feet thick. Risk of injury to boaters is high.

(4) Although there is a possibility that a boat and its occupants may be endangered by falling rocks or slides, the possibilities are too remote and the expenses too great to consider such measures as wide-spread blasting to stabilize cliff faces. Any benefits derived from blasting would only be effective for the short term since the processes leading to rockfall will continue. Equally hazardous conditions exist over a broad region and any attempts at stabilization should be applied to those areas as well. Stabilizing all hazards would be an impossible undertaking. This is not to say that isolated features that can be stabilized without great expense, should not be attempted. Sites 6 and 7 should be examined

to determine if blasting is warranted. Obvious and critical hazards when identified should, in most cases, be minimized by appropriate actions.

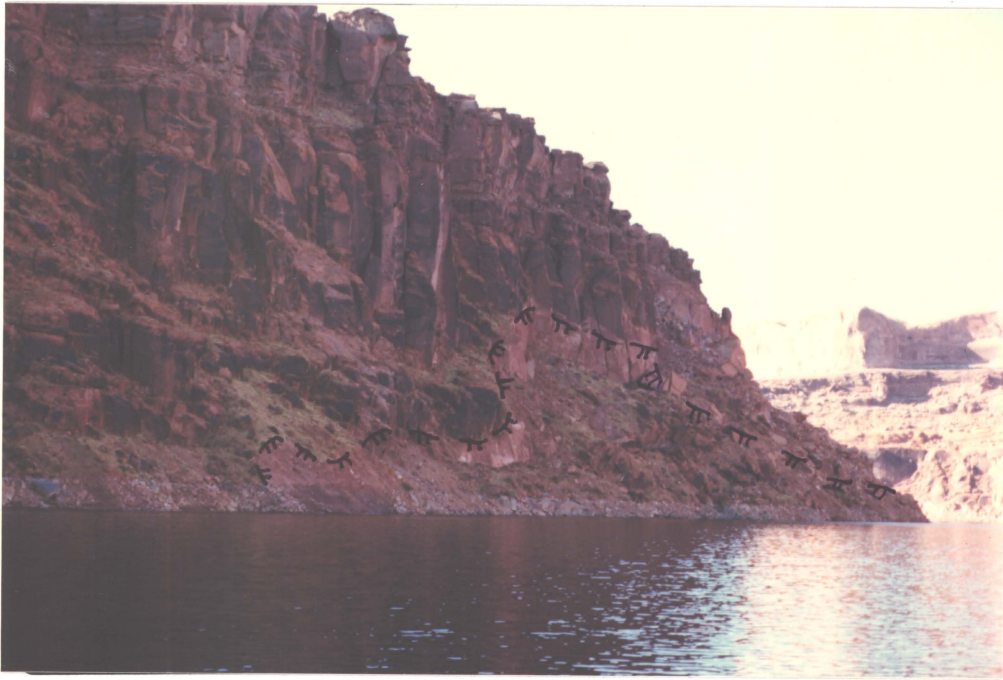
SITE 8: Failure of talus deposits located approximately $1\frac{1}{2}$ miles west of Cha Canyon. Note the presence of the high water line which is approximately 15 feet above the reservoir.

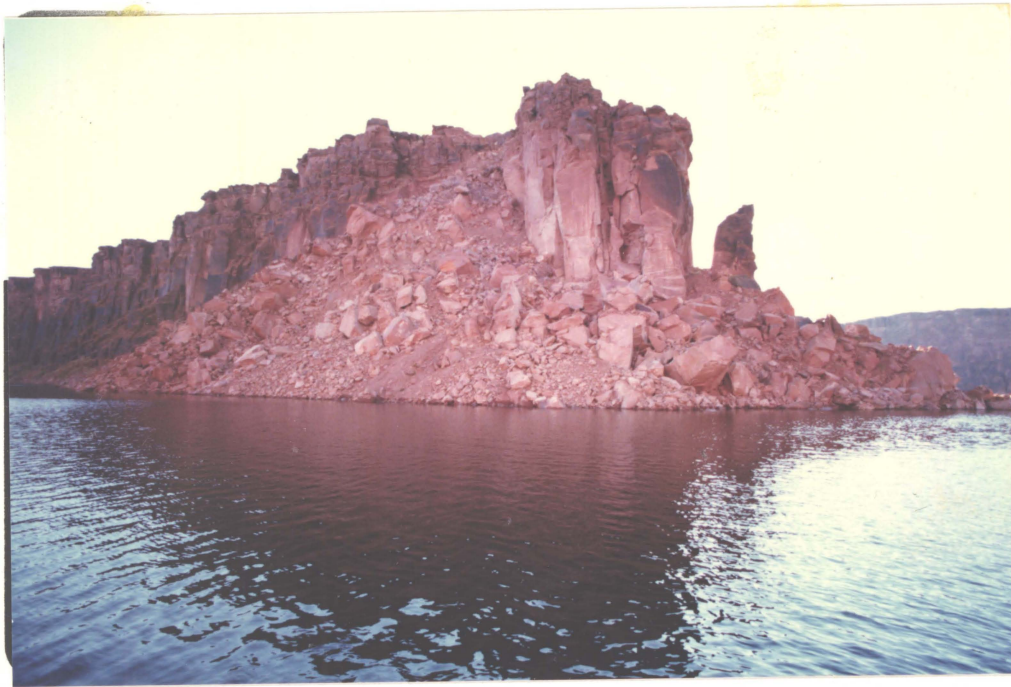
SITE 8: A fractured point in the San Juan arm of the reservoir. Failure may have resulted from movement of the underlying Chinle Formation (primarily shale) resulting in rockfall of the overlying Wingate Sandstone. Note the absence of high water mark over most of the slope.

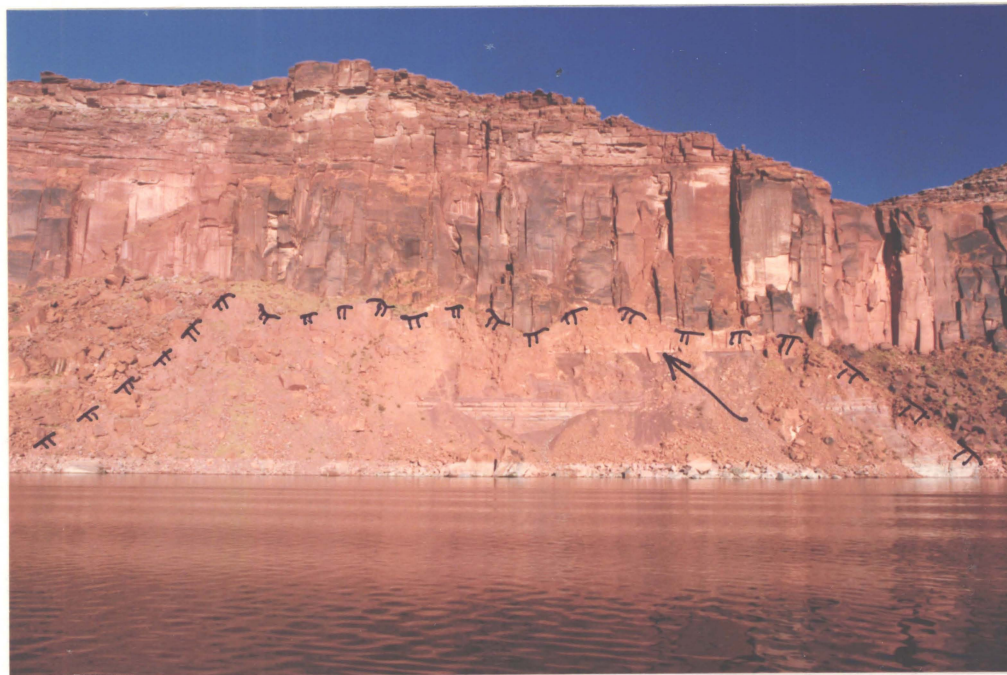
SITE 8: Failure of the Chinle Formation and talus deposits. Arrow indicates the contact between the Wingate Sandstone and the Chinle Formation. Failure is 1100 feet long and 200 feet high.

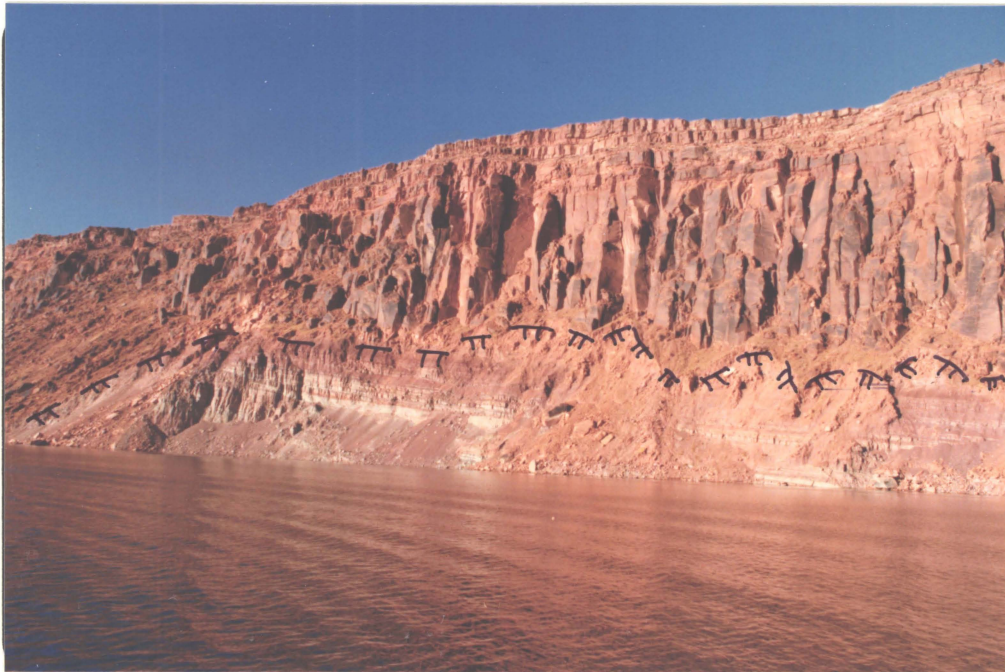
SITE 9: Failure of the Chinle Formation and overlying talus deposits. Note the absence of a high water line indicating that failure occurred after drawdown.

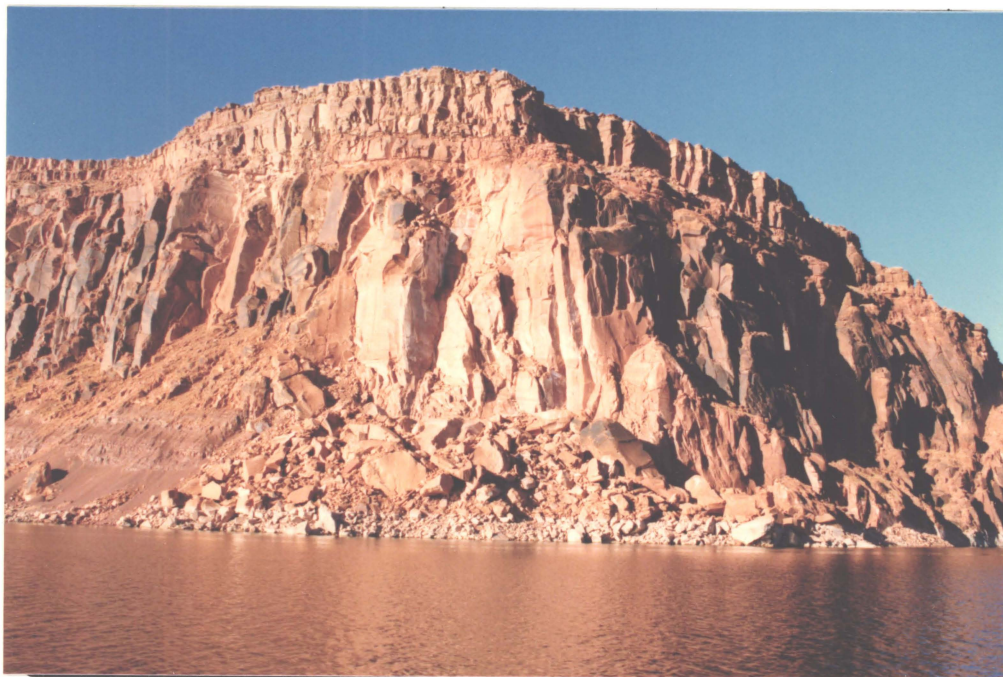
SITE 9: Recent rockfall involving the Wingate Sandstone. Presence of high water mark indicates that failure occurred prior to June, 1980.

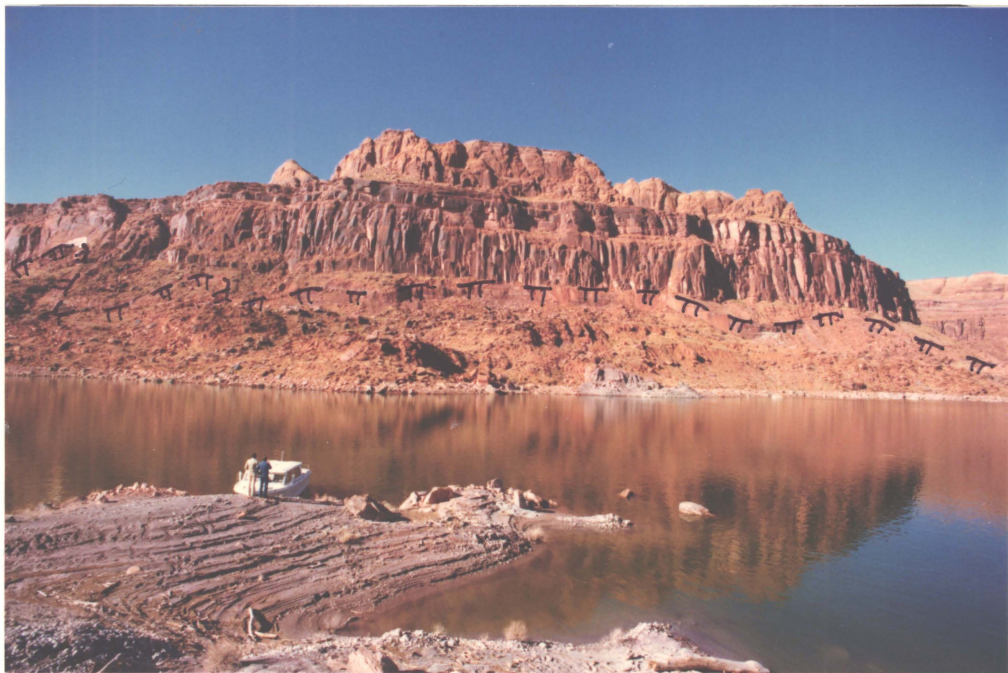
SITE 10: Large landslide involving the Chinle Formation. Slide is located in the San Juan arm at the mouth of Piute Canyon and is over one mile long. A closeup panorama of the slide can be found on the next page.

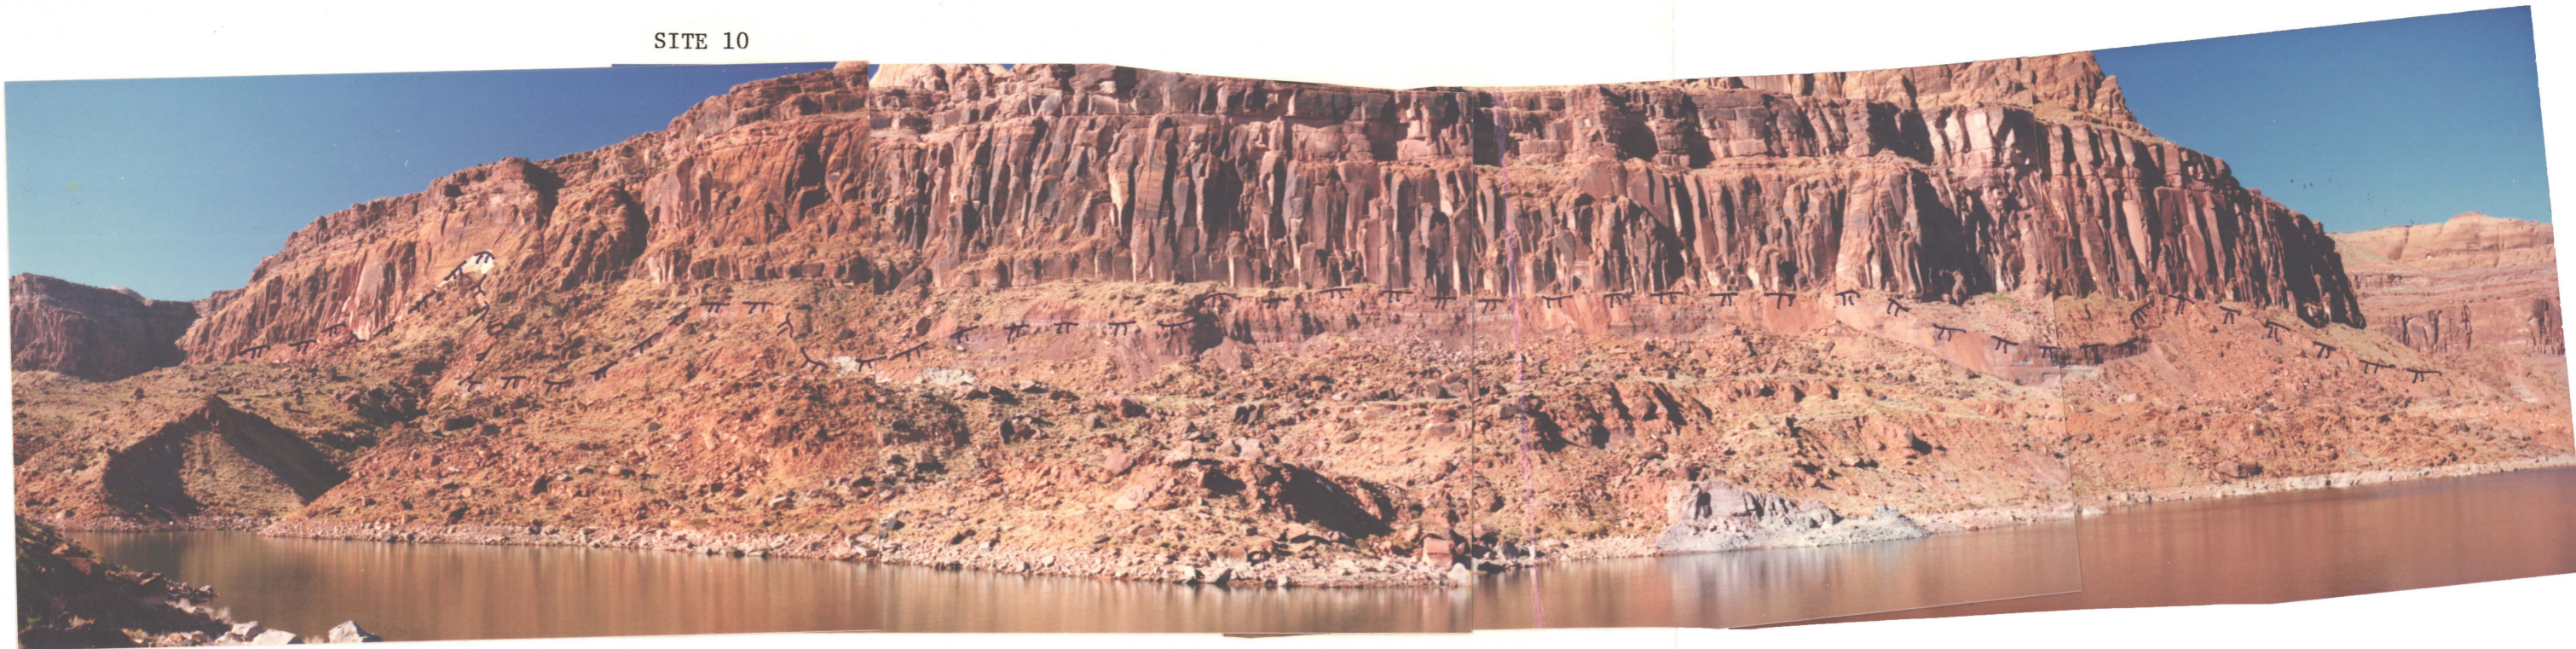
SITE 10: A panorama of the landslide at the mouth of Piute Canyon. The dashed line indicates the top of the main scarp. Numerous small scarps can be seen in the foreground (indicated by arrows). If failure continues, (which is expected) portions of Piute Wash may be closed off.

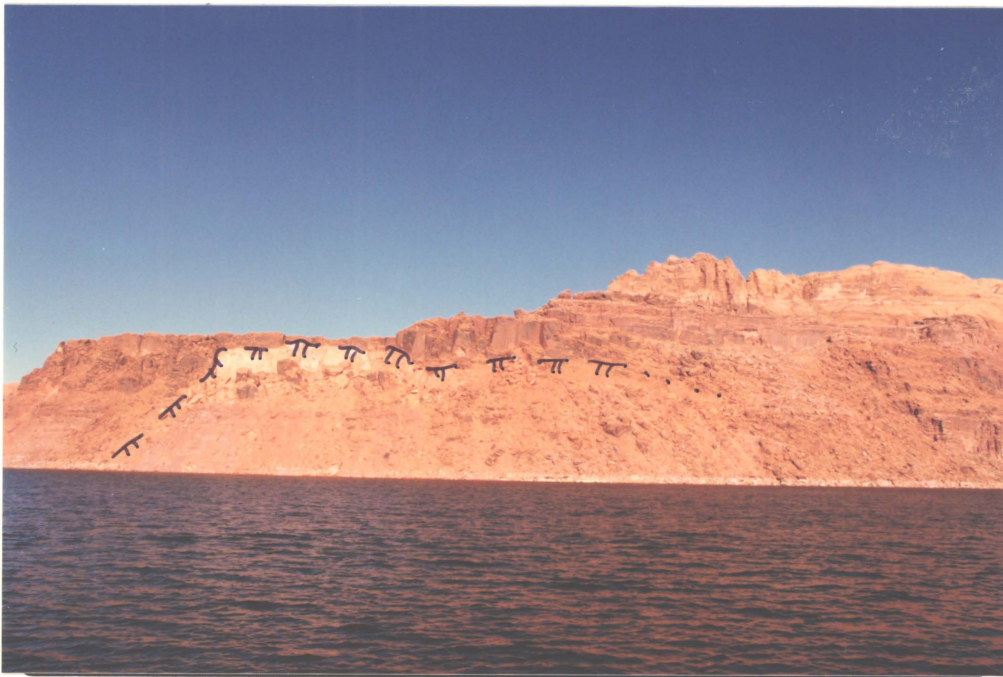
SITE 12: Failure of talus slope (in initial stages of movement) with attendant rockfall of the Wingate Sandstone. Slide is approximately 250 feet high and 1200 feet long and is presently active. Note absence of high water mark in left half of slide.

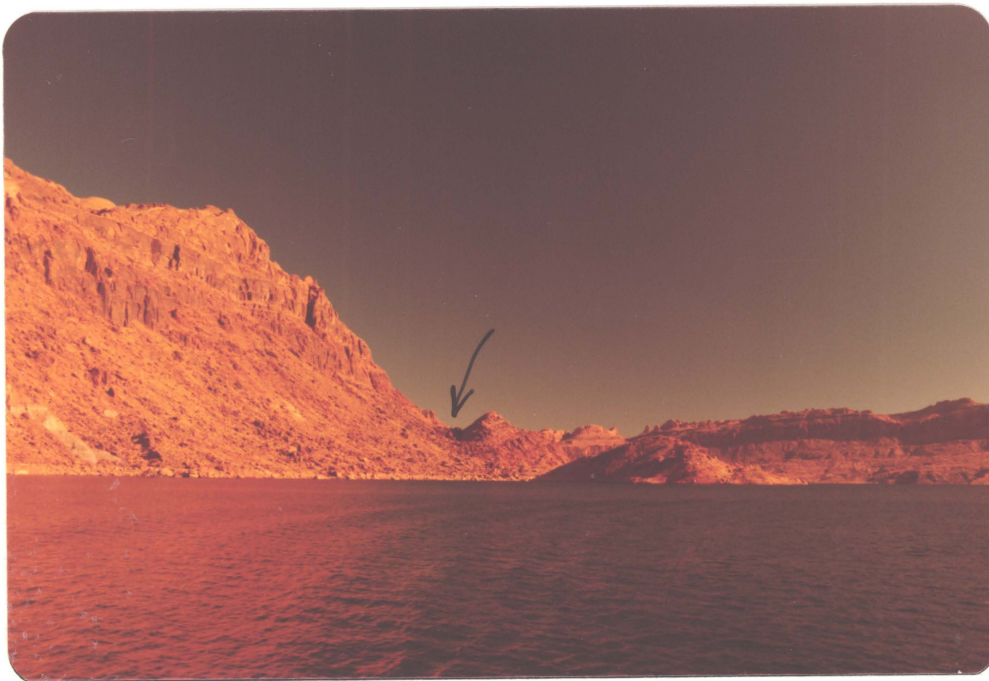
SITE 13: Old slump developed within the Chinle Formation. Note backward rotation of block to right of slide plane (indicated by arrow). Slump predates the reservoir, indicating that large scale landsliding can occur without wetting by reservoir water. Presence of reservoir may generate renewed movement along old slide planes, however.

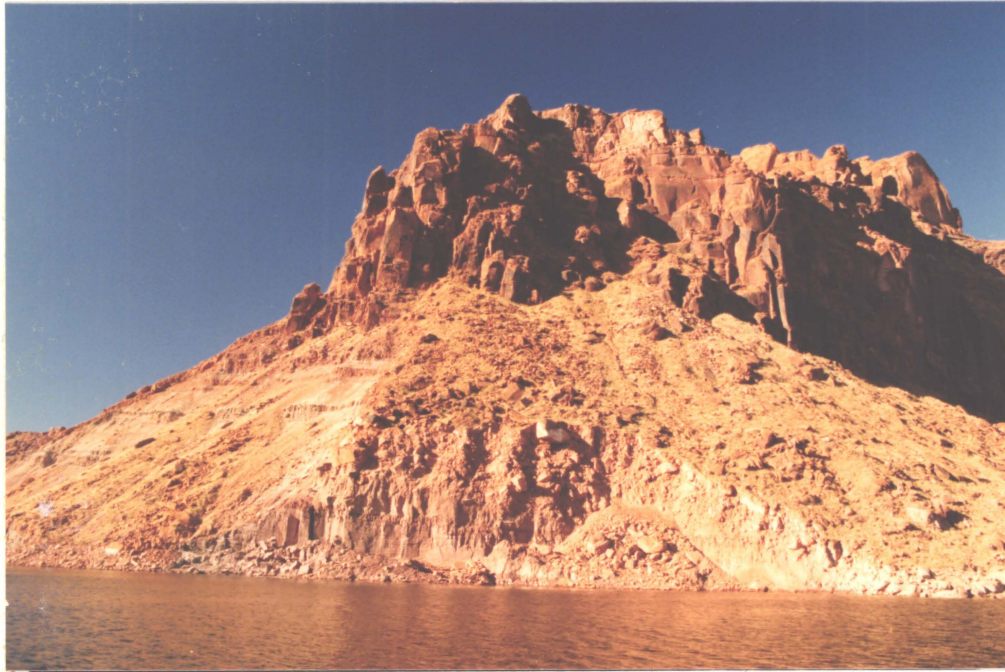
SITE 15: Oversteepened slopes and sloughing of talus resulting from slumping in Chinle. Slide is active as evidenced by lack of a high water mark. Slide scarp is approximately 100 feet high and 450 feet long.

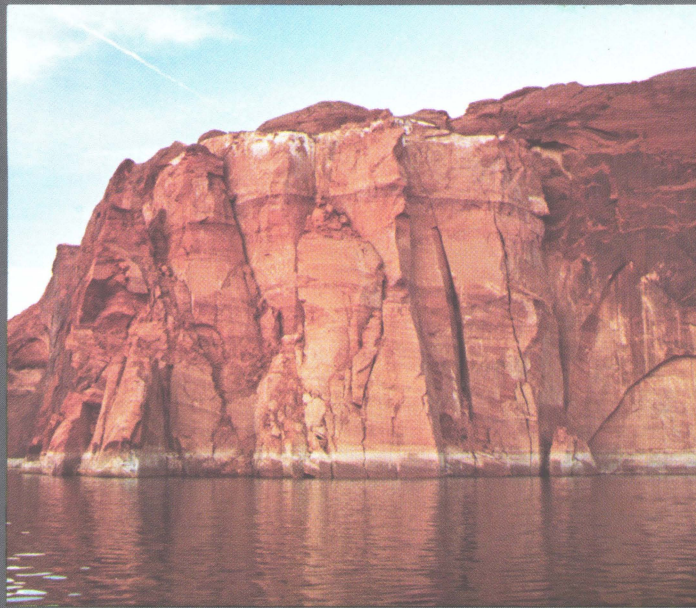
Fresh scar-loose rock

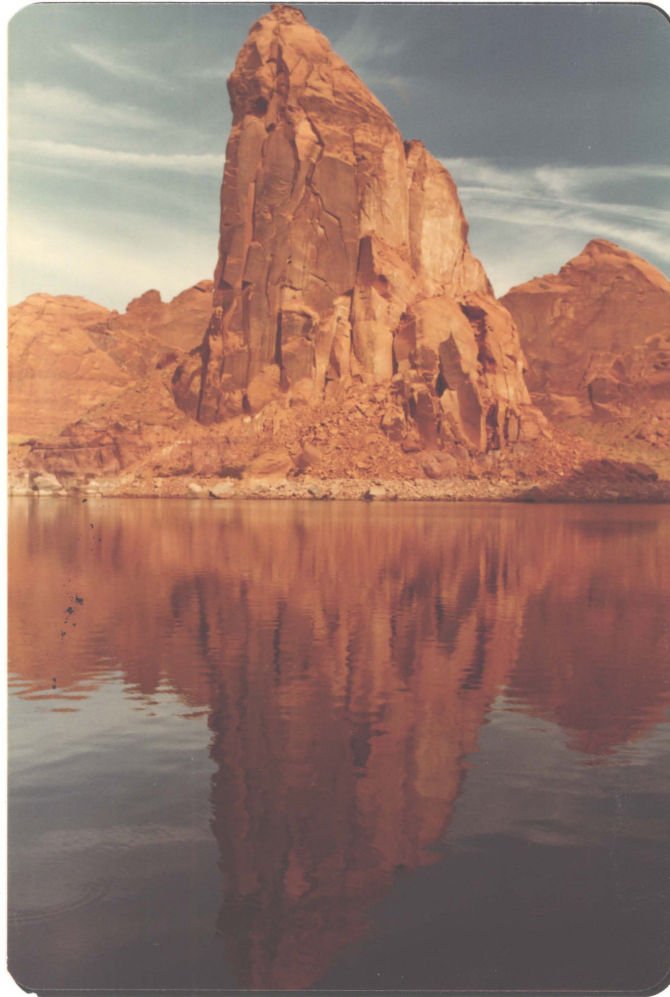
SITE 23: Failing pillar opposite Fence Canyon in the Excalante arm. Navajo Sandstone - Kayenta Formation contact is at the base of the cliff. Risk to boaters is moderate to high.

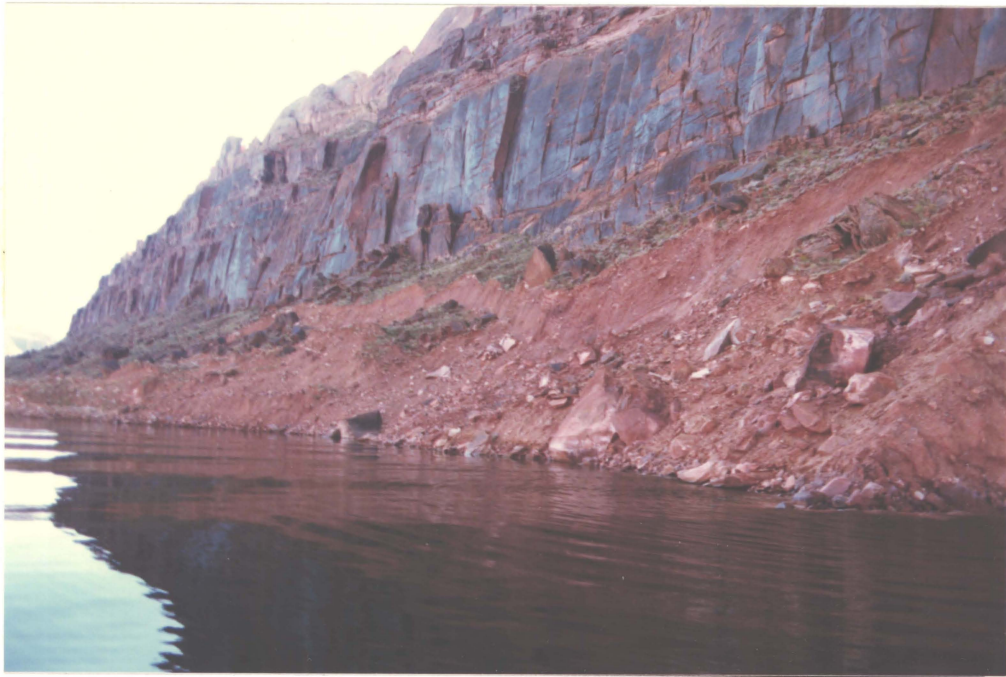
SITE 24: Talus slope failure located about 2 miles west of The Rincon. The Wingate - Chinle contact is just below base of cliff. Note the absence of the high water mark.

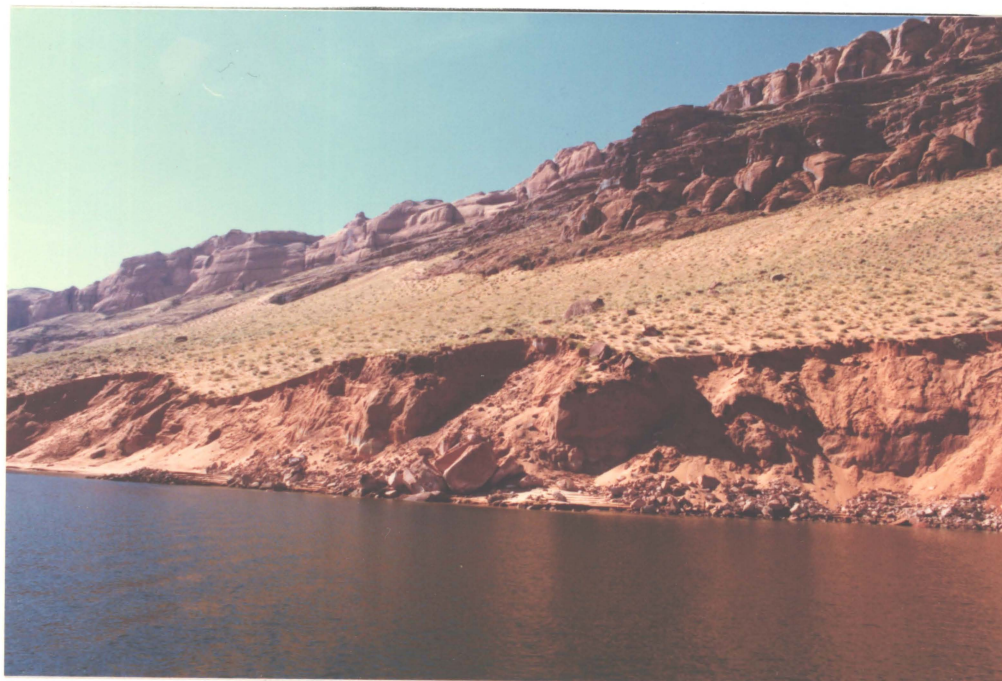
SITE 25: Failure of shoreline, involving sand and talus, located immediately west of The Rincon.

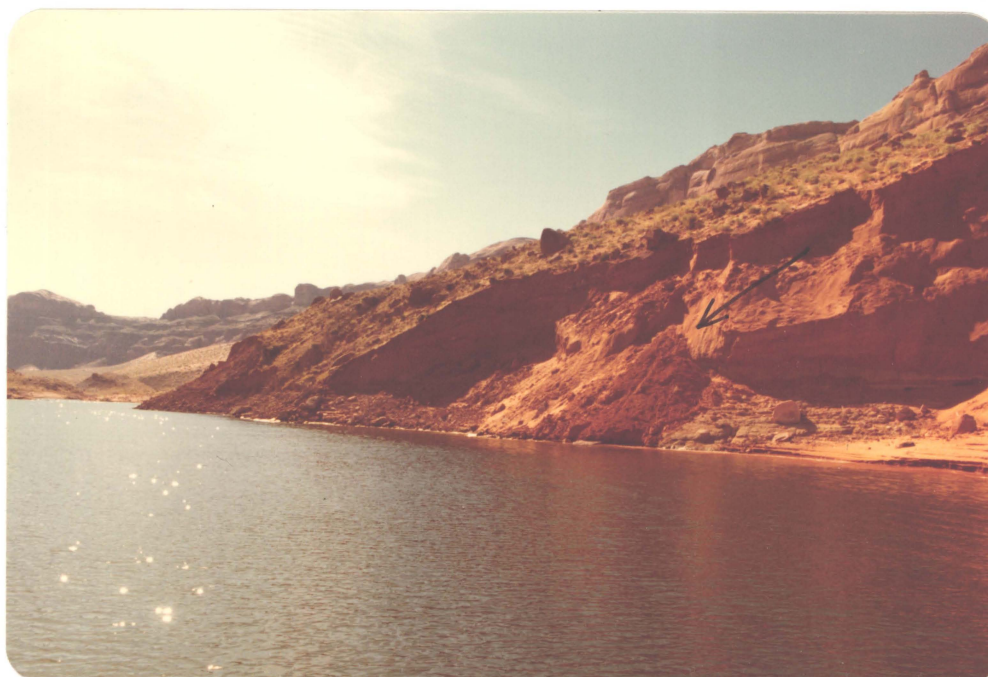
Sand deposits as high as 100 feet have accumulated beneath cliffs formed by the Navajo, Wingate, and Entrada Formations. When reservoir water comes into contact with these wind-blown deposits, the entire deposit can slide into the water within a few minutes. The level of hazard is variable but of a short term nature since the deposit is easily eroded by wave action with constant sliding of sand into the reservoir. Most of the failures had occurred prior to our inspection leaving some near-vertical

slopes approaching 80 feet in height. See the photographs of Site 25. In other cases, small remnants remained with only a white jagged mark on the cliffs to indicate their former presence. Extensive sand deposits had been reported in the Escalante Arm of the reservoir but at the time of our trip very few remained. The deposits had either been inundated by the rising lake or had failed and slid into the water.

Major sand accumulations such as those found west of The Rincon are particularly hazardous to campers because of the high vertical faces and poor consolidation of the materials. The sandy beaches and slopes make this site a favorite camping place. The accompanying photos (see Site 25) illustrate very well the high hazard that is created by actions such as standing beneath an 80-foot-high vertical slope of damp sand to write initials. When failure occurs, a person standing near the base could be buried by tons of sand in a matter of a few seconds.

SITE 25: Note the very recent slide (dark color) indicated by the arrow. This area is a favorite of boaters because of the sandy beaches and slopes. Risk to boaters is high due to the high faces and poor consolidation of the deposits.

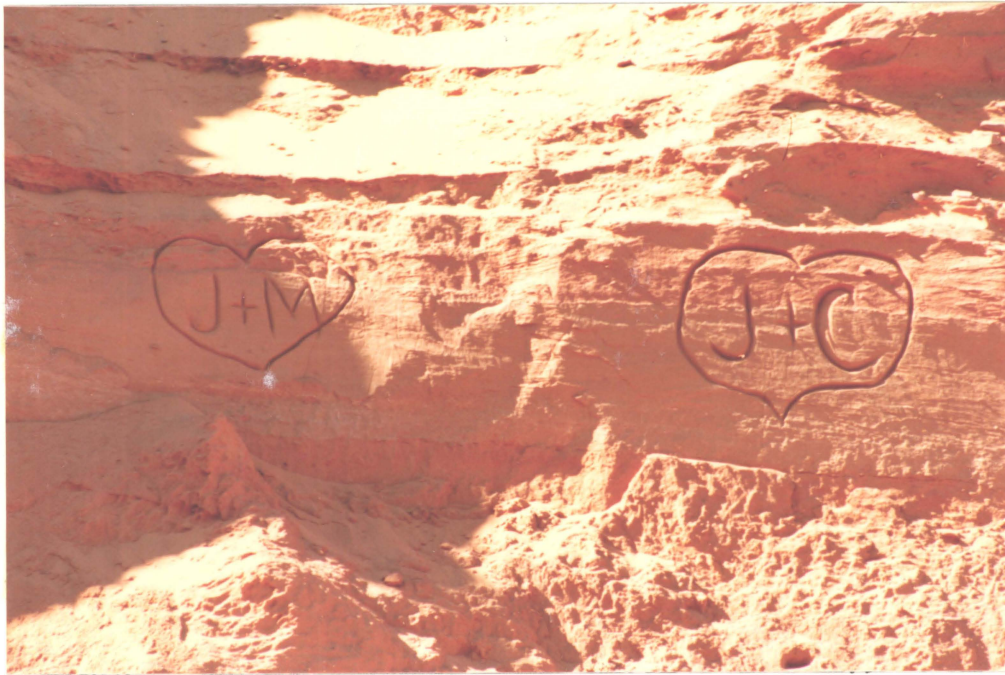
SITE 25: Closeup of failure surface showing initials carved in vertical face. Such a practice subjects the boater to high risk since the deposits are poorly consolidated and the vertical faces in places approach 80 feet in height.

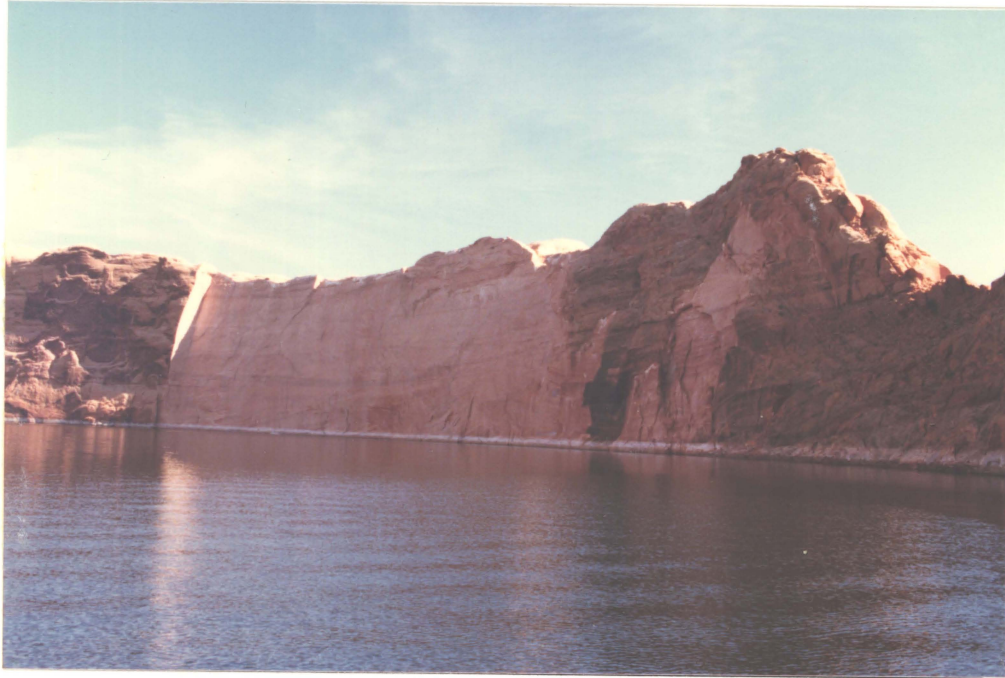
SITE 26: Slab failure near Iceberg Canyon. Most recent failure occurred in June, 1974 and resulted in damage to one boat. Area is presently being monitored by Glen Canyon personnel. Risk to boaters is rated extreme.

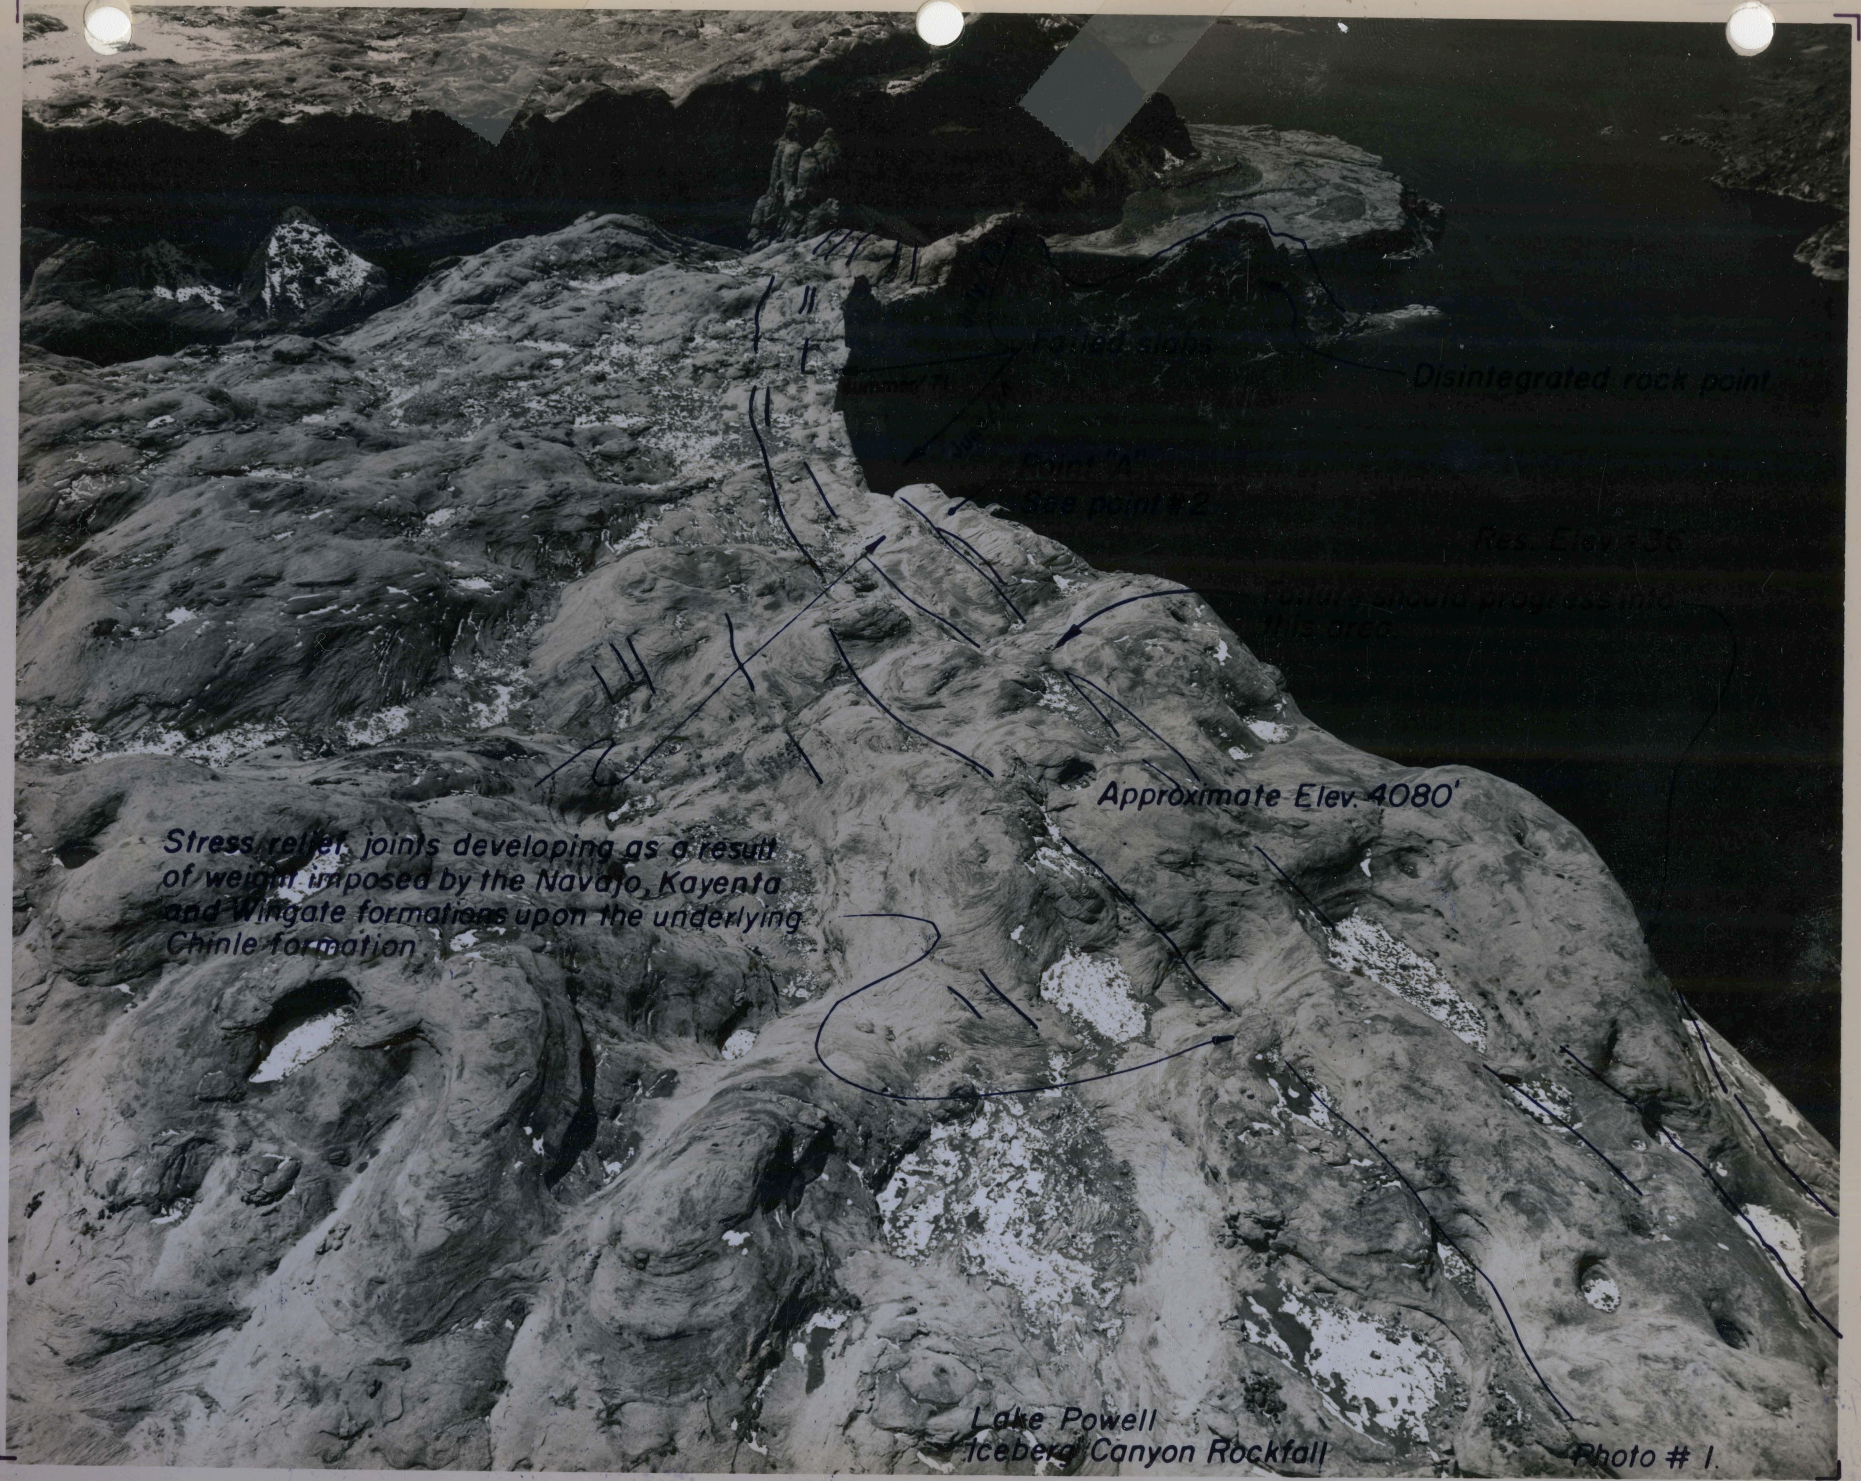
Stress relief joints developing as a result of weight imposed by the Navajo, Kayenta and Wingate formations upon the underlying Chinle formation
