G-321
LANDSLIDE SURVEILLANCE
OF
LAKE POWELL

UPPER COLORADO REGION

DECEMBER 1980

Geology Report No. G-321
Field Work and Report
by D. Grundvig

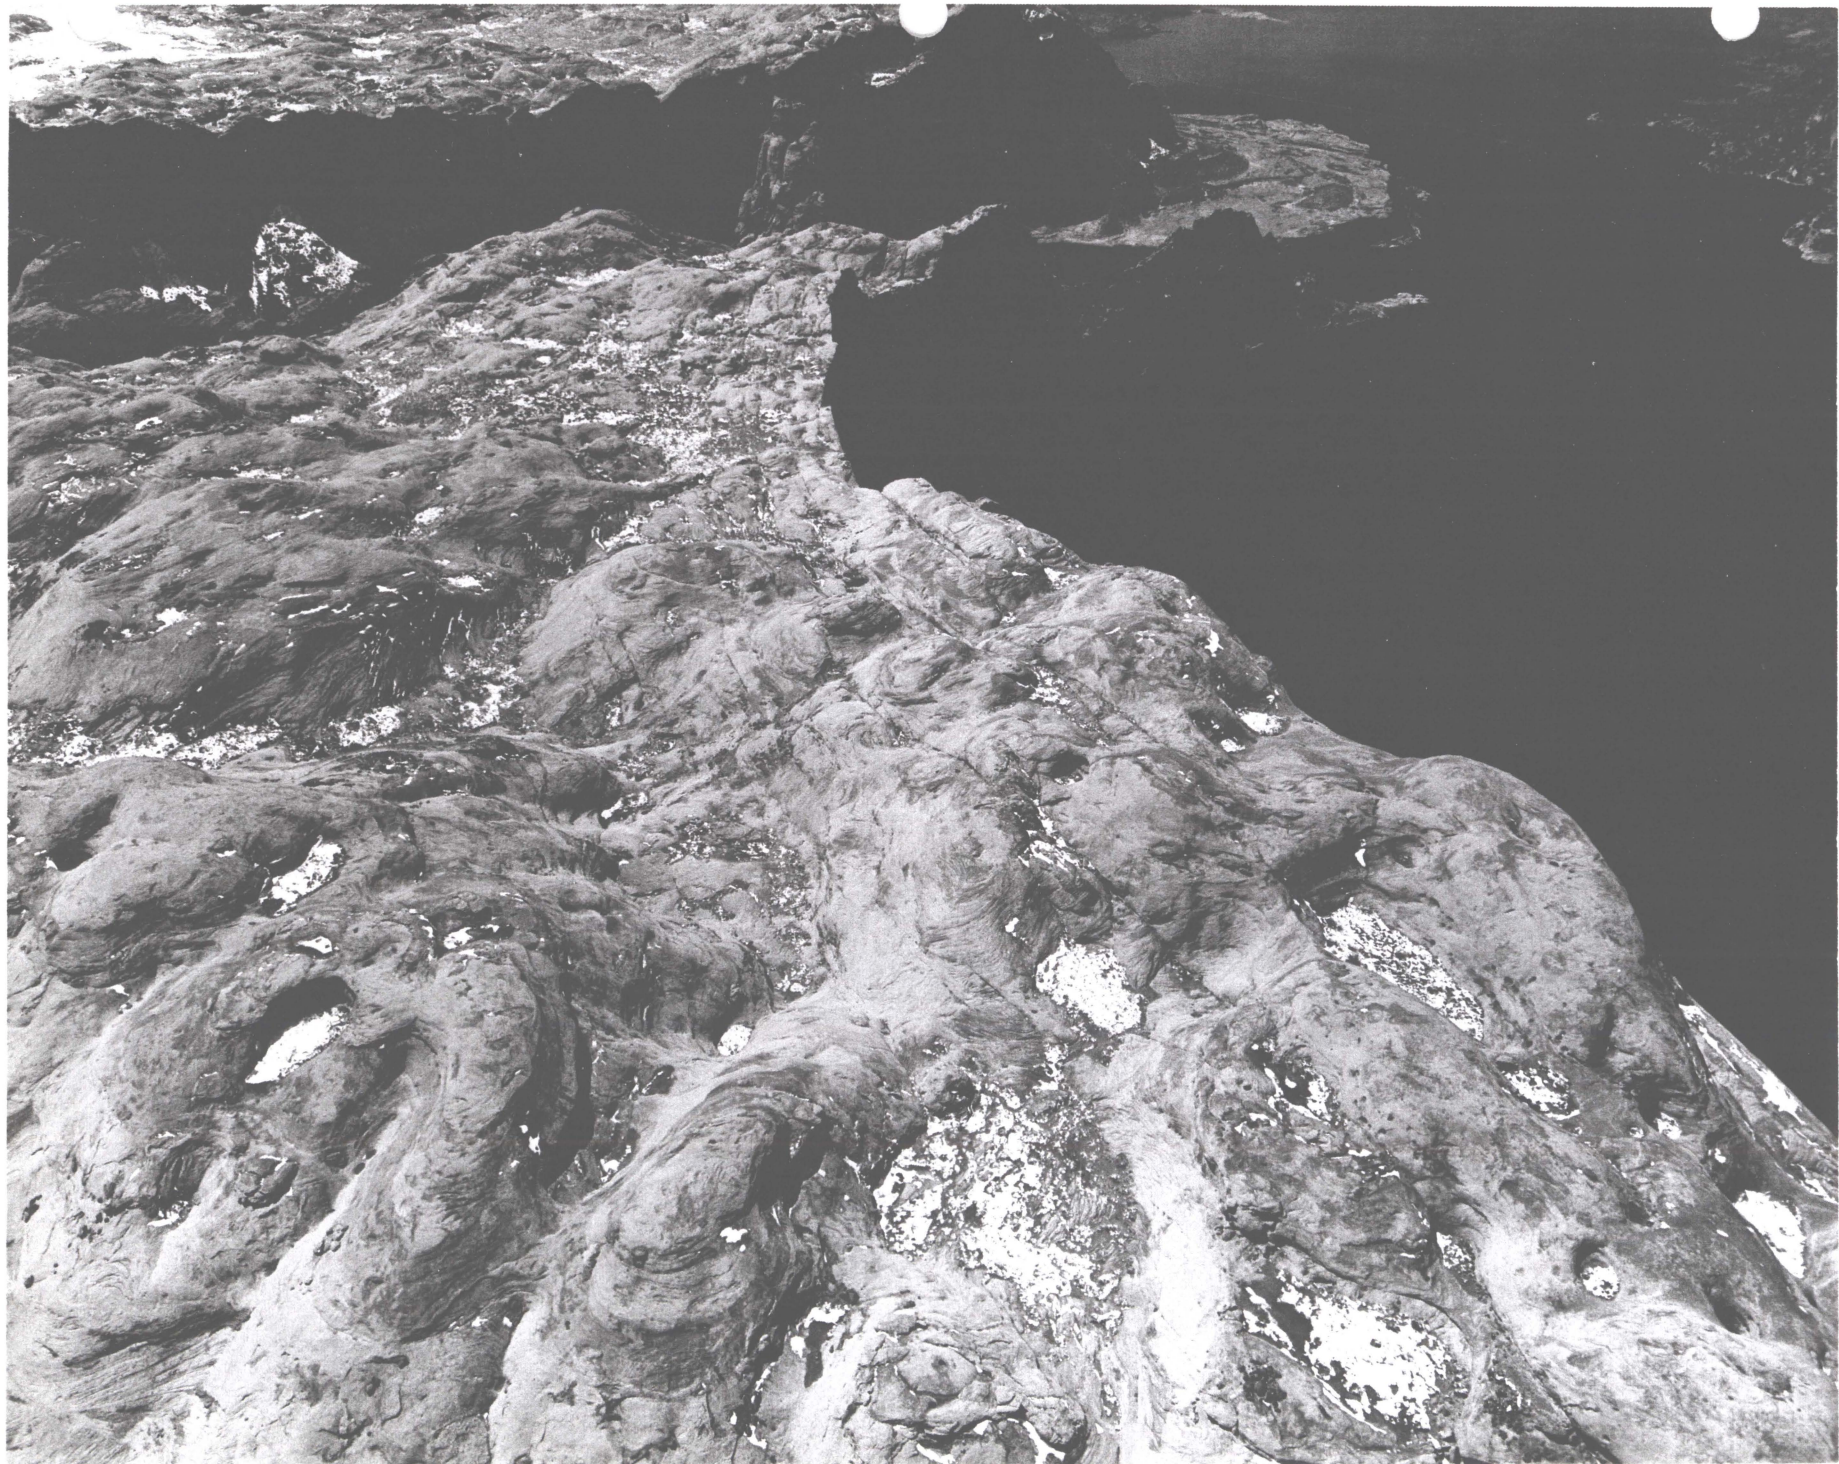
Stress relief joints developing as a result of weight imposed by the Navajo, Kayenta and Wingate formations upon the underlying Chinle formation.

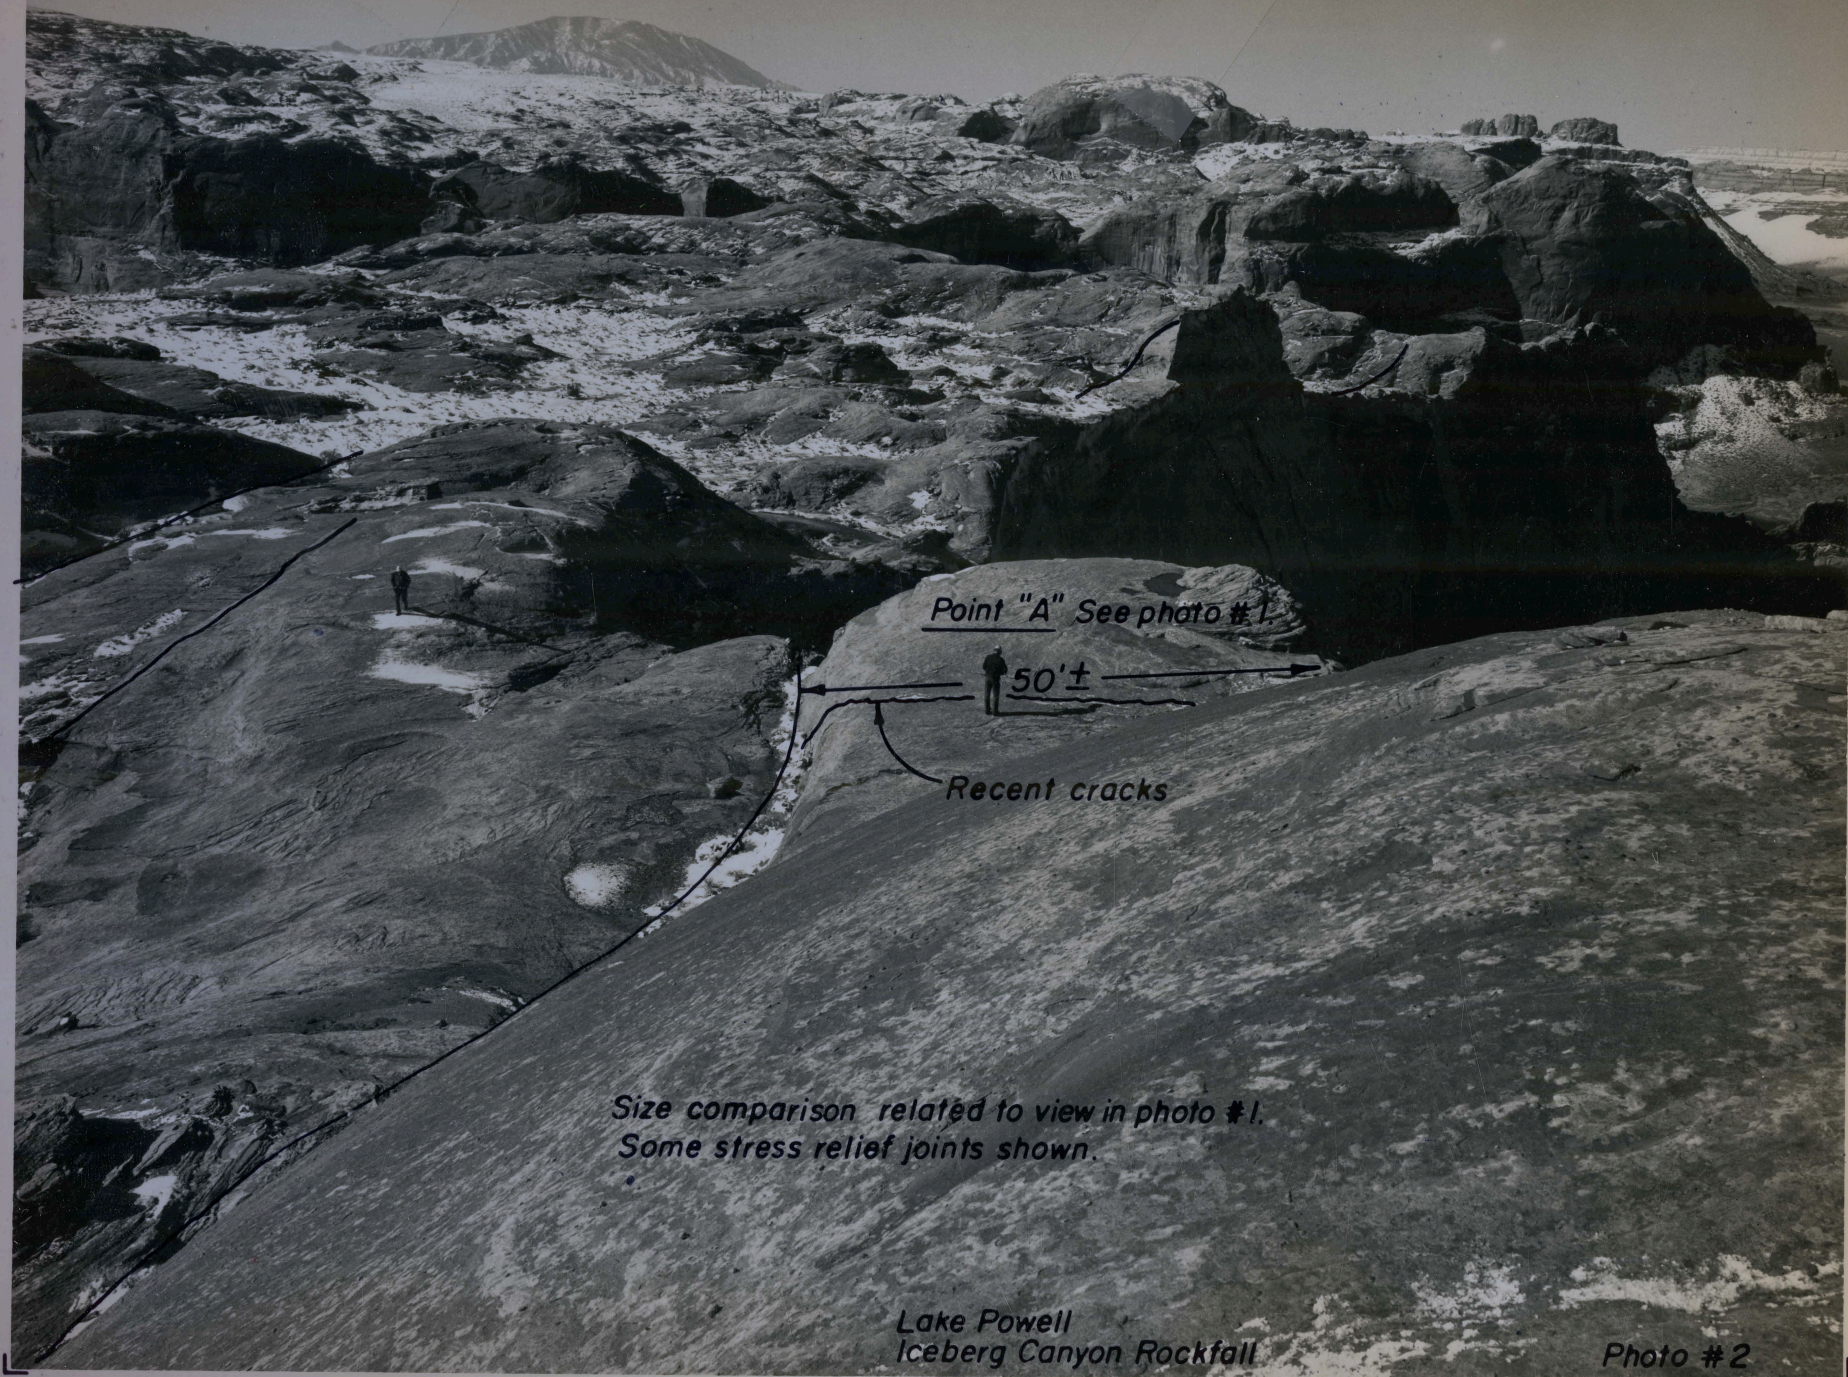
Size comparison related to view in photo #1.
Some stress relief joints shown.

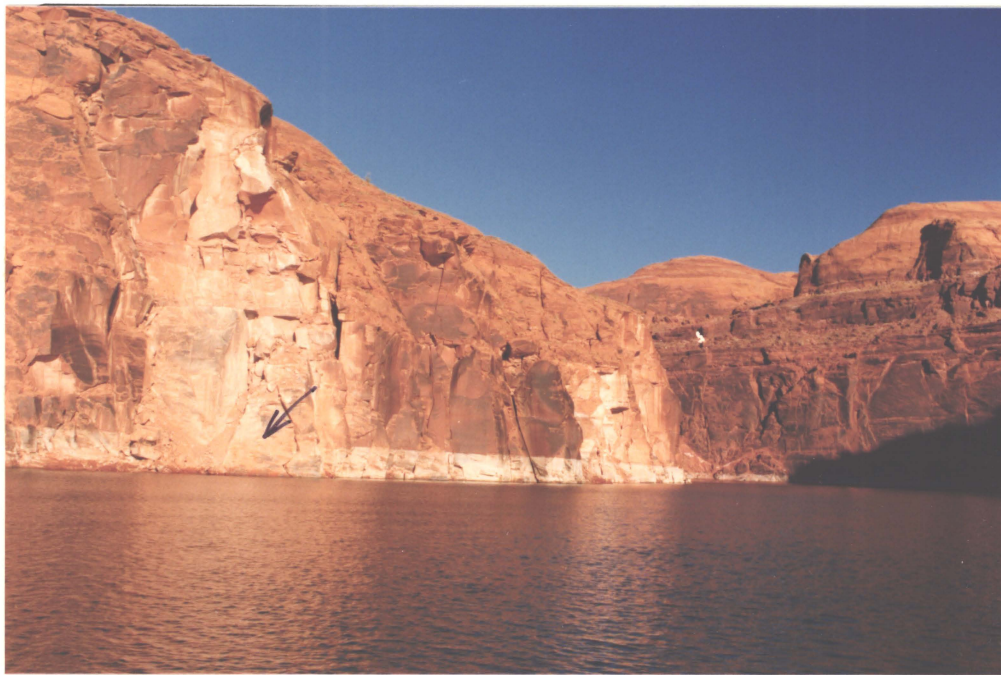
SITE 19: Failed points in the Wingate Sandstone. Note absence of the high water mark at the point indicated by the arrow. Boat operator indicated that several of these points failed only a few weeks before our survey.

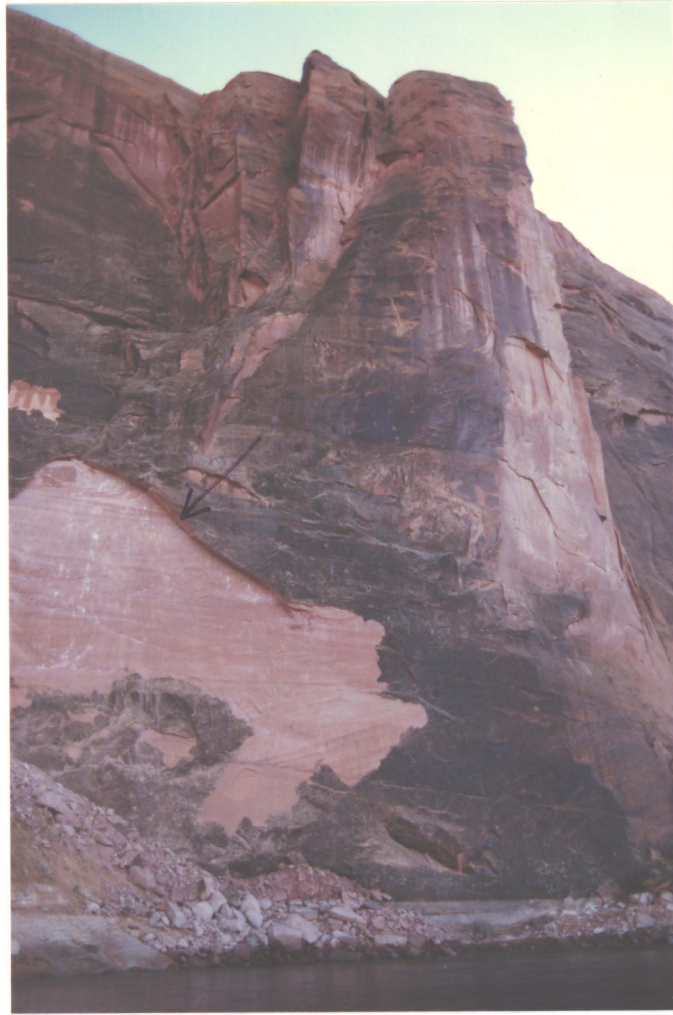
SITE 28: Small slab of Navajo Sandstone has failed (indicated by arrow). Large pillar to the right of slab has potential for failure due to presence of vertical cracks which separate the column from the wall.

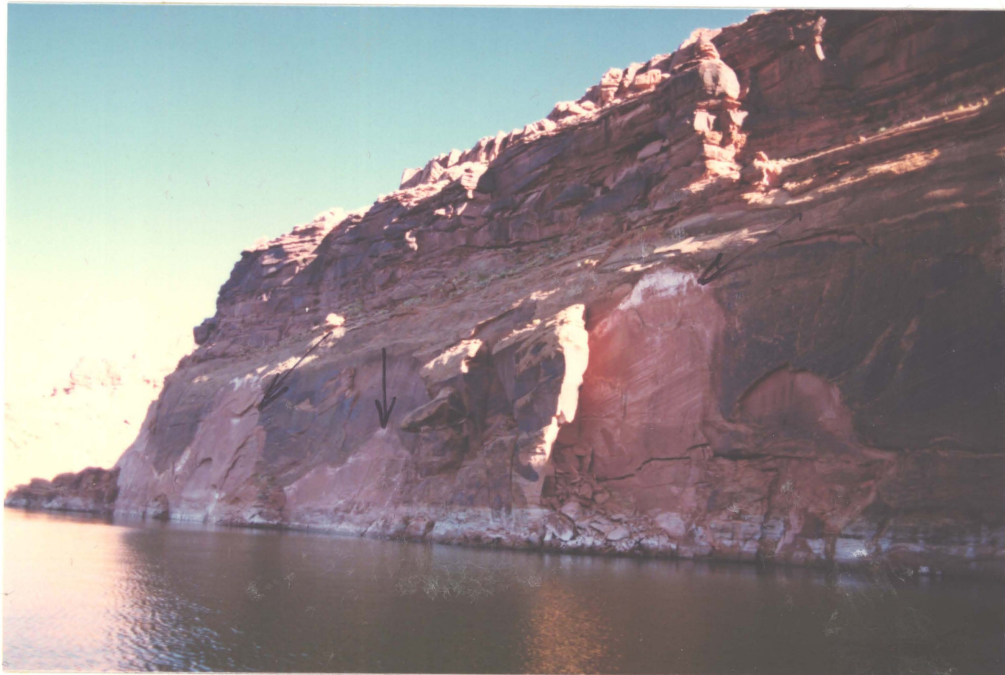
SITE 29: Slab failures occurring in Wingate Sandstone (indicated by arrows). Chinle Formation is just below lake surface.

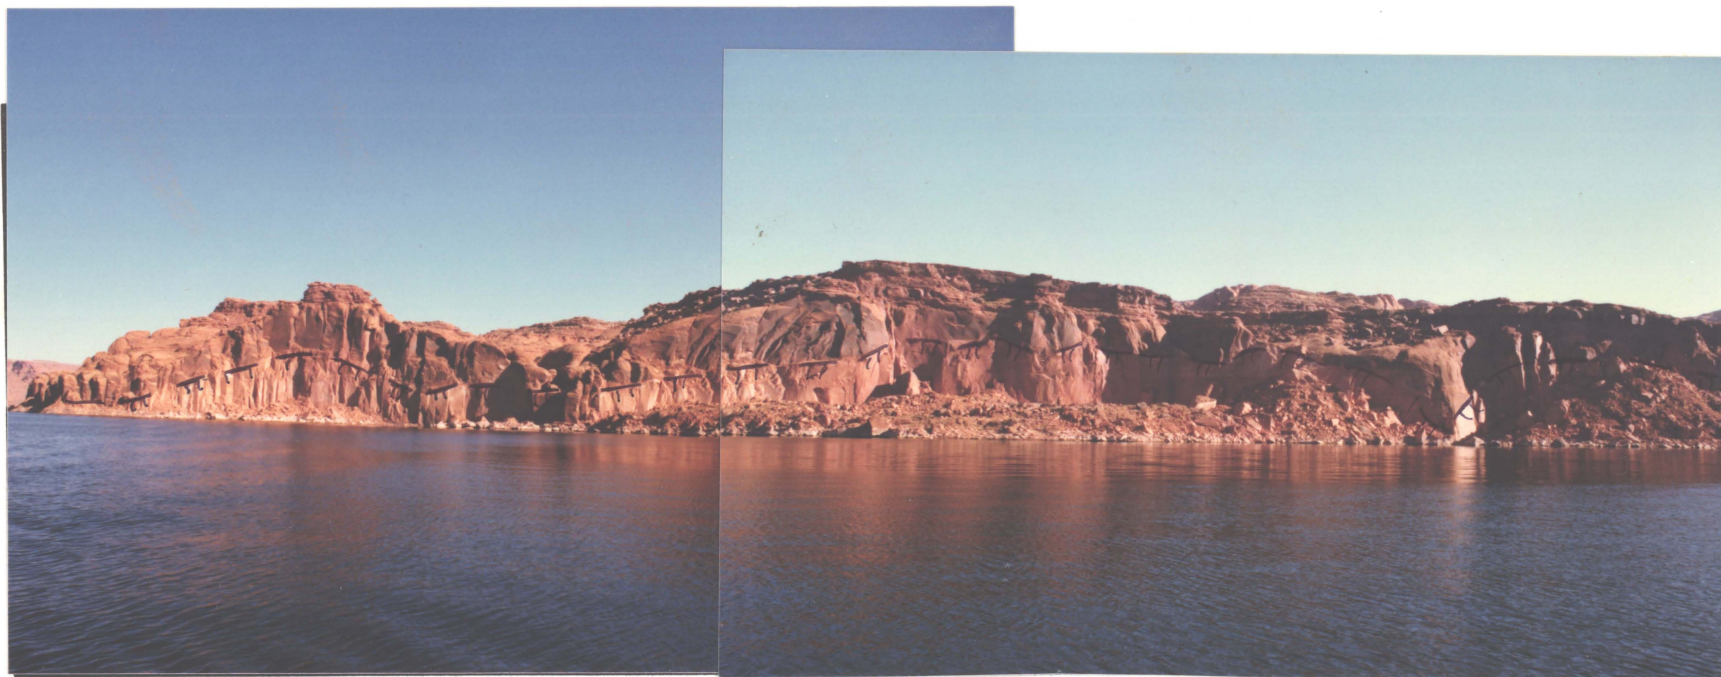
SITE 30: Large scale landsliding located south of Good Hope Mesa. Slide probably results from renewed movement of old slides in the Chinle Formation. The sliding material is mostly talus and large slabs derived from the Wingate and Kayenta Formations. Risk to boaters is high along some portions of the slide particularly where the slide has created fractured vertical walls. Slide is approximately 3/4 mile long and several hundred feet high. With the exception of active rockfall, most sliding occurred prior to June, 1980 (note the high water mark).

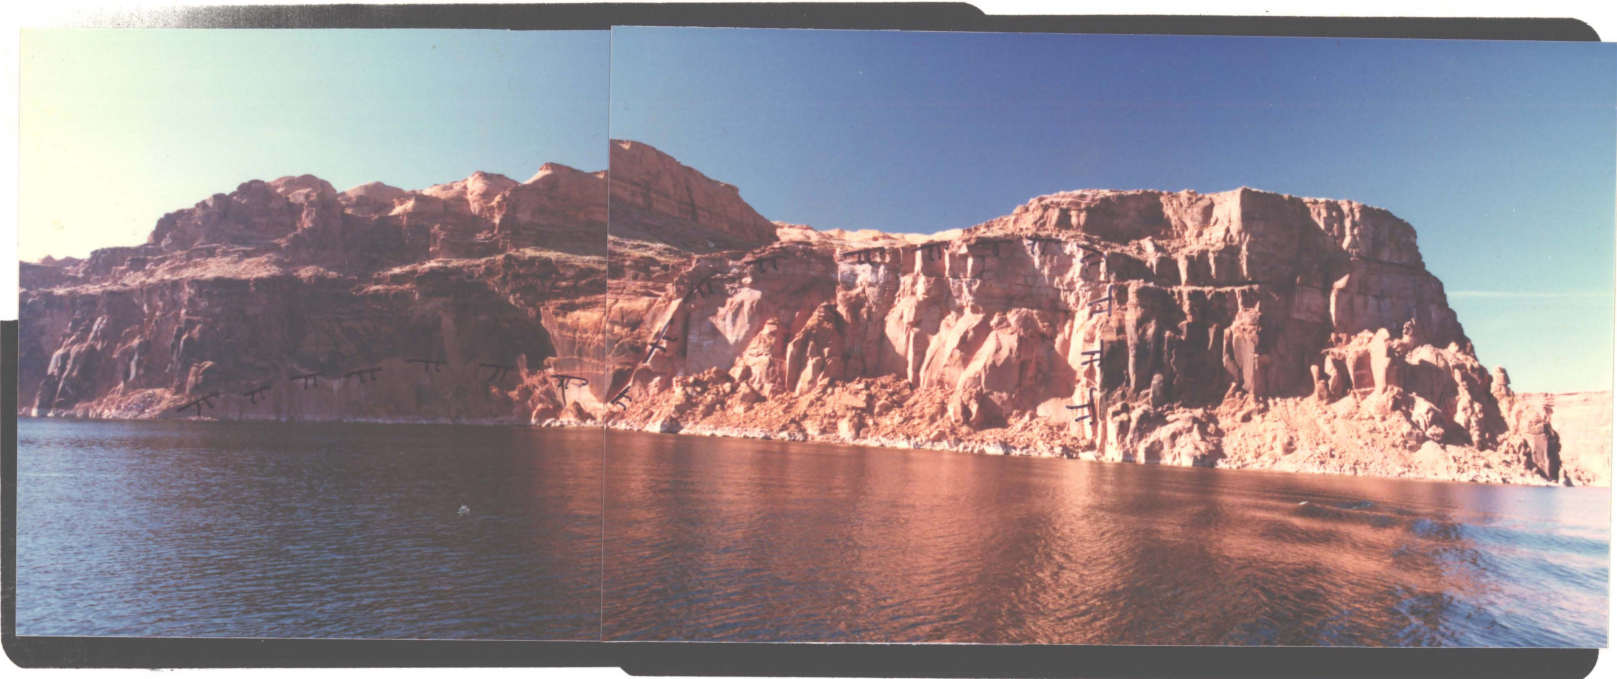
SITE 31: Landslide and rockfall located south of Good Hope Mesa. The Wingate-Chinle contact is just below the water surface. The landsliding involves both the Kayenta and Wingate Formations (rockfall) and talus derived from both. With the exception of active rockfall, failure occurred prior to June, 1980 (note the high water mark).

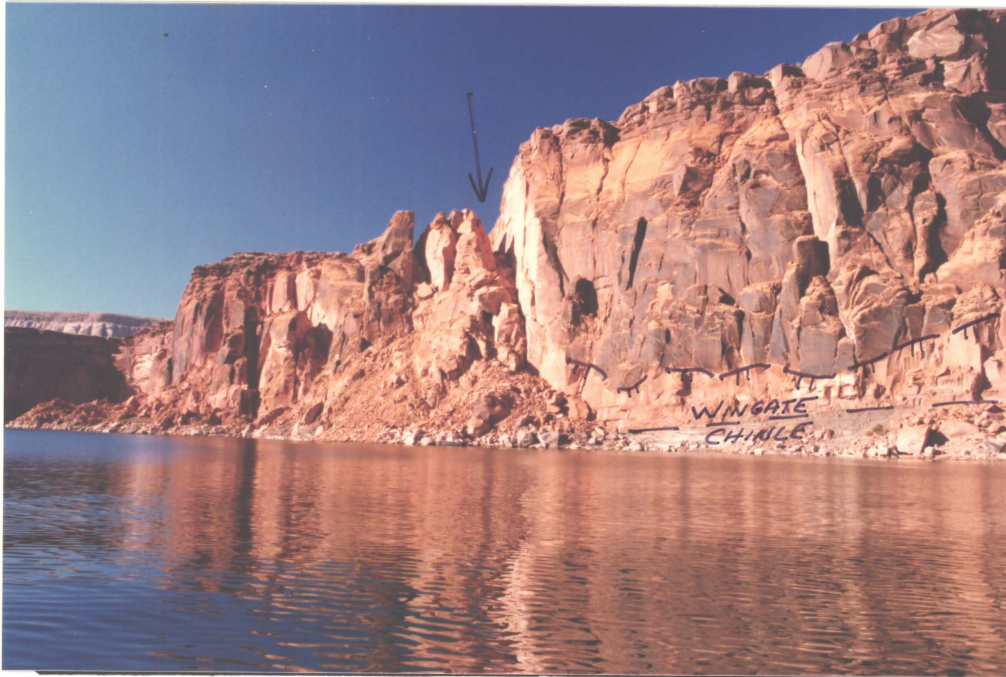
SITE 33: Foundation failure (Chinle Formation) resulting in failure of the point (Wingate Sandstone) below Good Hope Mesa. Movement in the Chinle has resulted in sloughing and sliding of the talus deposits with attendant rockfall. Vertical slide plane is indicated by arrow in both photos.

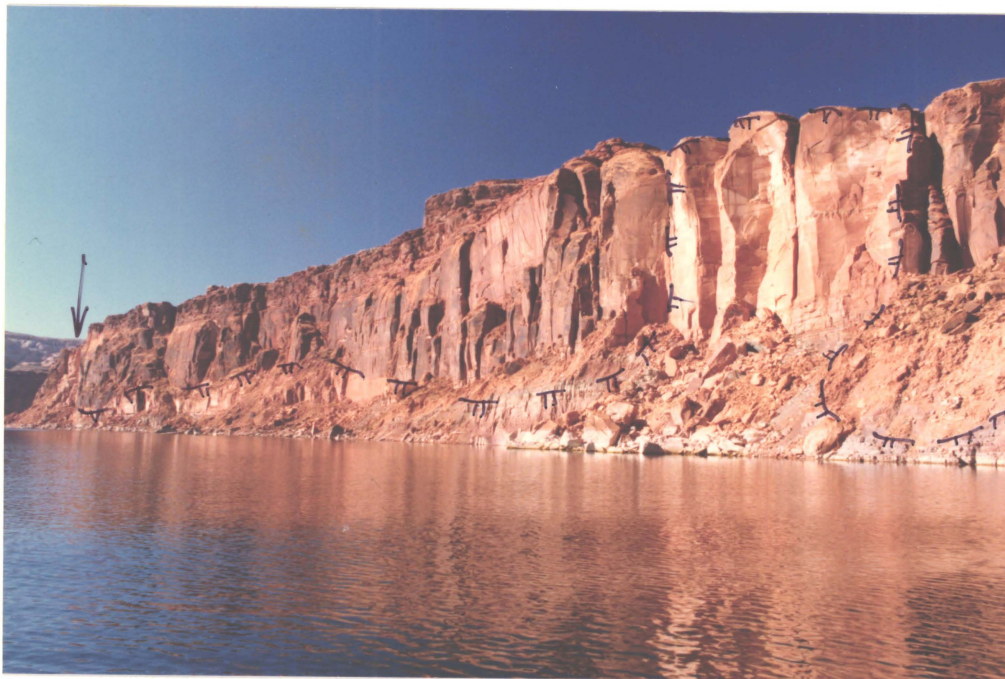
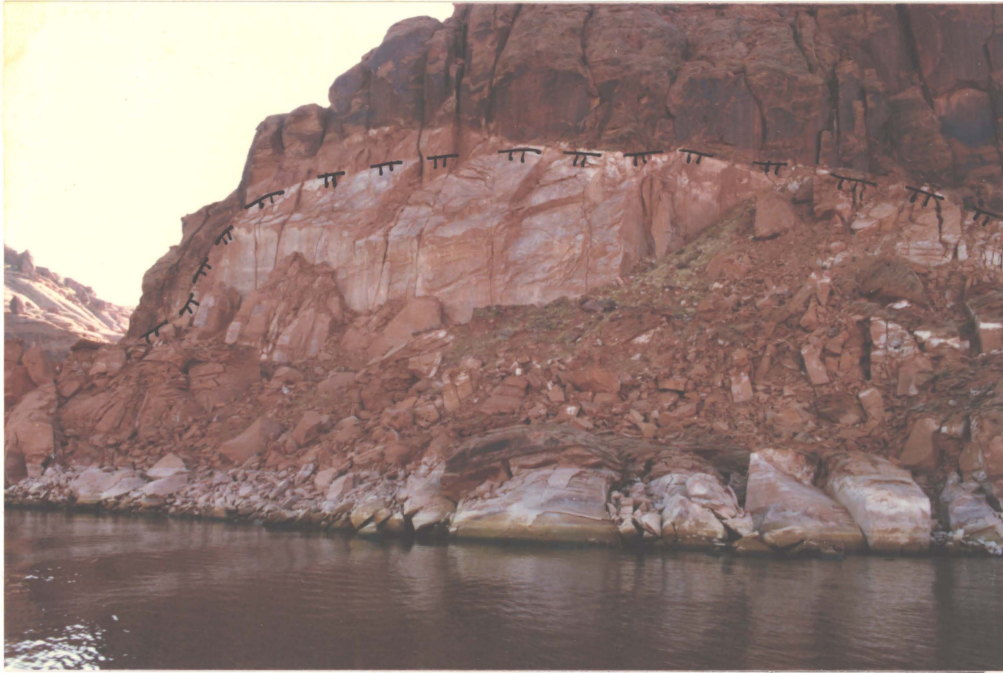
SITE 36

SITE 36: The above point has dropped as a result of foundation failure (Chinle-MoenKopi). The talus slide below has slid down the cliff face approximately 75 feet. The slide probably results from wetting and lubrication of the Chinle shale (now underwater).

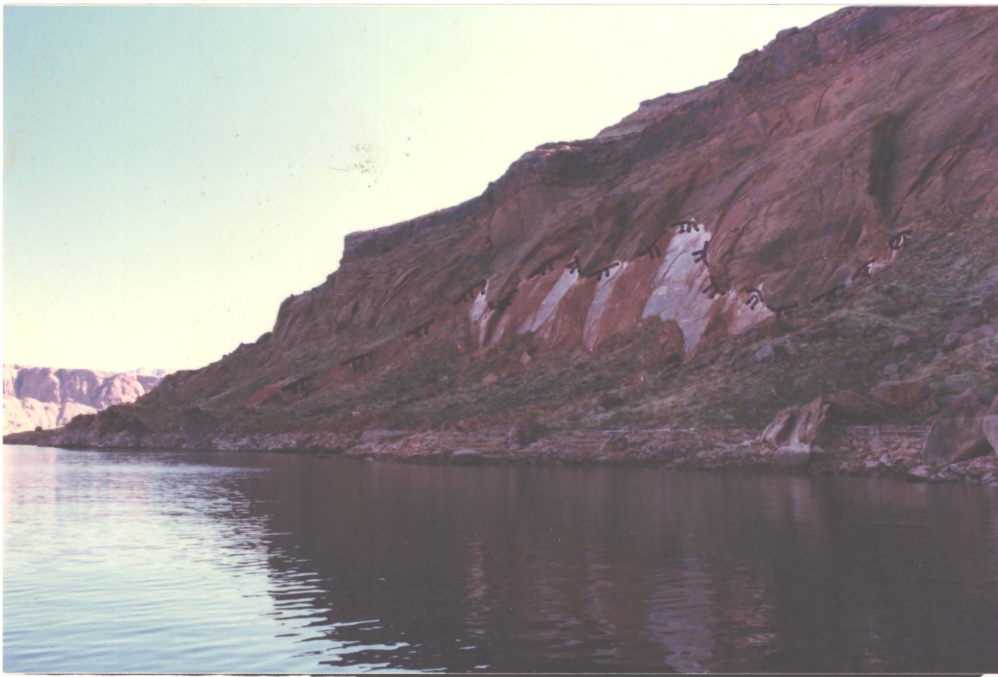
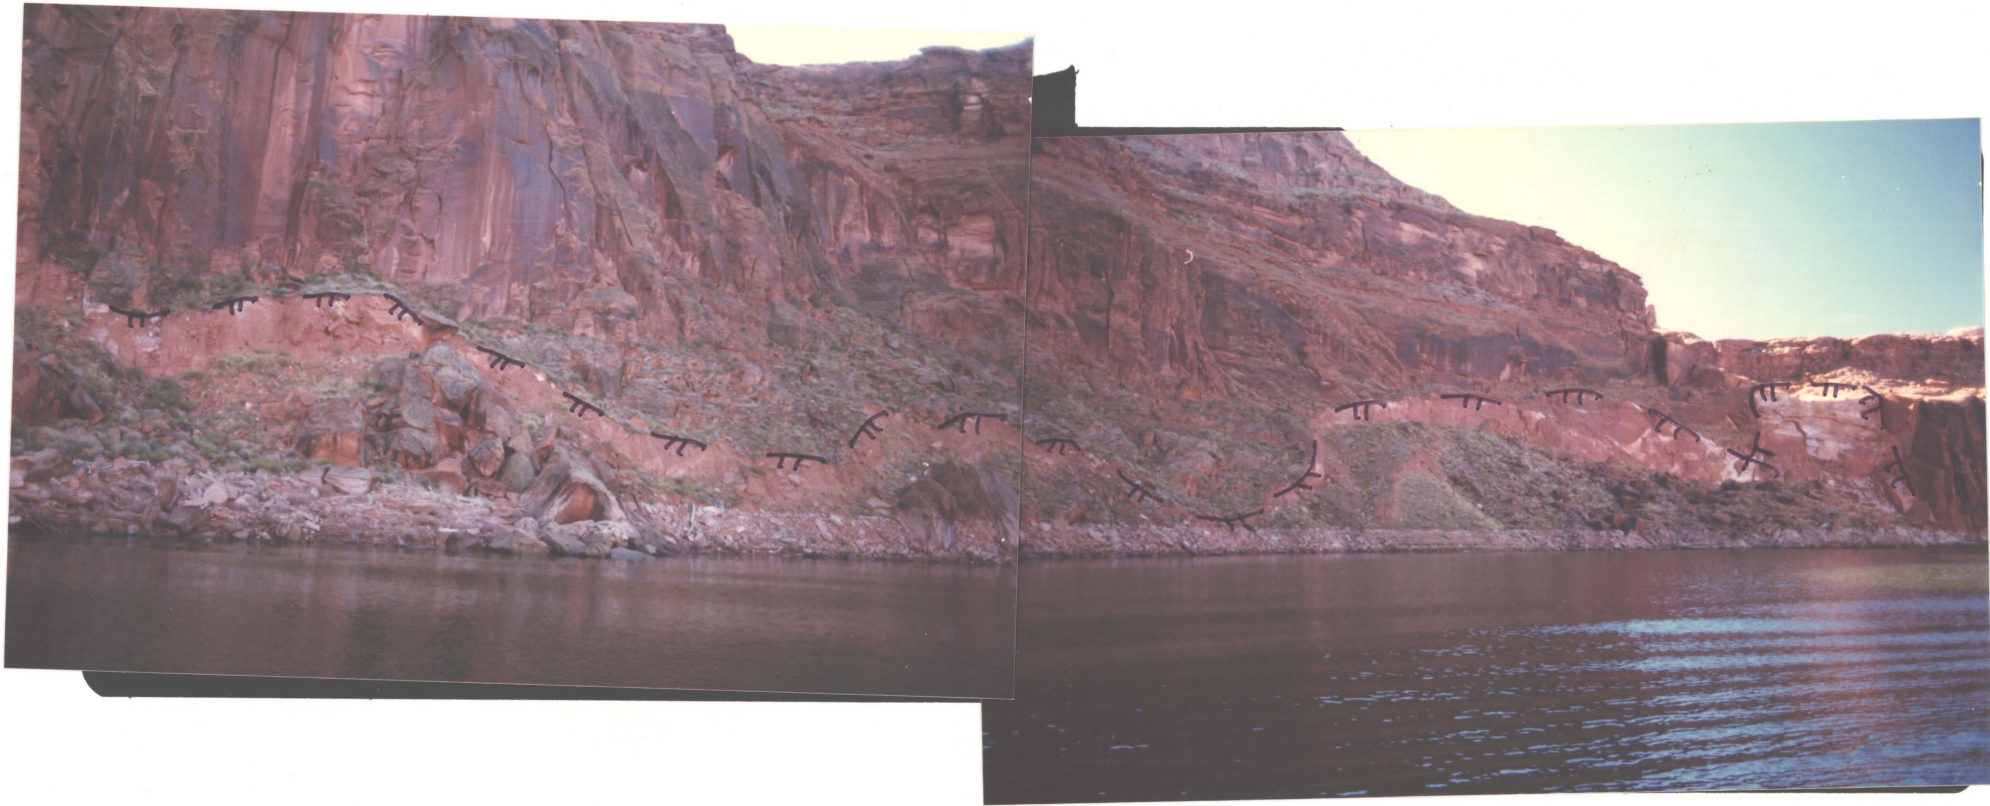
SITE 37

More abundant and usually larger in size were failures involving talus slopes. Extensive failures were found at the mouth of Ticaboo Creek (see Site 37) and Trachyte Creek (see Site 46). Some continuous scarps were identified that exceeded $\frac{1}{2}$ mile in length. The most frequently seen talus slide occurred where debris, derived from the Wingate and Kayenta Formations rested upon the weathered shale slope of the Chinle. When the slopewash and talus deposits become wetted on these steep shale surfaces they become unstable and slide down slope. Erosion by wave action and saturation generally increases this instability and results in sloughing at the toe of the slide.

SITE 37: Extensive talus slides probably resulting from wetting and lubrication of underlying Chinle Formation. Slide is located in Ticaboo Creek and is over $\frac{1}{2}$ mile long.

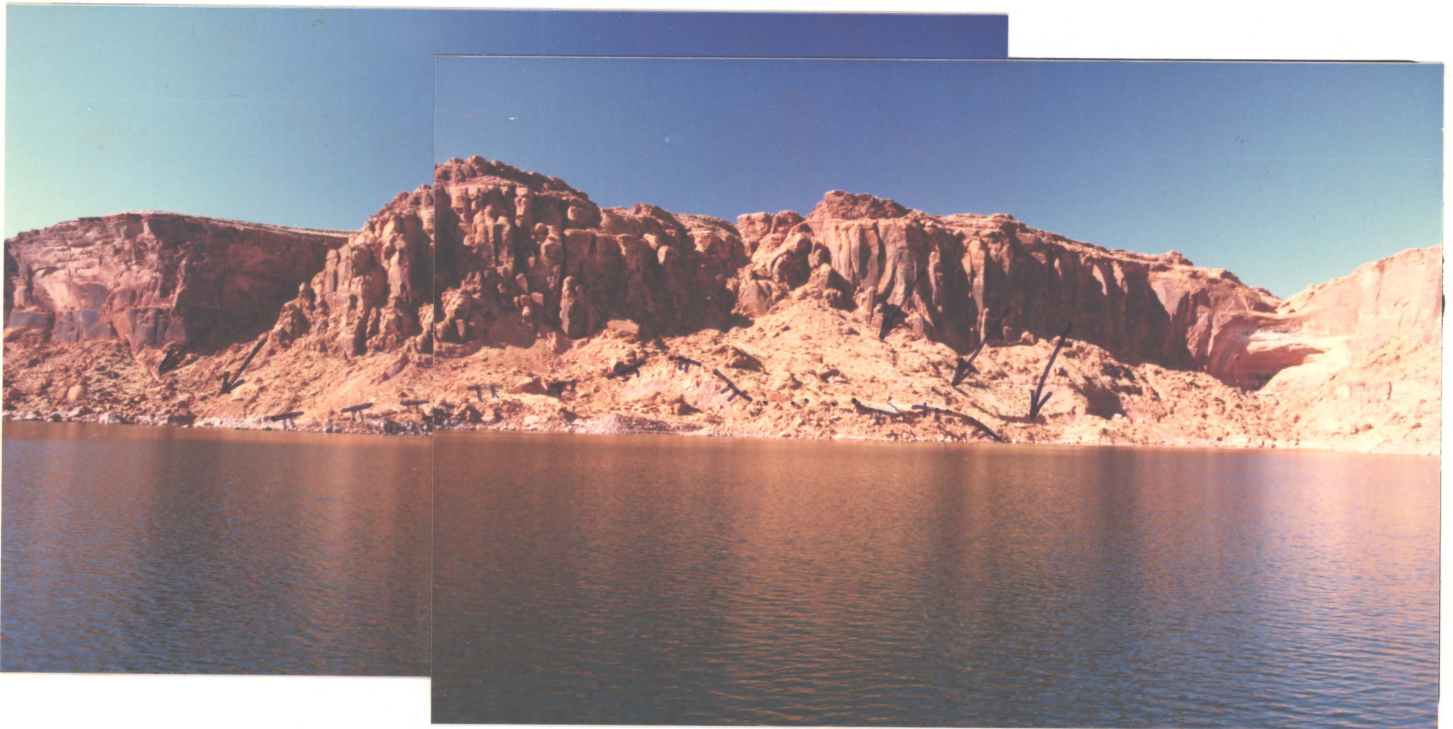
SITE 38: Active sliding occurring on the north side of Ticaboo Creek. Slide involves talus accumulations and some shale beds of the Chinle. Arrows indicate cracks developing in the talus deposits.

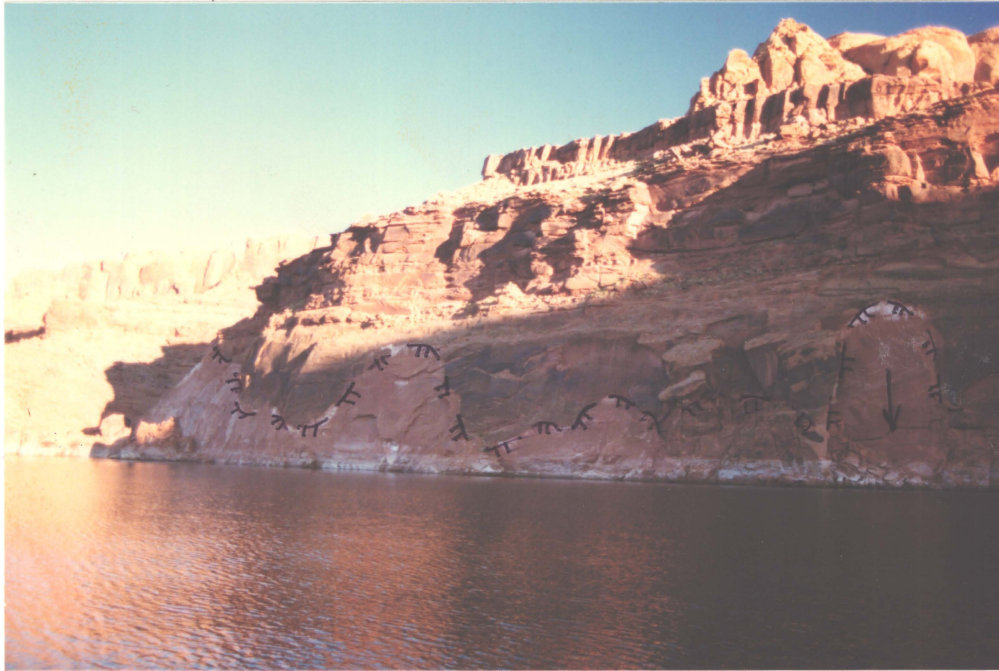
SITE 32: Site of previous talus slides. Although most of the talus deposits are now underwater, slide area is still active as evidenced by large open cracks, slabs and broken rock.

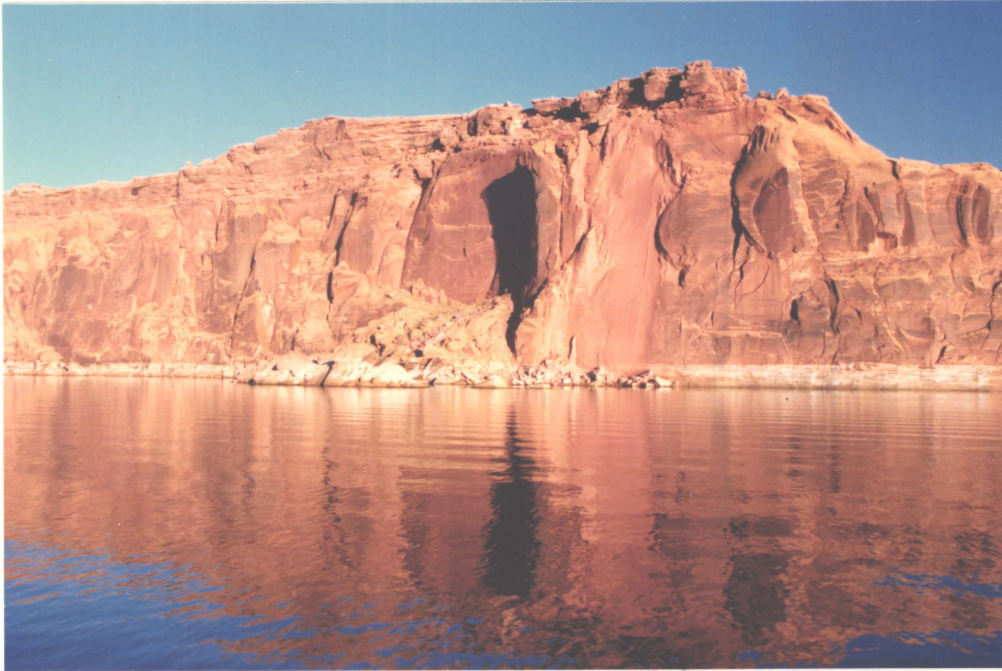
SITE 34: Slab and talus failures located upstream of The Rincon involving the Wingate Sandstone. Observers indicate that failures occurred about 2 years ago. The Chinle Formation is just below waterline. One of the larger rockfalls is indicated by the arrow in the photo below. High water mark is 15 feet above the lake to give an idean of scale.

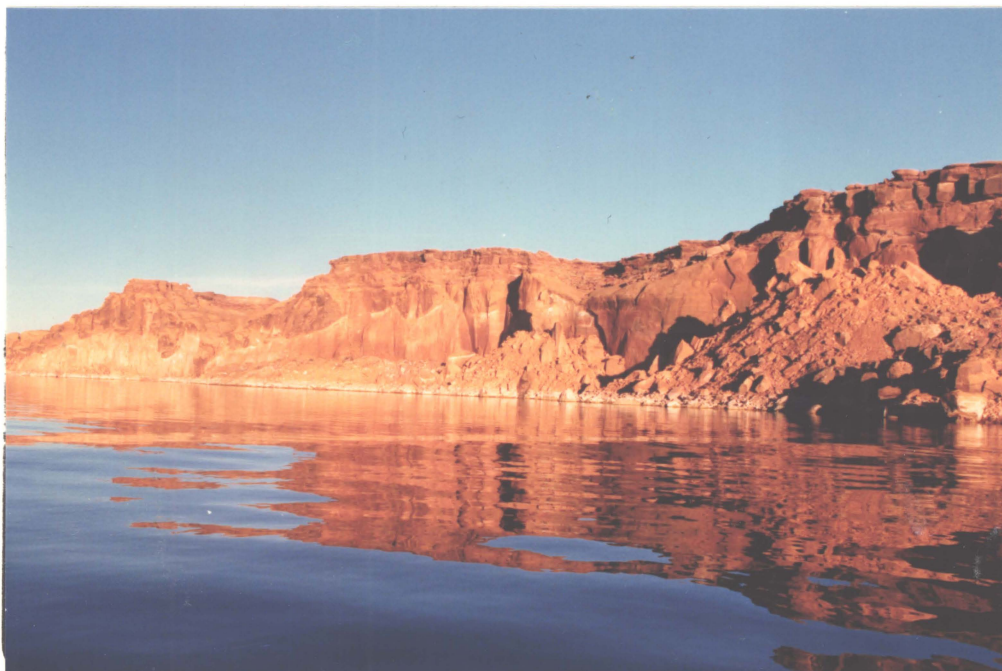
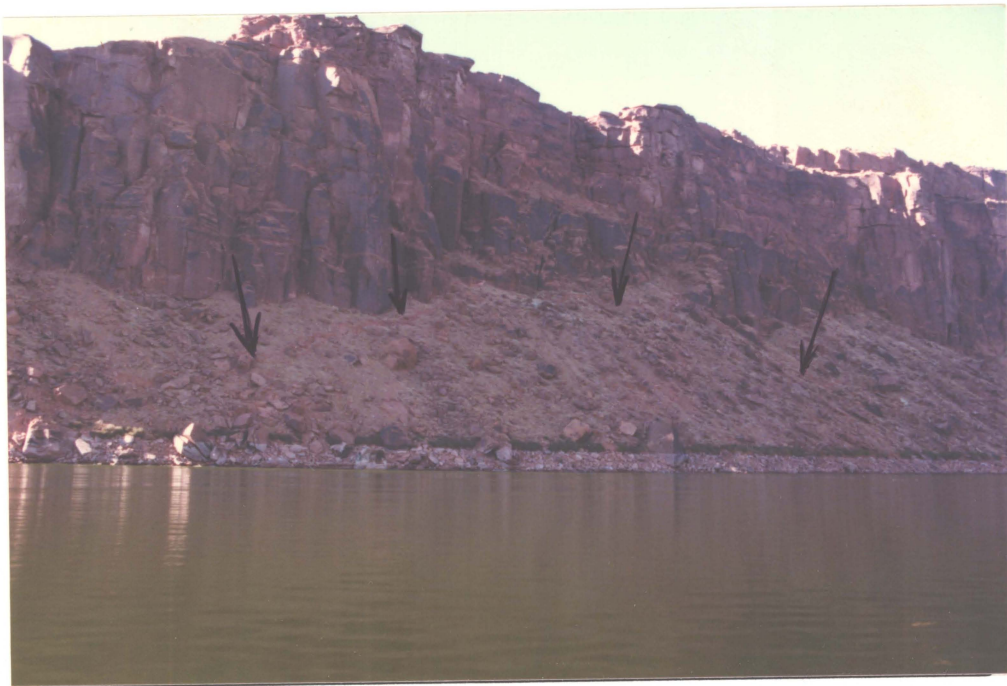
SITE 35

SITE 35: Faint but continuous crack developing in talus deposits below Wingate Sandstone cliffs. Developing landslide scarp is indicated by the arrows.

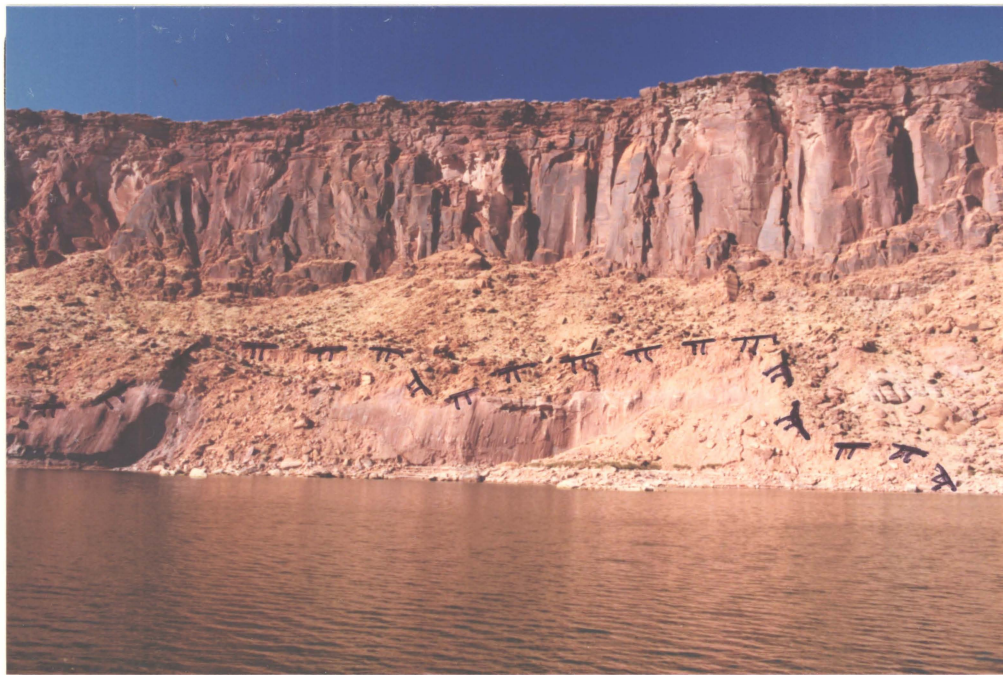
SITE 39: Landslide in the Chinle Formation and overlying talus accumulations. Slide is approximately 90 feet high and 500 feet long and is located north of Ticaboo Creek.

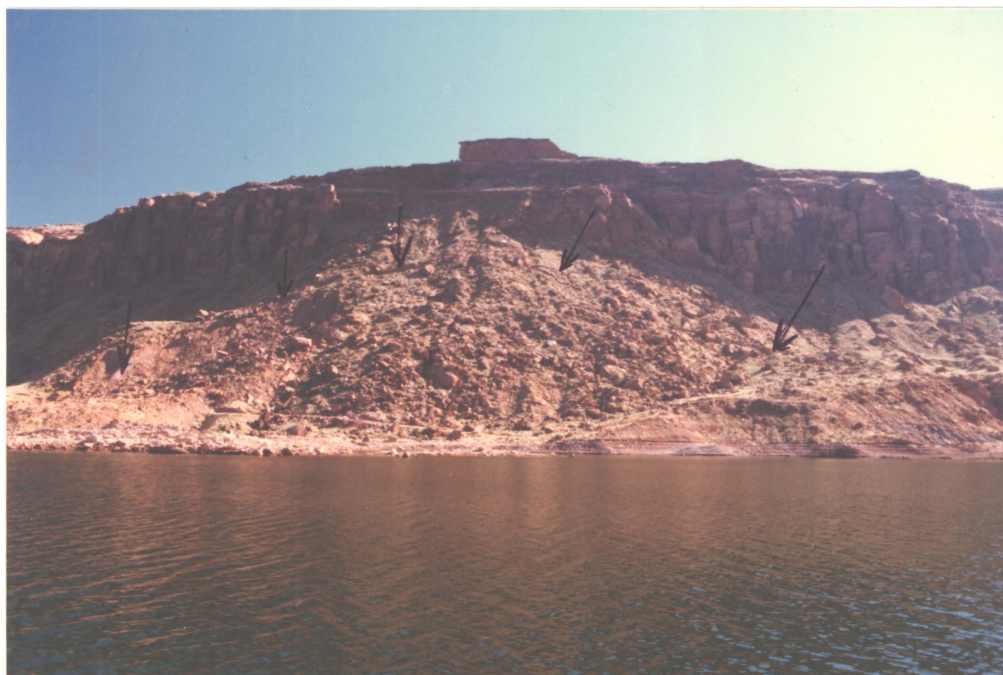
SITE 41: Faint but continuous crack developing in talus deposits south of Ticaboo No. 1 rapids.

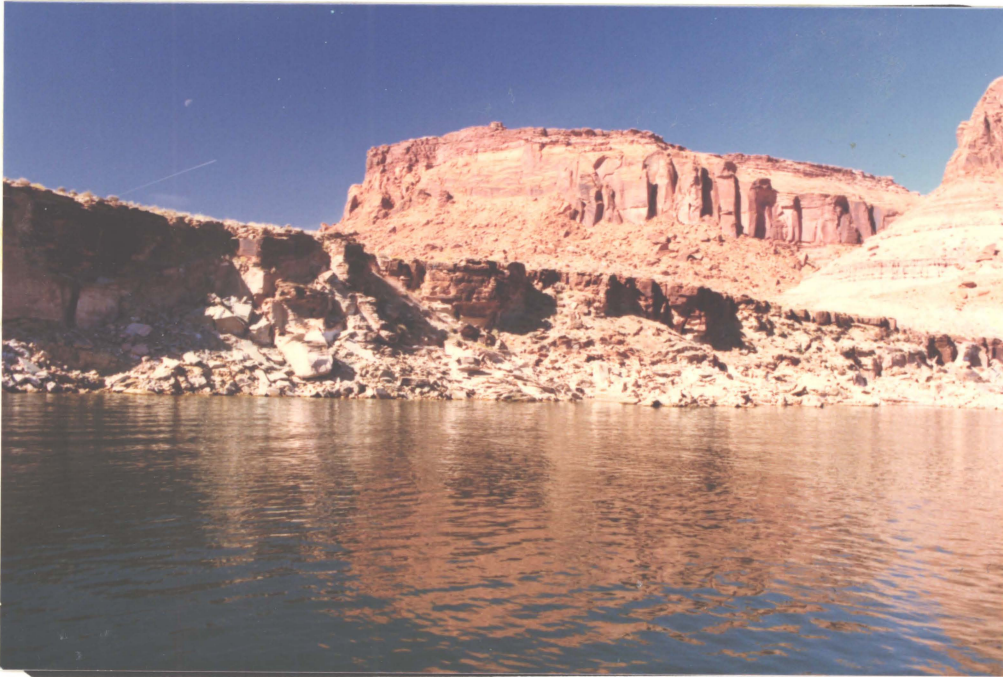
Examples of extensive rockfall involving the Wingate and Chinle Formation can be seen in the photographs taken in Two Mile Canyon (see Sites 44 and 45). Most rockfalls involving these formations occurred where the soft Chinle Formation was found at or just below the water surface. Wave action erodes the soft shale removing the support of the overlying sandstone beds. In some cases, inundation saturates, lubricates, and softens the shale resulting in foundation movement with attendant failure of the sandstone beds above.

SITE 44: Extensive shoreline failure of sandstone beds in the ~~Chinle~~^{Shinarump} Formation. Site is located on south shore of Two-mile Canyon.

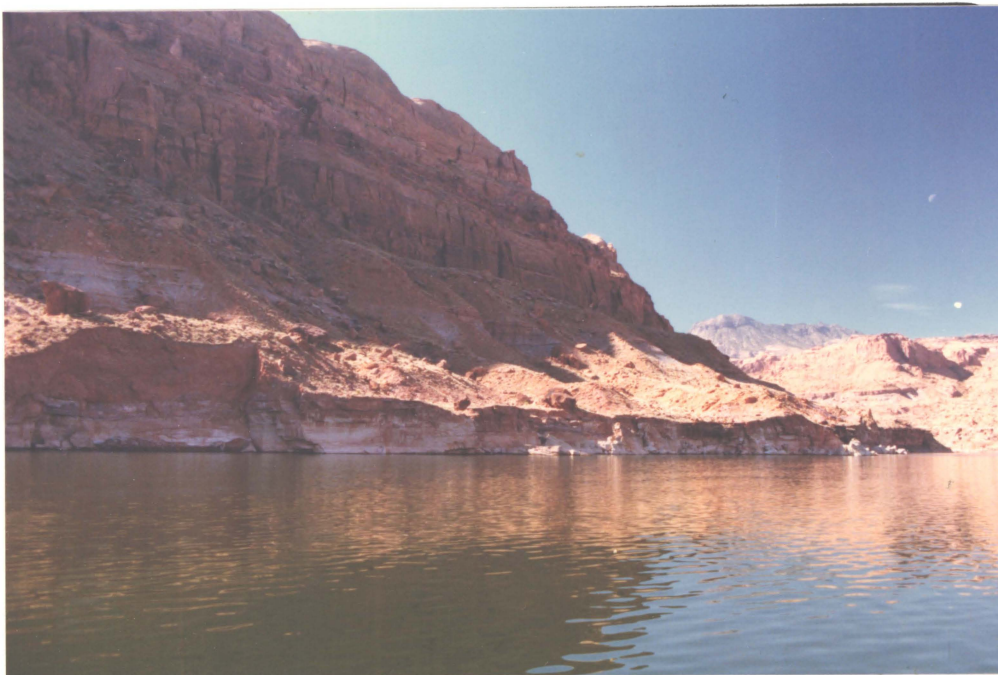
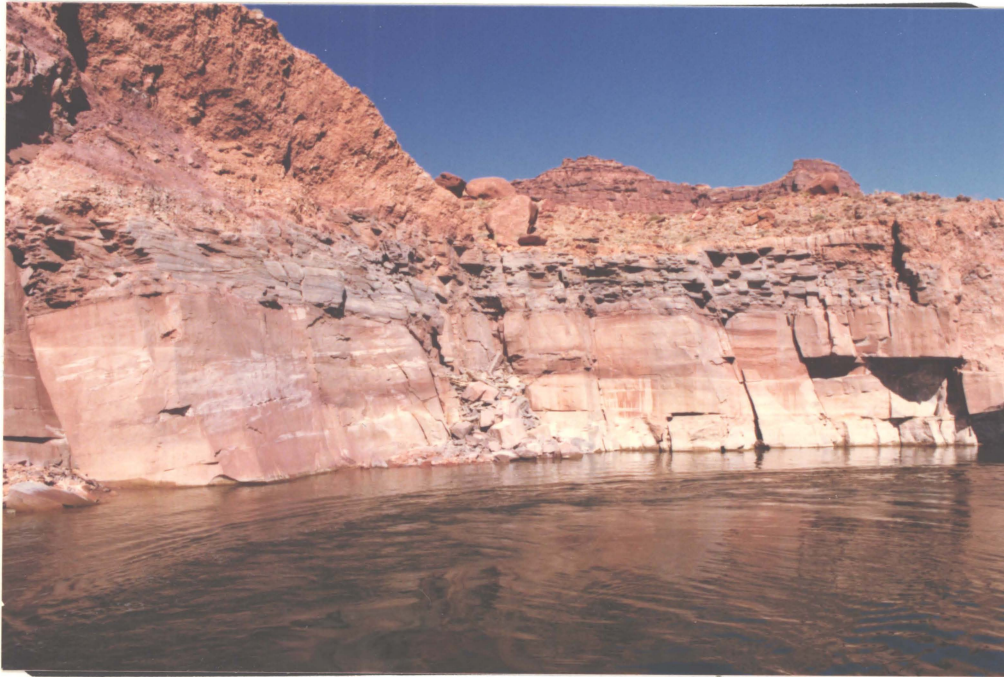
SITE 45

SITE 45: Extensive shoreline failure of sandstone units in the ^{Shinarump} Chinle Formation and overlying talus accumulations. Risk to boaters is high as rockfall continues and vertical slopes in the talus are created. Area is located about 1 mile north of Two-mile Canyon.

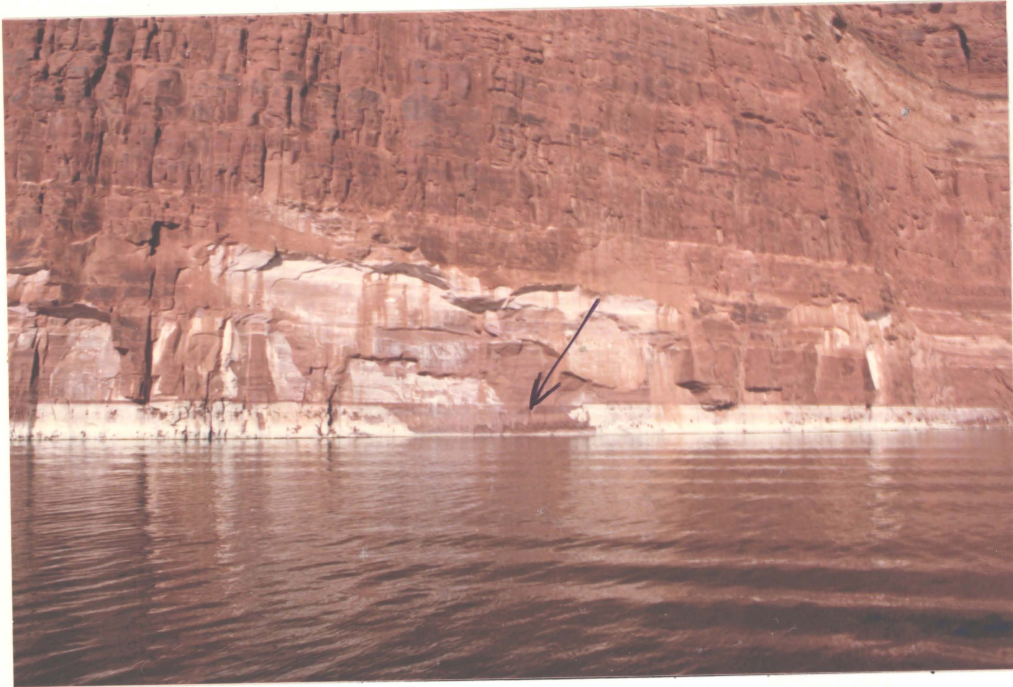
SITE 50: Recent rockfall has taken out the high water mark (indicated by the arrows in these two photos). Sandstone is the Organ Rock Tongue Member of the Cutler Formation. Photos were taken across the reservoir from Hite Marina.
