# **Utah Geological Survey Geologic Field Investigation Following the February 21, 2008 Wells, Nevada, Magnitude 6.0 Earthquake**

Christopher DuRoss, Greg McDonald, and Steve Bowman  
Utah Geological Survey  
February 26, 2008

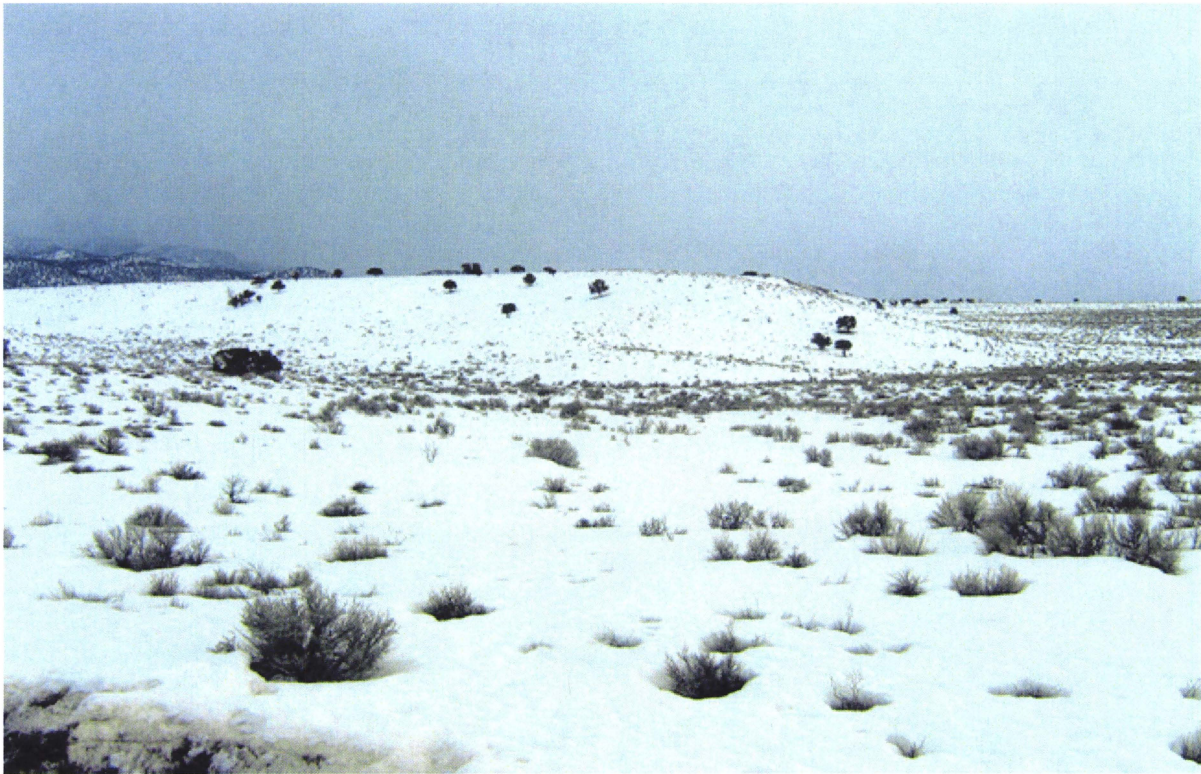
In Independence Valley, we continued south for about 6.5 km on dirt roads to Quaternary scarps associated with the southern section of the Independence Valley fault zone. This trace is mapped about 3 km west of the northern section. At this site, we parked at an active drilling pad and walked west along a dirt road that crosses the mapped fault trace. We observed (snow-covered) scarps north and south of the road (photo 1), but did not find any evidence for surface faulting, ground movement, or road damage. We also used binoculars to scan hillslopes along the western margin of the valley, but did not observe any evidence for rock falls or landslides.

*Photo 1. Fault scarps along the Independence Valley fault zone, southern section.*

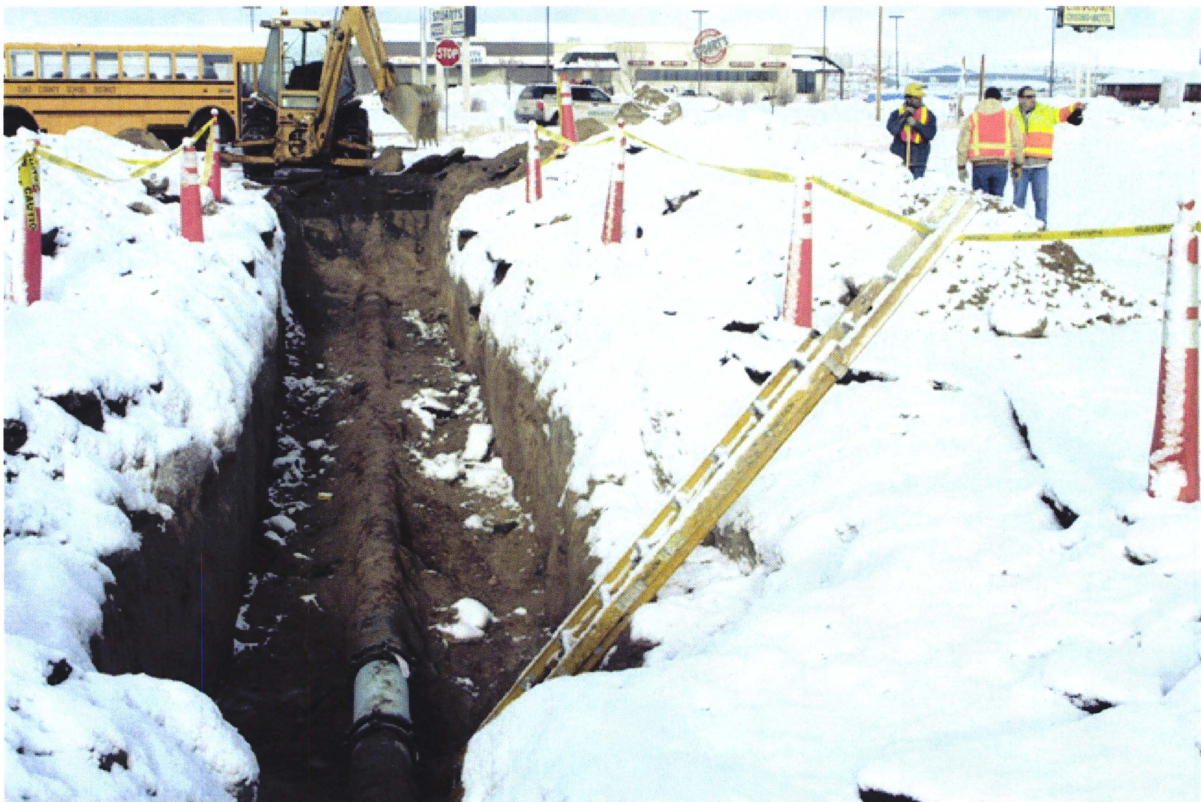
Friday morning (February 22) we observed a water main damaged during the Wells earthquake (photos 2 and 3). The main is located in the southwest part of town (Easy Street). The exposed, approximately 8-inch-diameter pipe showed no horizontal or vertical offset. Sediments exposed in the trench wall showed no signs of liquefaction or displacement; however, we did not enter the excavation and the walls had not been cleaned. Although recent snowfall hampered our efforts, we walked the surrounding area to look for ground cracks and liquefaction features, and found neither.

*Photo 2. Water main break in Wells.*

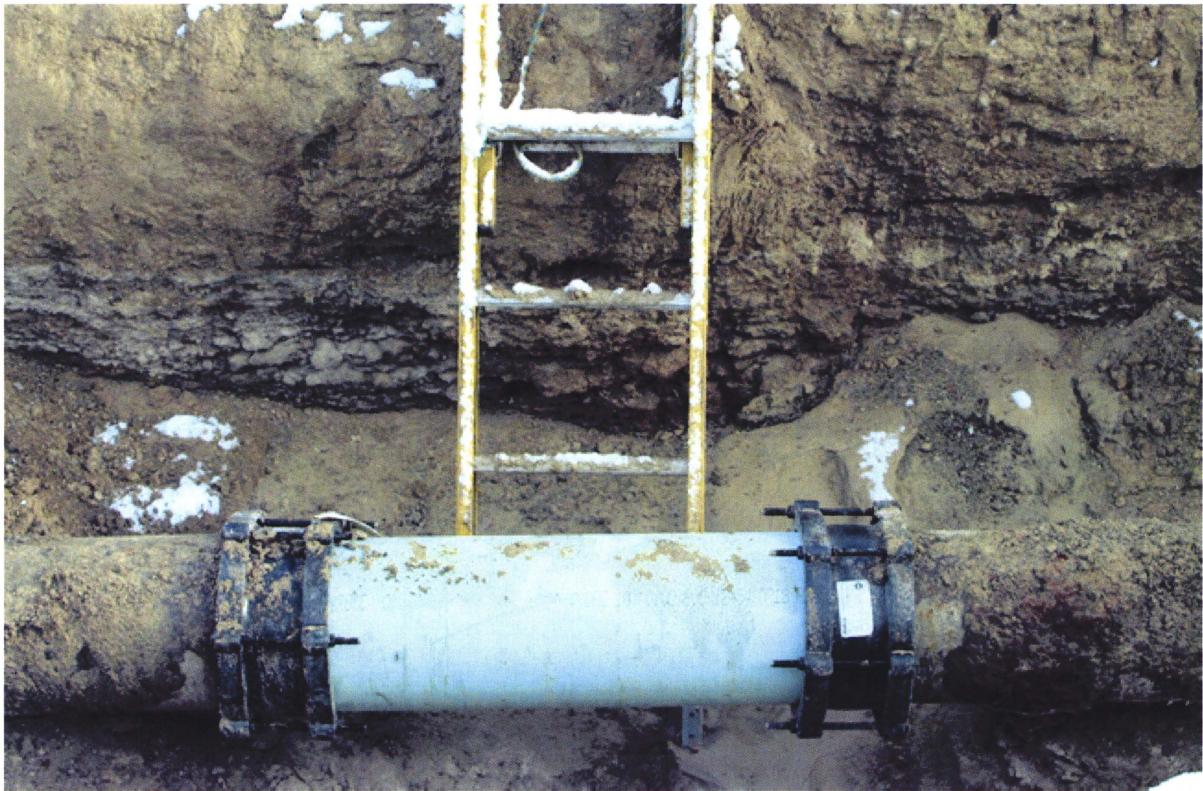
*Photo 3. Water main break in Wells.*

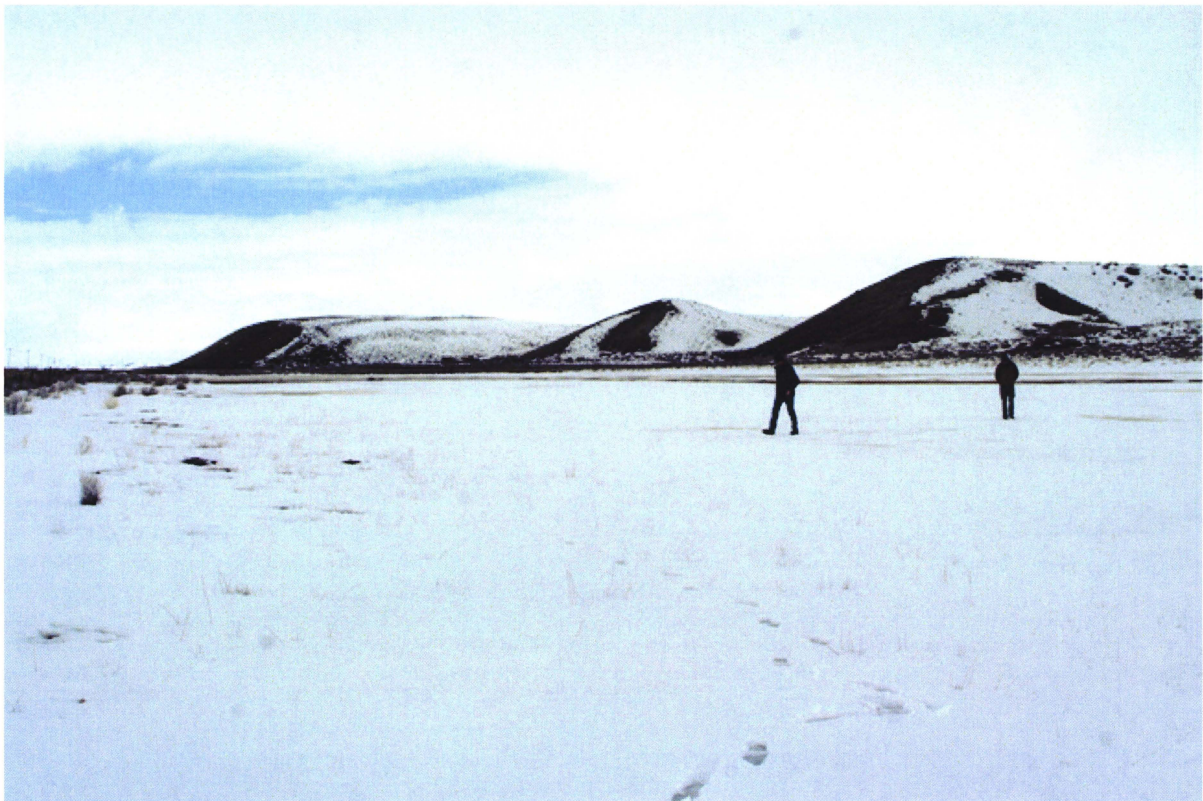
From the intersection of Wells Avenue and 9<sup>th</sup> Street, we traveled about 1.5 km north to the Humboldt River (Stop 10a). We investigated the wide flood plain southeast of the main channel of the river (now mostly dry, photo 4) and searched, but did not find evidence for liquefaction (e.g., sand blows or ground cracks). We also looked for liquefaction features about 1.3 km northwest of the intersection of Wells Avenue and 8<sup>th</sup> Street (Stop 10b). In this area, surface water is flowing west, and the banks and marsh areas are mostly covered by ice. We did not observe any evidence for liquefaction or lateral spreading along stream banks. We did not investigate the Humboldt River or Town Creek northeast of Wells due to impassable roads.

*Photo 4. Humboldt River flood plain.*

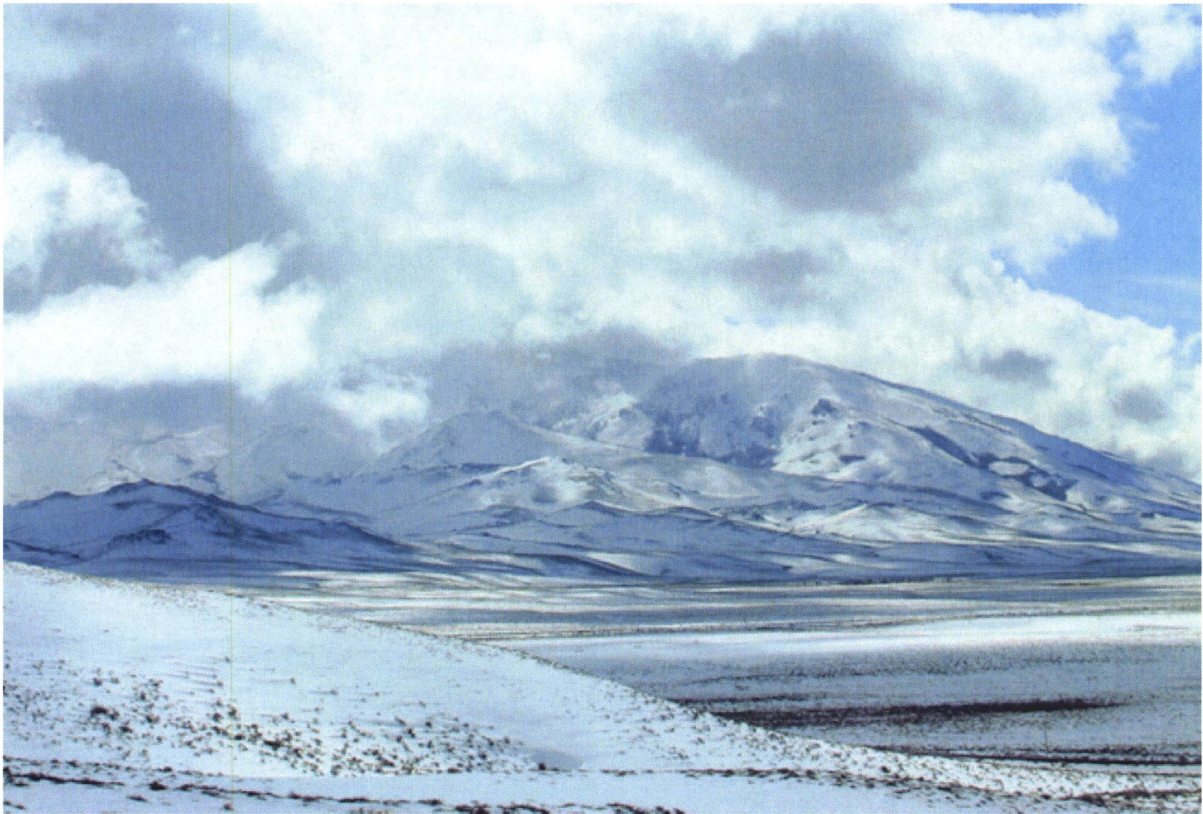
From the last stop, we continued west to the intersection of 8<sup>th</sup> Street and Highway 754 (Stop 11a), looking for surface faulting or ground cracks associated with the Northern Snake Mountains fault (photos 5 and 6). We traveled about 1.5 km north on Highway 754 and walked a dirt road that crosses the main trace of the fault (Stop 11b). Deep snow drifts impeded travel, and we did not observe any ground deformation or road damage.

*Photo 5. Fault scarps along the Northern Snake Mountains fault (Ruby Range in background).*

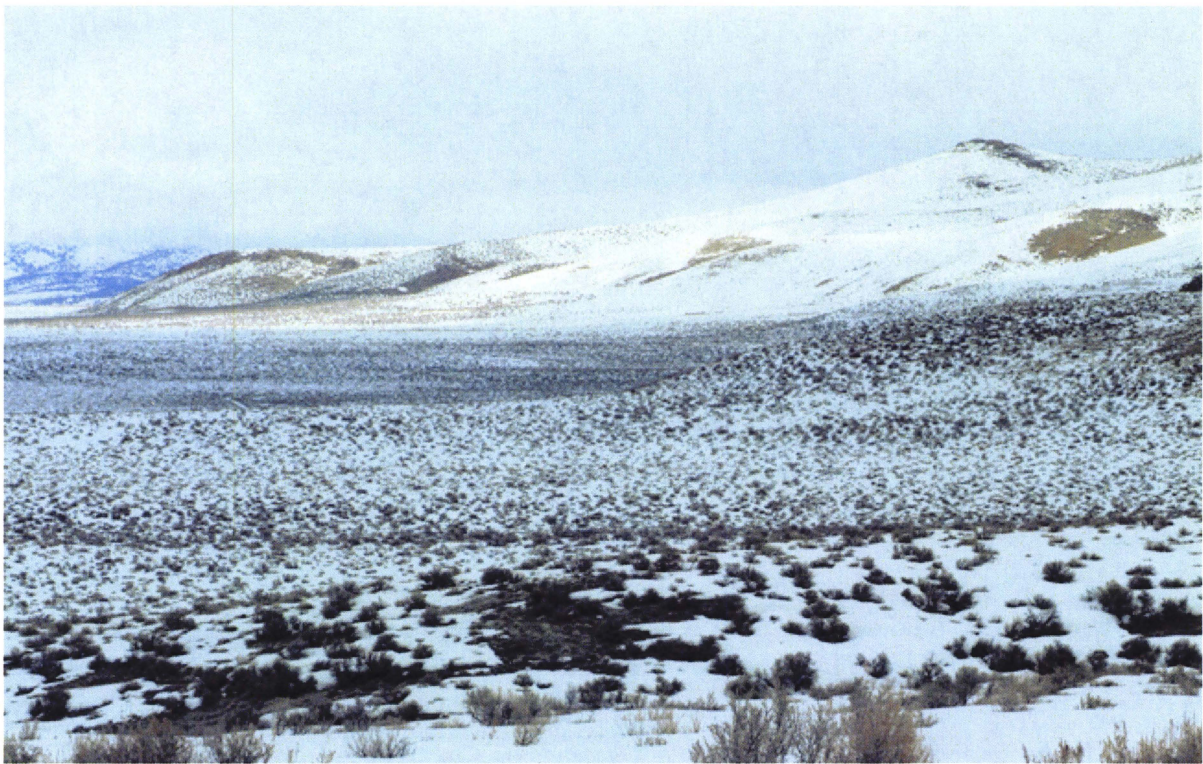
*Photo 6. Fault scarps along the Northern Snake Mountains fault.*
