## INTERIM GEOTECHNICAL REPORT

● MANTI CANYON NORTH SLIDE  
STABILITY STUDIES

● DEBRIS DAM FOUNDATION  
INVESTIGATIONS

SEPTEMBER 1976

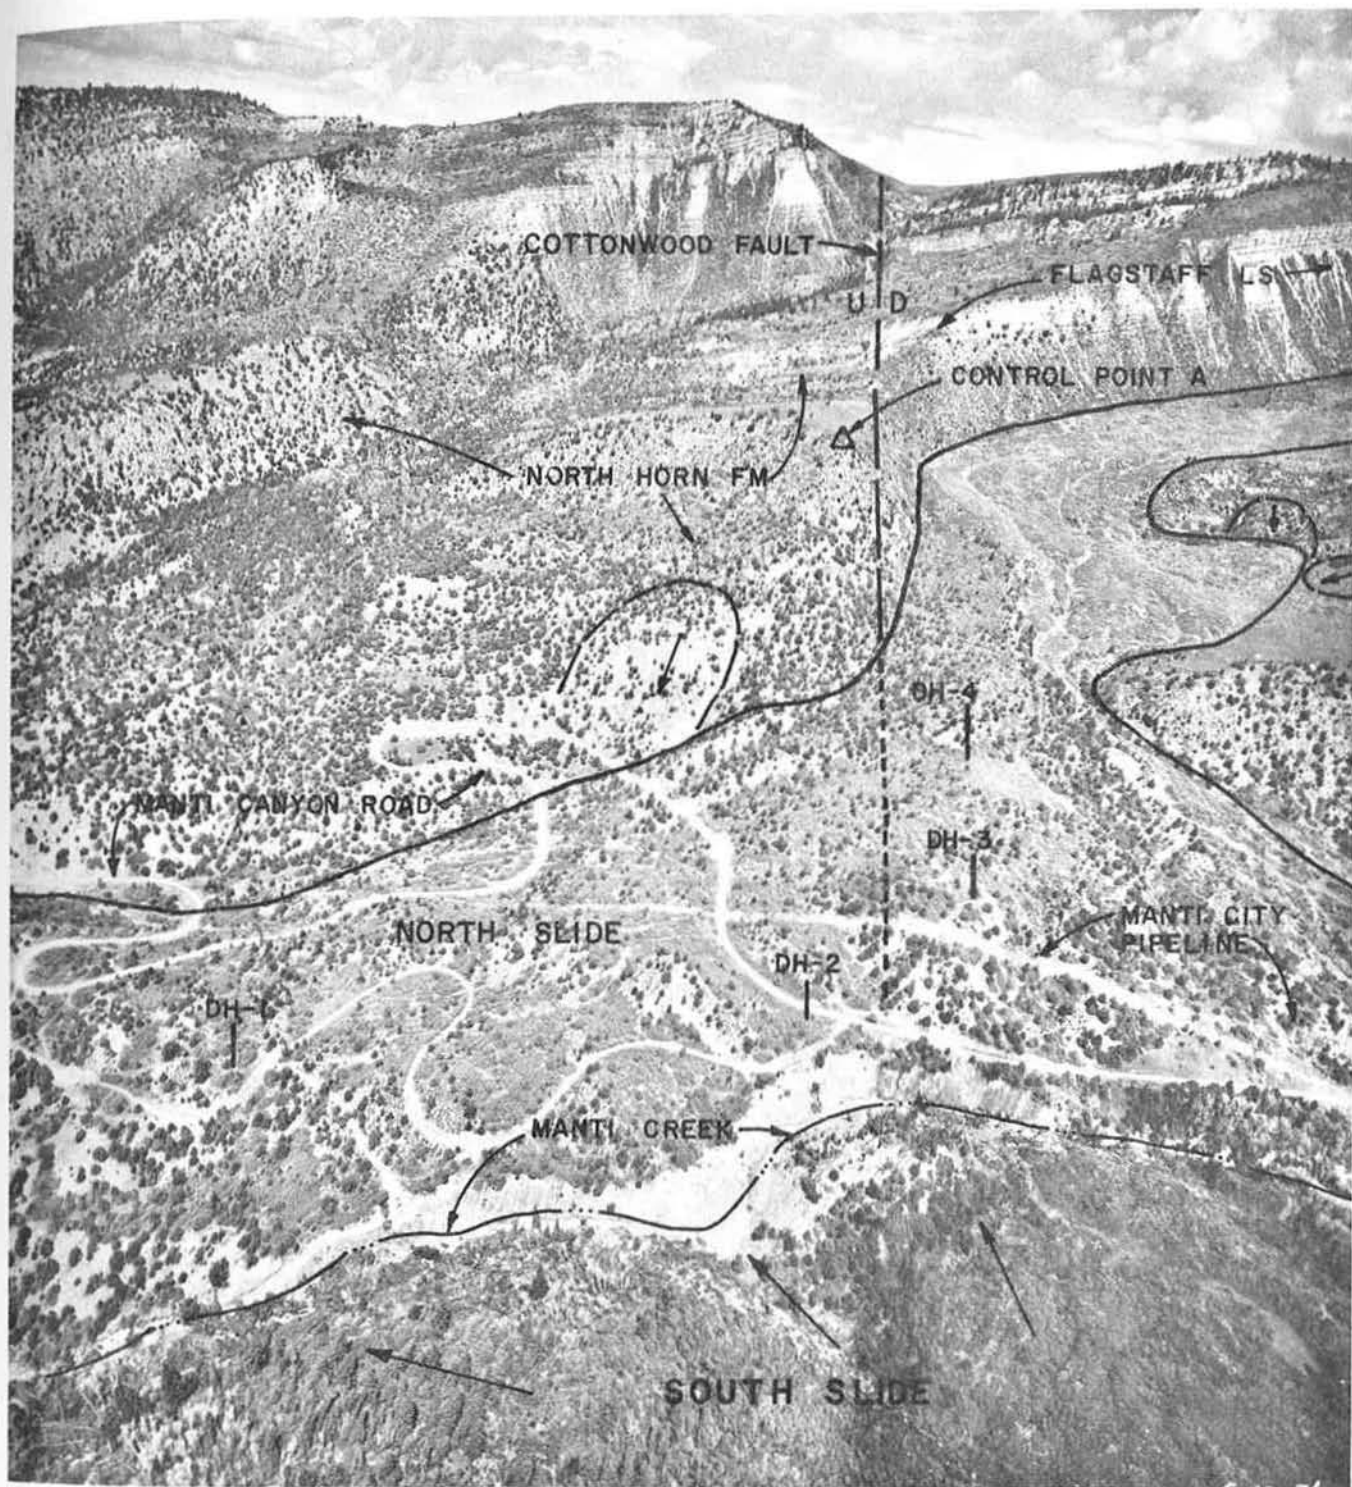
PHOTO 1 - PORTION OF NORTH SLIDE

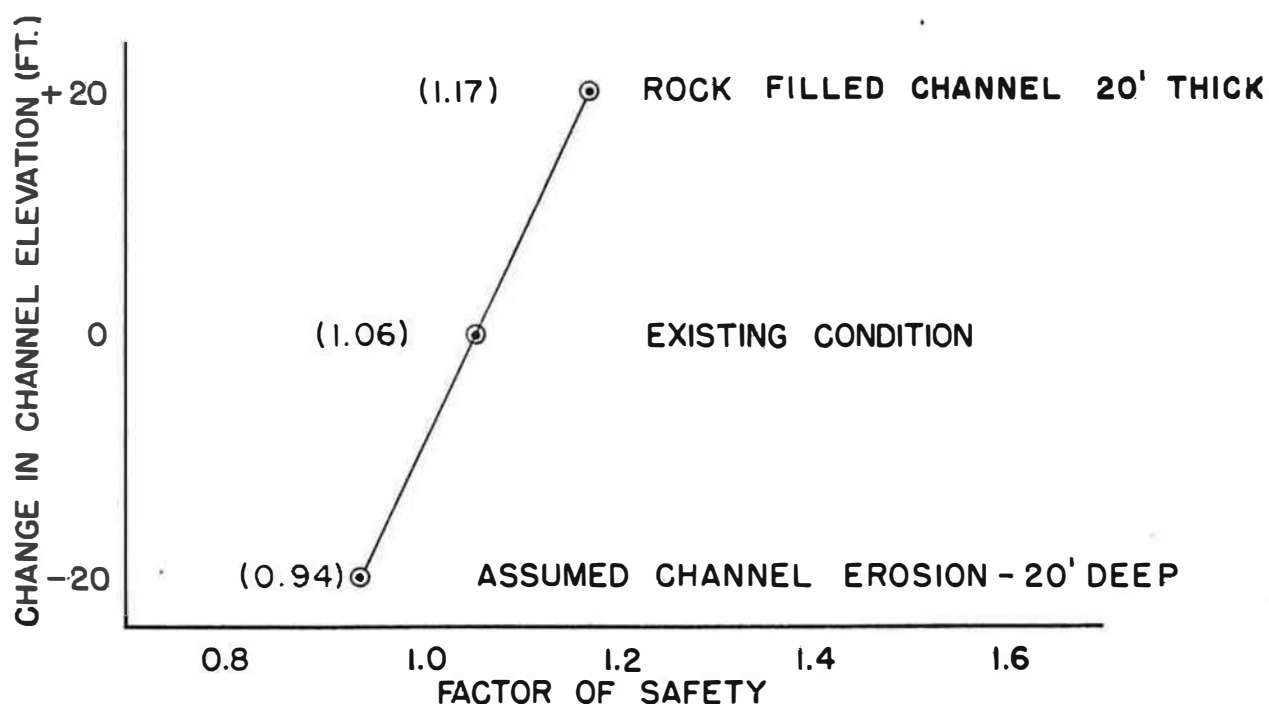
FIGURE 2-4 — FACTOR OF SAFETY OF NORTH SLIDE  
BISHOP STABILITY ANALYSIS — SEC. 2

The critical factors of safety for the three conditions of analyses are shown on Figure 2-4. The computed critical or minimum factor of safety for the existing condition (F.S. of 1.06) is very close to 1.0 and again, as in Section 1, the factor of safety could be slightly below 1.0.

The factor of safety for the eroded channel in Section 2 is 0.94. This value indicates that further erosion of the channel would induce slip circle failure.

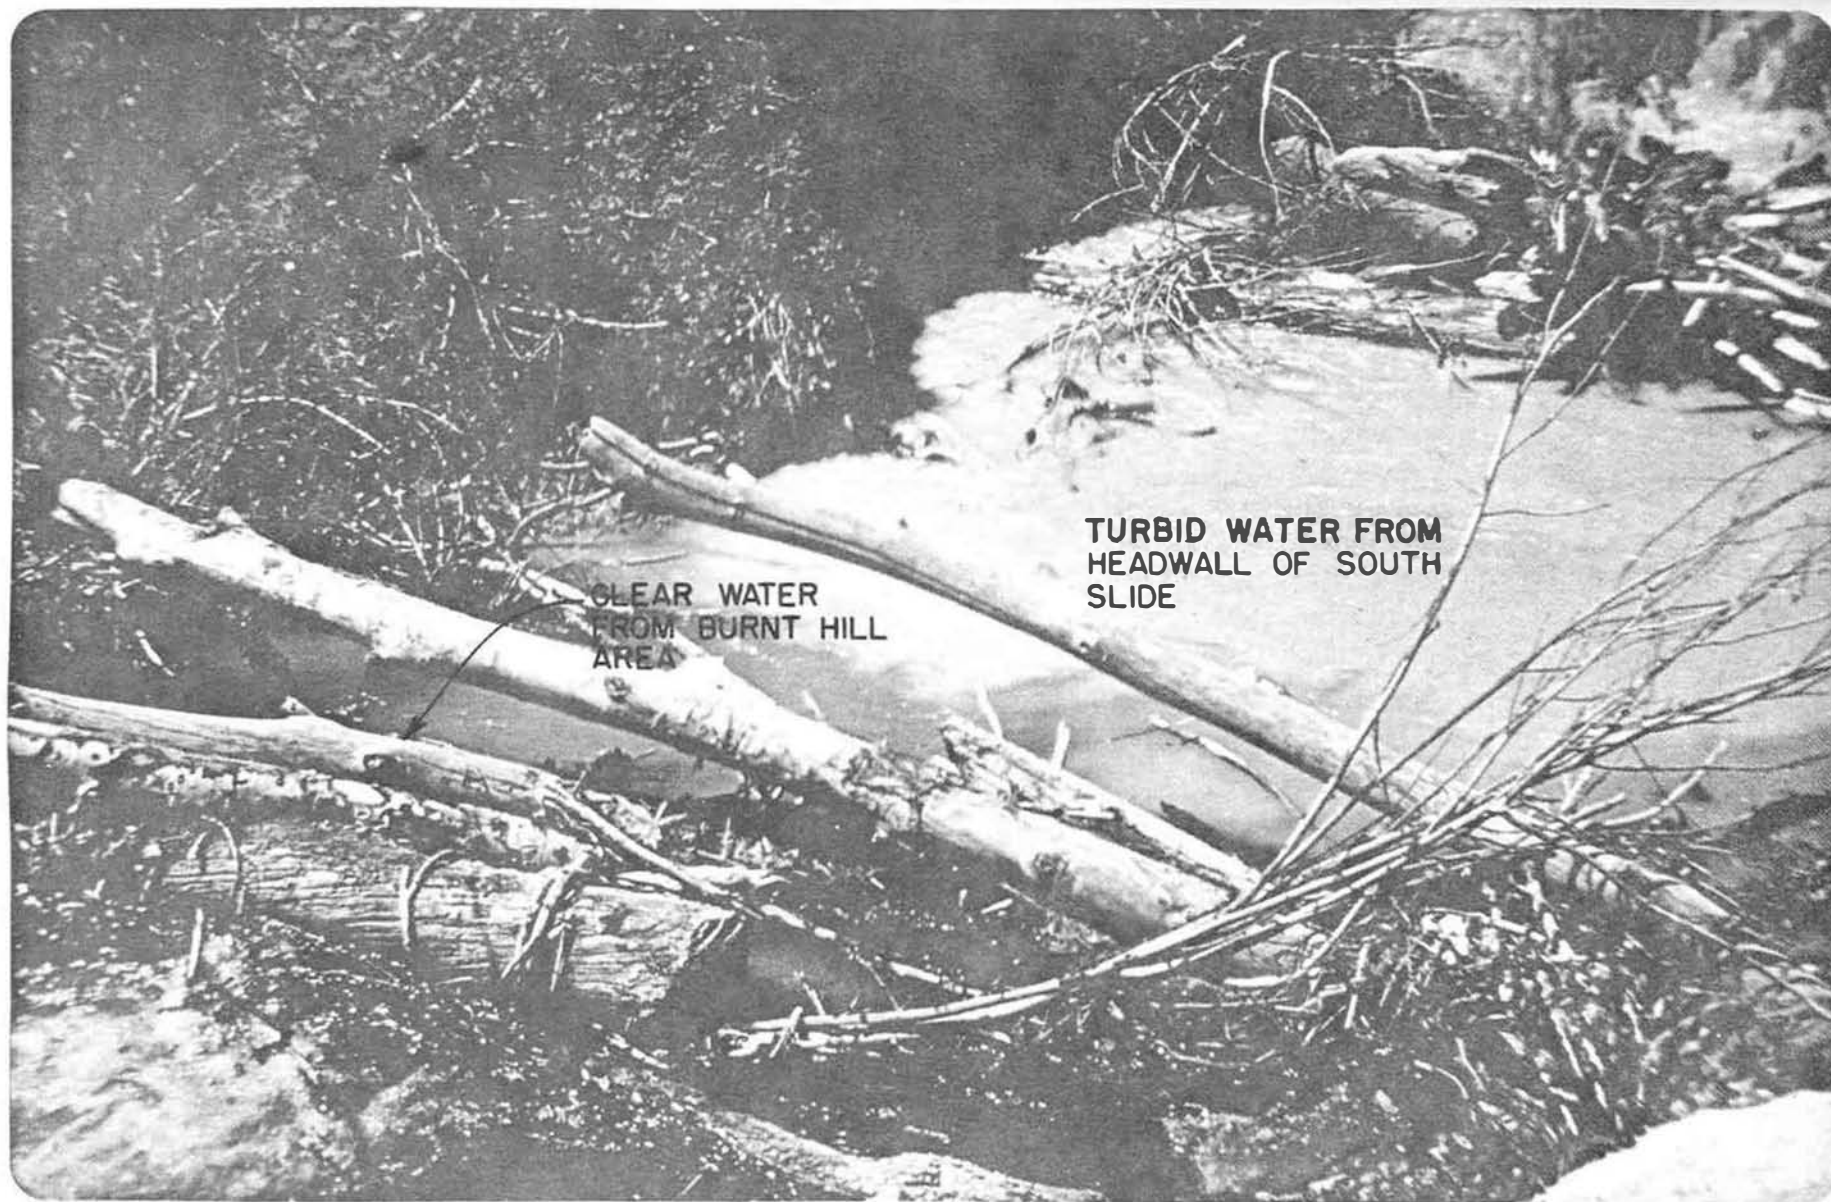
CLEAR WATER  
FROM BURNT HILL  
AREA

TURBID WATER FROM  
HEADWALL OF SOUTH  
SLIDE

PHOTO 3 — MIXING OF CLEAR WATER FROM BURNT HILL FORK AND TURBID WATER FROM THE SOUTH FORK OF COTTONWOOD CREEK

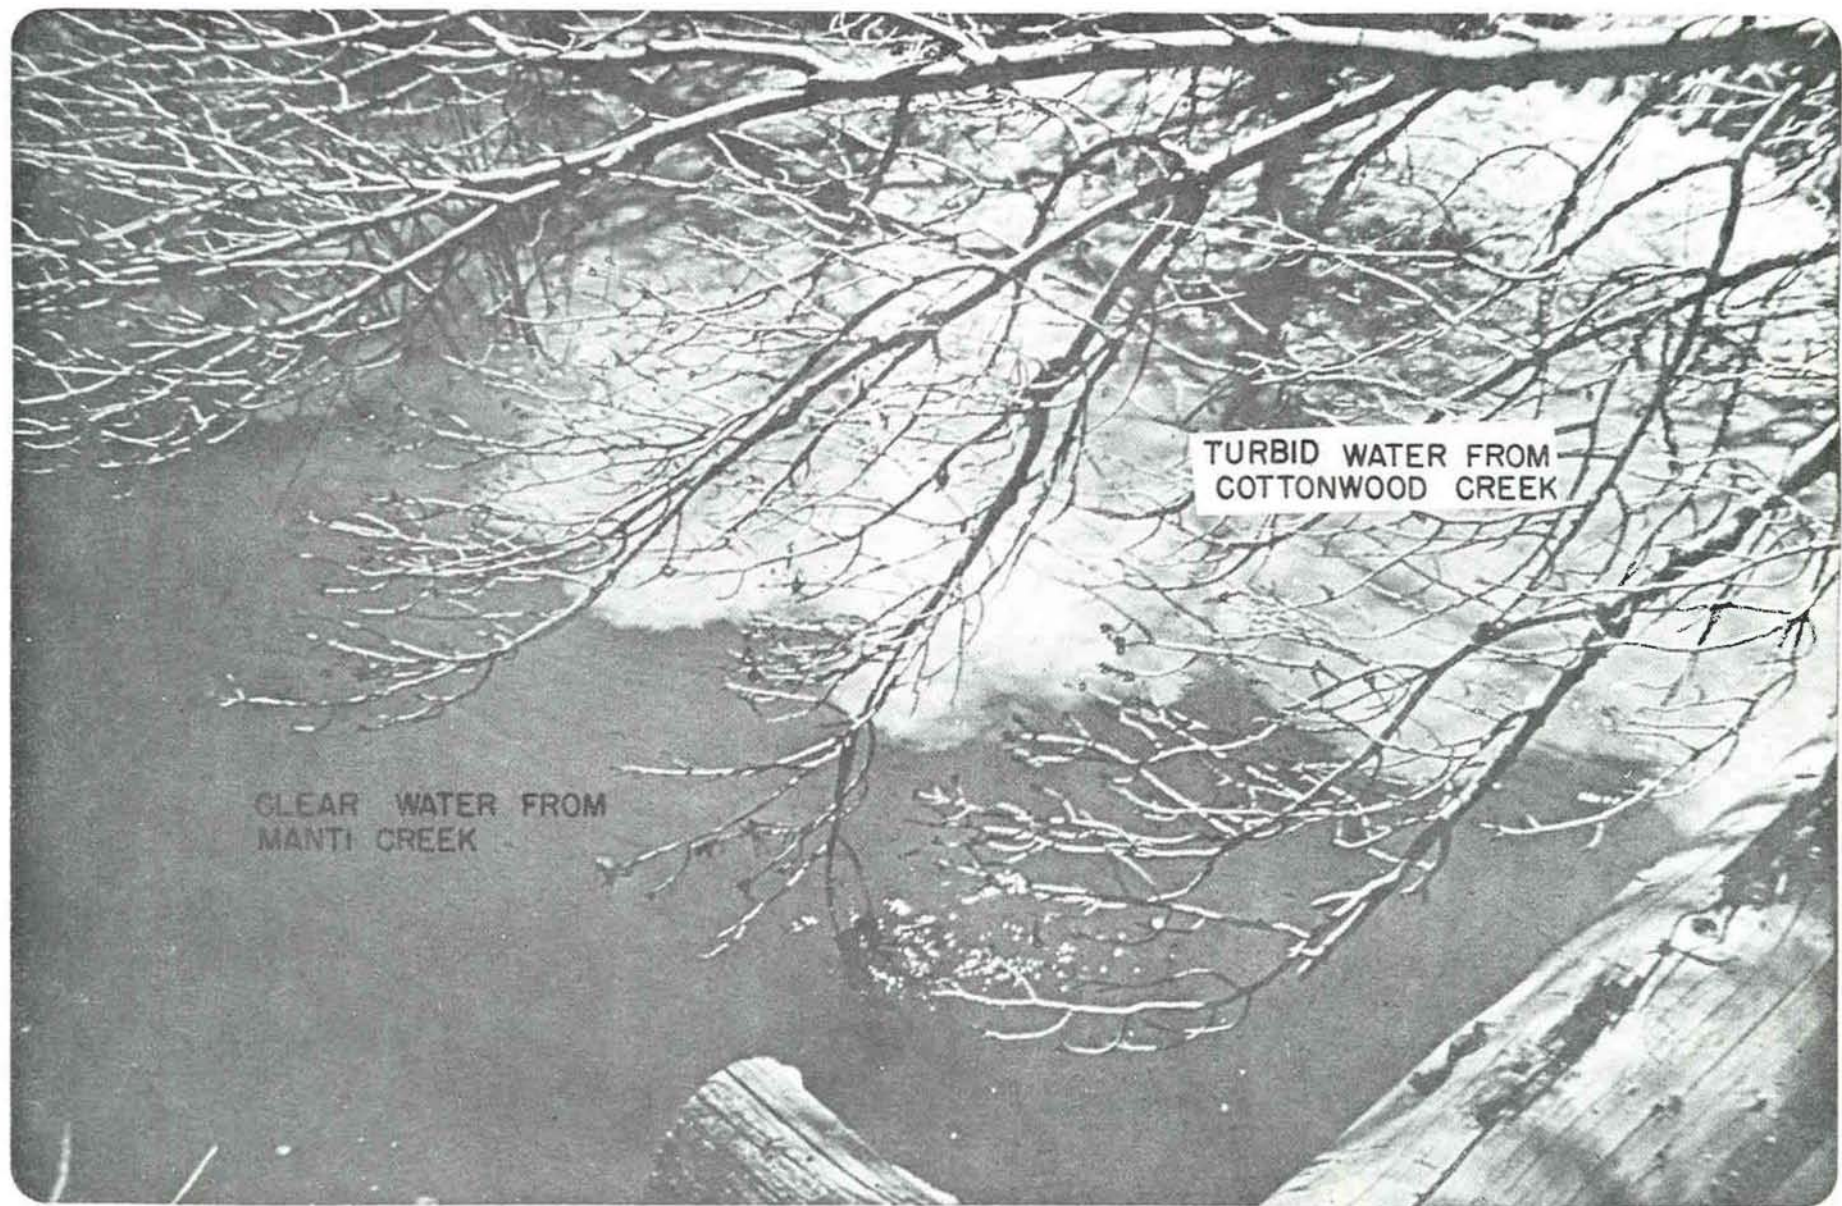
PHOTO 4 - CONFLUENCE OF MANTI CREEK AND COTTONWOOD CREEK  
SHOWING MIXING OF CLEAR AND TURBID WATERS

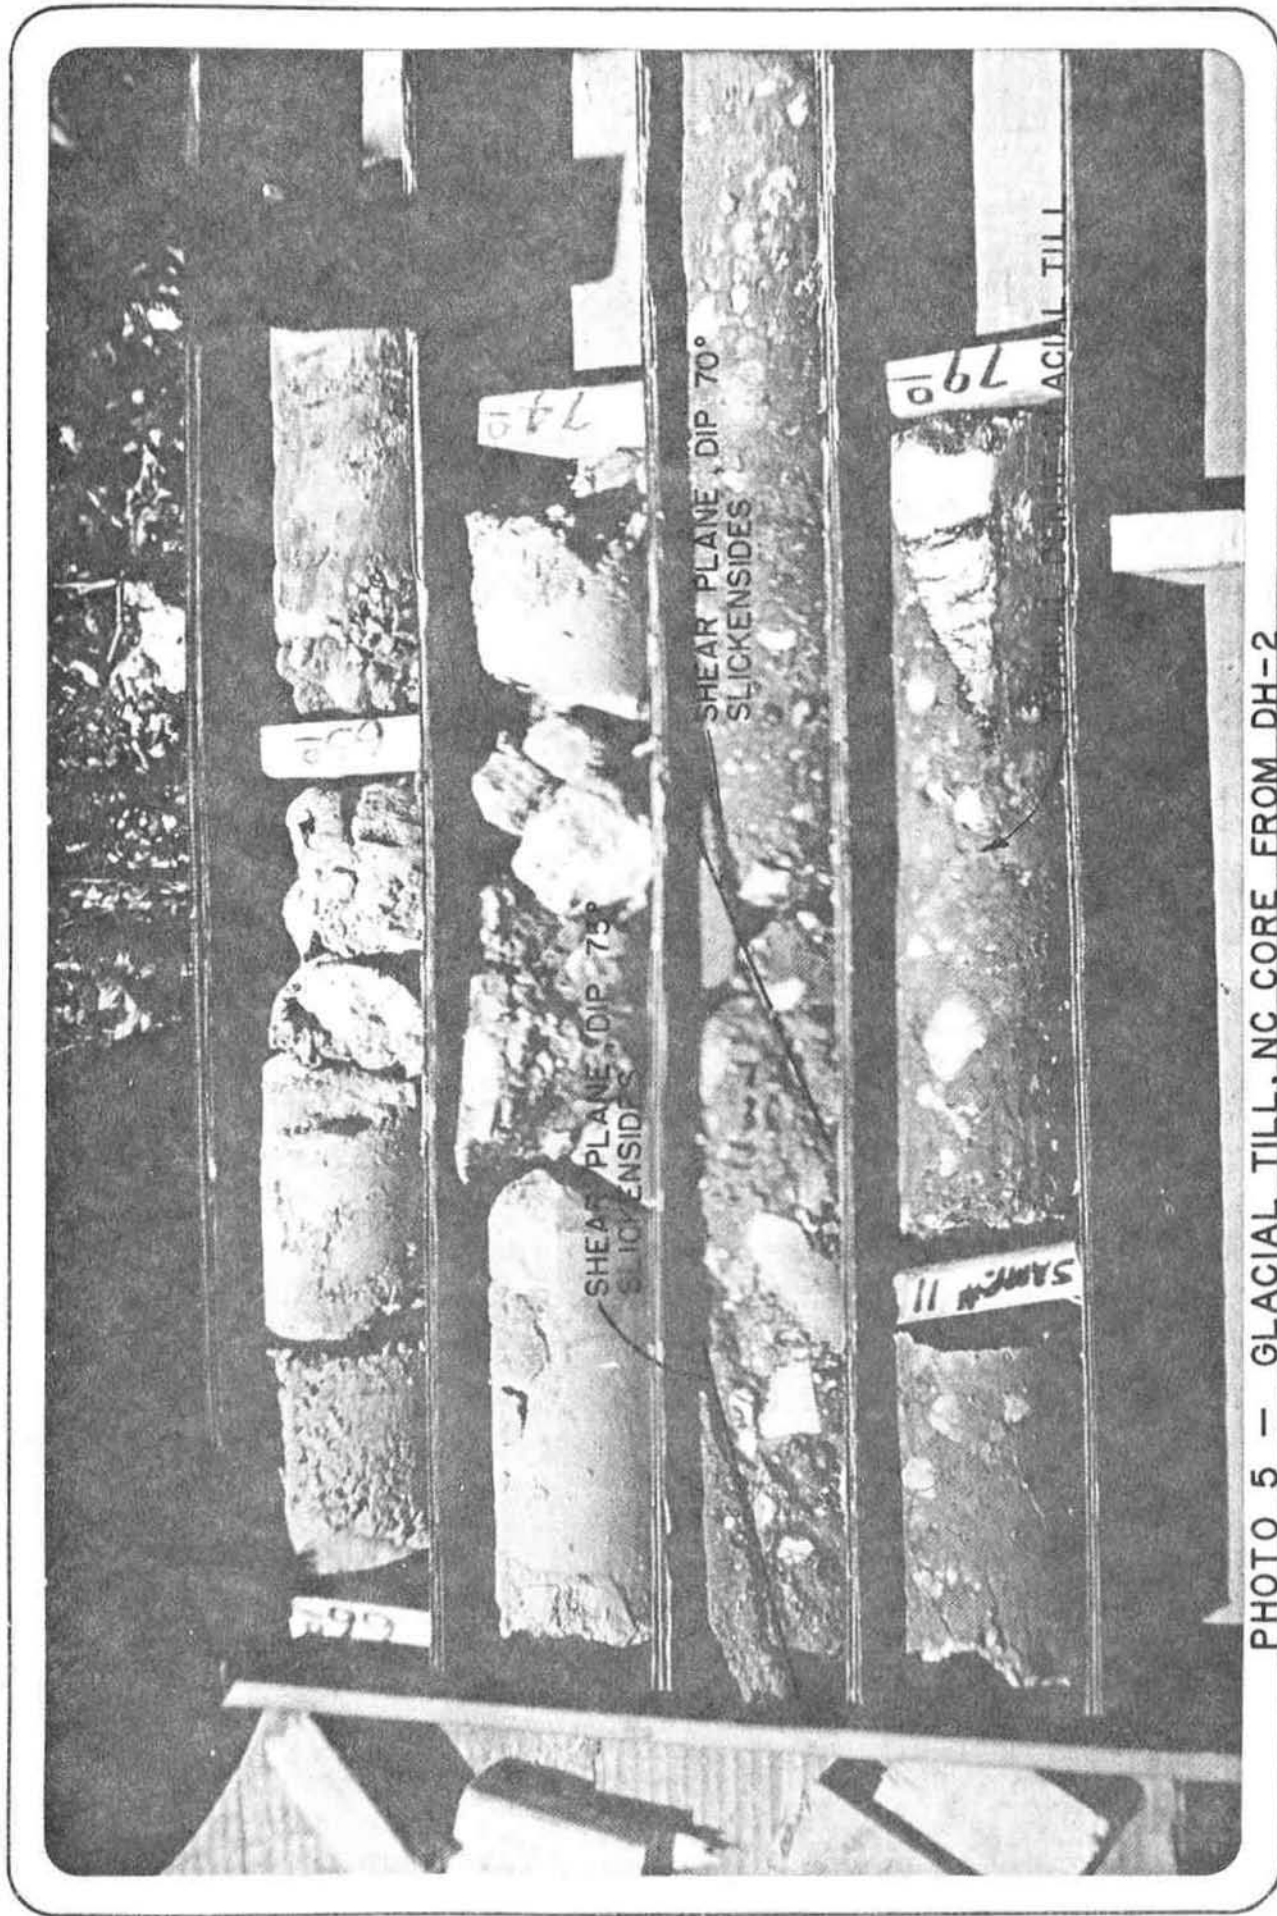
Several small shear zones and shear planes were noted in the drill core obtained from exploratory holes (see Drill Logs and Exhibits 3, 4 and 5). Photo 5 shows two shear planes at the depth of 75.0 feet in DH-2. The shear zones are characterized by dark gray and bluish gray sandy clay

with natural moisture up to 23%, and numerous irregular discontinuous slickensided surfaces. Dip of the shear planes range from  $16^{\circ}$  to  $80^{\circ}$ . The shear zones result from local differential settlement and slumping during glaciation or slow plastic deformation similar to soil creep. Several dark gray clay shear zones can be seen in the bank of Manti Creek near DH-2. These zones are approximately 1 foot thick, irregular and discontinuous.

PHOTO 5 - GLACIAL TILL, NC CORE FROM DH-2

SHOWING SHEAR PLANES

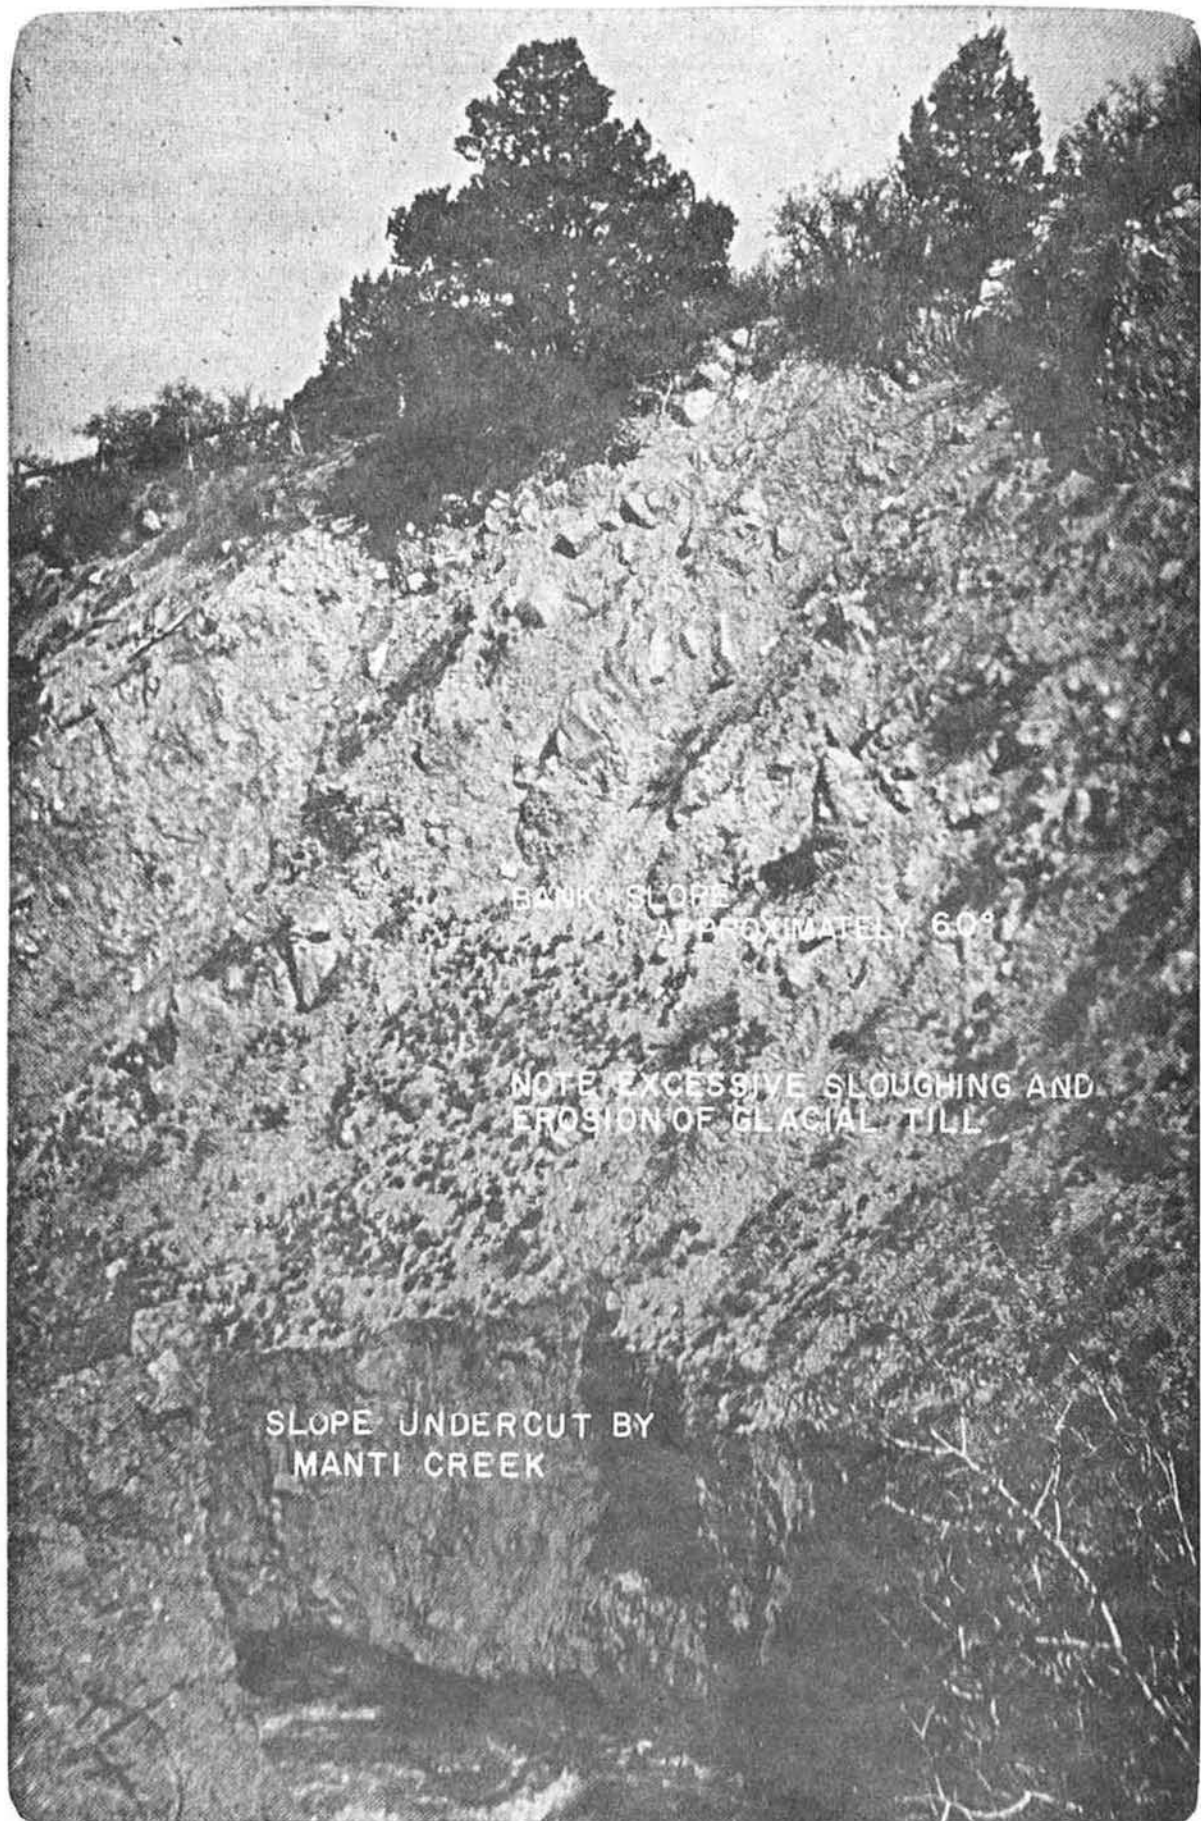
PHOTO 6 - TAKEN AT BASE OF STABILITY  
SECTION I

BANK SLOPE  
APPROXIMATELY 60°

NOTE EXCESSIVE SLOUGHING AND  
EROSION OF GLACIAL TILL

SLOPE UNDERCUT BY  
MANTI CREEK

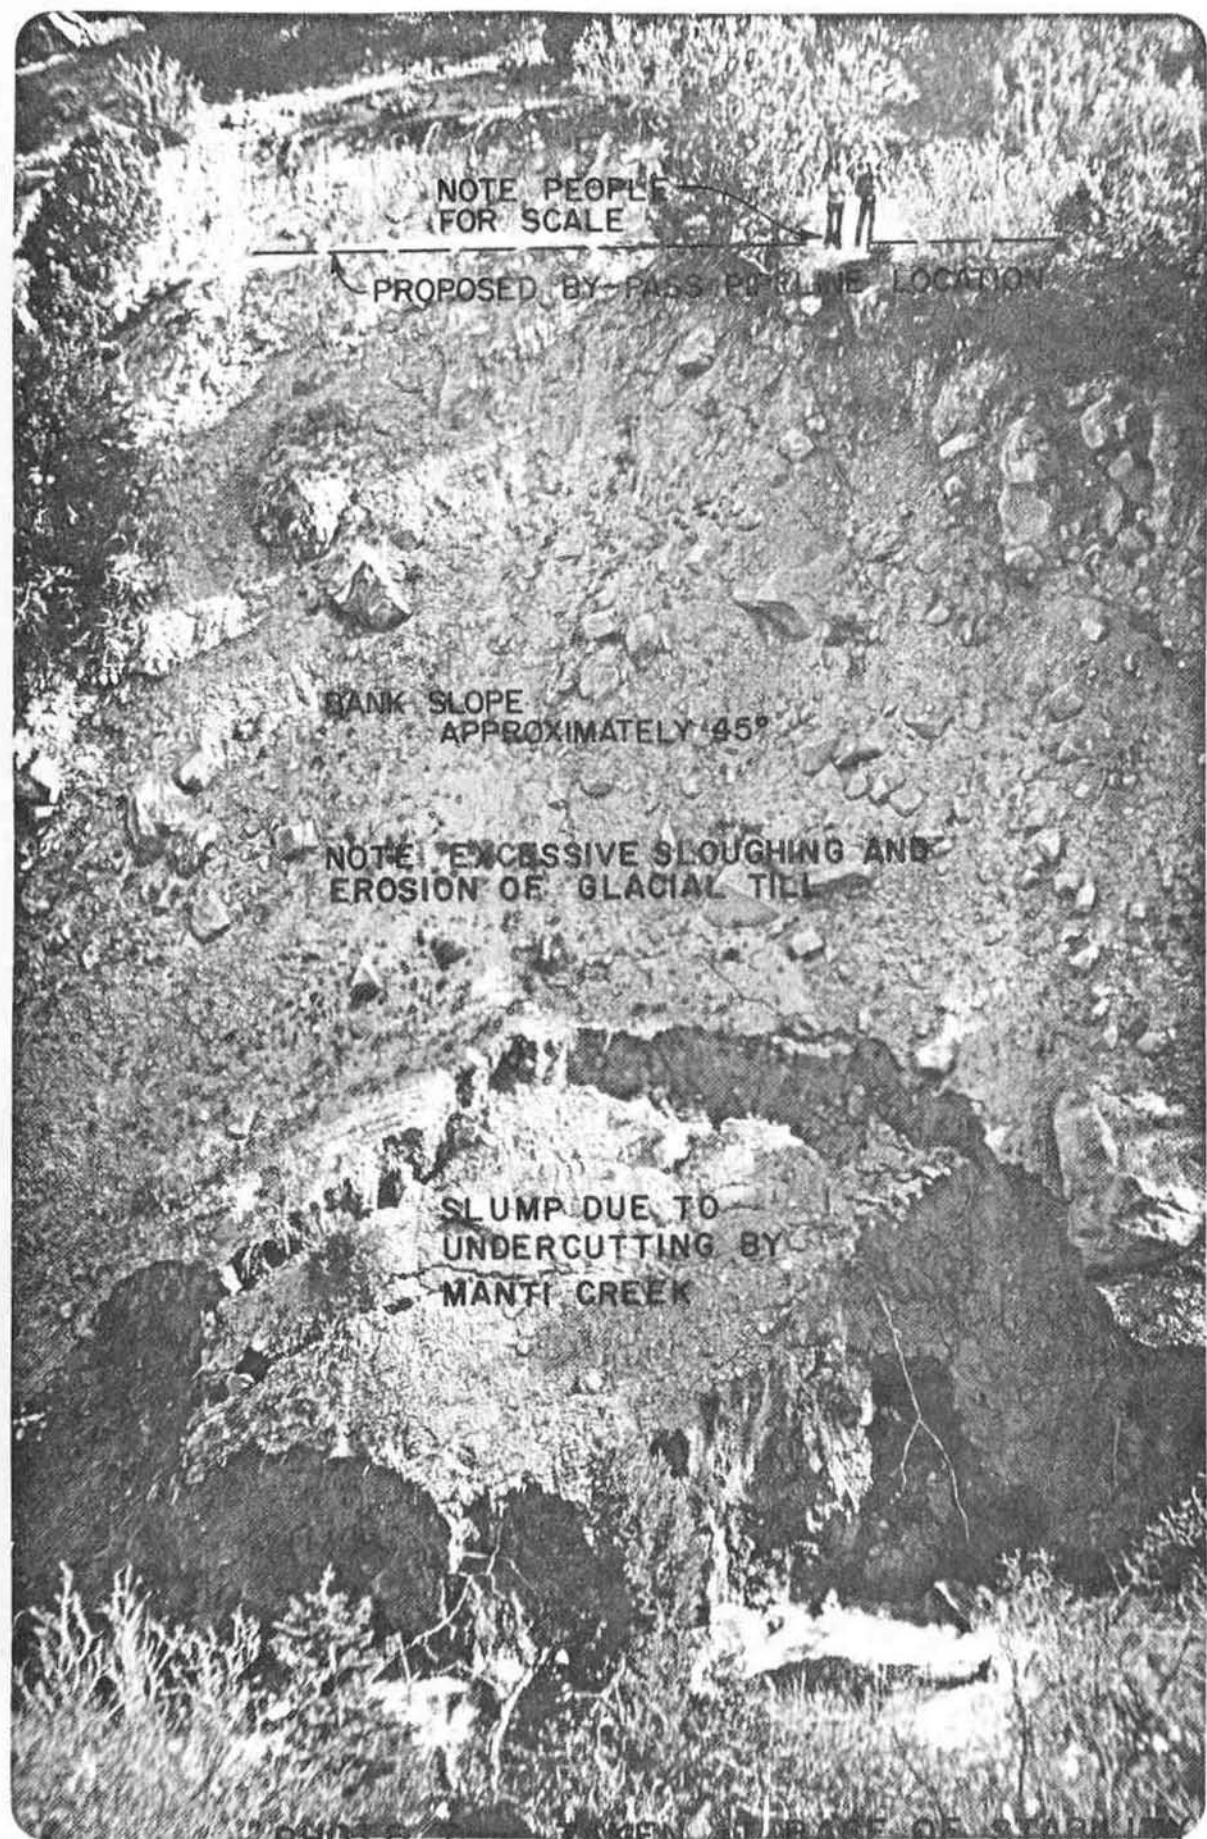
PHOTO 1 TAKEN AT BASE OF STABILITY  
SECTION 2

3. Stability of Section 2 - Section 2 was chosen because the toe of the slope is being eroded by Manti Creek (see Photo 7). A failure in this section would remove the Forest Service road and the proposed by-pass pipeline and the City of Manti's water pipeline (see Exhibit 12).
