U.S. Forest Service
Research Paper RM-7

Snow Avalanches Along Colorado Mountain Highways

by Hans Frutiger

ROCKY MOUNTAIN FOREST AND RANGE EXPERIMENT STATION
Fort Collins, Colorado
FOREST SERVICE

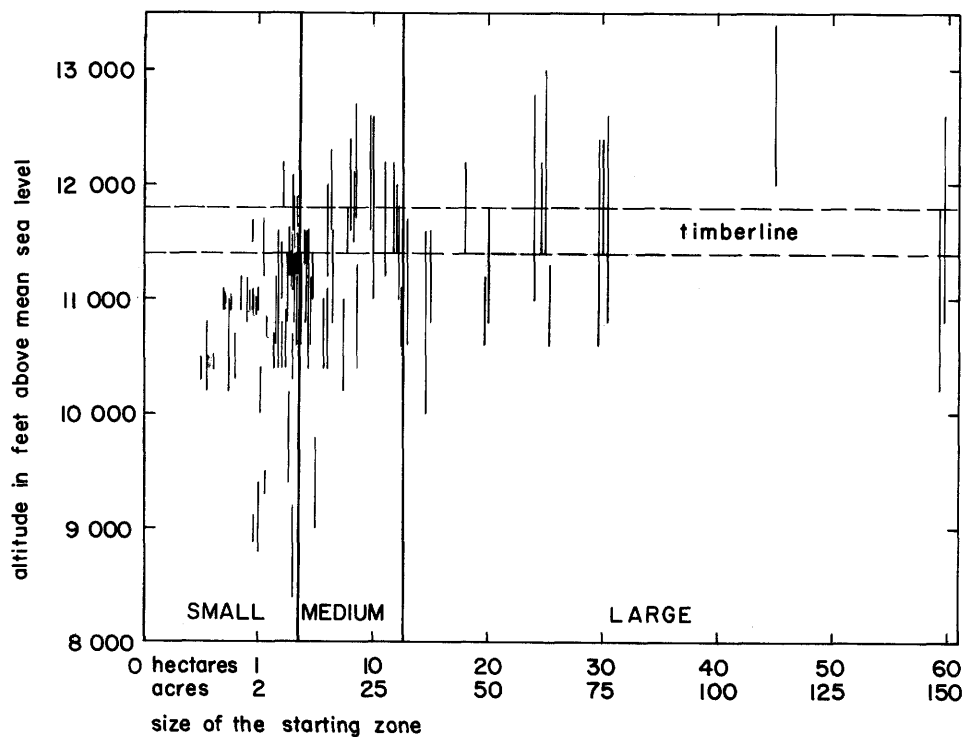
Figure 1.--Size and altitude of the starting zone of 80 avalanches in four mountain passes in Colorado, 1961-62. An expanded scale has been used for the 0- to 2-acre classification.

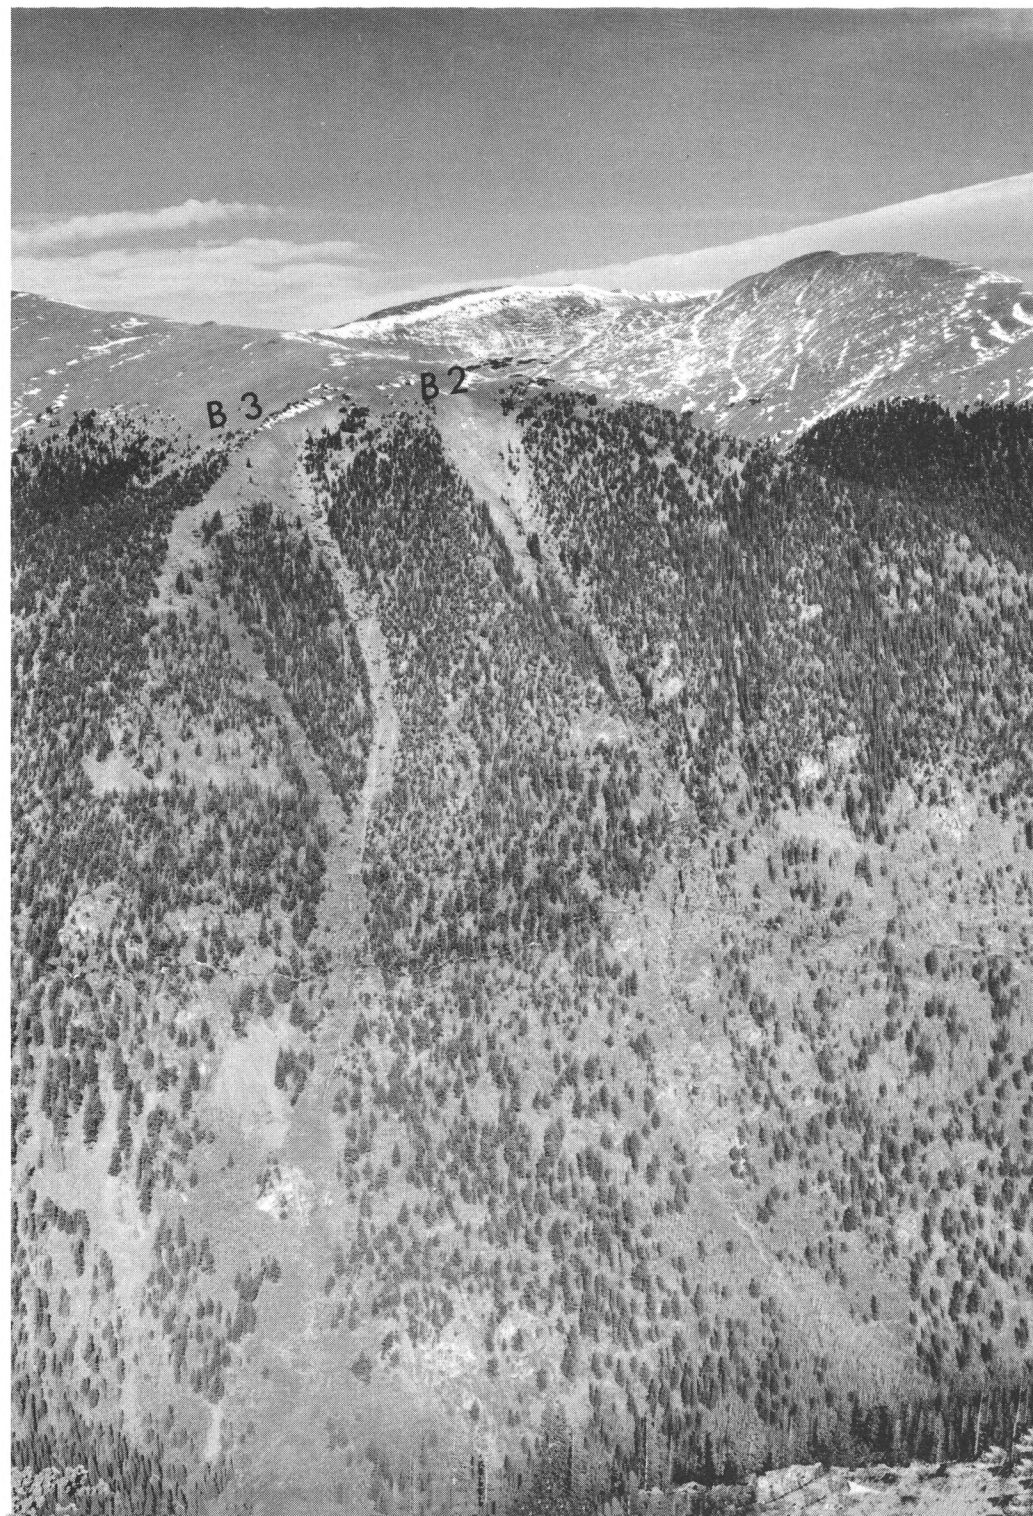
Highway No. 40 --
Berthoud Pass
Photo: April 23, 1962

Supporting structures in starting zone and afforestation. Snowfences to windward of catchment area might help trees get started by reducing snow depths.

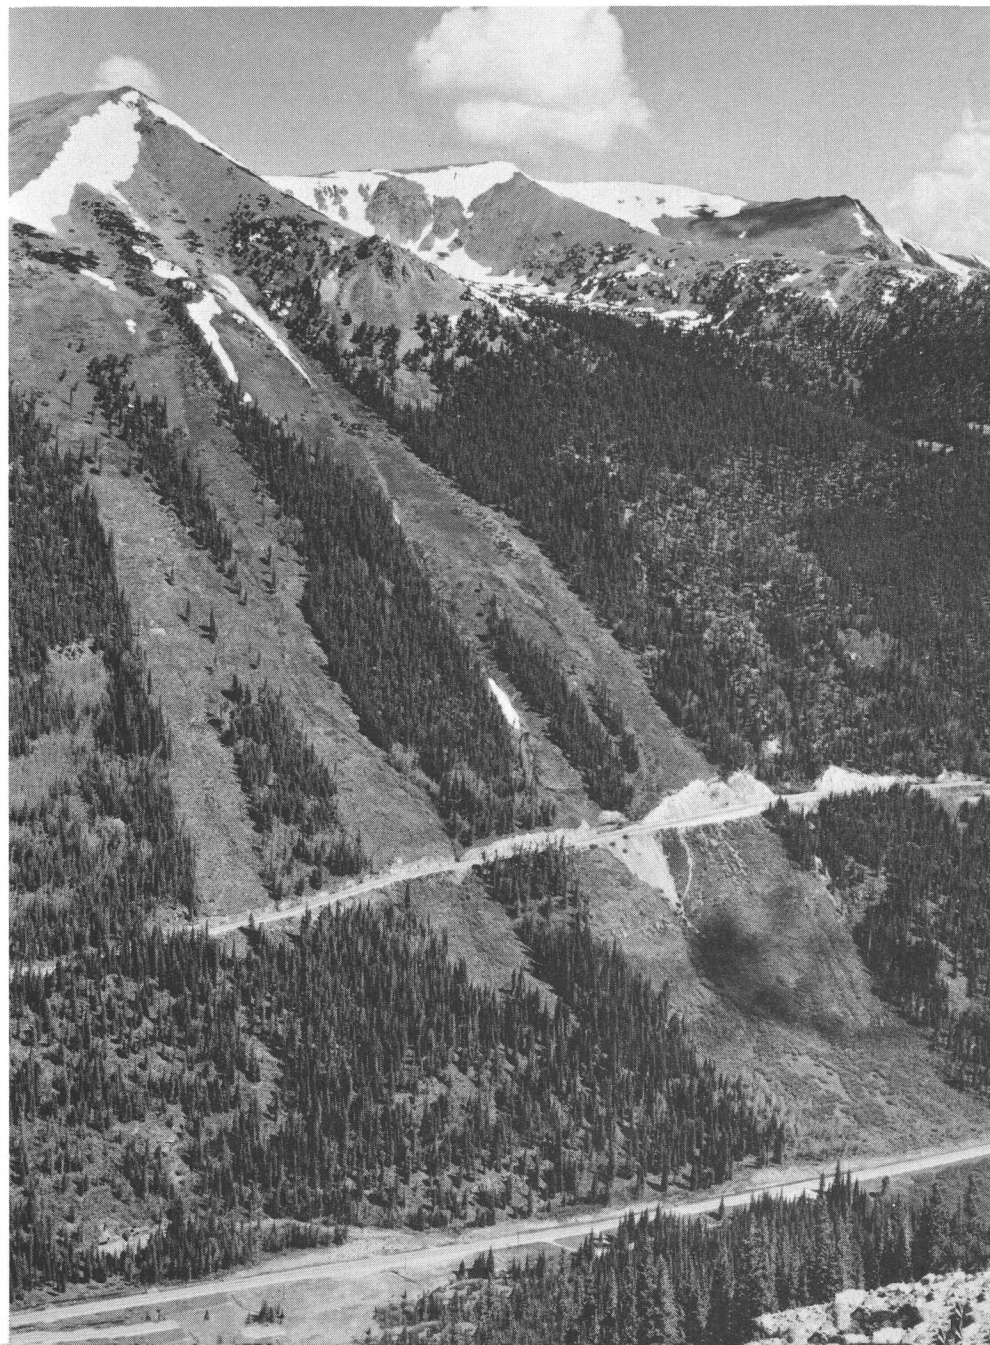
Highway No. 40 --
Berthoud Pass
Photo: April 23, 1962

Structural controls in the catchment basin or an avalanche shed are the two possibilities. A detailed study has been made of the possibility for structural control of this avalanche.¹⁰

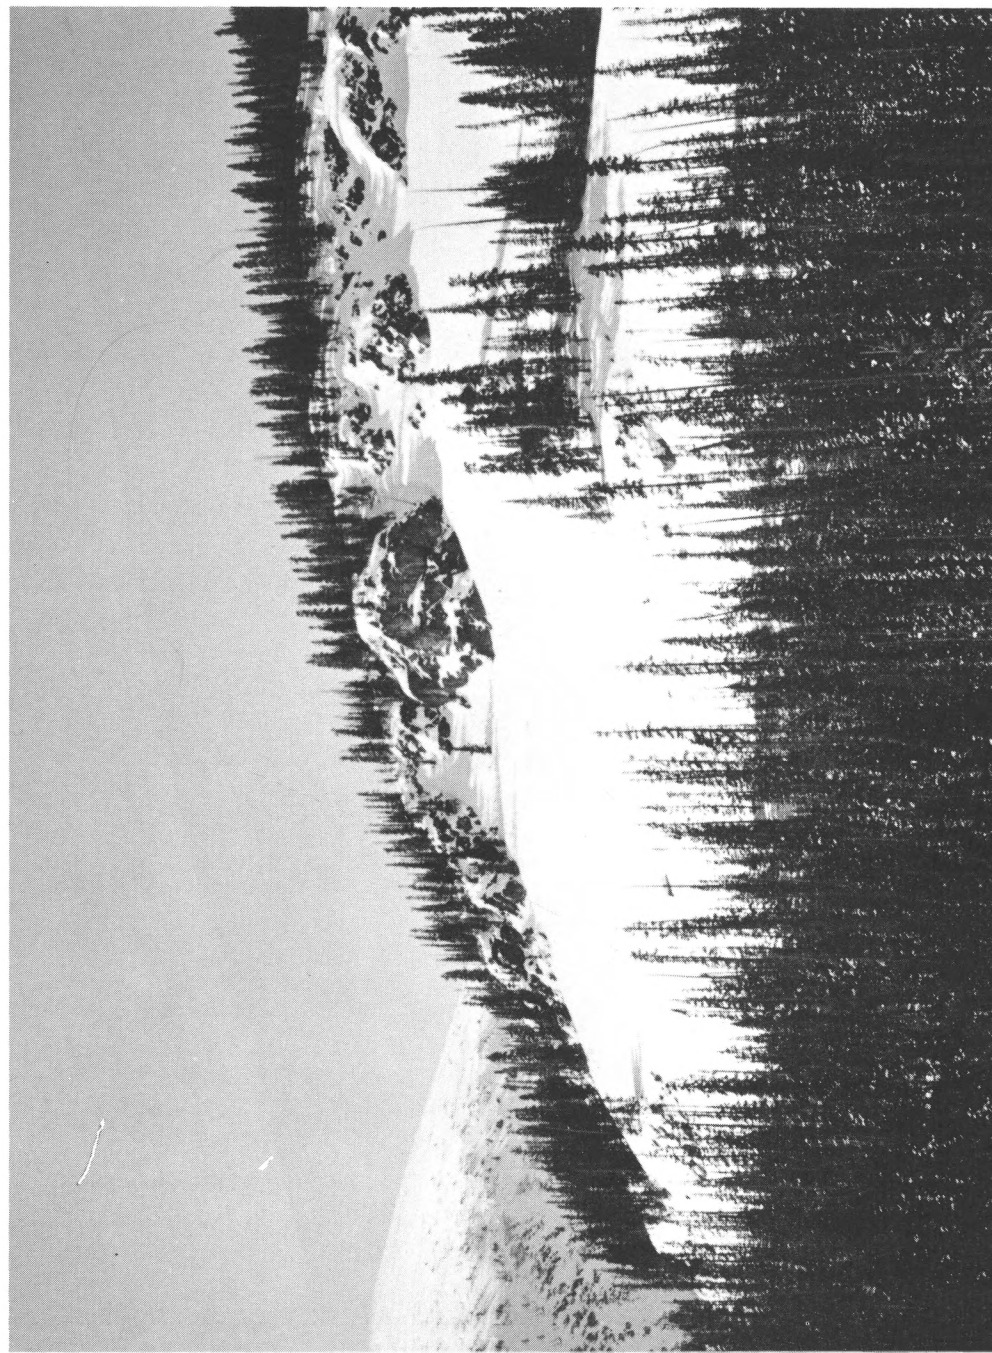
Access is easy, so supporting structures would present no problem. Afforestation may be difficult on the talus.

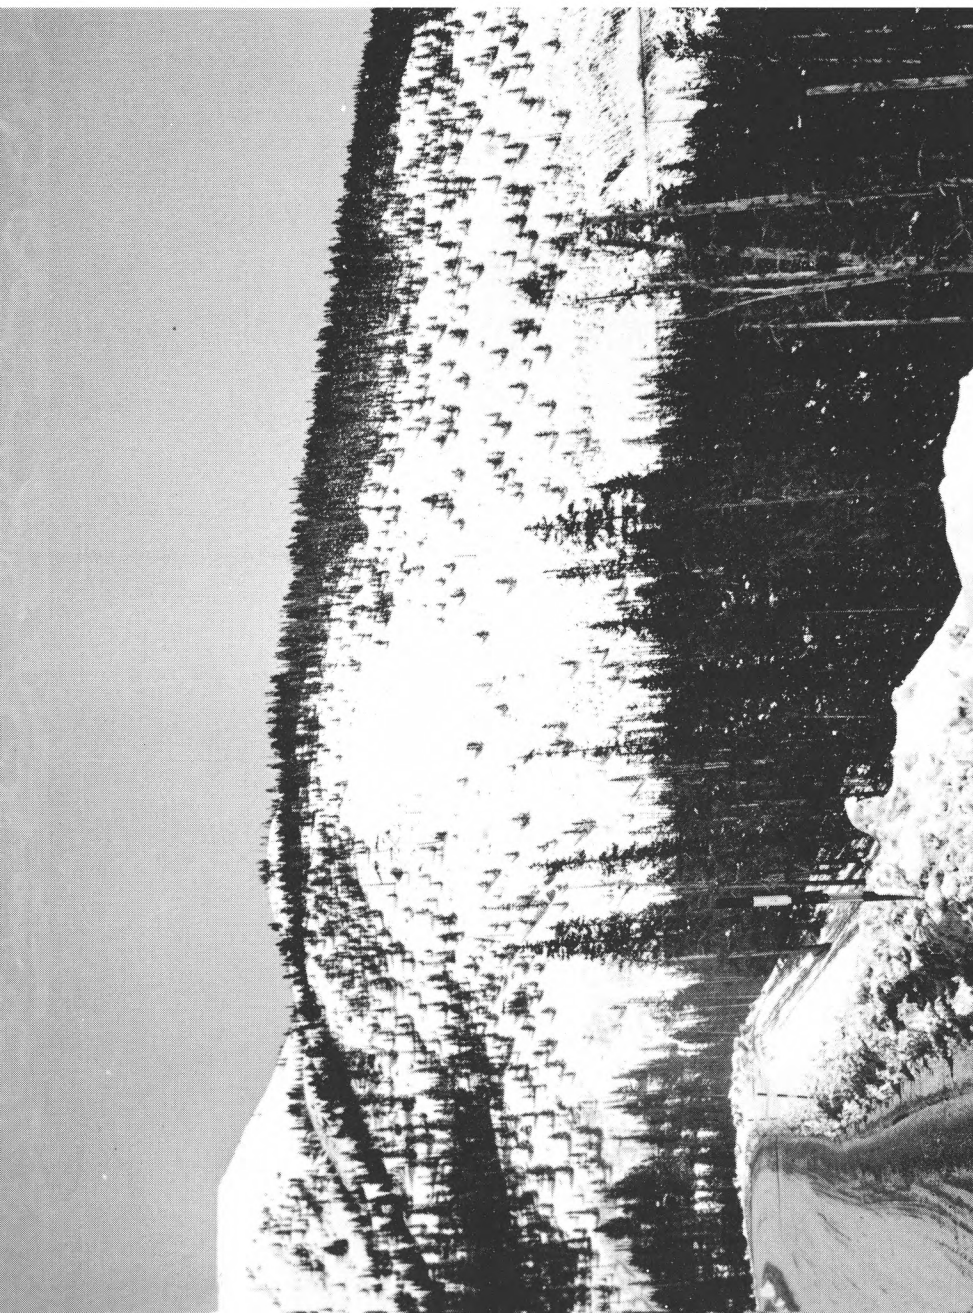
TWO-FORTY (B-12)

Afforestation protected by supporting structures.

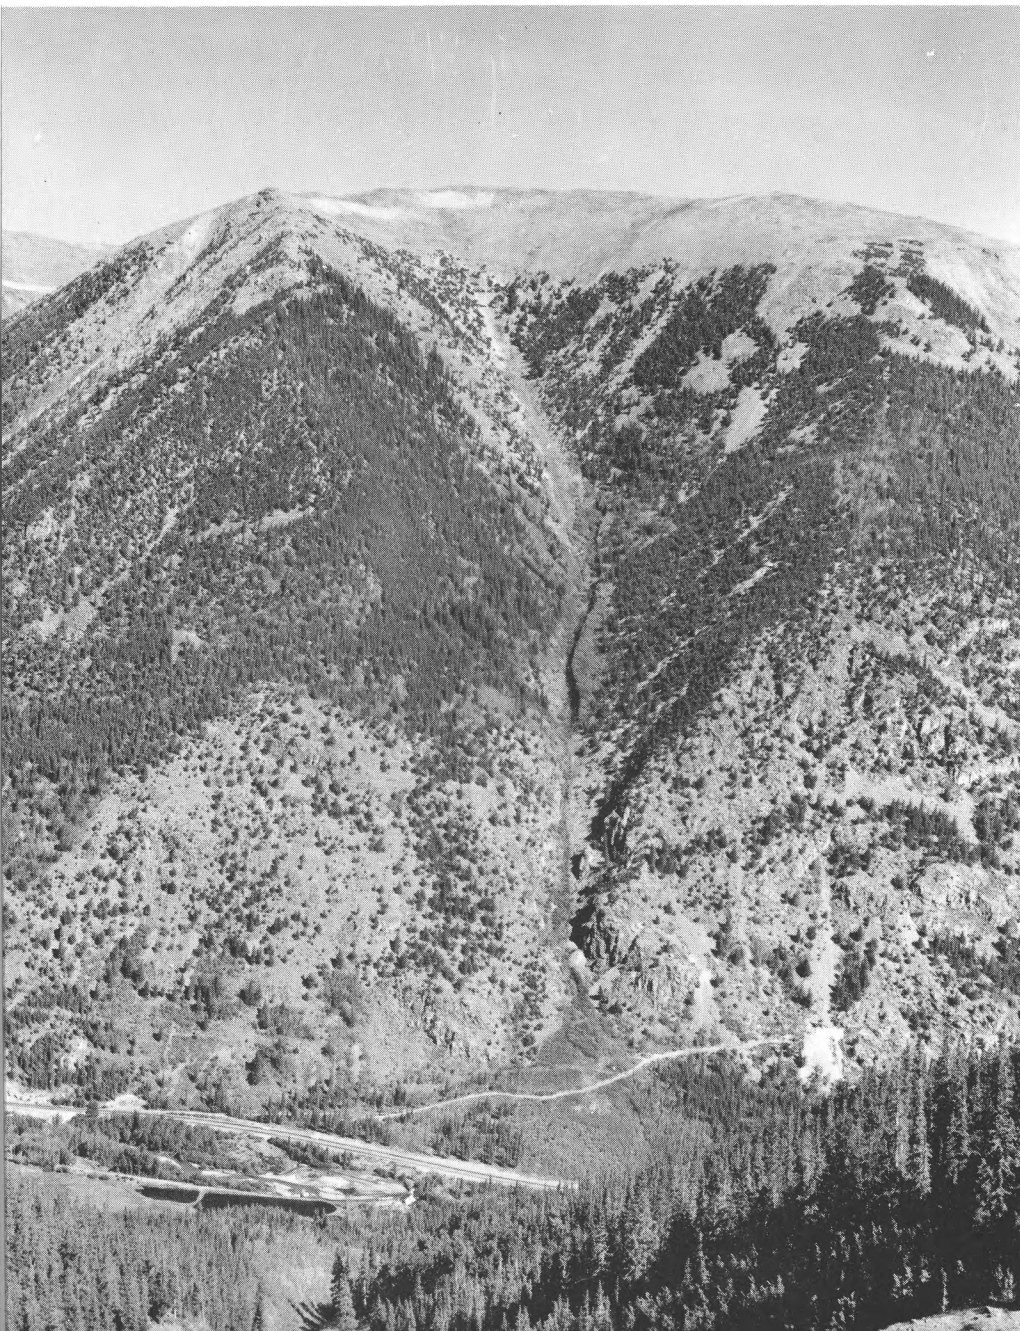
PINKERTON GULCH (L-1)

Highway No. 6 --
Loveland Pass
Photo: September 1, 1962

Because it is an erratic, large avalanche, structural control seems to be not very economical, especially supporting structures. The runout zone offers some possibilities for the installation of retarding structures. Whether such control is possible can be answered only by a detailed study of the frequency of occurrence and the terrain conditions in the runout zone.

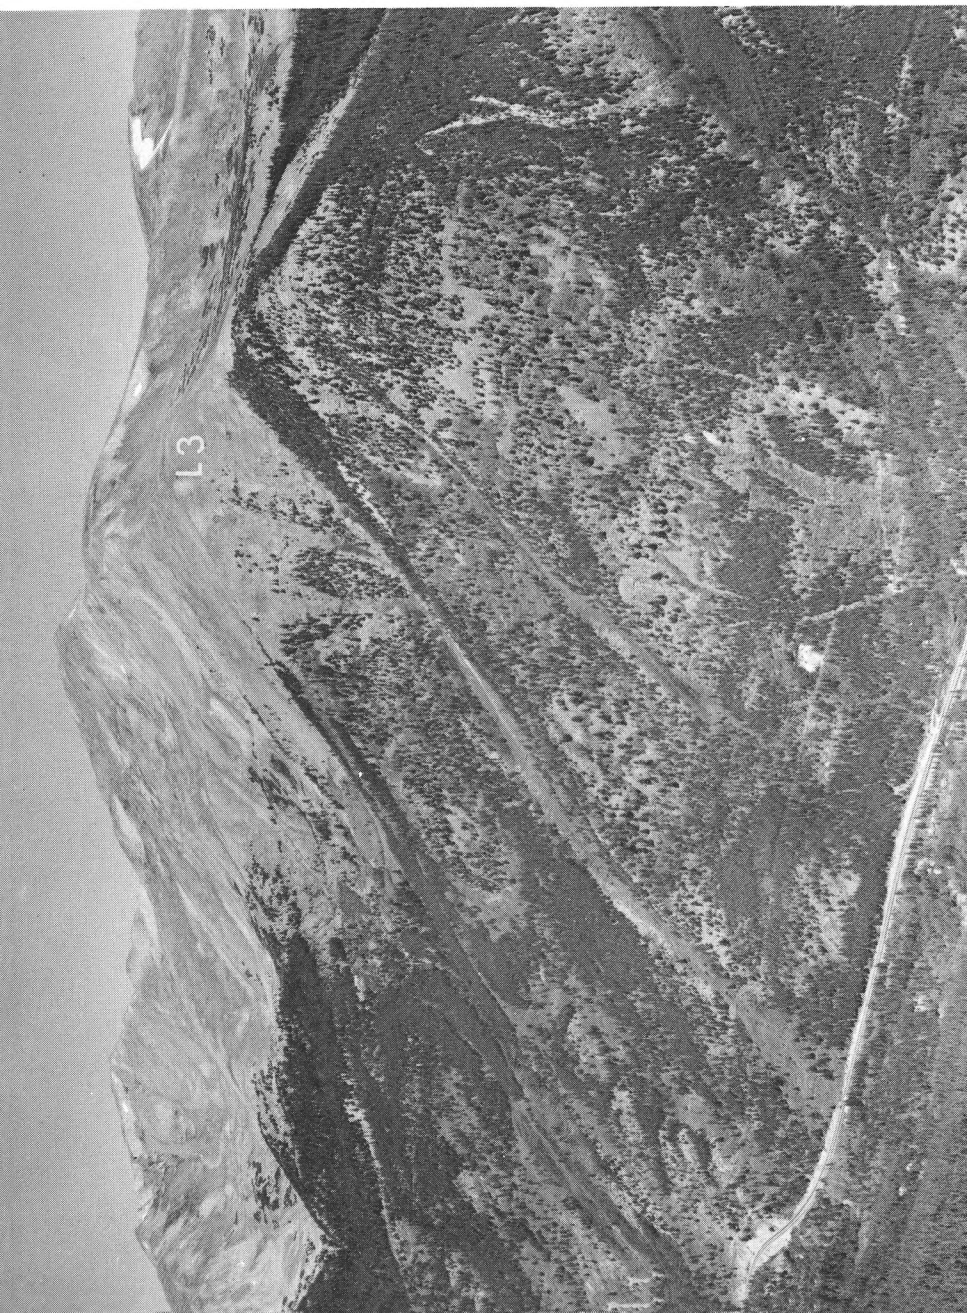
BARD SHOULDER (L-3)

Highway No. 6 --
Loveland Pass
Photo: September 1, 1962

The ruggedness and steepness of the catchment basin, together with the excessive snow accumulations (drifts), create some problems for supporting structures. Two diversion dams already installed, are not always effective because the runout zone is too steep and the dams too small. Control measures either in the track or in the runout zone are out of the question if full protection is expected from all avalanches. Only very expensive supporting structures or an avalanche shed would give full protection to the road. Guide walls parallel to the avalanche track could be used with an avalanche shed to shorten the length of the expensive shed.

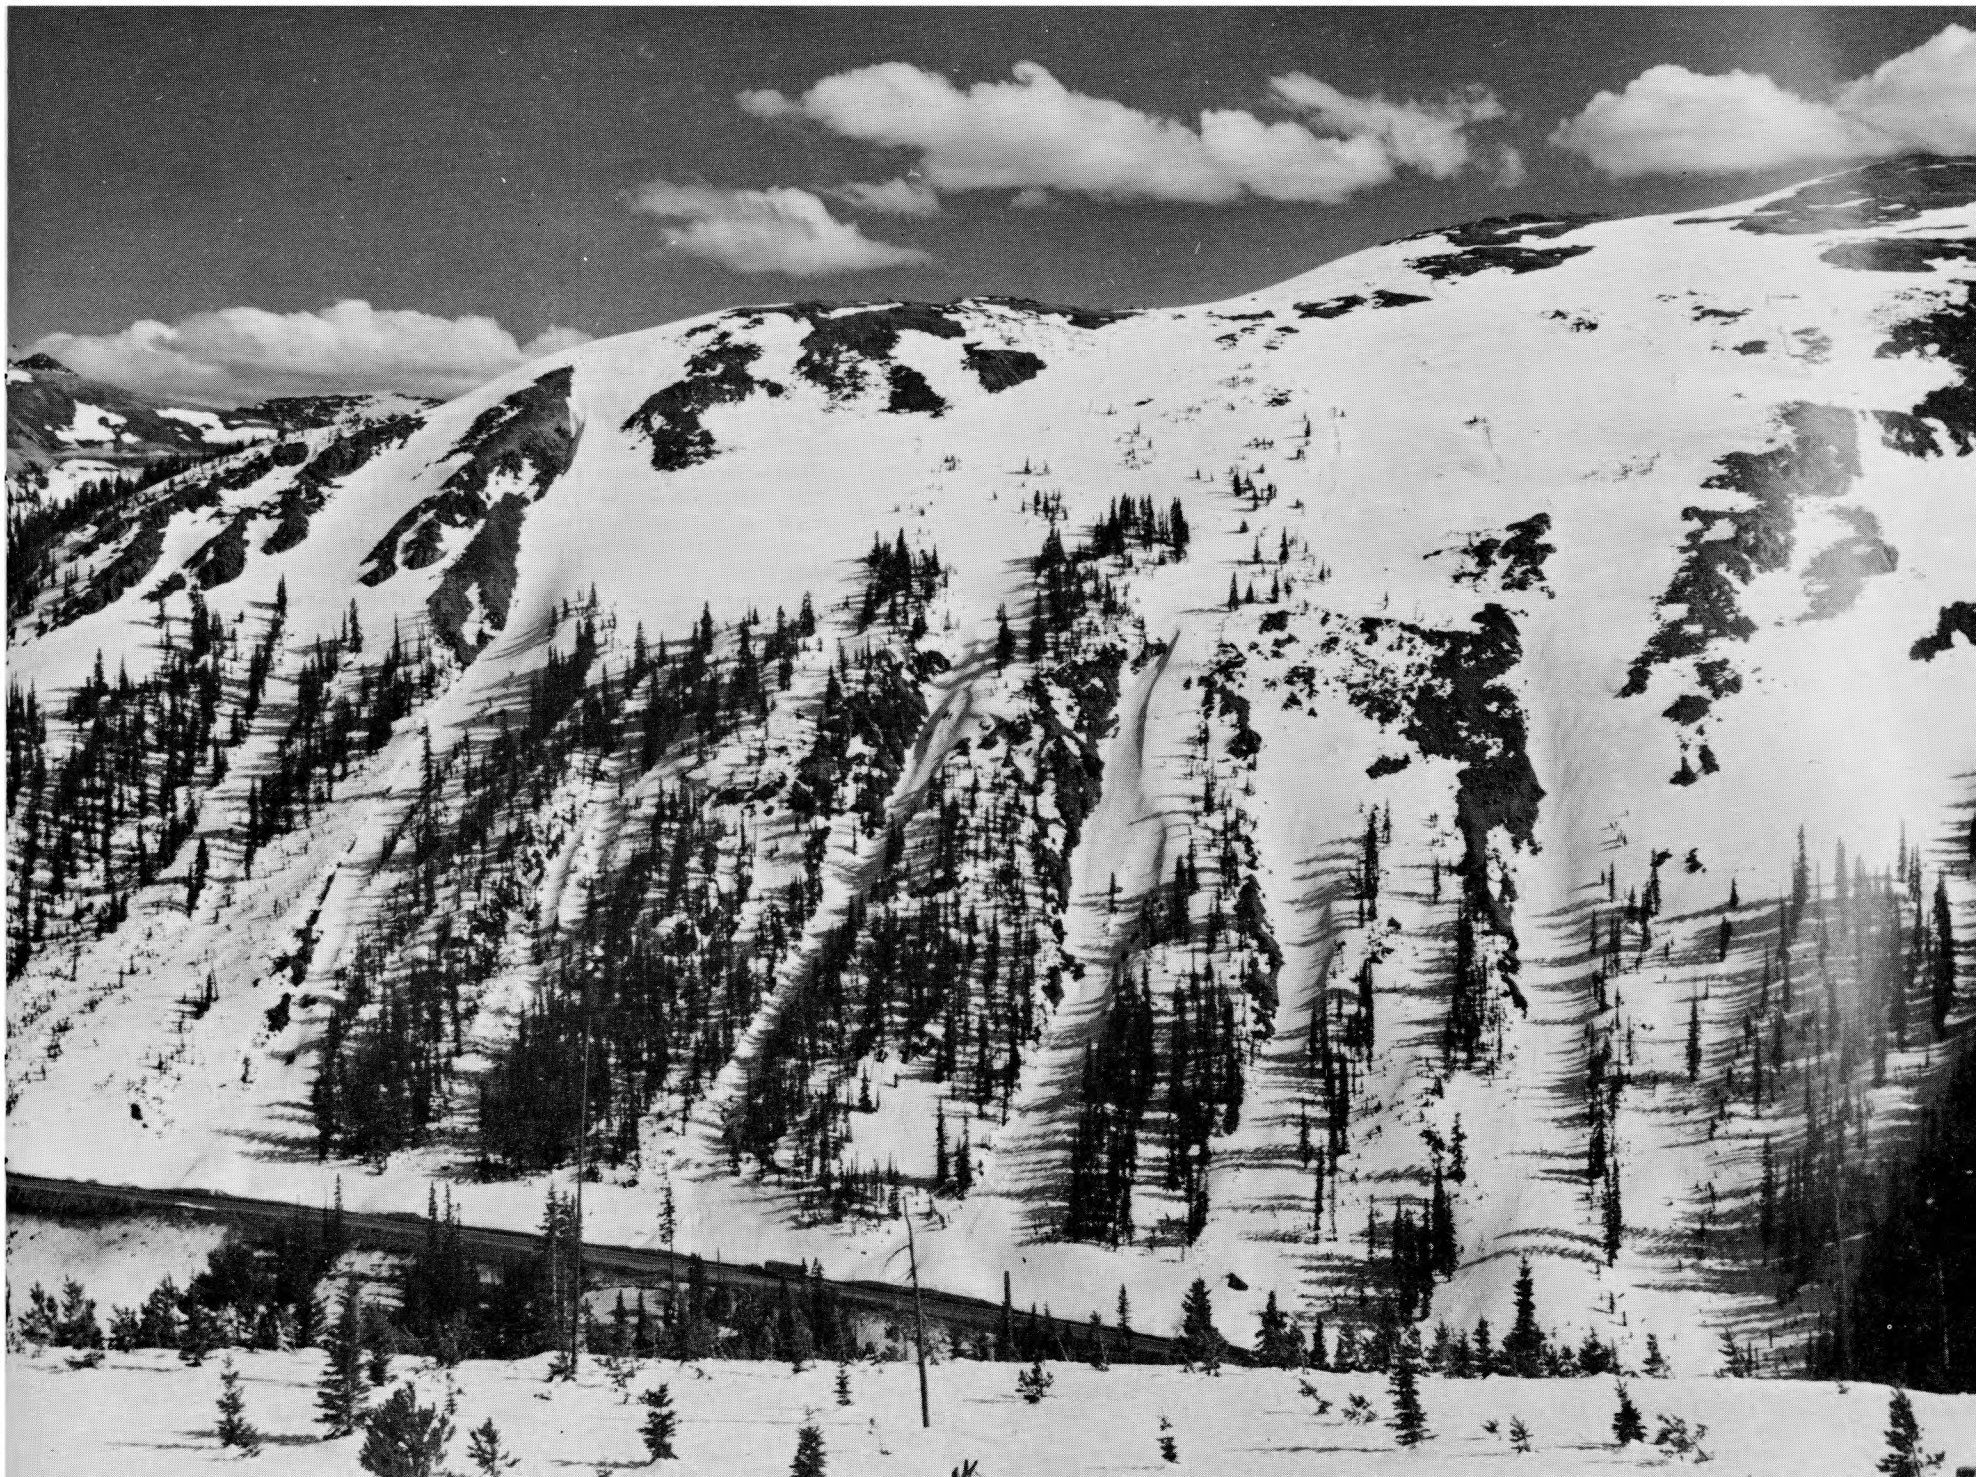
*Highway No. 6 --
Loveland Pass
Photo: May 11, 1962*

The terrain offers no special difficulties for control by supporting structures. Since the avalanches are frequent, control measures should be studied immediately. Control by supporting structures in connection with snowdrift control and afforestation is the most economical procedure. Because of the proximity of Loveland Basin ski area and the chair lift, it would be a good test and study field.

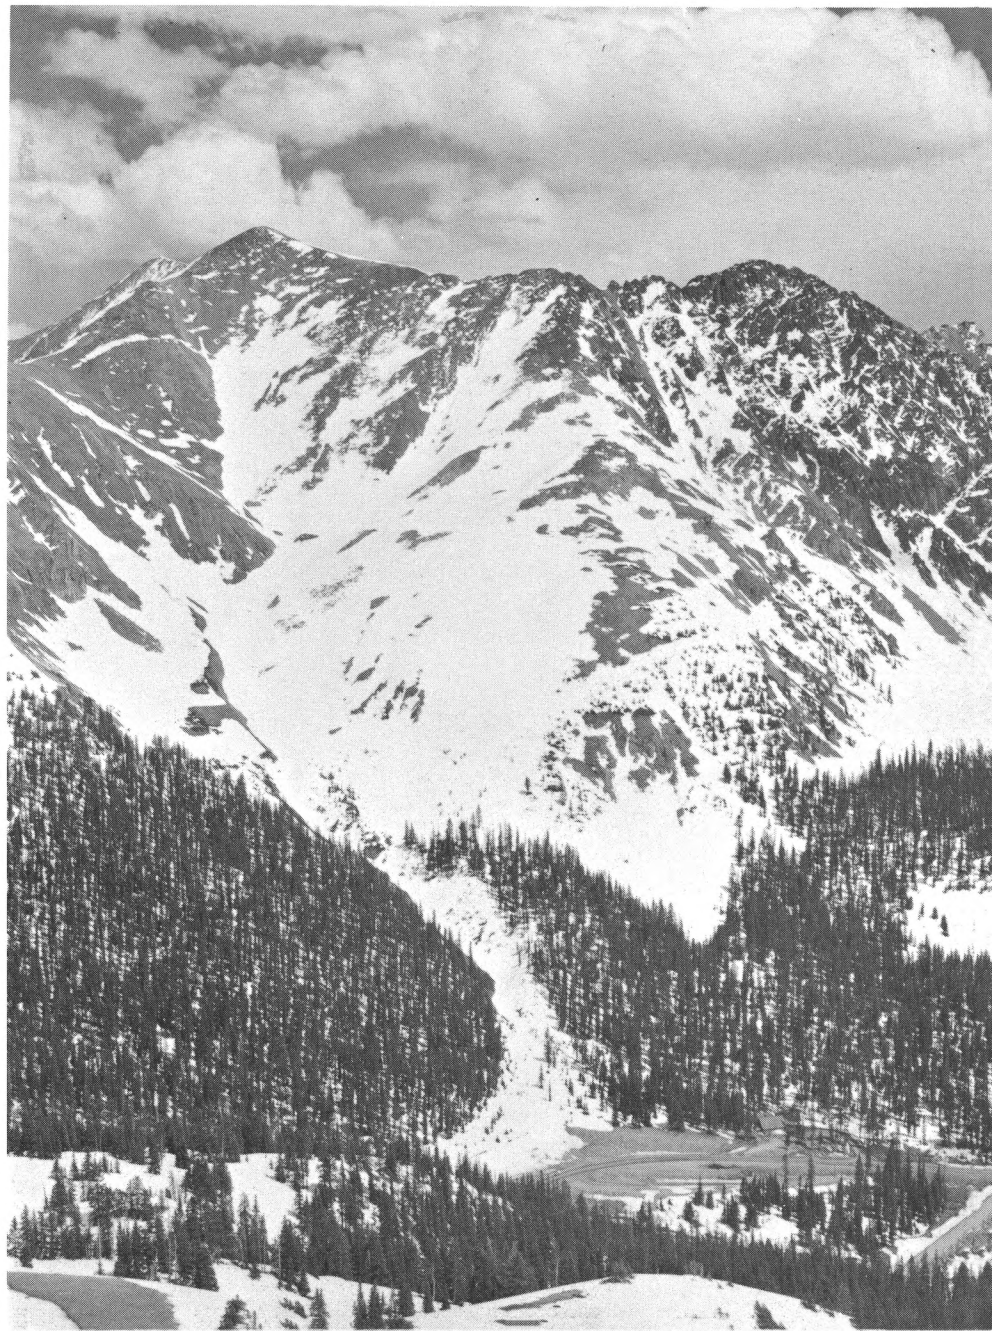
Highway No. 6 --
Loveland Pass
Photo: May 11, 1962

Control is not urgent, but if it is desirable to protect the highway, terrain conditions are rather favorable for a diversion dam in the runout zone. Control in the starting zone is out of the question because it is too big and rugged.

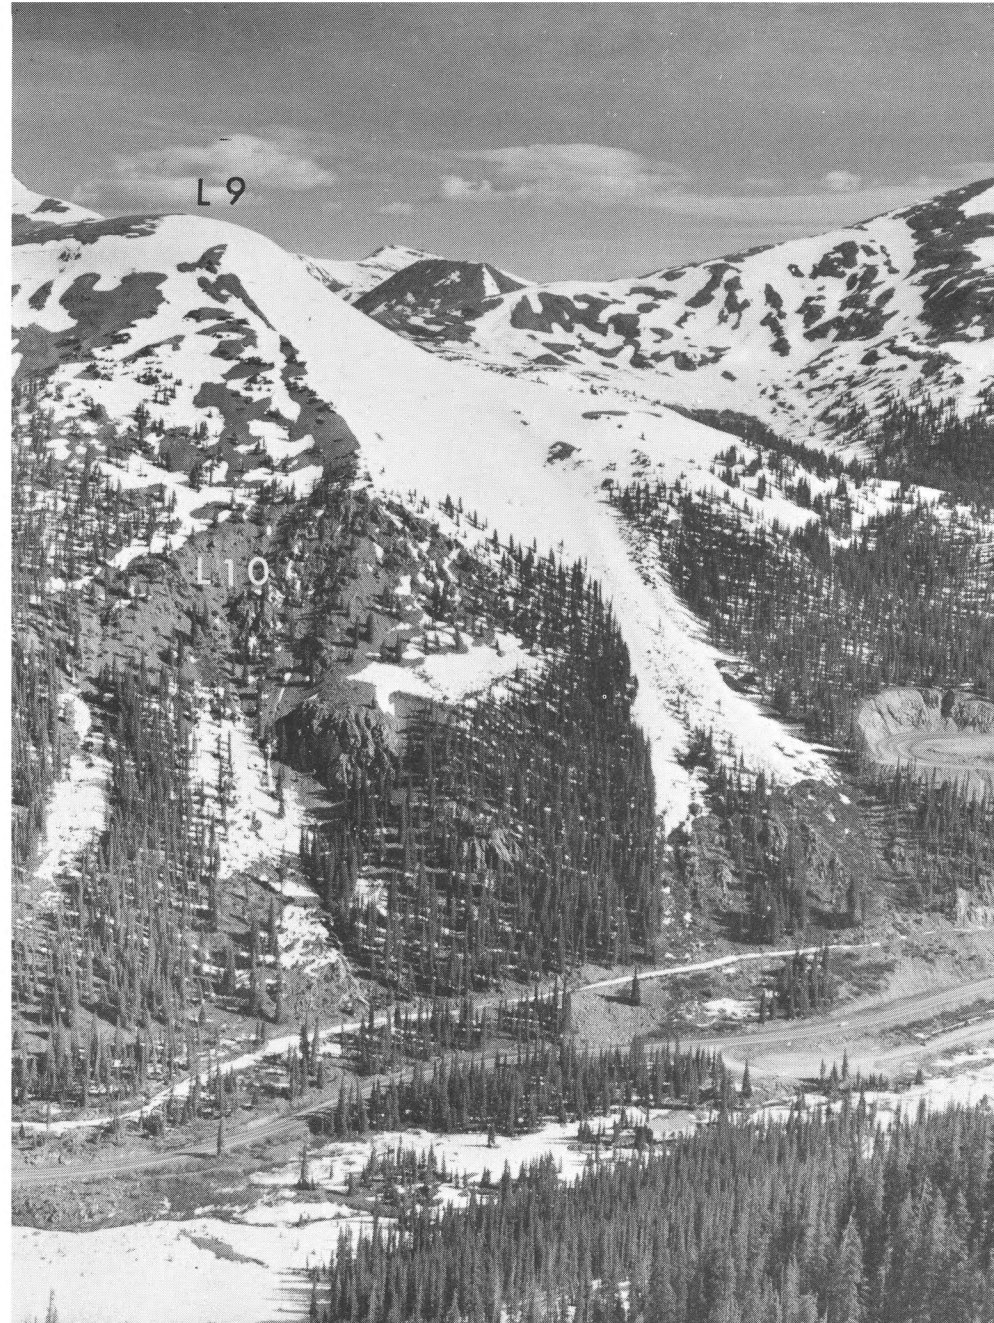
Since the starting zone shows a tendency to erode
by rockfall, its stabilization should be studied.
Except for the unstable ground and some very
steep spots, there are no difficulties for control
with supporting structures. Afforestation would
be the most important control measure.

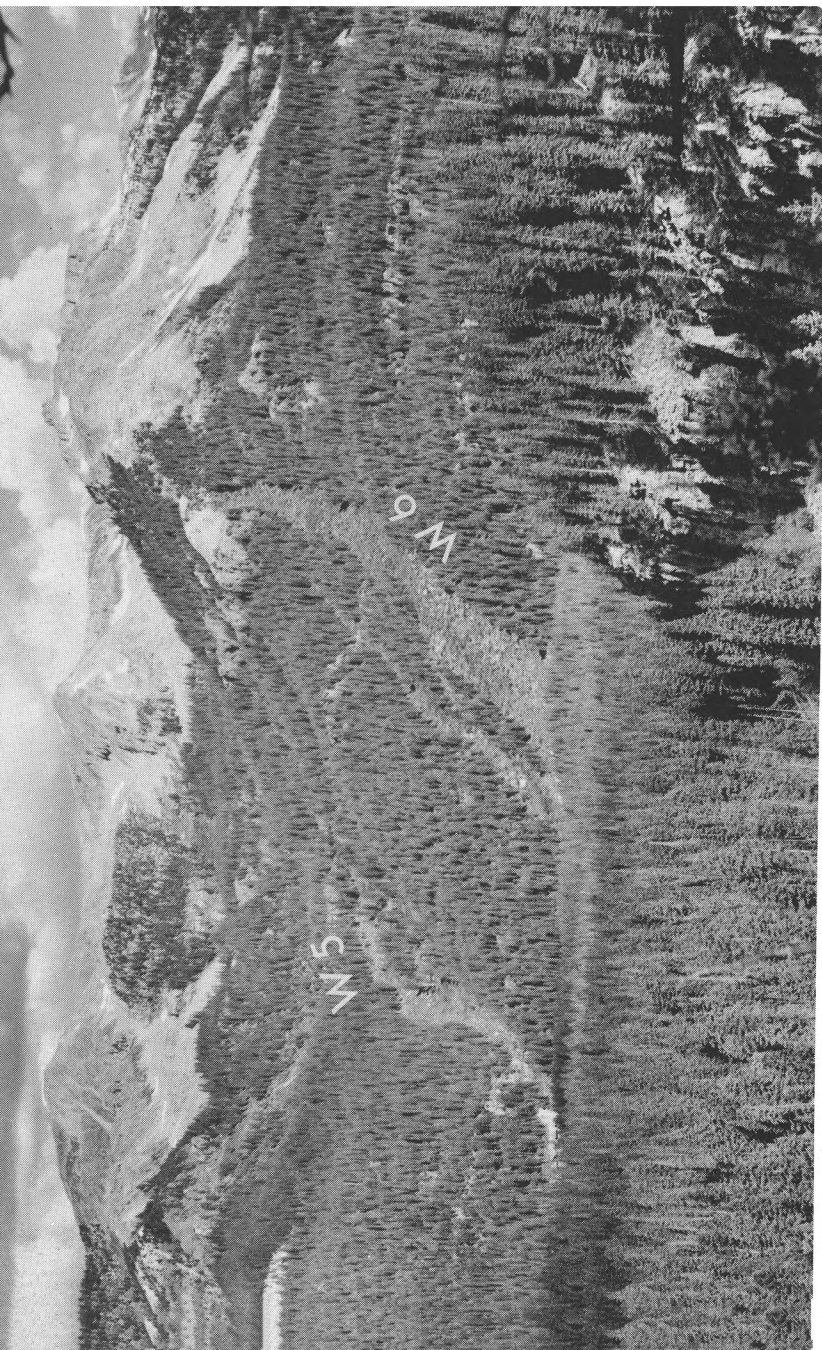
CAMP (W-5)

Highway No. 160 --
Wolf Creek Pass
Photo: July 5, 1962

Control of starting zone is probably most economical control measure. Since whole track lies on timbered slope, afforestation would be an integral part of project.

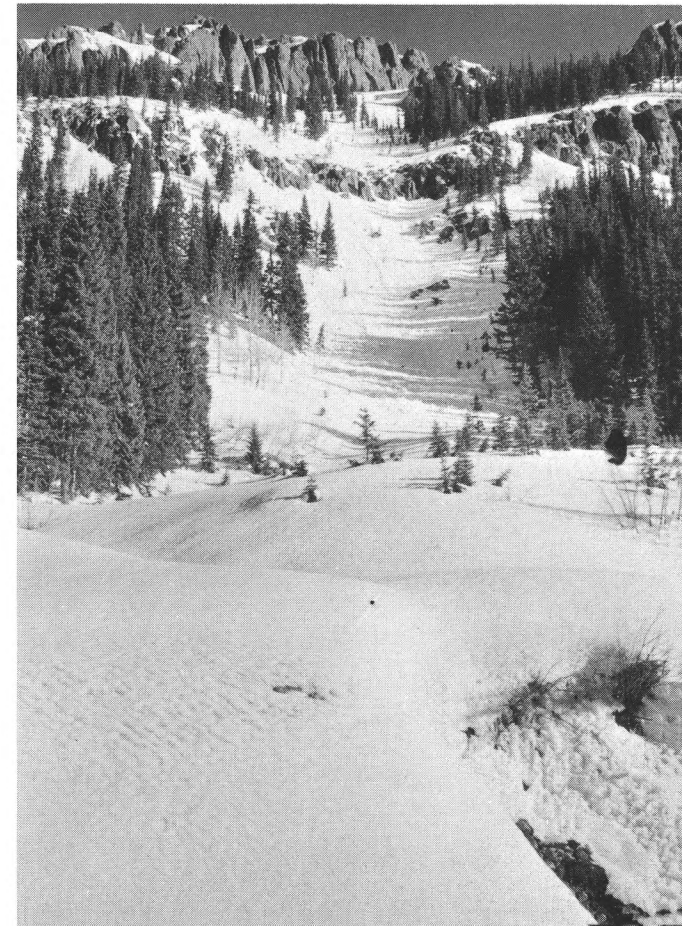
Control of starting zone may be difficult because the starting spots are rugged and indefinite. Since it is only a small avalanche, the possibilities of controlling the starting zone should be studied in more detail.

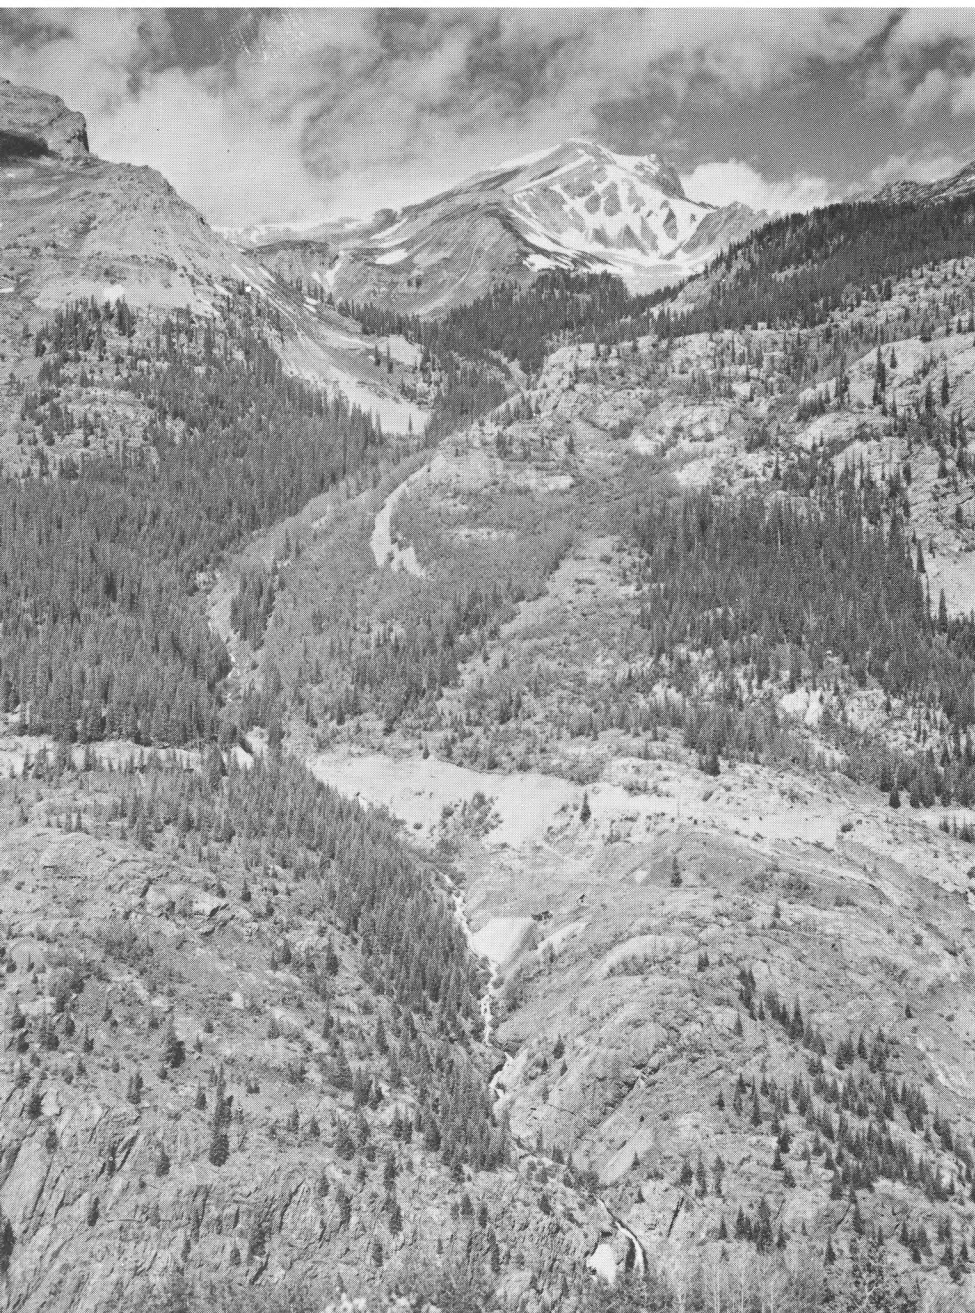
DEADWOOD (M-3)

*Highway No. 550 --
Molas Divide
Photo: July 4, 1962*

Terrain and vegetation conditions are favorable for supporting structures.

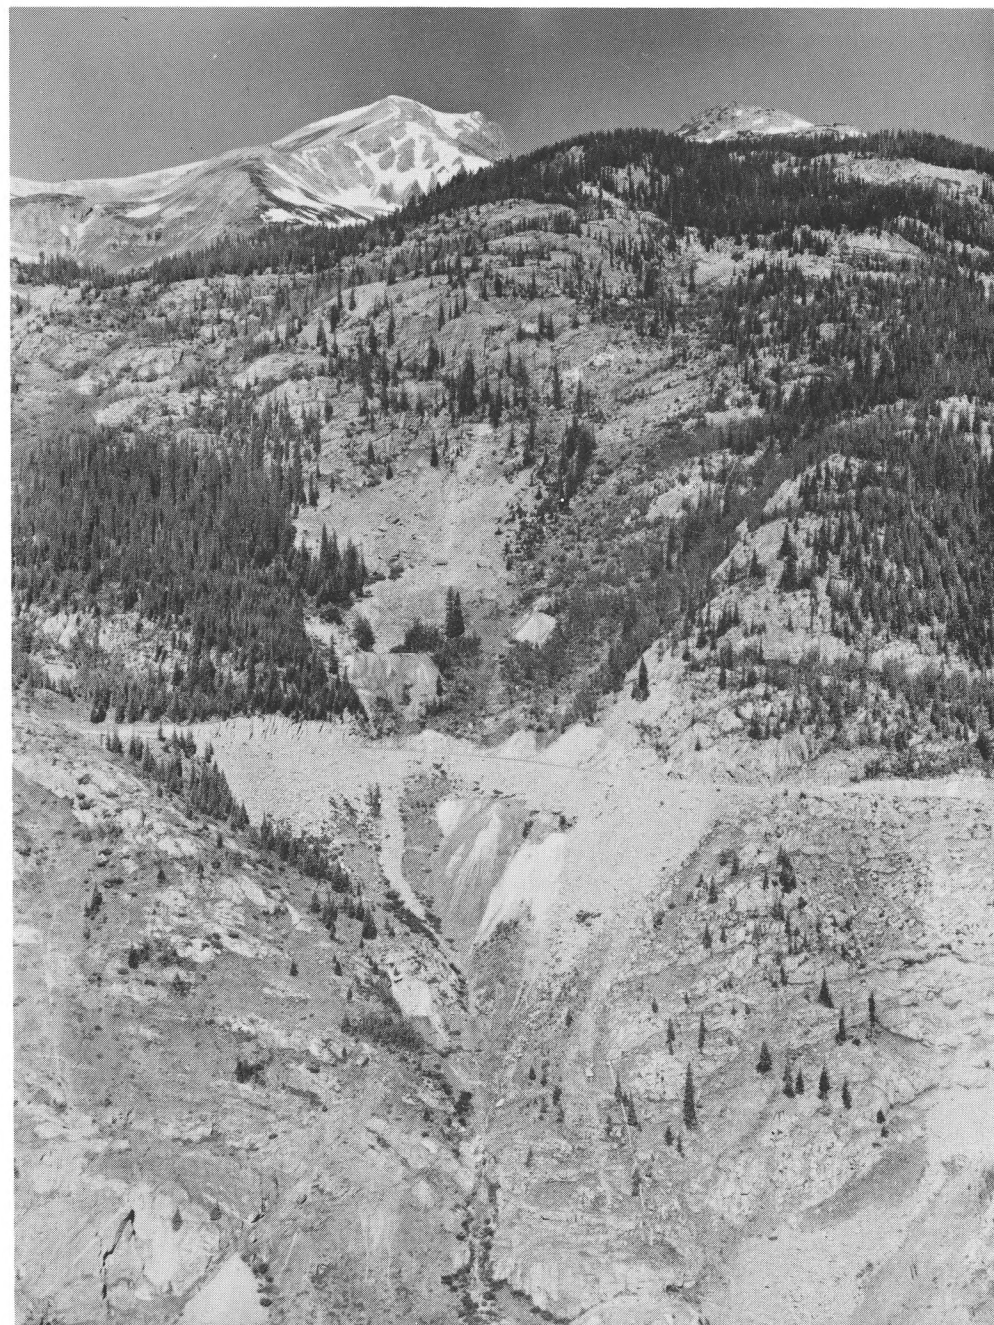
*Highway No. 550 --
Molas Divide
Photo: July 4, 1962*

Terrain conditions are favorable for installation
of supporting structures. Some field checks needed
to locate starting spots.

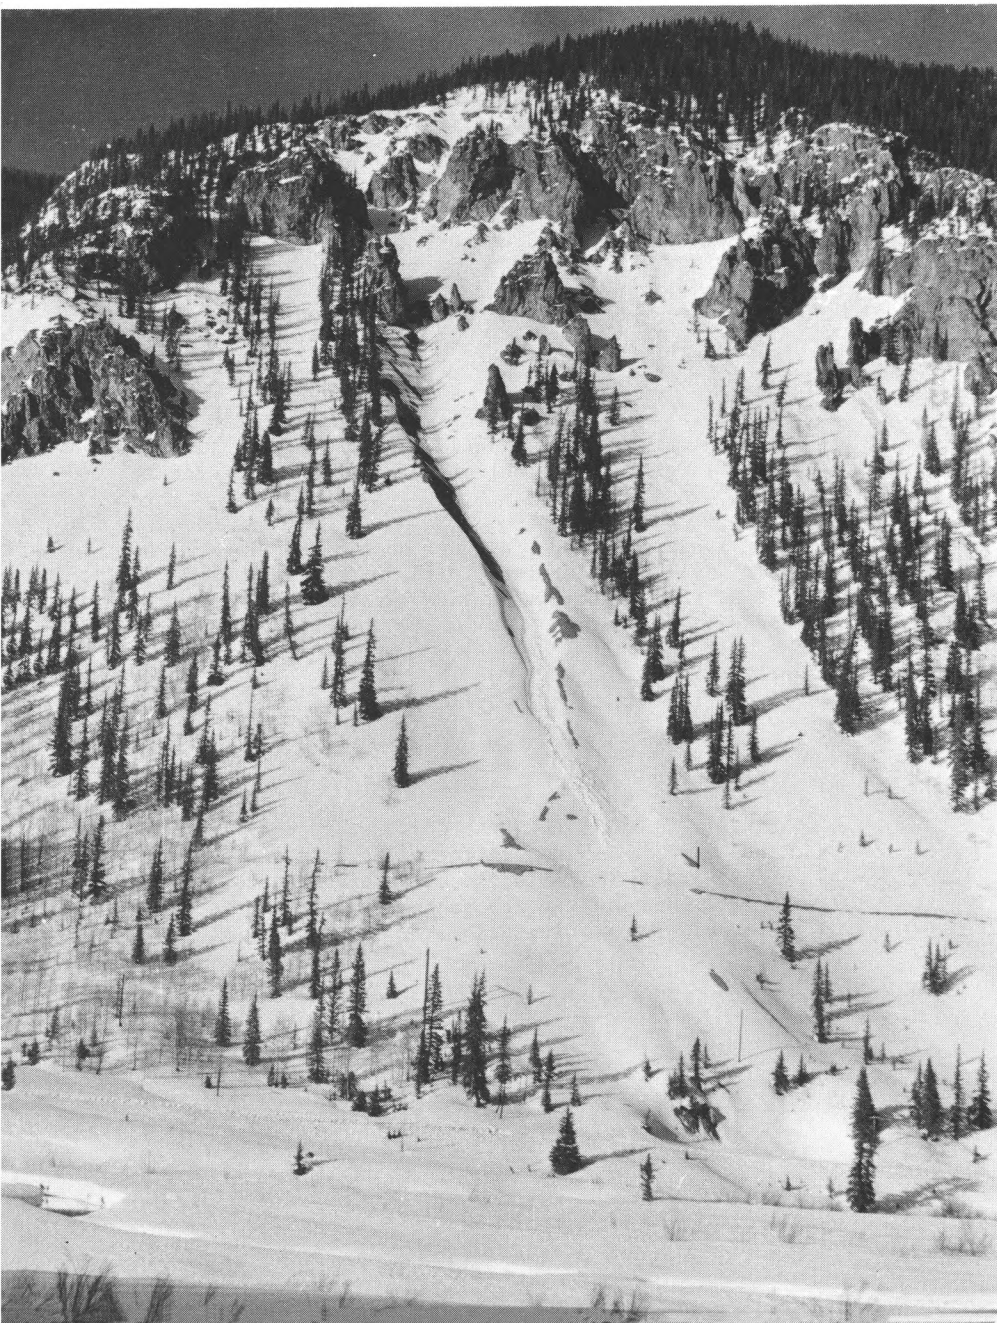
PIT (R-3)

*Highway No. 550 --
Red Mountain Pass
Photo: March 25, 1962*

Runs very seldom, but when it runs, very big snow masses with much debris are expected. If control is desired, the only possibility would be an avalanche shed.

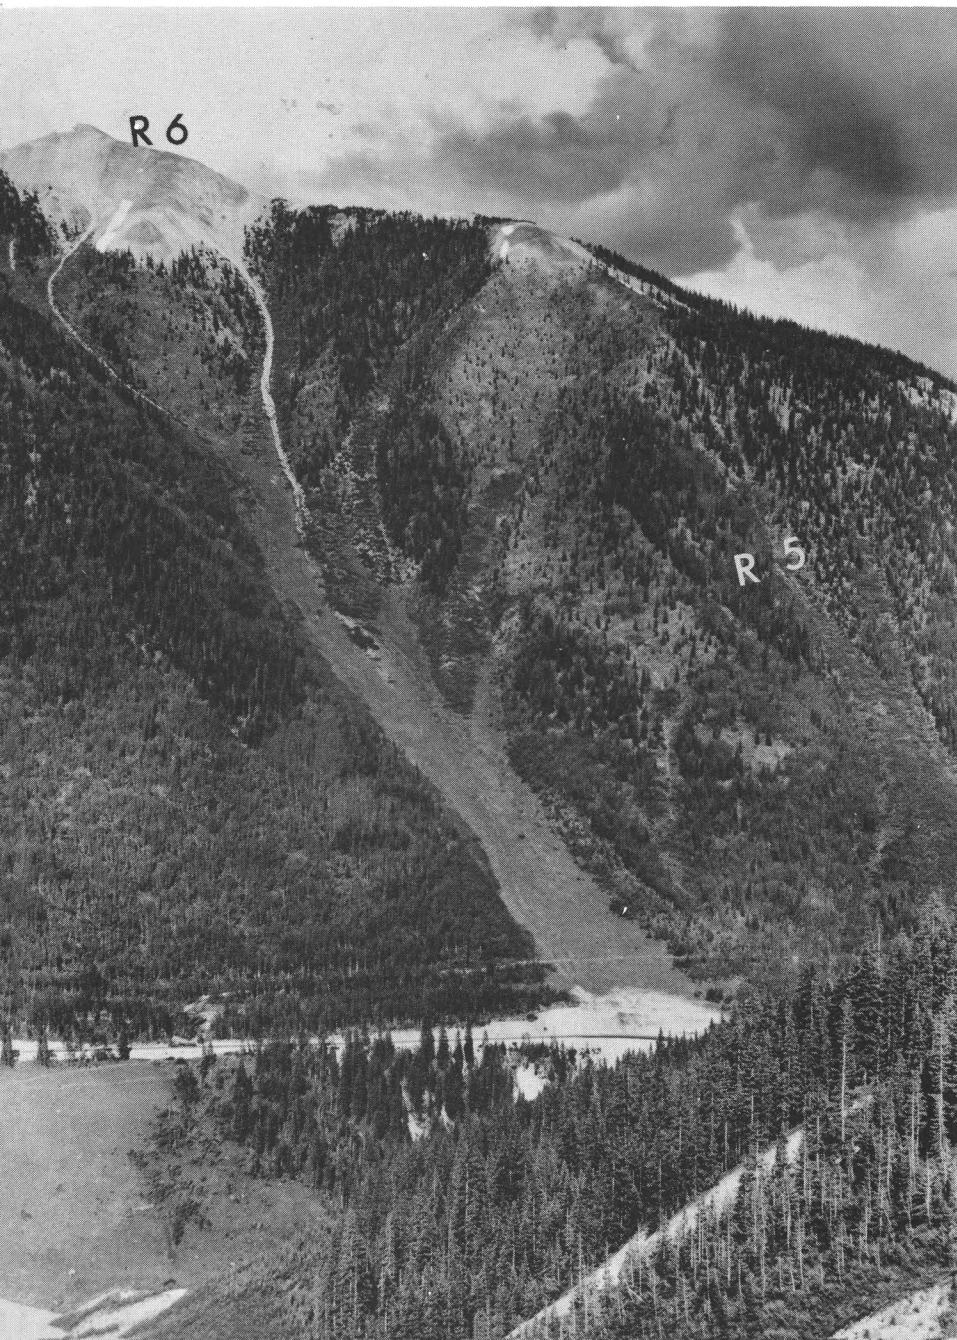
LOWER CEMENT FILL (R-5)

Highway No. 550 --
Red Mountain Pass
Photo: July 3, 1962

Supporting structures with afforestation of forest openings.
