U.S. Forest Service
Research Paper RM-7

Snow Avalanches Along Colorado Mountain Highways

by Hans Frutiger

ROCKY MOUNTAIN FOREST AND RANGE EXPERIMENT STATION
Fort Collins, Colorado
FOREST SERVICE

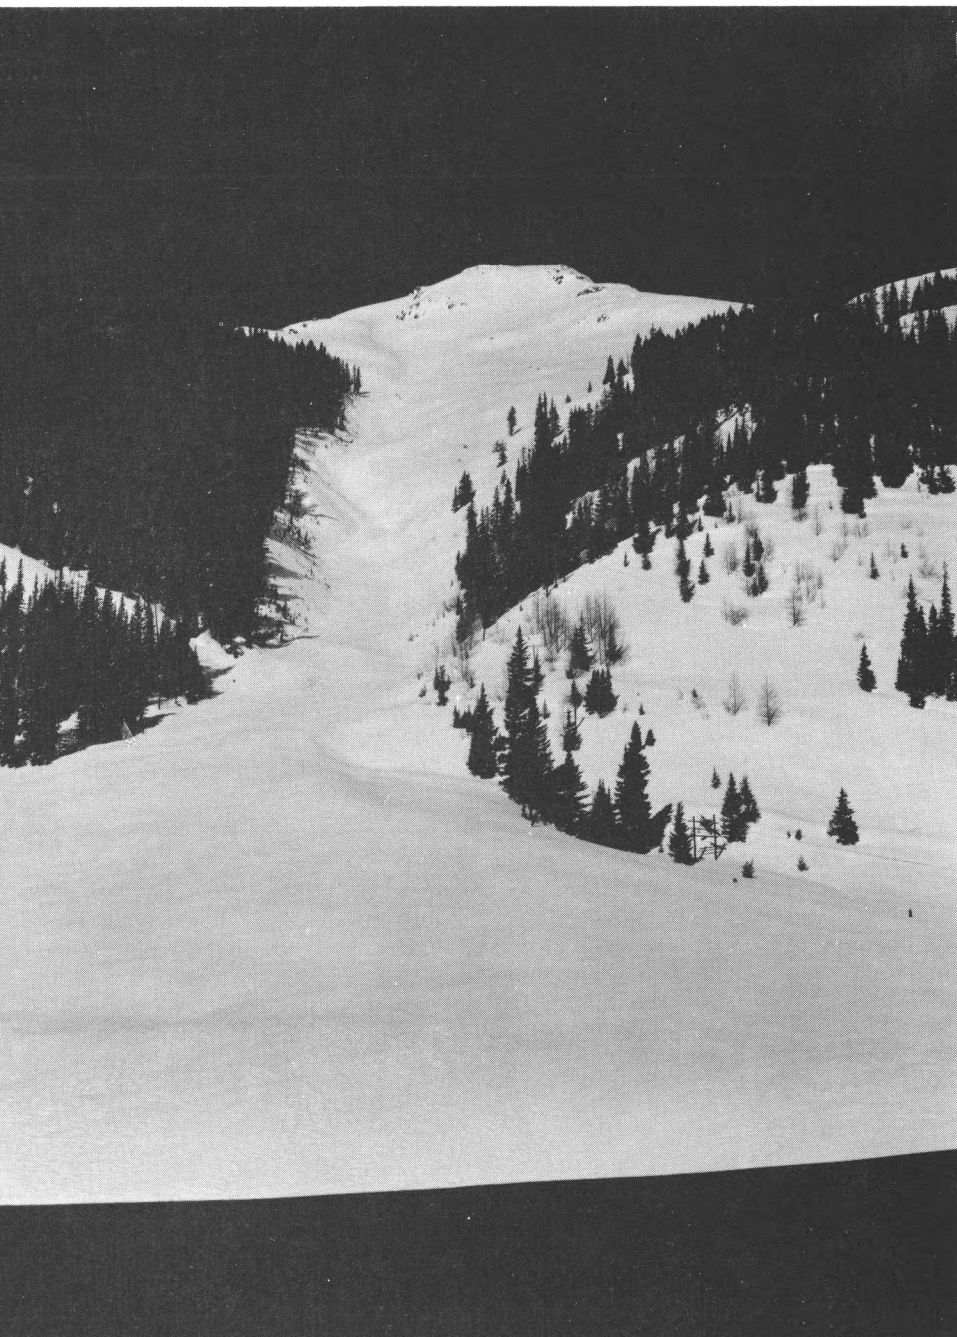
IMOGENE (R-9)

Highway No. 550 --
Red Mountain Pass
Photo: March 25, 1962

Although the rugged top of starting zones and scree slopes give some problems, control by supporting structures is possible for a considerable number of the tracks.

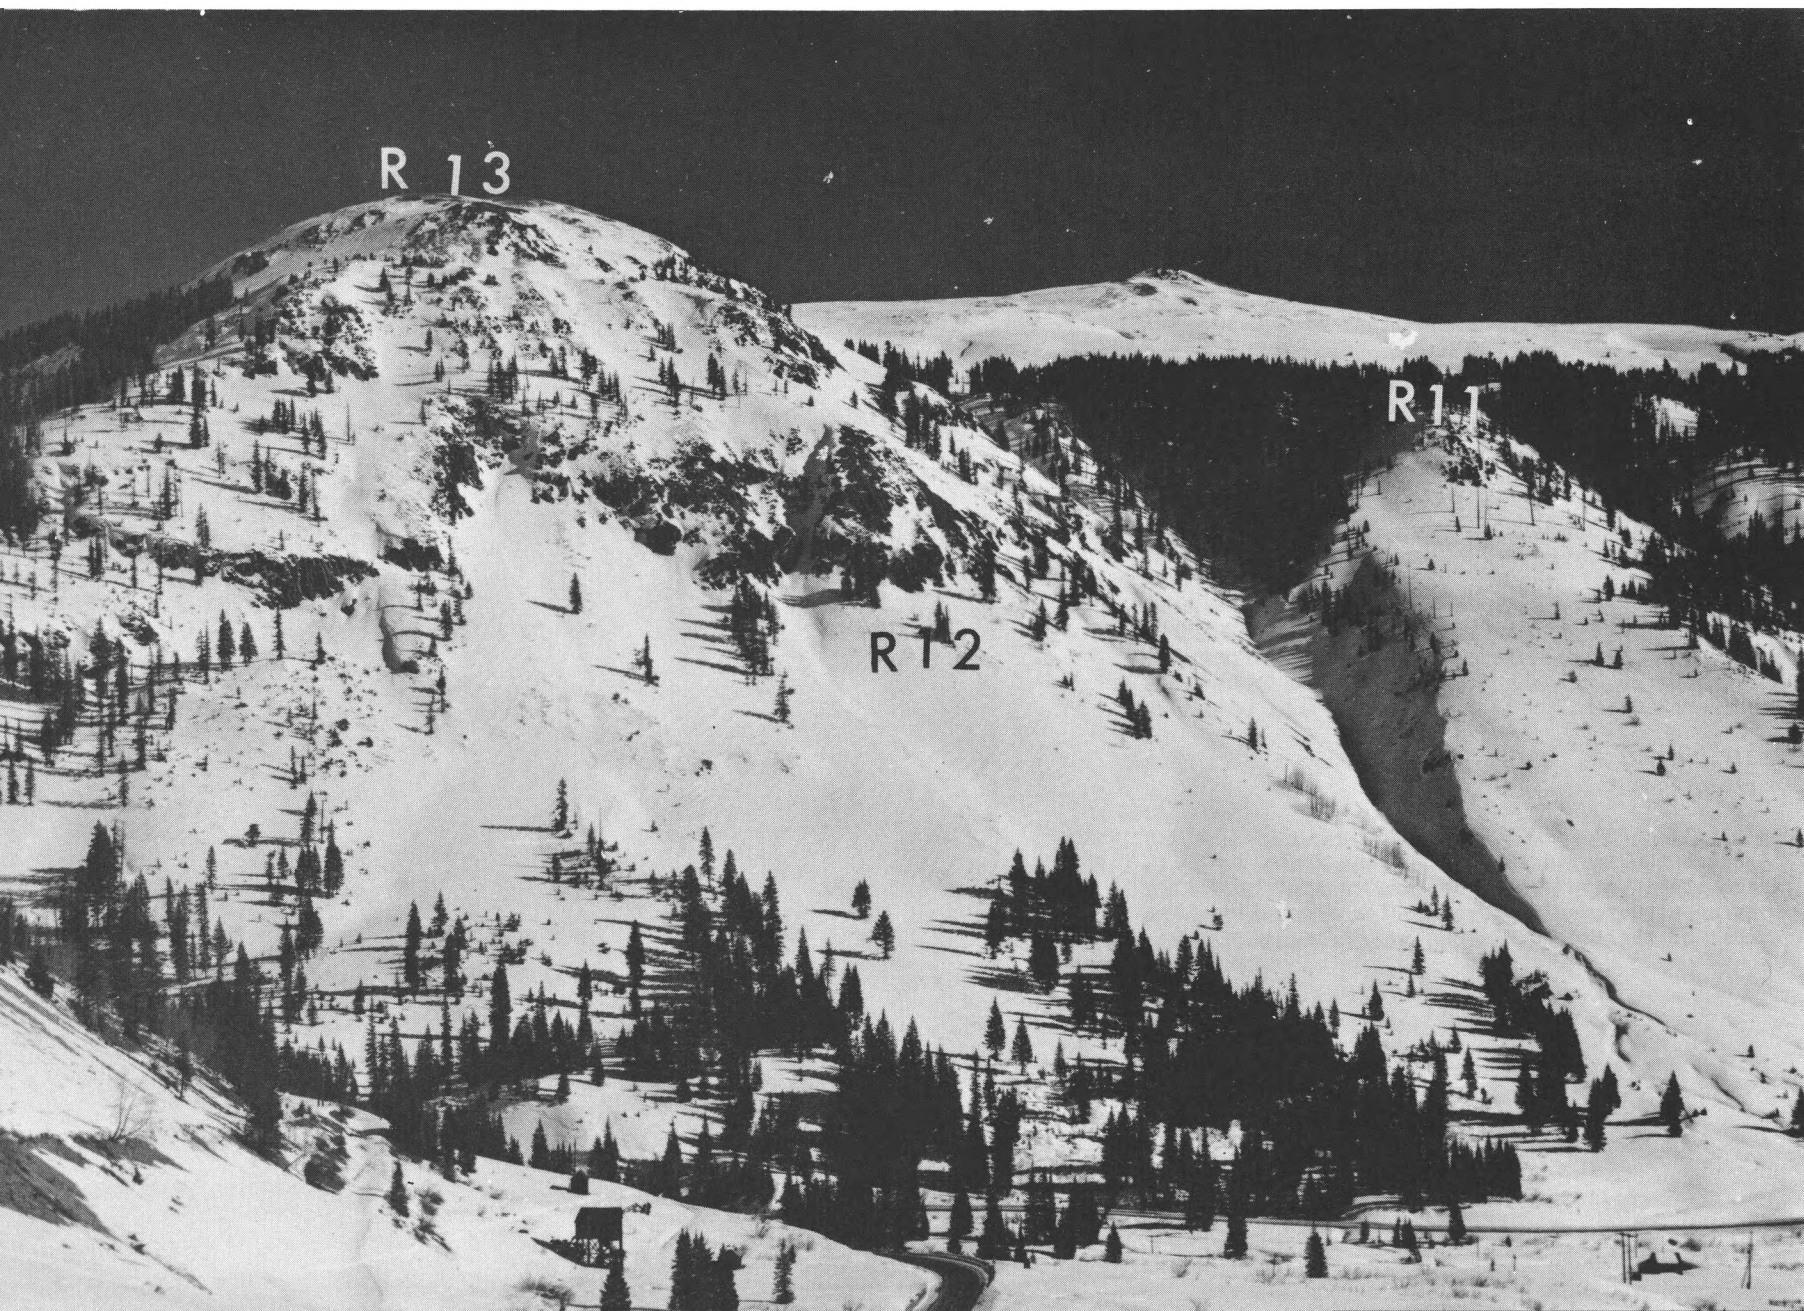
CEMETERY (R-11)

Highway No. 550 --
Red Mountain Pass
Photo: January 3, 1962

Supporting structures not recommended because of rugged starting zone; retarding structures might be possible.

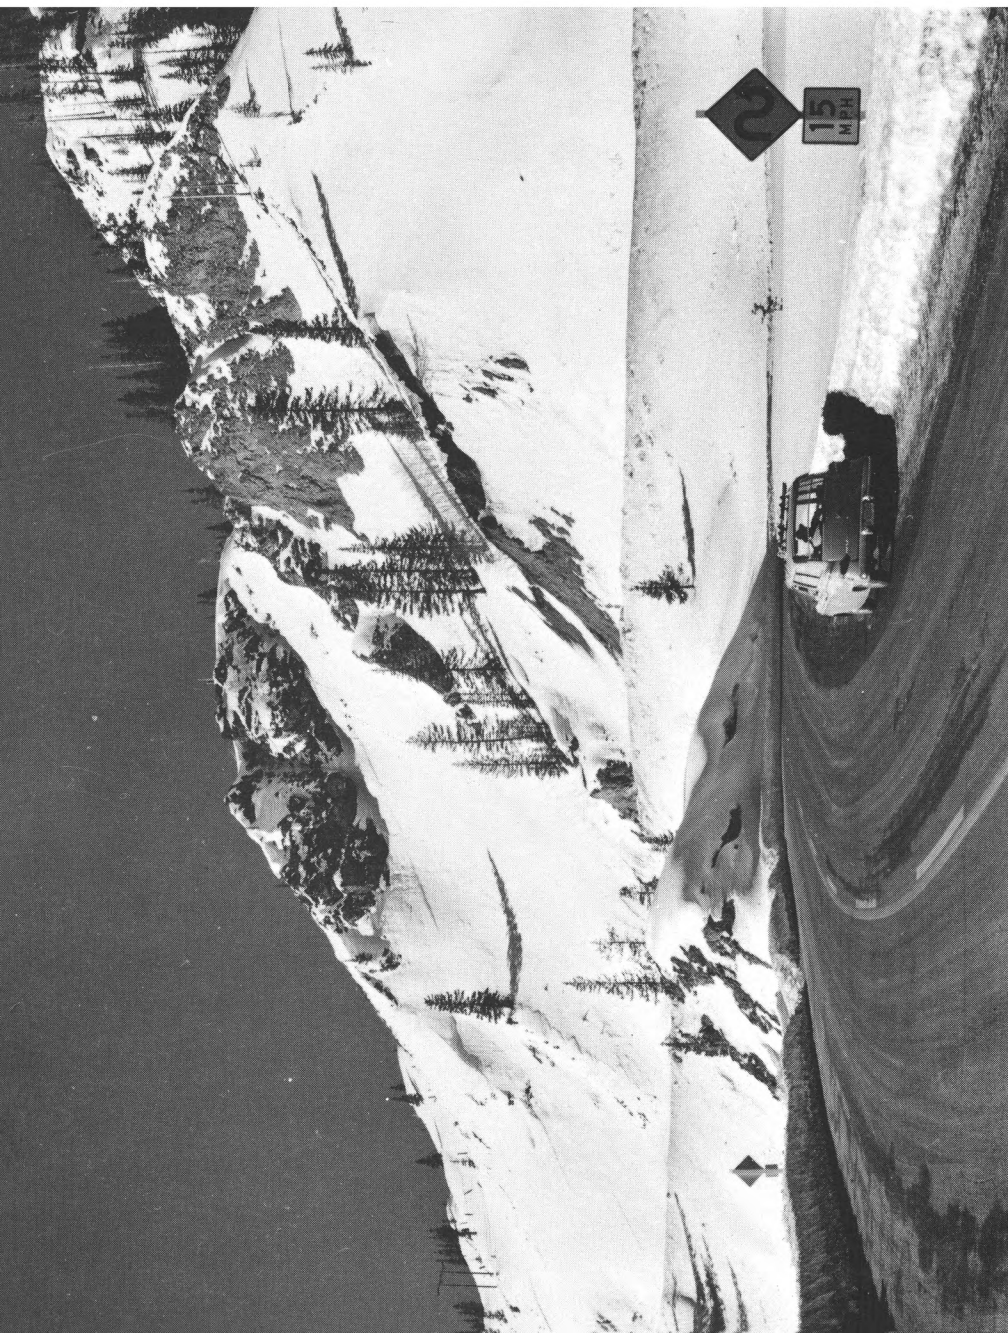
BLUE POINT (R-18)

*Highway No. 550 --
Red Mountain Pass
Photo: January 3, 1962*

Control of starting zone by supporting structures and afforestation; diversion dam could also be used to reduce number of supporting structures.

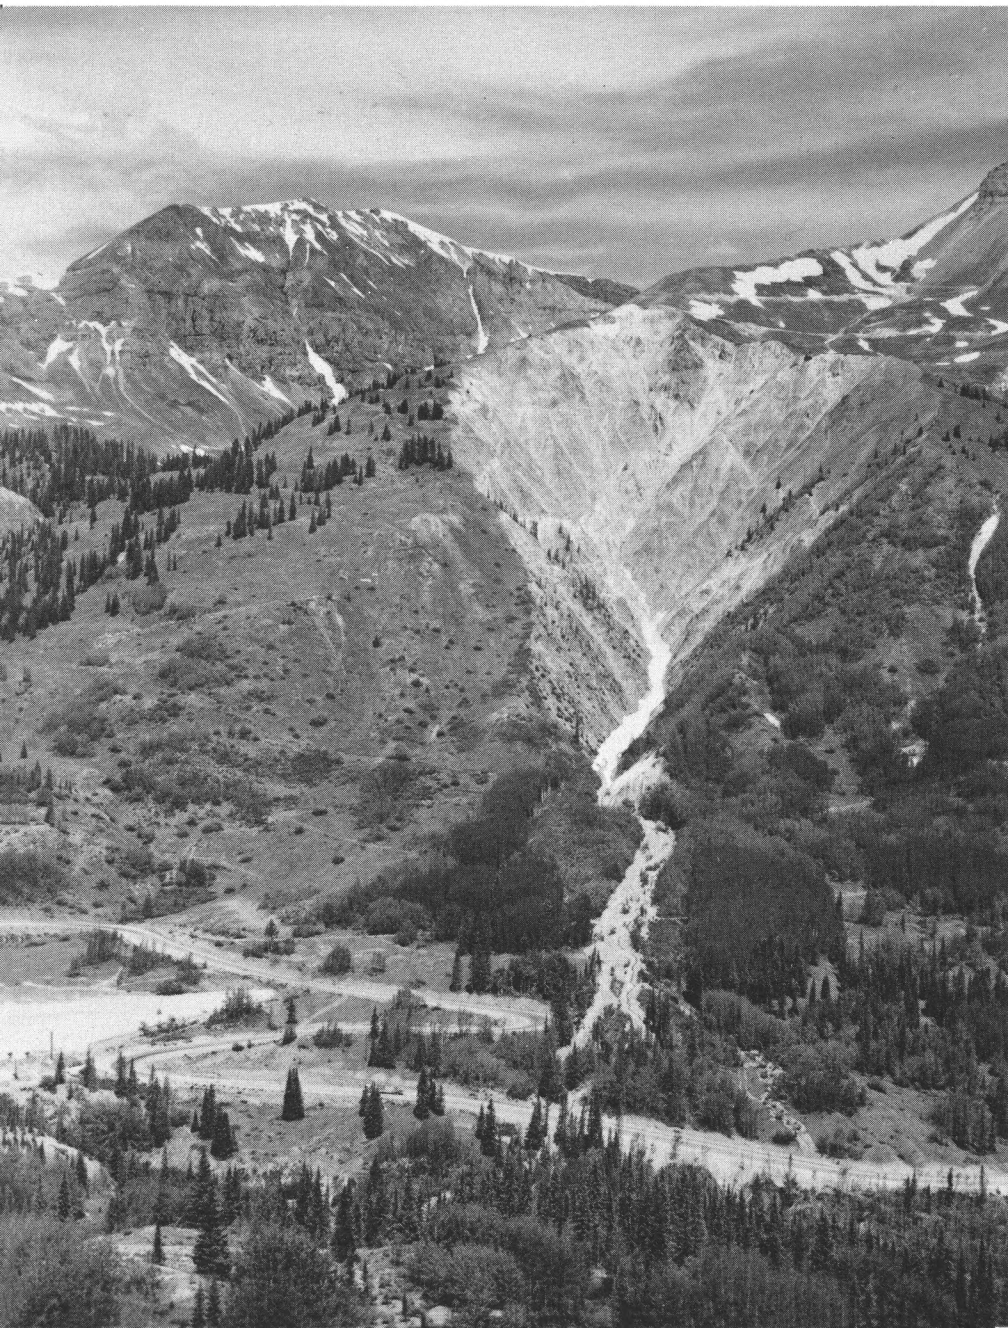
GOVERNOR GULCH (R-21)

*Highway No. 550 --
Red Mountain Pass
Photo: July 2, 1962*

Since the runout zone is very gentle and long, avalanches seldom reach the highway. A cut in the aspen stand shows that in exceptional situations it does happen, however. If control is considered necessary, the terrain features are favorable for diversion structures.

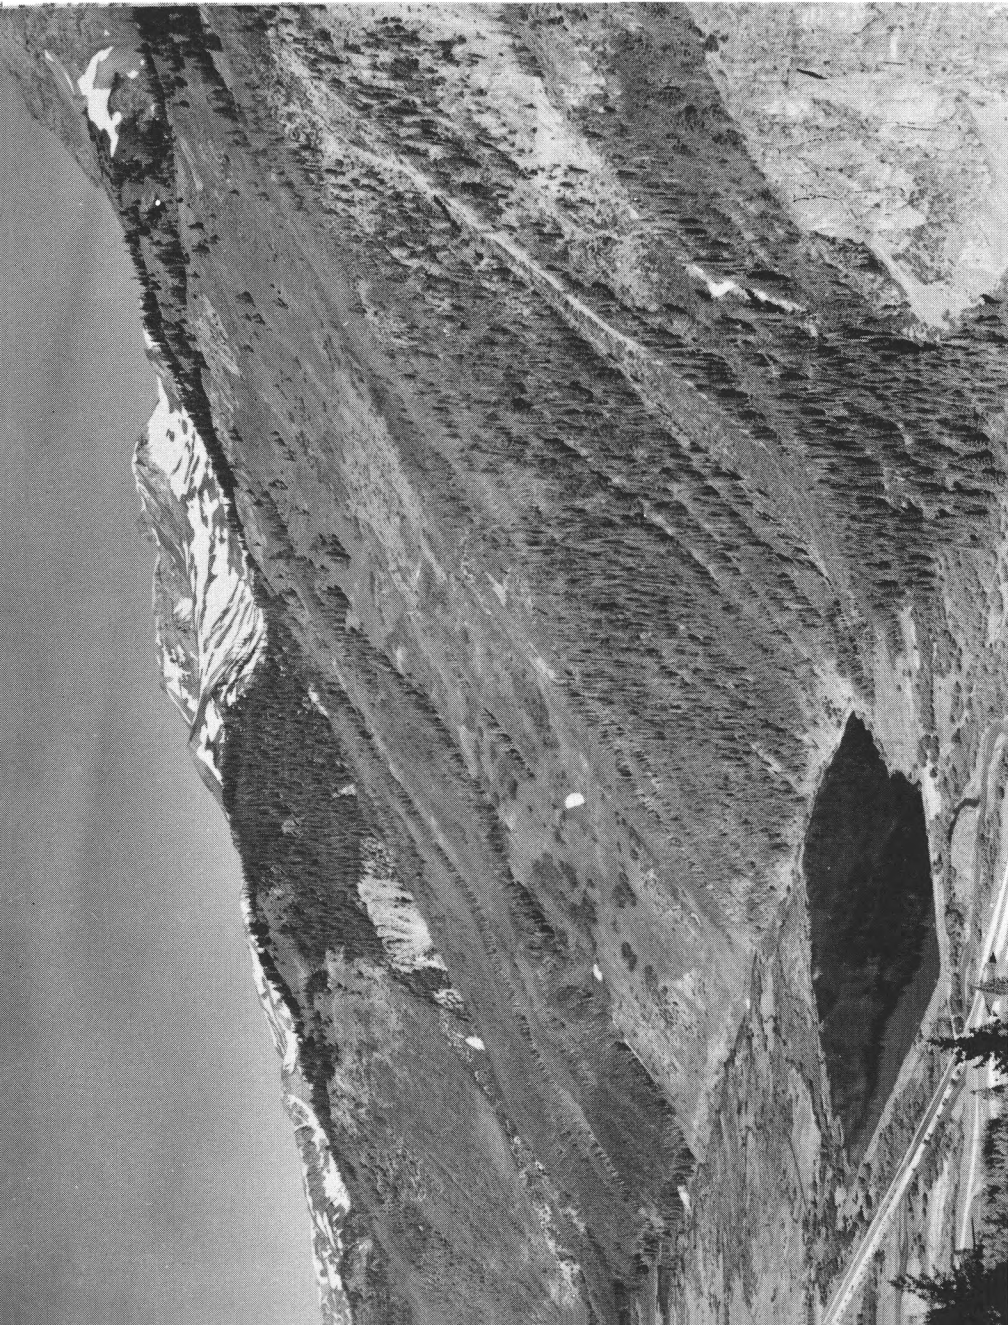
IRONTON PARK (R-23)

*Highway No. 550 --
Red Mountain Pass
Photo: July 3, 1962*

The only possible control is an avalanche shed, which would serve at the same time as protection against the EAST GUADALUPE avalanche.

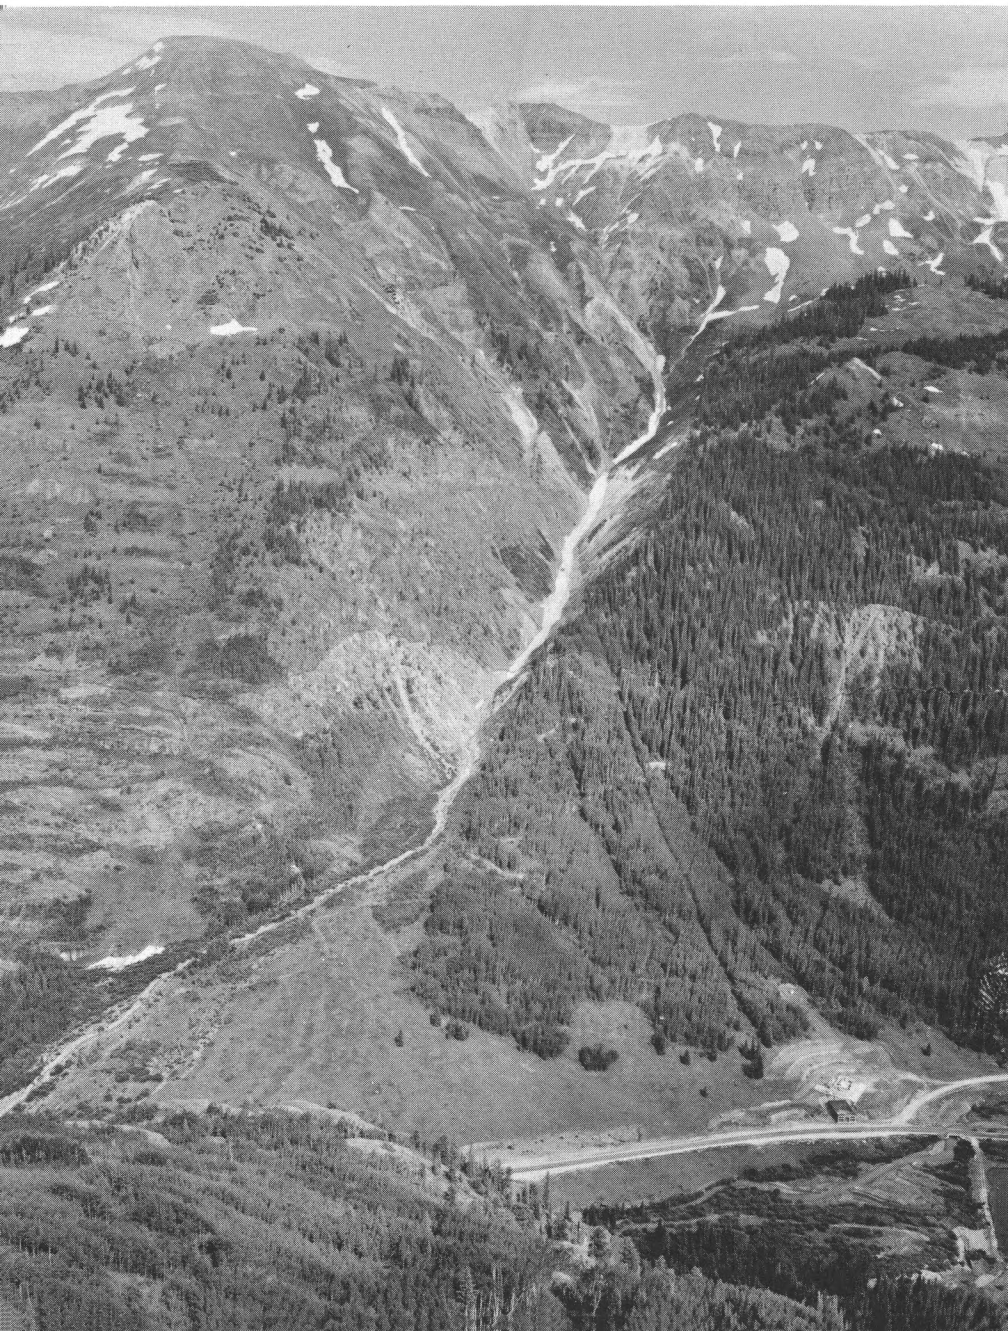
EAST GUADALUPE (R-25)

*Highway No. 550 --
Red Mountain Pass
Photo: July 2, 1962*

Control of the starting zone is possible. However, considering neighboring avalanches (EAST and WEST RIVERSIDE) the simplest solution would be a tunnel.

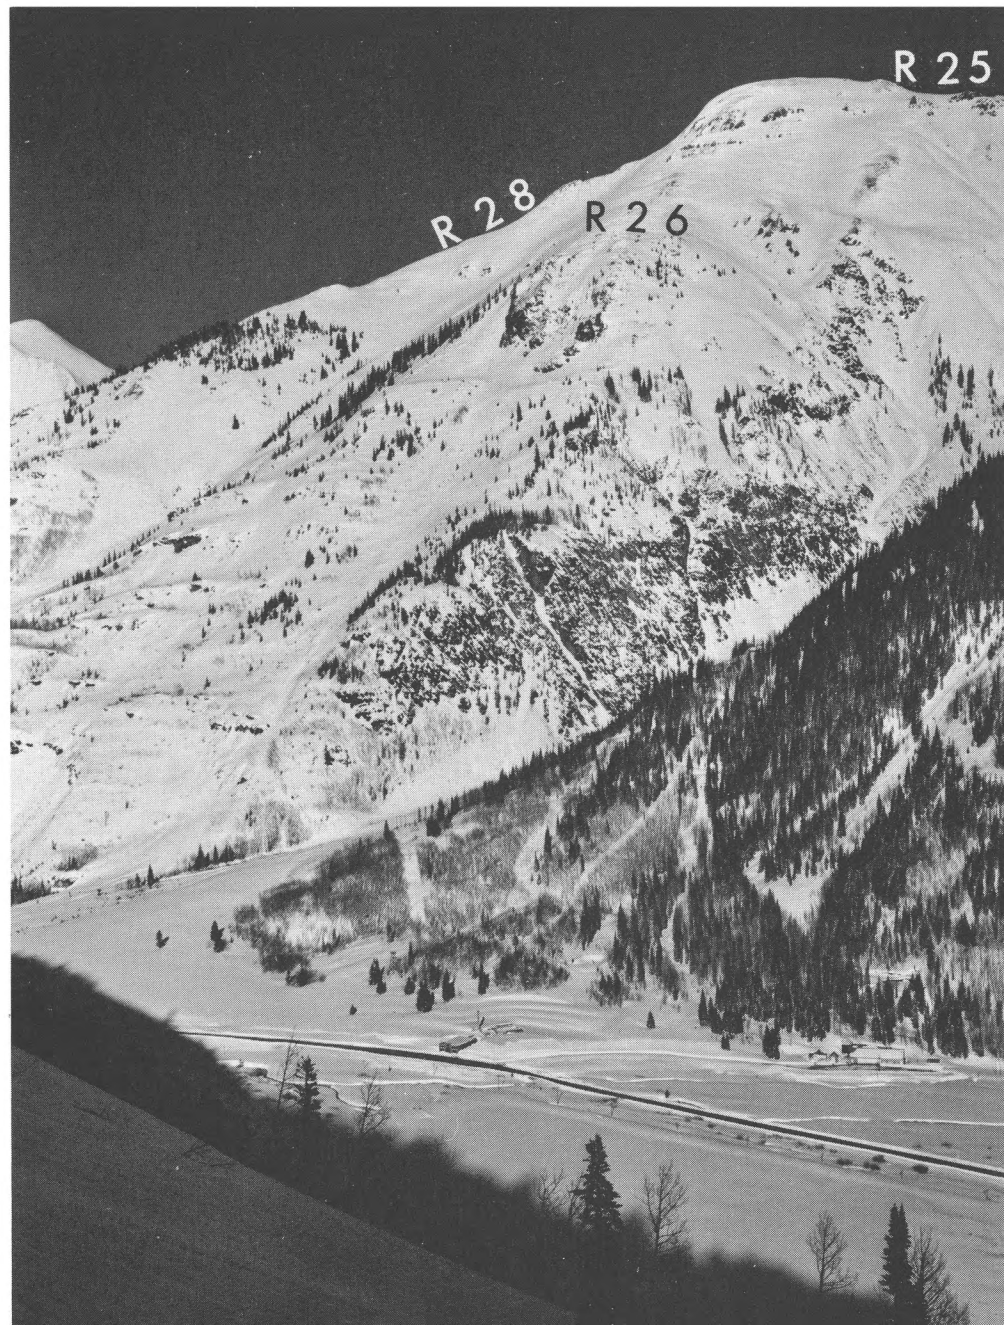
WEST RIVERSIDE (R-27)

Highway No. 550 --
Red Mountain Pass
Photo: July 3, 1962

Starting spots must be examined in more detail before any suggestions can be made. Since the starting zone is very rugged an avalanche shed seems the most logical structural defense.
