Chelemes Farms Subdivision

Rockery Analysis

**PREPARED FOR:
IVORY HOMES**

**PREPARED BY:
WILDING ENGINEERING**
14721 SOUTH HERITAGE CREST WAY
BLUFFDALE, UTAH 84065

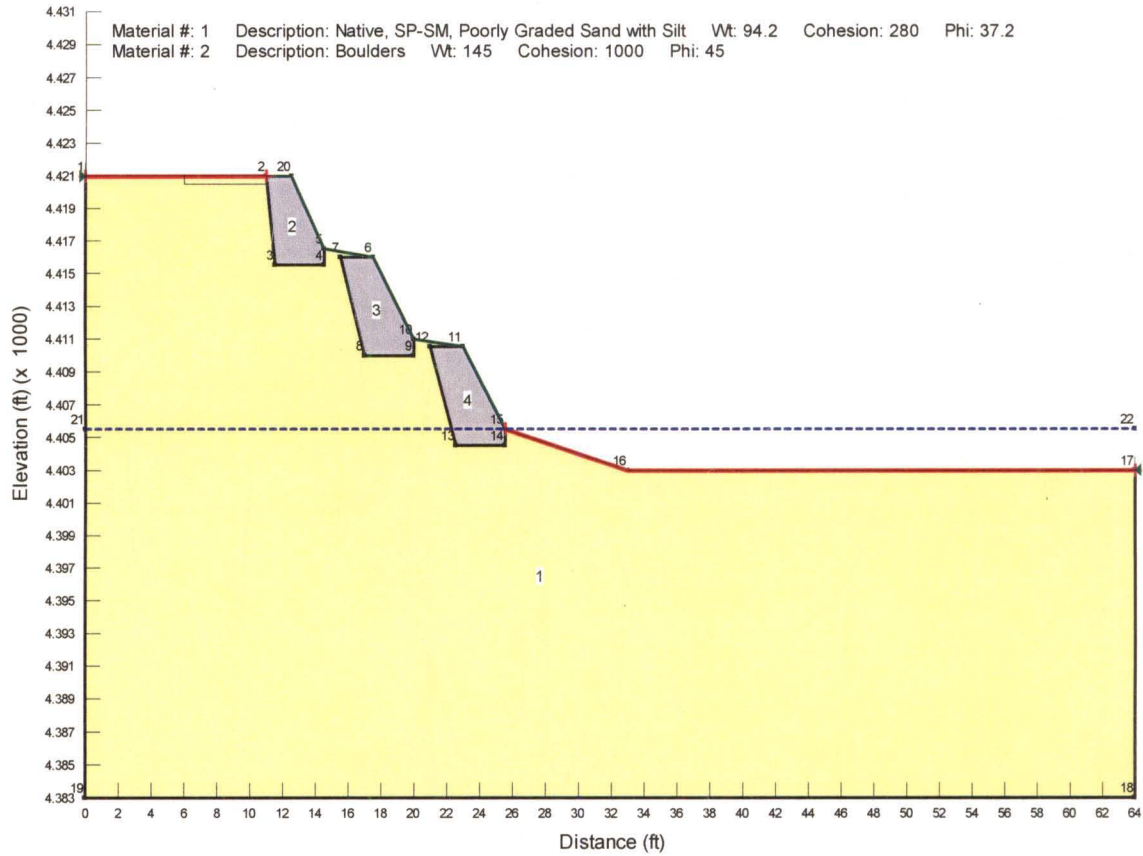
Figure 1 – Slope Model

Region 1 is comprised wholly of Material 1 as indicated in the figure. Regions 2, 3, and 4 are to be comprised of material 2. The piezometric surface is modeled by the blue line.

Slope/W software, a module of GeoStudio 2004, was used to perform the slope stability analysis. A sample of the onsite materials was obtained and classified as SP-SM, Poorly Graded Sand with Silt according to the Unified Soils Classification System. No indication of groundwater was observed while collecting this sample. A portion of this sample was remolded to 100% of the maximum dry density and 100% of the natural moisture. The soil strength parameters were integrated into a model of the proposed slope according to the results of direct shear testing (ASTM 3080-04) performed on the aforementioned remolded samples. The date of this testing was August 12, 2008. Parameters used for the soils in this analysis were 94.2 pcf for unit weight, 37.2° and 280 psf, for friction angle and apparent cohesion respectively. See appendix for lab results. In as much as the rockery is to be located adjacent a detention pond, the slope was modeled assuming the pond was completely full to emulate the worst case. A model of the slope using these strength parameters is presented in Figure 1.

An analysis after the Morgenstern-Price Method was specified to determine the factor of safety for this slope. The failure surface entry and exit range was specified as shown in red on Figure 1. The results of the static analysis are presented in Figure 2. The factor of safety for the critical circle was calculated to be 2.2. The critical circle is represented in Dark Green. The center of the potential failure circle is shown in the upper right corner of Figure 2 with its associated calculated factor of safety.
