## AUGUST 7 FLASH FLOOD NEAR ARCHES NATIONAL PARK, UTAH

*Paul Guardy, Superintendent, Arches National Park  
William F. Case, Utah Geological & Mineral Survey*

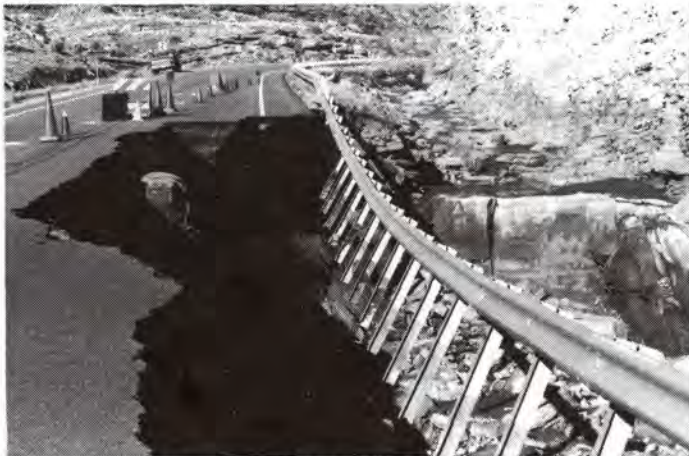
U. S. Highway 191 damage with the water gap to the right. Note the shallow channel which normally carries runoff without overflow (photo by Paul Guardy).

Bloody Mary Wash, with a total drainage area of only about six square miles, also received rainfall. The wash parallels U.S. Highway 191 from the junction with Highway 313 to the Colorado River, a few miles north of Moab. Bloody Mary Wash makes a severe bend as it enters Moab Canyon through a normally dry water gap in the cliffs near the Arches National Park visitor's center. A 1000-foot-long natural raceway eroded in a limestone member of the Pennsylvanian Hermosa Formation, constriction of flow, and a 15-20-foot drop at the water gap worked like a nozzle of a fire hose at the gap. Highway fill

and the north lane of U.S. Highway 191 were eroded away as the water ran through the gap, swirled in a plunge pool, and deposited a boulder-bar directly downstream. The water faced one more barrier as it ran toward the Colorado. A culvert constructed by the Civilian Conservation Corps lies beneath the Arches National Park entrance road. The arched opening is about 20 feet square but could not carry the flow. Water backed up into a large pool, which slowed the flow and may have prevented further damage downstream. The culvert was partially undermined and suffered several thousand dollars damage. Water came within 6 inches of flooding the Arches National Park entrance road. Peak flow in Bloody Mary Wash was estimated to be approximately 54,000 cubic feet/second.

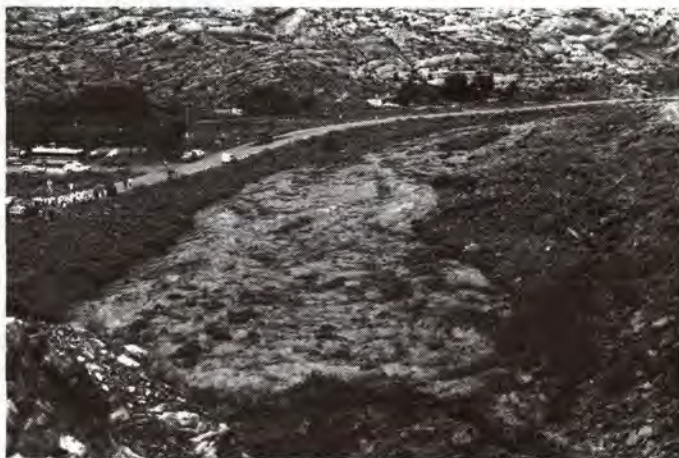
Flood water from Bloody Mary Wash going towards the culvert. Arches entrance road is on left (photo by Paul Guardy).

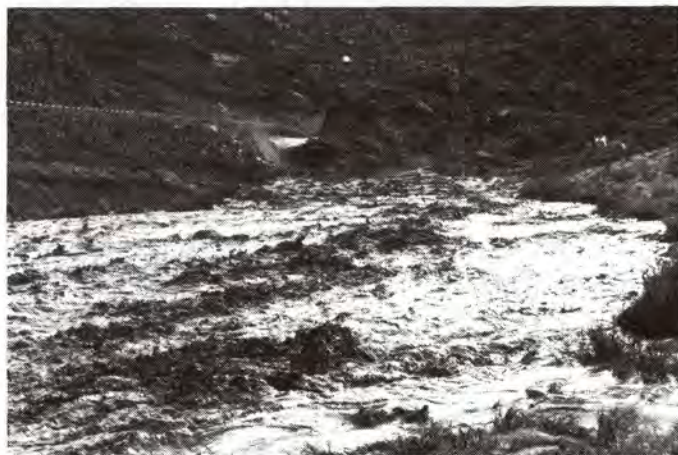
Flash flood waters coming through the Bloody Mary Wash water gap (photo by Paul Guardy).
