**REPORT
GEOTECHNICAL STUDY AND
SLOPE STABILITY ANALYSIS
PROPOSED WASATCH ROCK DEVELOPMENT
6695 WASATCH BOULEVARD
COTTONWOOD HEIGHTS, UTAH**

May 13, 2020

Job No. 528-005-20

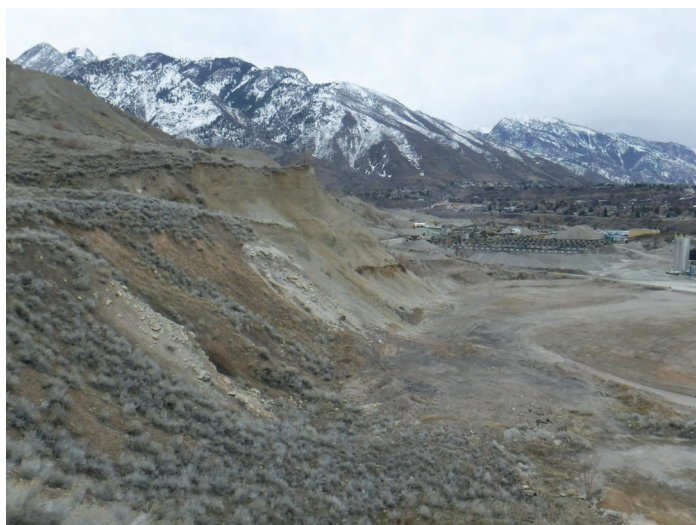
#1 Looking south.

Representative photographs of the site area are shown on Figure 6, Photographs.

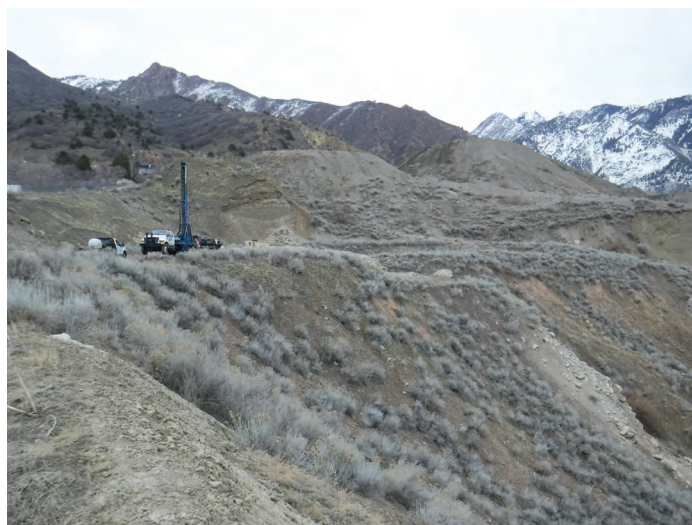
#2 Looking east/southeast.

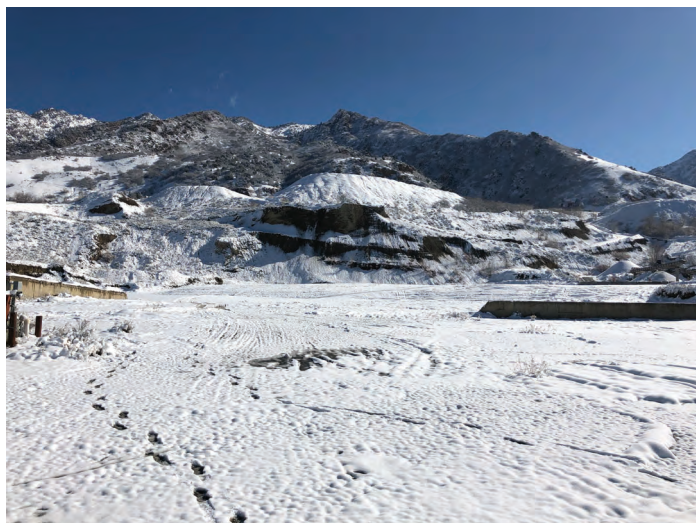
#3 Looking east.

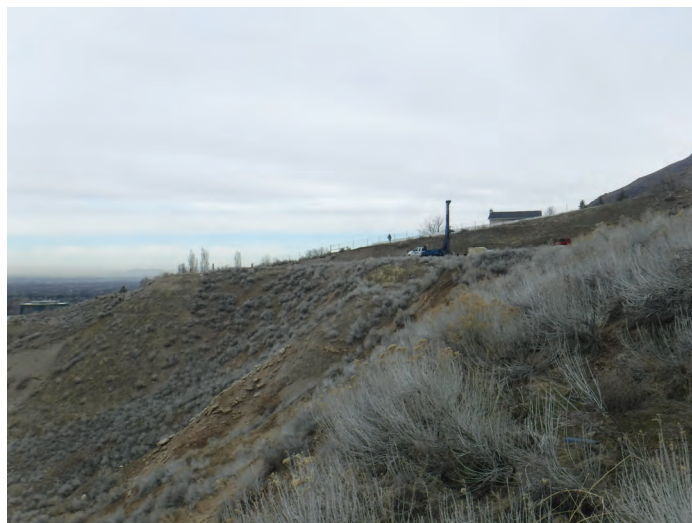
FIGURE 6 PHOTOGRAPHS

#4 Looking north.

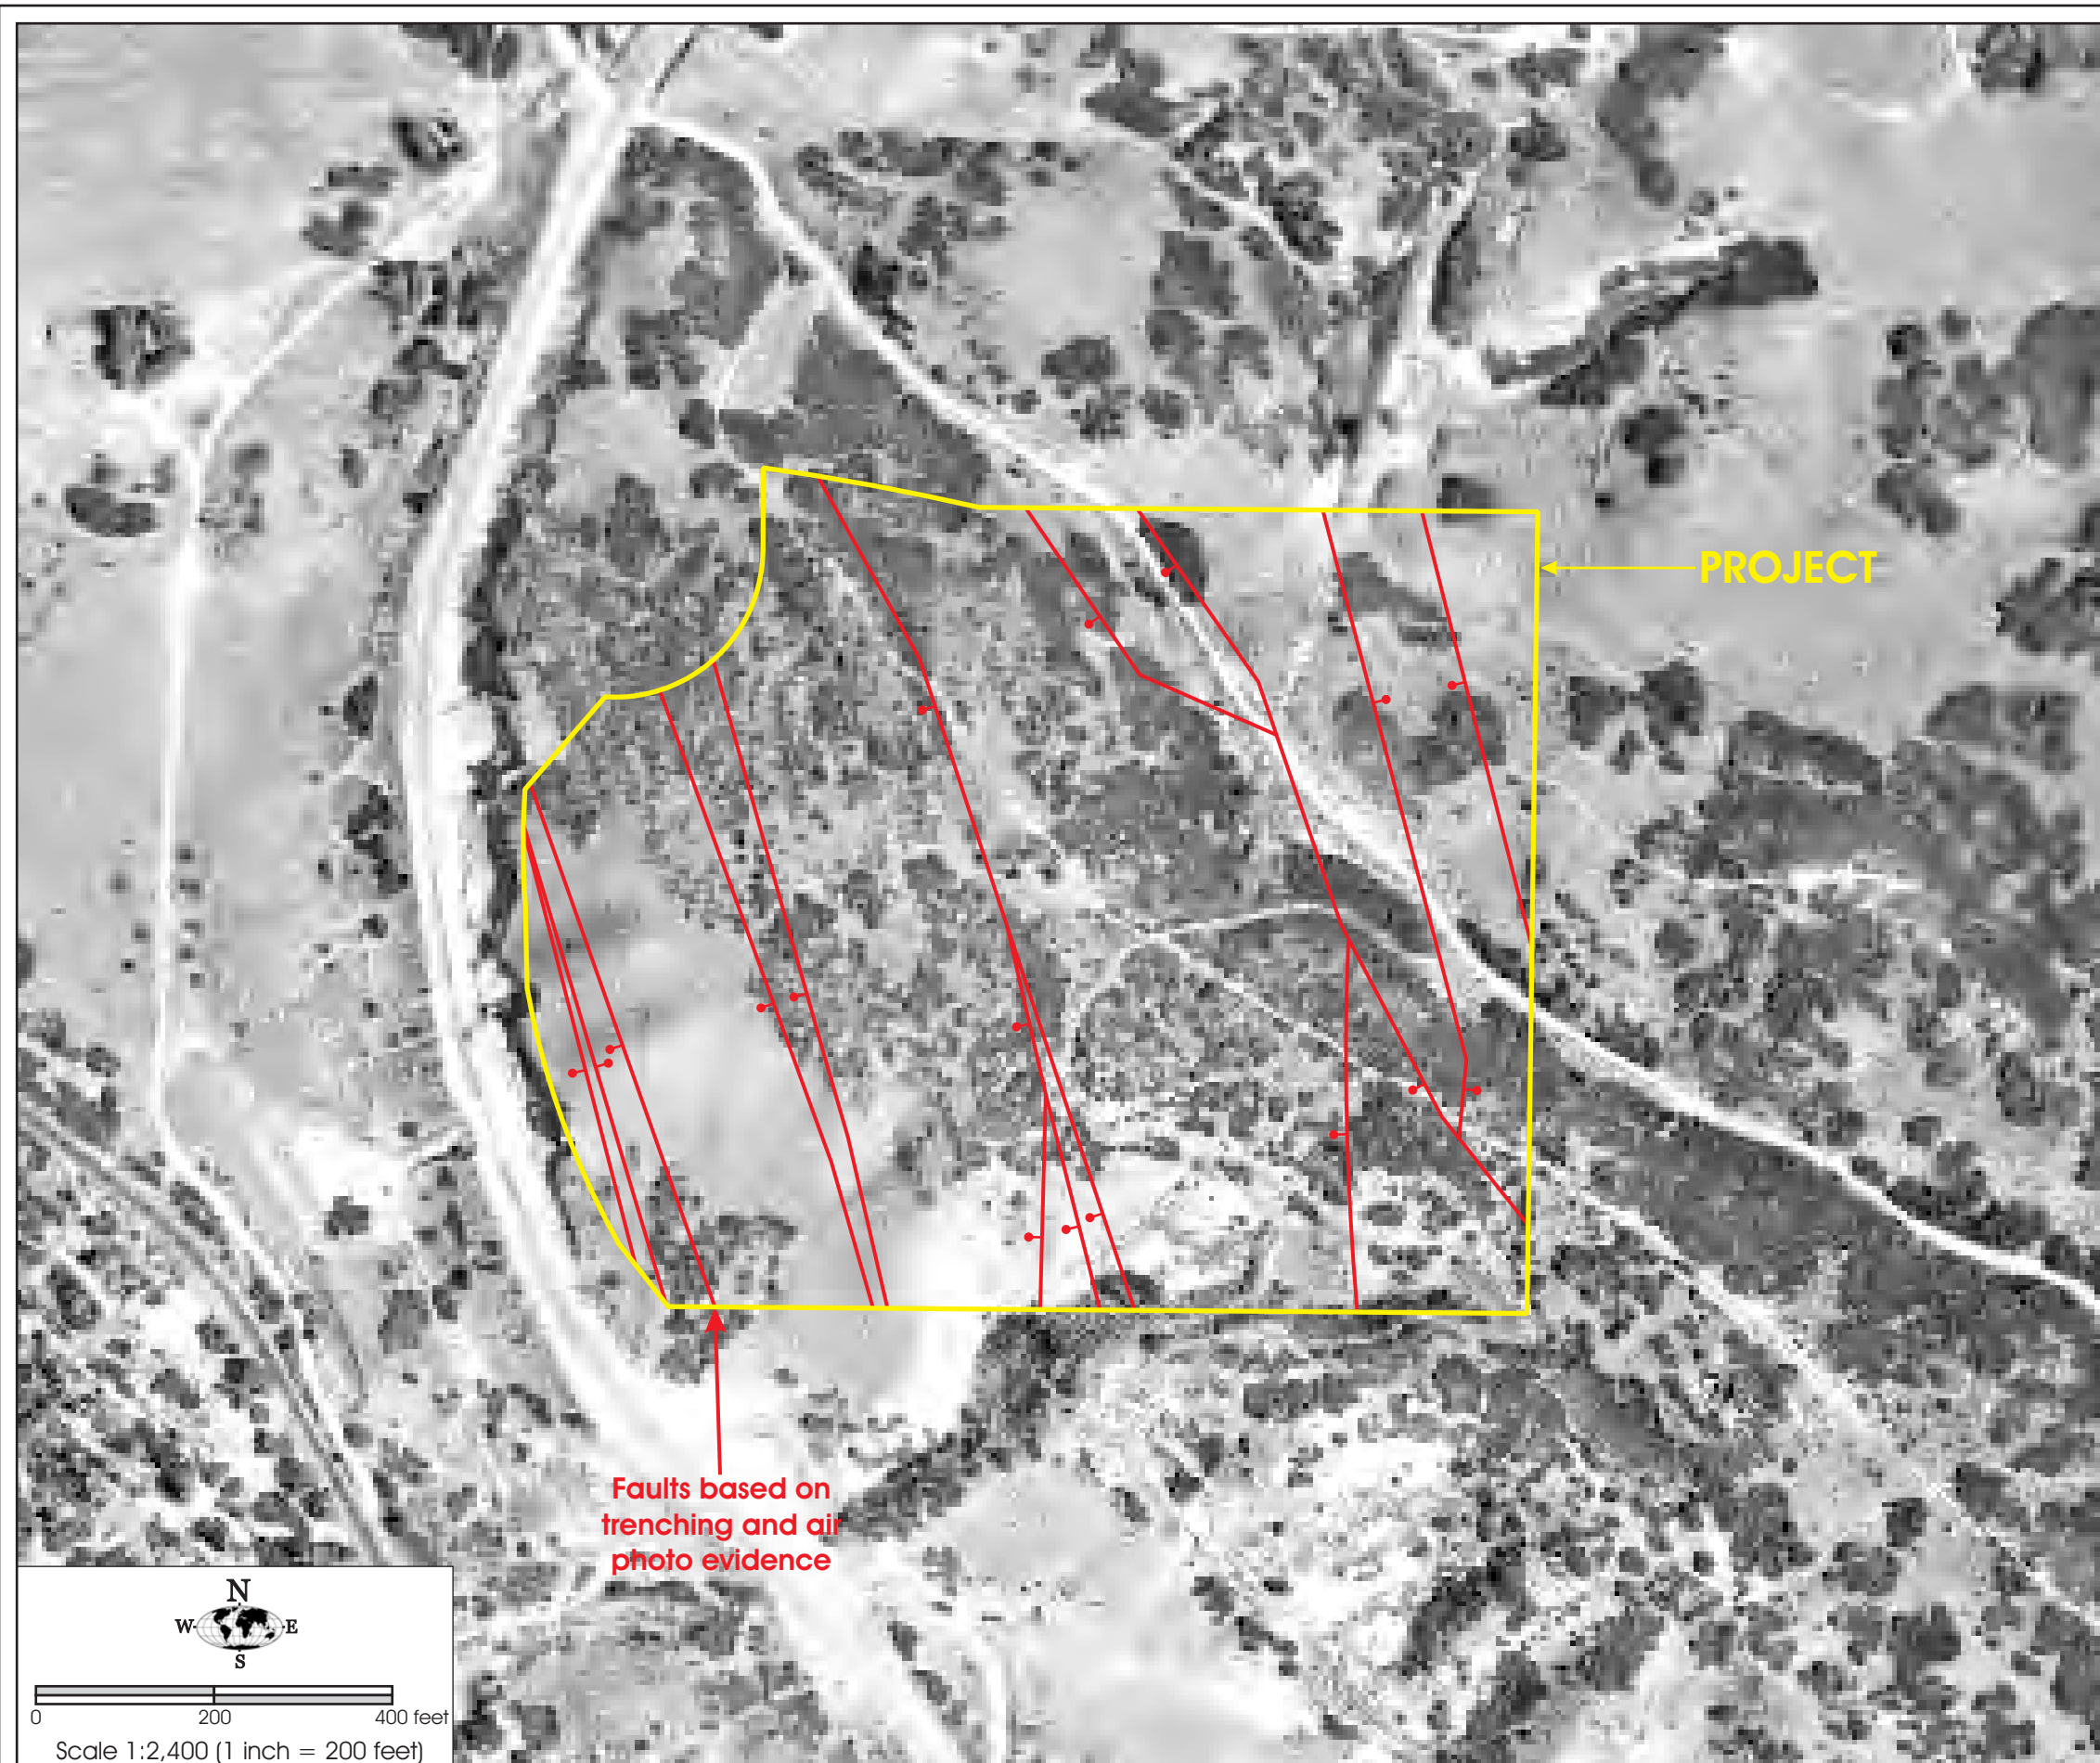
FIGURE 3A

Air Photo Source: 1938 U.S. Bureau of Reclamation Salt Lake Aqueduct historical photography, reproduced and georeferenced in Bowman and Beisner (2008), frame sla1-20, approximate original scale 1:20,000.

1938 AIR PHOTO

Figure 3A shows a 1938 pre-gravel mining air photo of the site from historical photography flown for the Salt Lake Aqueduct Project (frames sla1-20 and sla1-21, original scale 1:20,000; Bowman and Beisner, 2008). The air photo center was approximately registered to the UTM NAD83 grid system by Bowman and Beisner (2008). However, we further adjusted the photo scale, rotation, and placement to correspond to range front bedrock exposures evident on the 1938 photos and 2006 U.S. Geological Survey digital orthophotography available from Utah AGRC. The 1938 photos were then enlarged and overlaid with the site boundary for stereo viewing. Several northwest-trending escarpments were observed on Figure 3A crossing the site, which correspond to locations of significant faults encountered in the trenches (discussed below and shown in red, with bar and ball on downthrown side). Except for some broad correlations, surficial faulting

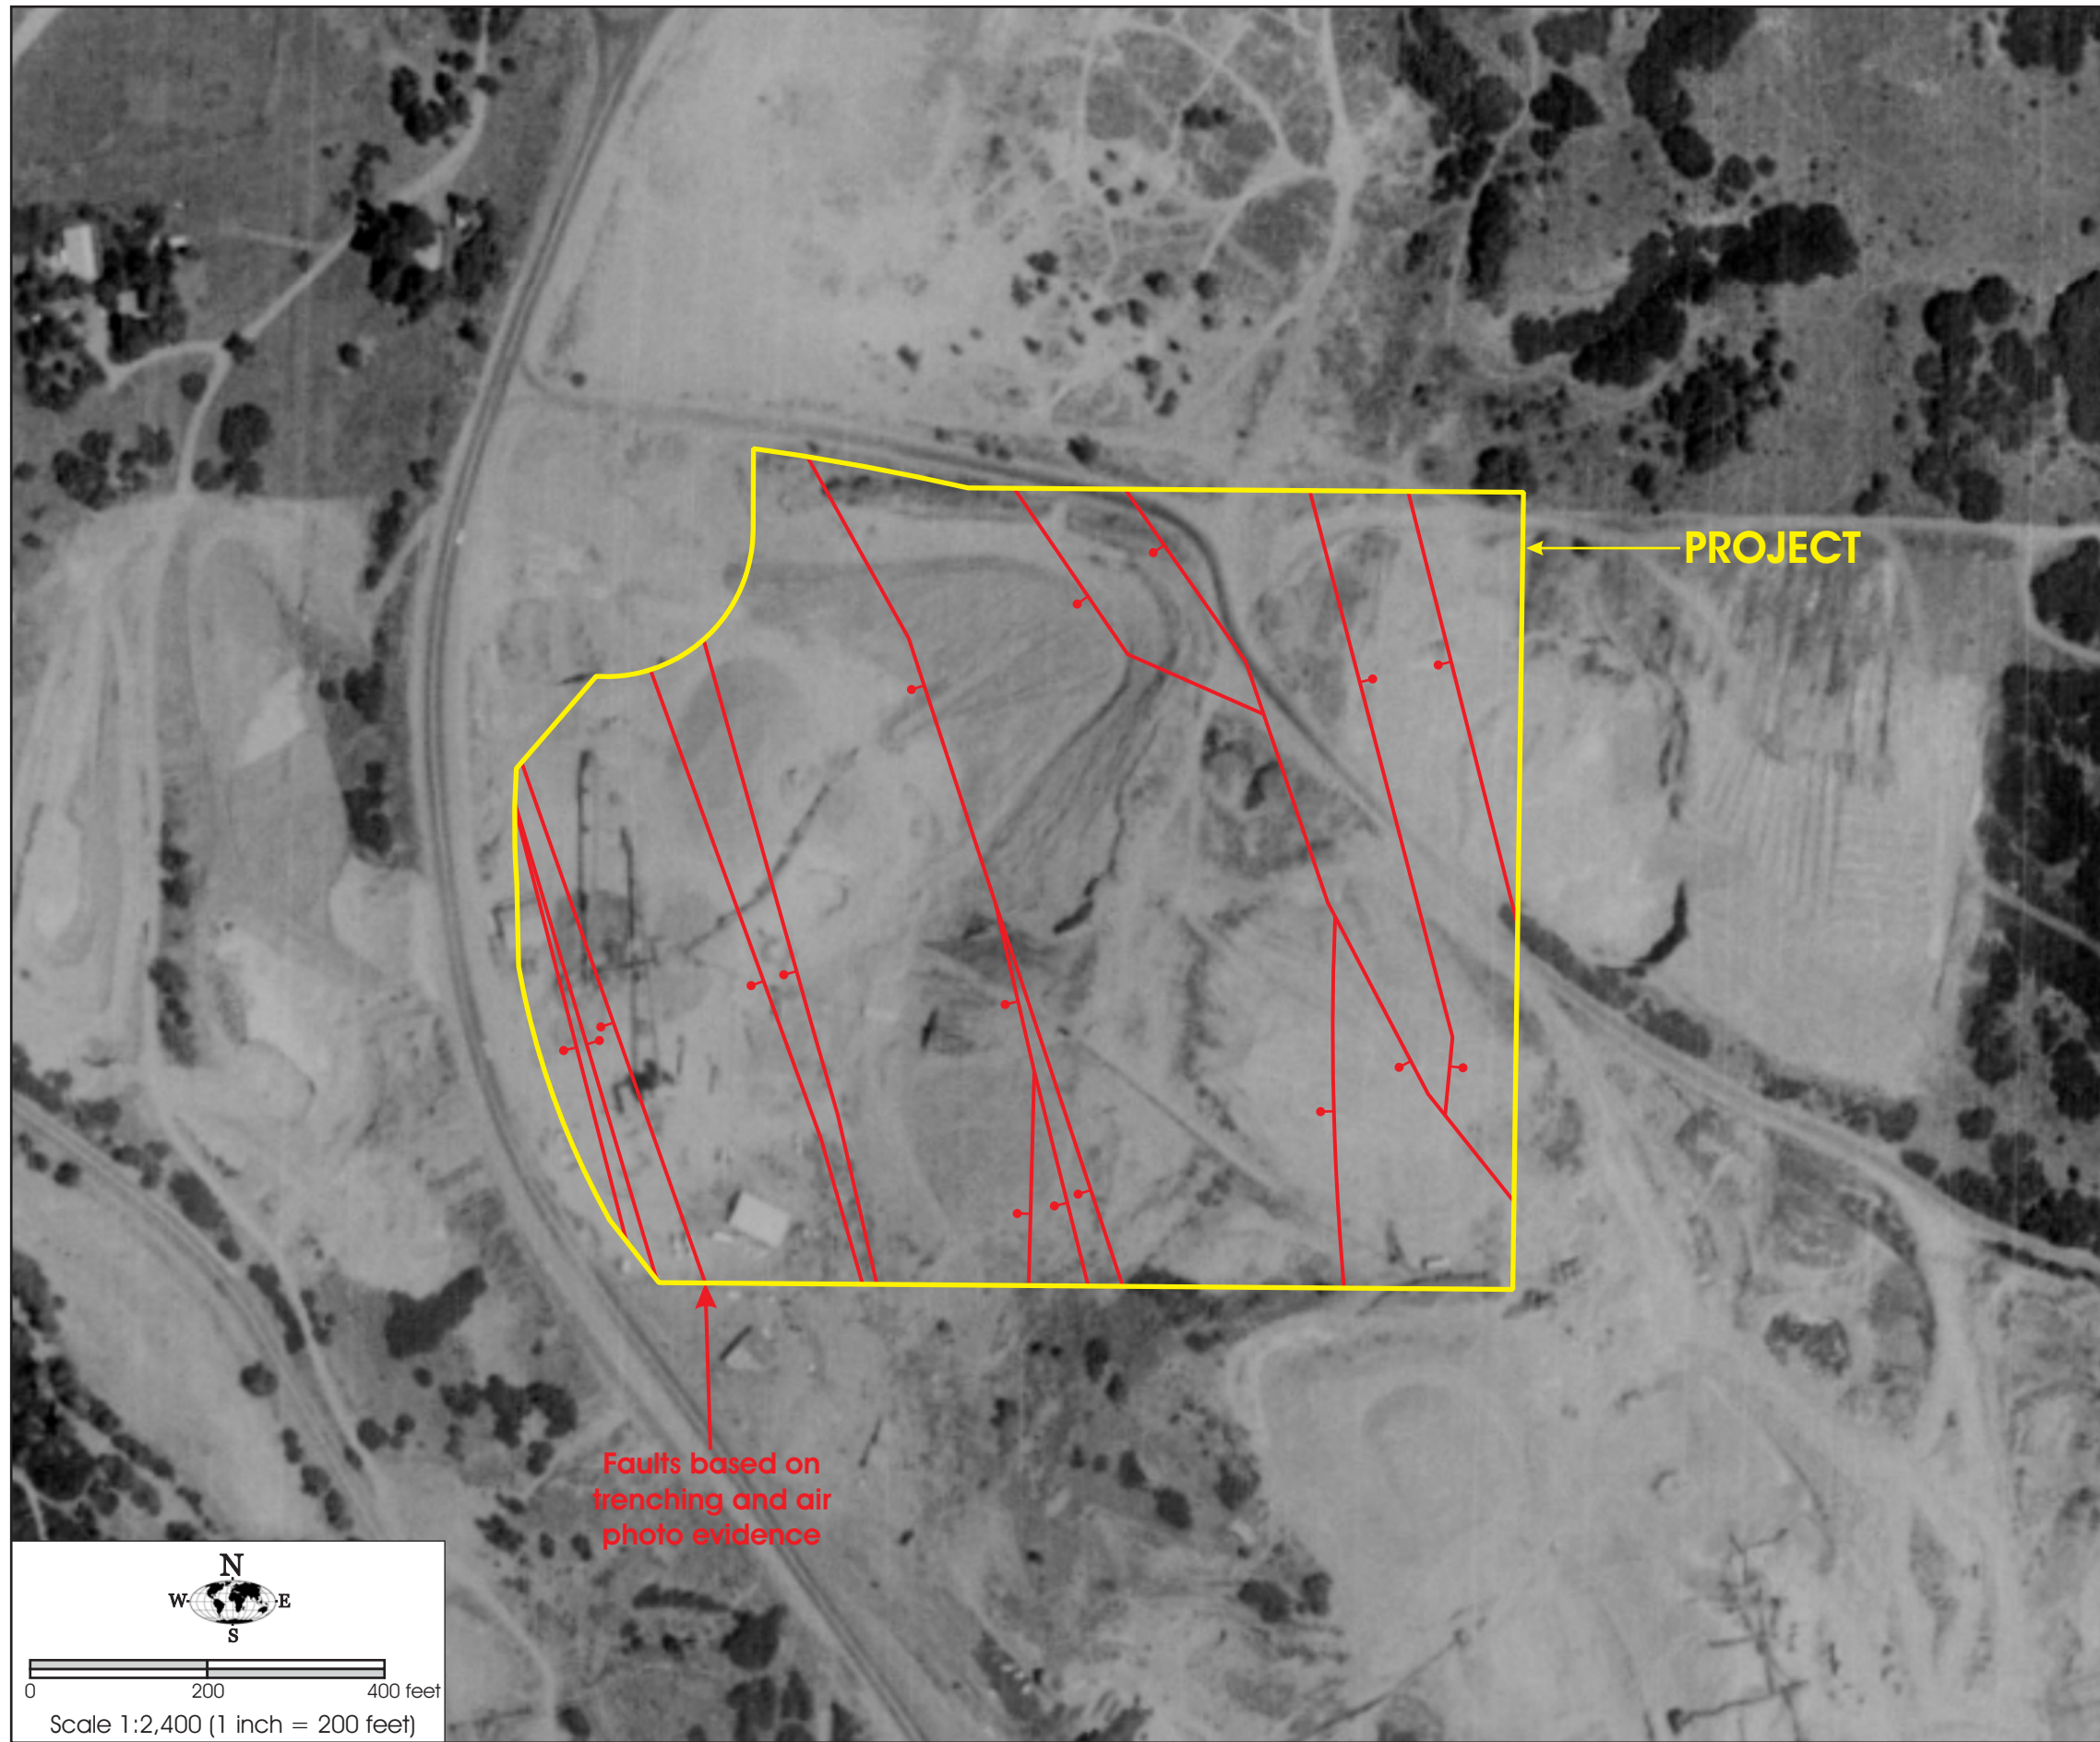
FIGURE 3B

Air Photo Source: Utah AGRC, 1977 Digital
Orthophoto Quadrangle, frame q1320-1977,
1 meter resolution.

1977 AIR PHOTO

evidence is obscured by gravel mining disturbance on 1977 and later air photos and a 2013 geoprocessed LIDAR image available from the Utah AGRC (Figures 3B through 3E). No evidence for other geologic hazards was observed on the air photos at the site or in the area.
