**RED NARROWS LANDSLIDE  
US-6 SPANISH FORK CANYON  
M.P. 192.9**

**GEOTECHNICAL DIVISION REPORT**

**FIELD TRIP REPORT  
GEOTECHNICAL SECTION**

**Landslide Site Reconnaissance**

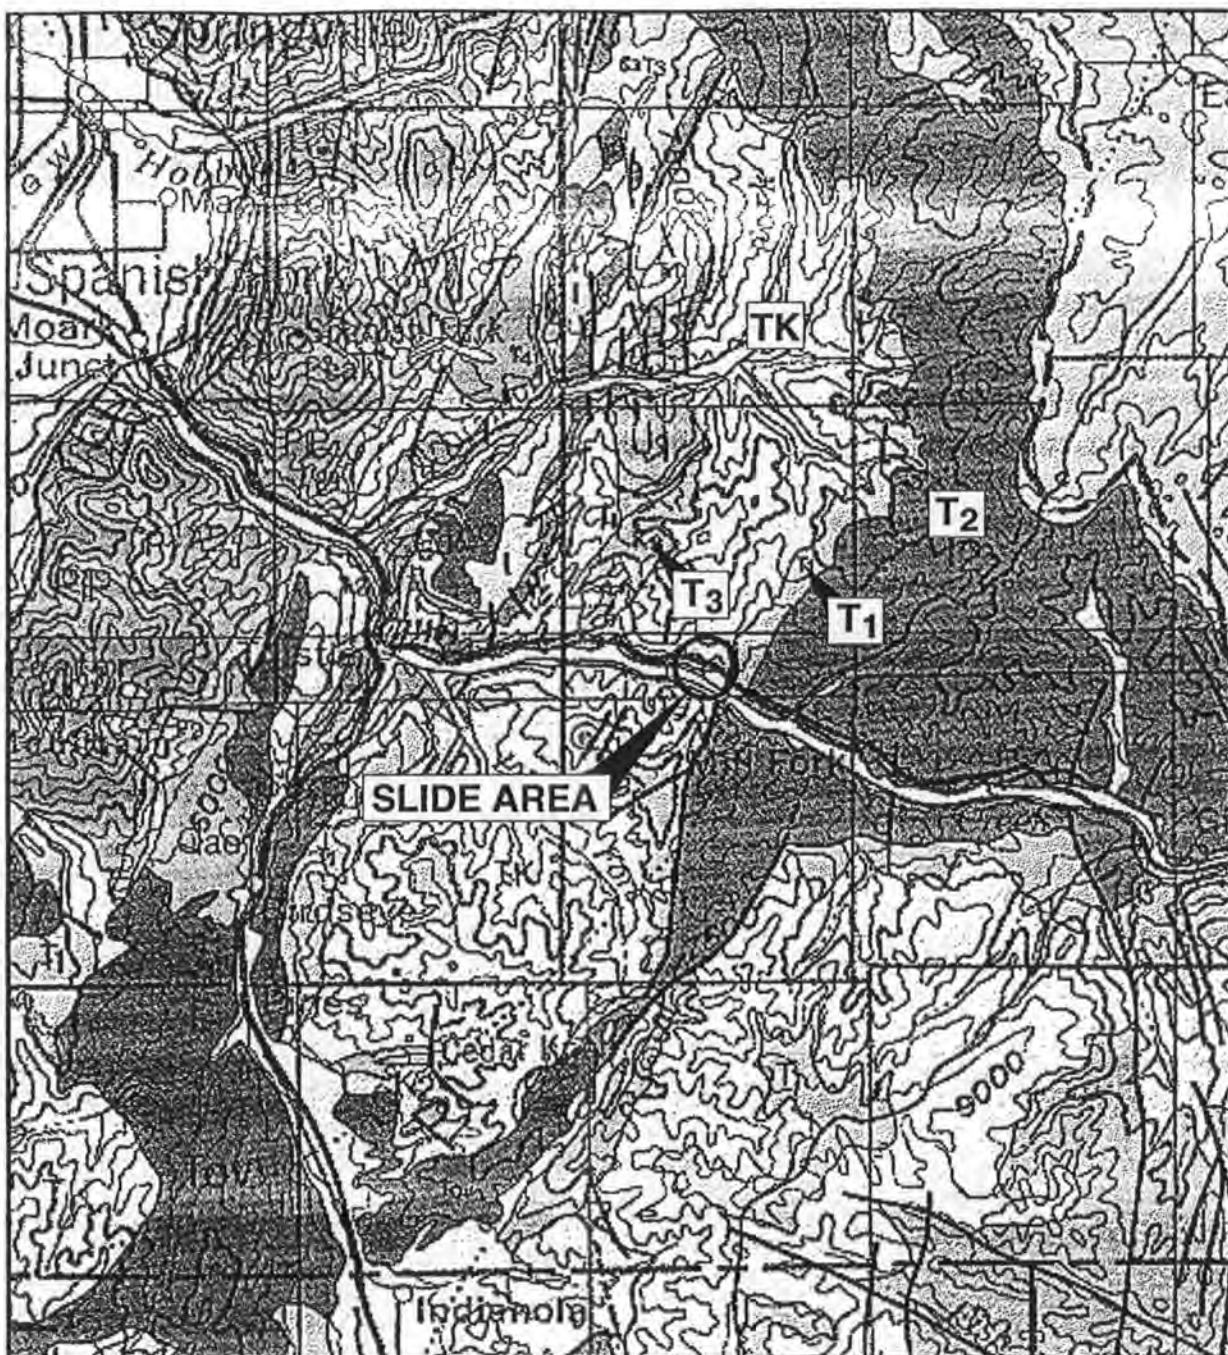
The regional geology in the vicinity of the slide is presented on Figure 4. The overall slope of the ground surface upslope from the head scarp forms an angle of about 33 degrees from horizontal. This slope is covered by a dense growth of live oak and other vegetation. Seepage was observed on this slope near the western flank of the slide. Isolated outcrops of conglomerate were observed on the slope above the slide area, but it was not possible to determine if the outcrops were in place or float material. Tension cracks were not observed up slope from the head scarp which indicates that the slide is currently not progressing up slope. However, depending on the groundwater levels, depth to rock, and engineering properties of the soil, it is our opinion that the slide will likely progress upslope with time.
