## INTERIM GEOTECHNICAL REPORT

● MANTI CANYON NORTH SLIDE  
STABILITY STUDIES

● DEBRIS DAM FOUNDATION  
INVESTIGATIONS

SEPTEMBER 1976

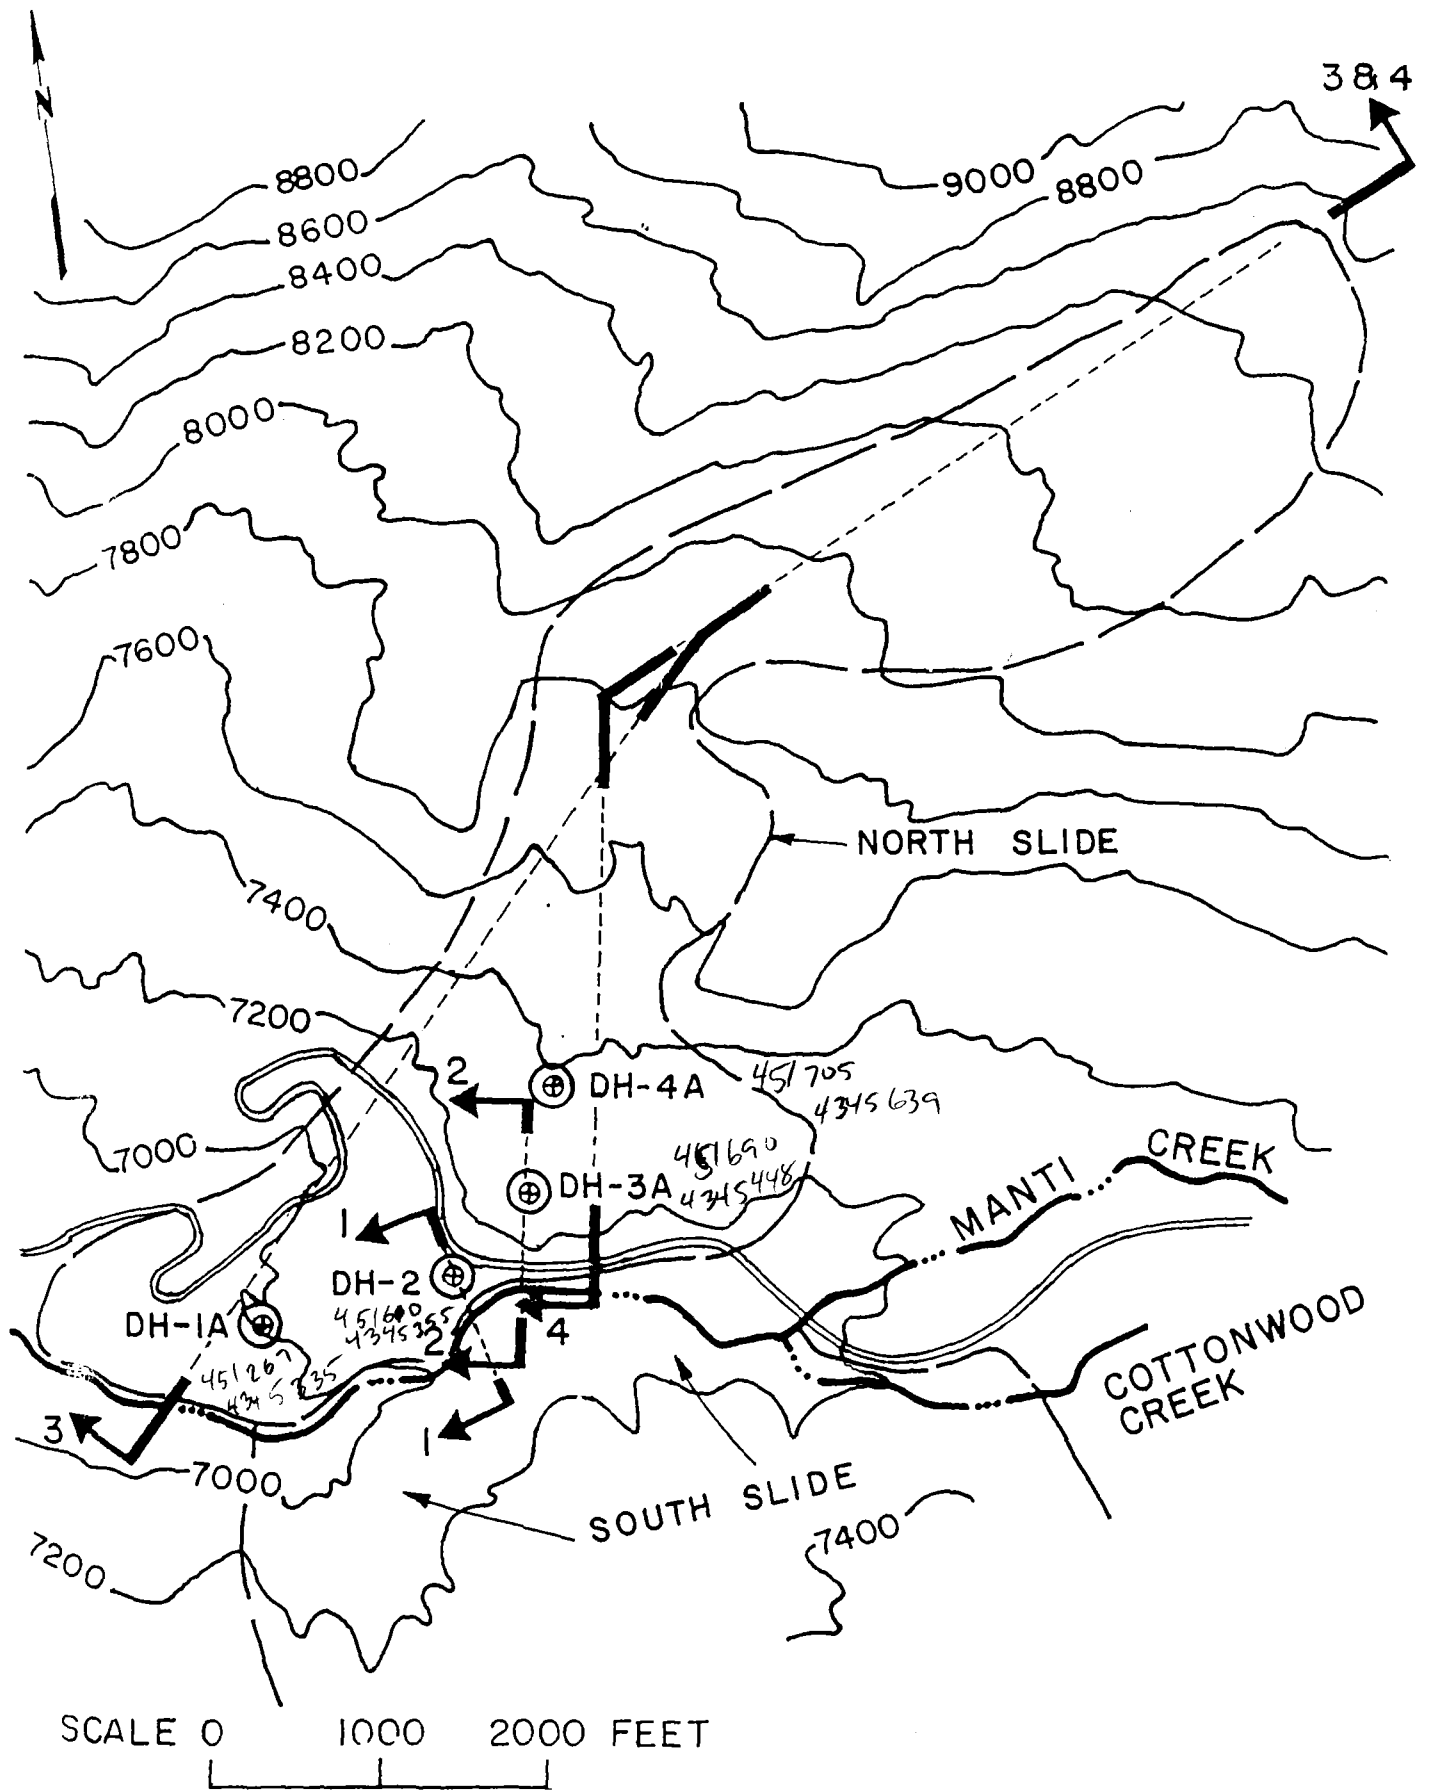
FIGURE 2-2 — LOCATION OF STABILITY ANALYSIS SECTIONS

Stability analyses were performed on four sections taken through the North Slide (see Figure 2-2). The selection of these sections was based on their

impact on the proposed by-pass pipeline if failure should occur. Two of the sections were analyzed by Bishop's method of slices for slip circle failure and two sections were analyzed by the planar slide stability method.

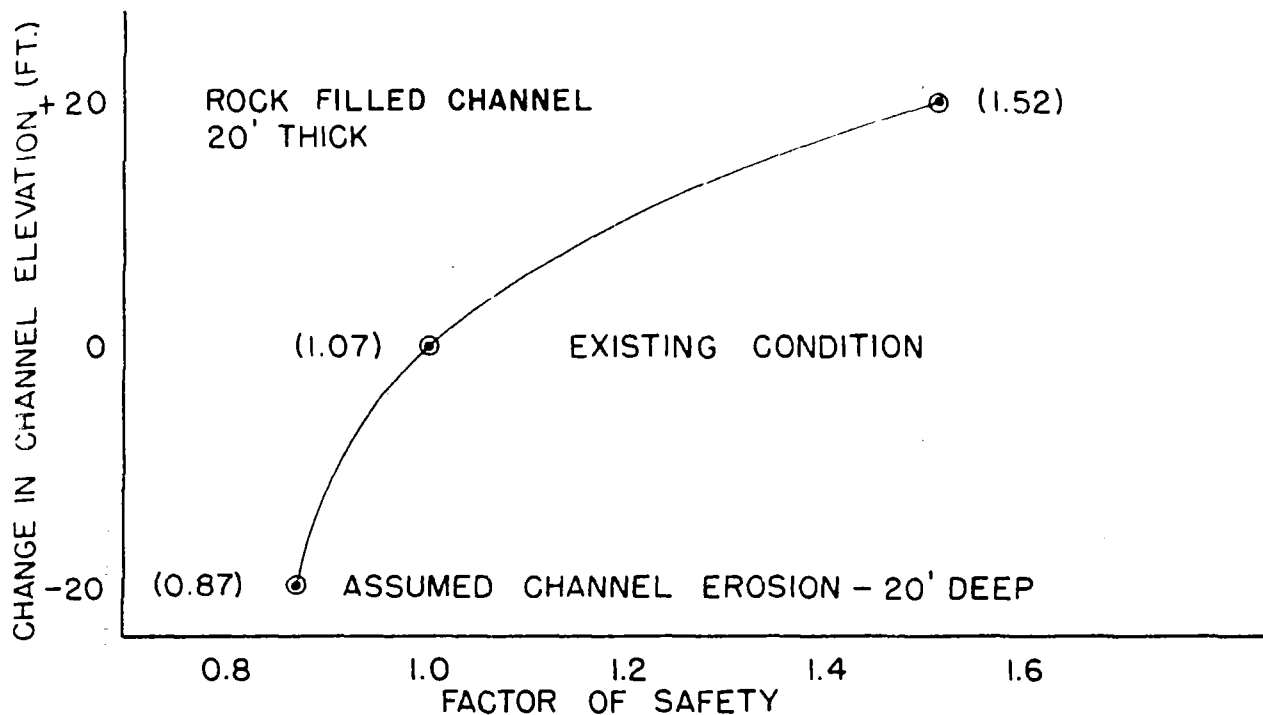
FIGURE 2-3 — FACTOR OF SAFETY OF NORTH SLIDE  
BISHOP STABILITY ANALYSIS — SEC. 1

2. Stability of Section 1 - Section 1 was chosen because of its steep bank slope and its high susceptibility to erosion and undercutting by Manti Creek (see Figure 2-2). A failure of this section would induce progressive failure up the slope and that would endanger the Forest Service access road and the proposed by-pass pipeline by erosion of toe support of the steep bank of Manti Creek (see Photo 6).

The critical factors of safety for the three assumed conditions of analyses are shown on Figure 2-3. The computed critical or minimum factor of safety for the existing condition (F.S. of 1.07) is very close to 1.0 and could be slightly below 1.0 since there is evidence of movement on the North Slide. It would be very desirable to have a higher factor of safety due to the numerous unknowns such as the in situ materials properties, earthquake possibilities and hydrologic conditions.

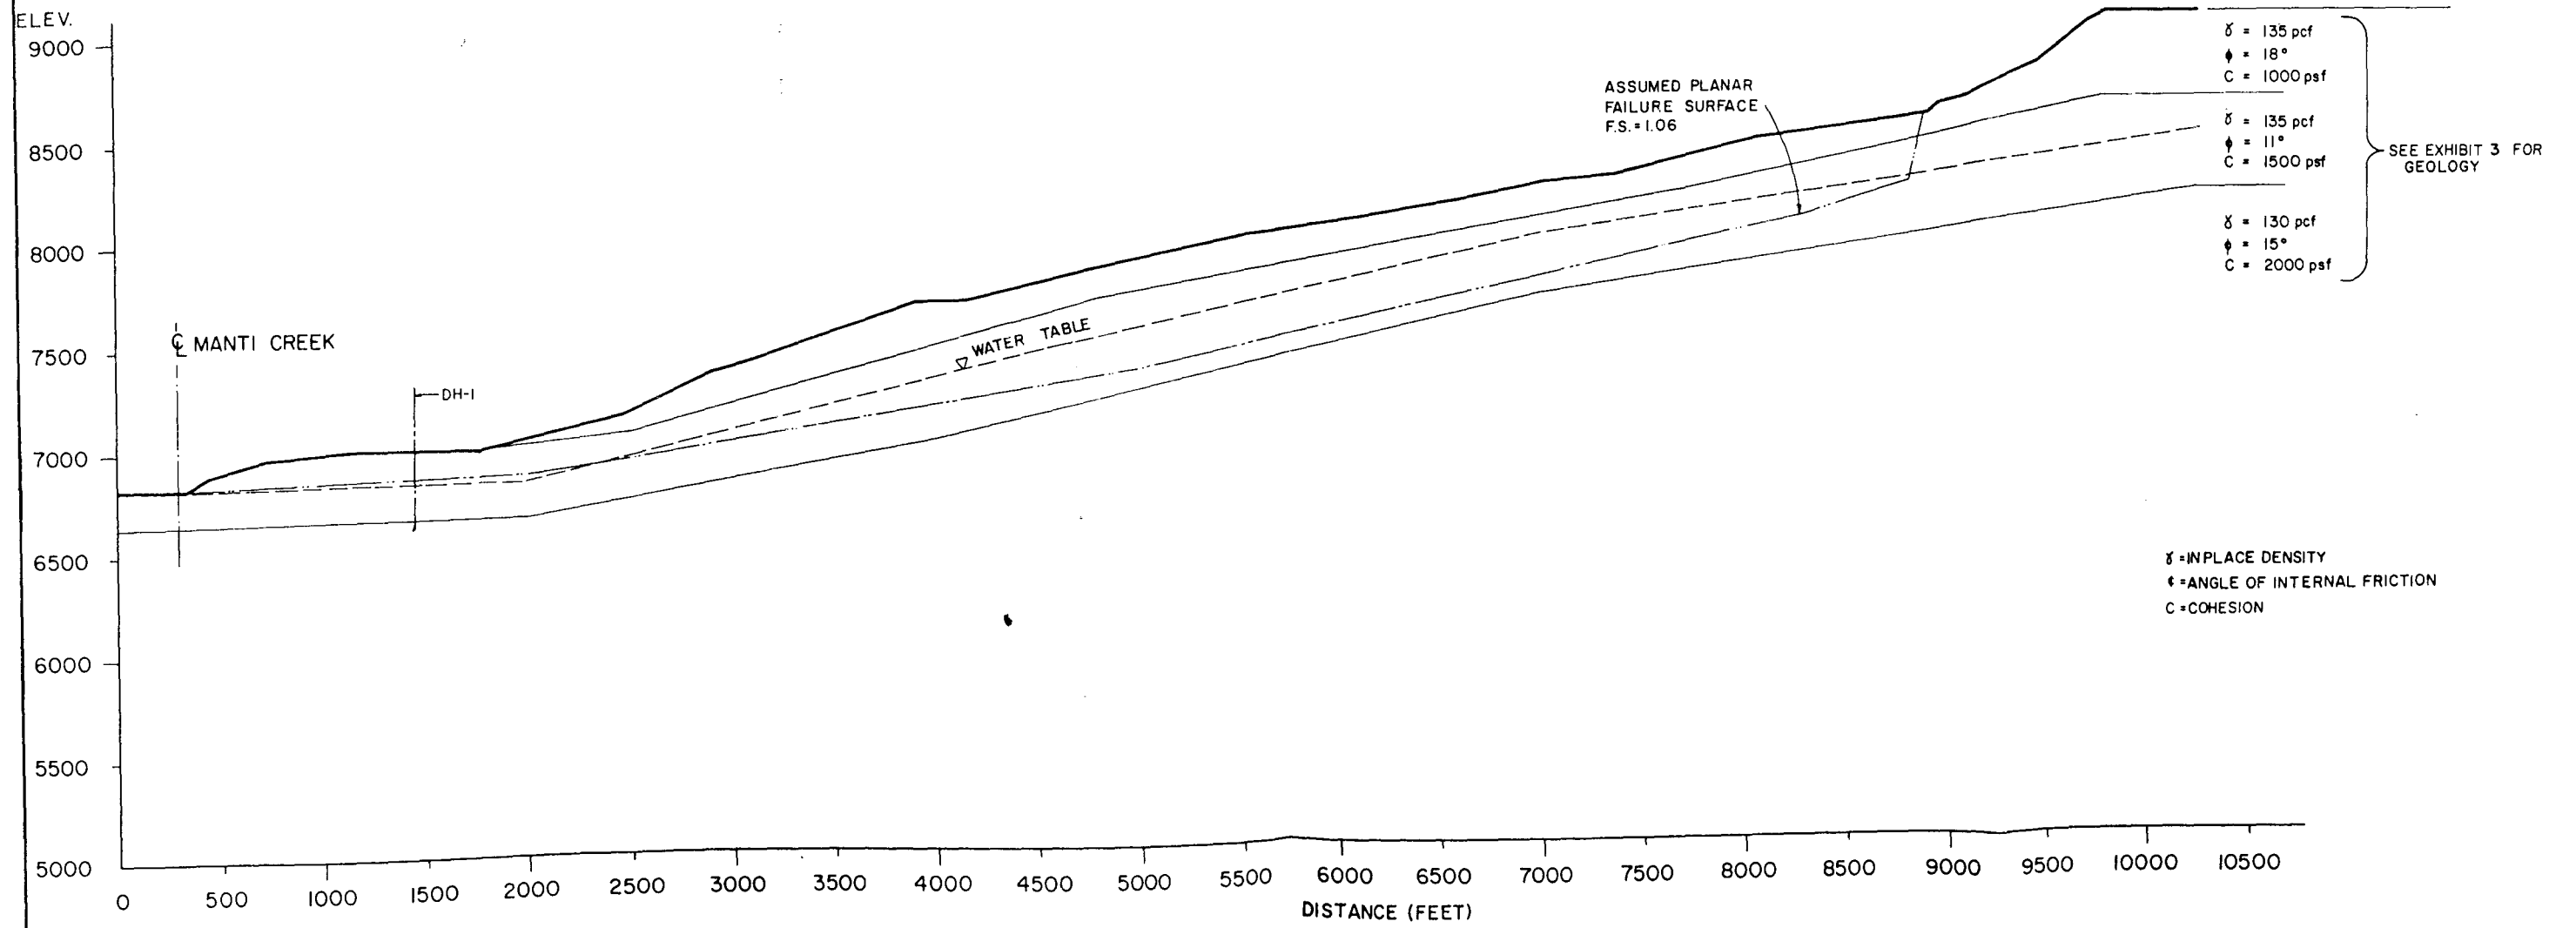
NORTH SLIDE  
STABILITY ANALYSIS SECTION 3

Two sections were chosen to evaluate the overall stability of the North Slide mass (see Figure 2-2). These are Sections 3 and 4 (see Exhibits 13 and 14.)

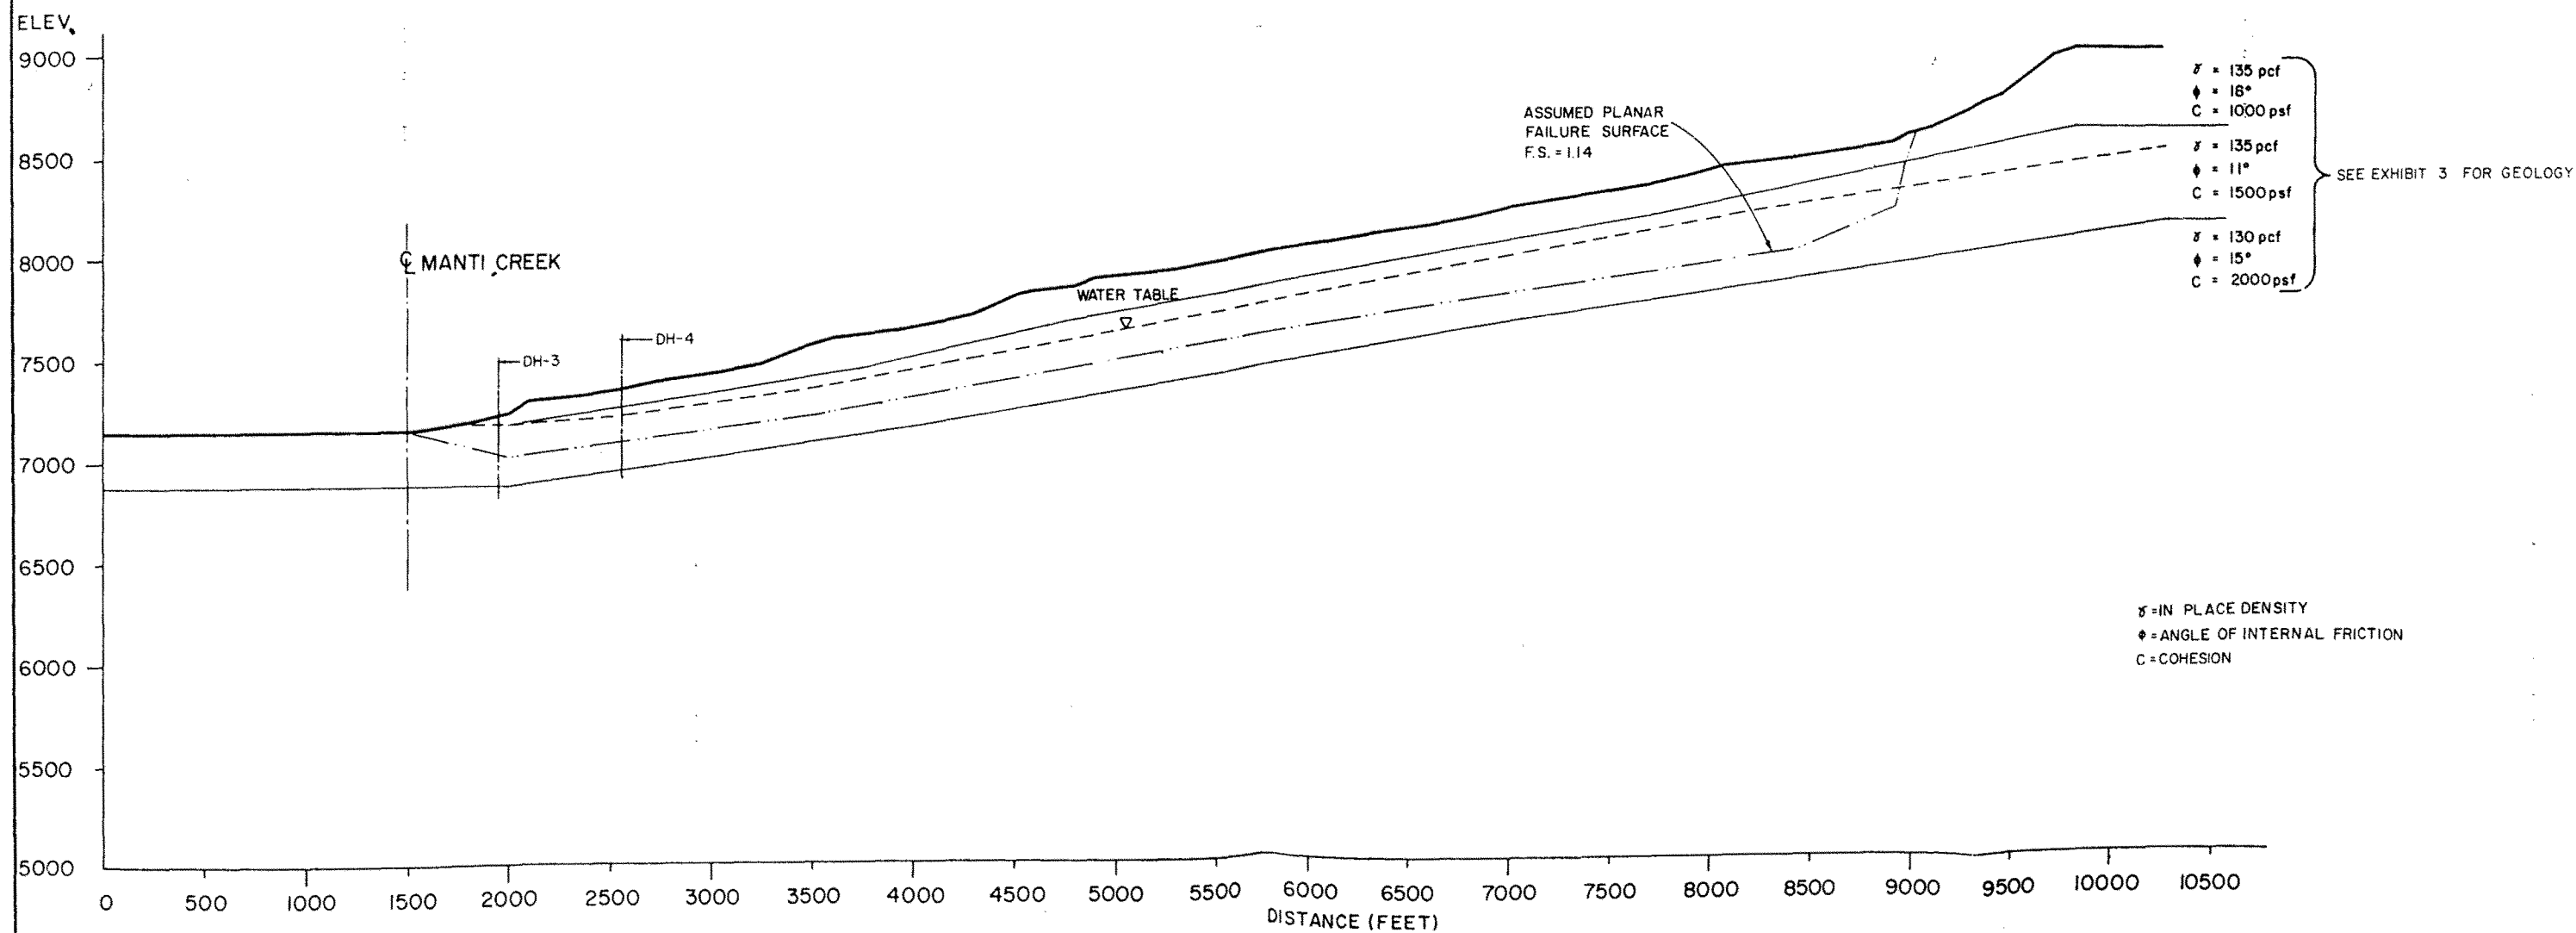
NORTH SLIDE  
STABILITY ANALYSIS SECTION 4

3. Stability of Section 4 - Section 4 begins at the base of the North slide, but is located further upstream than Section 3 (see Figure 2-2). As with Section 3 the failure plane was approximated from shear zones observed during field exploration. This assumed failure plane extends from the toe of the slope in Manti Creek to the top of the slide.
