UGMS HAZARDS SECTION

August 14, 1985

SUBJECT: Laketown Project

This is to report on two recent trips to Laketown, Utah, to inspect the existing reservoir and sites for proposed new reservoirs.

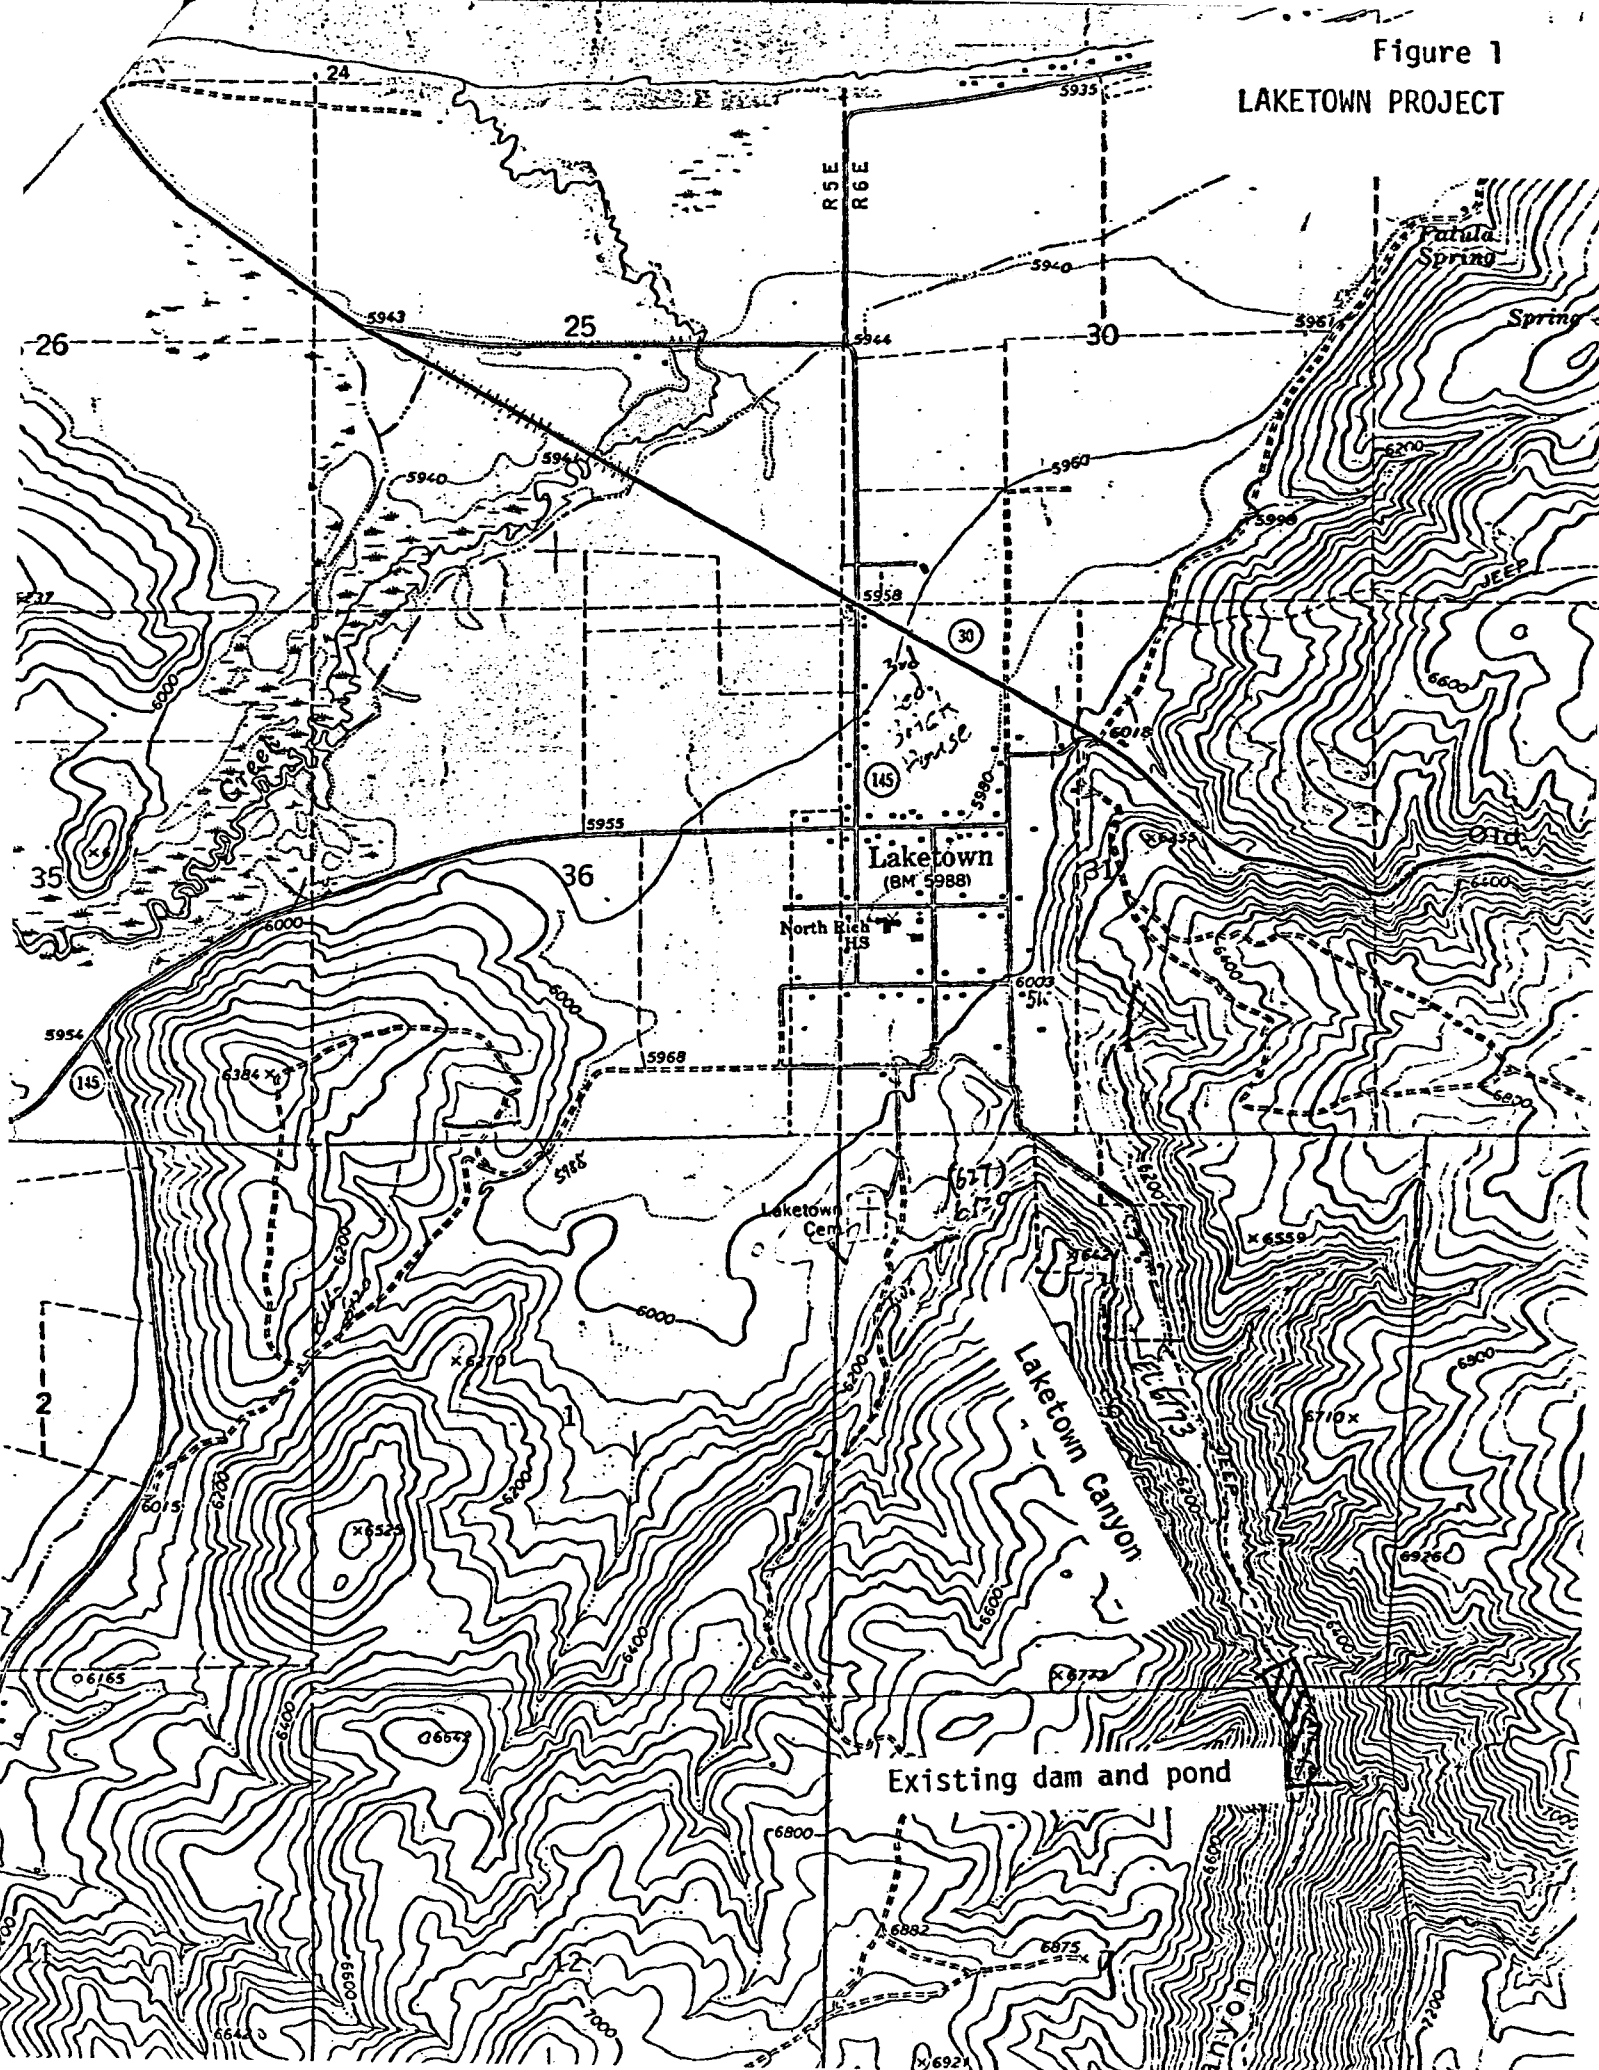
Figure 1
LAKETOWN PROJECT

The small existing reservoir in Laketown Canyon (Figure 1) has a capacity of about 10 acre feet. It is underlain by fractured limestone. We understand that seepage losses are estimated to be about 1 cfs when it is full. During our visit on 24 June 1985, the reservoir was drawn down, permitting inspection of part of the bottom and sides, which showed a curious network of cracks and several sinkholes where reservoir silt has been piped into the subsurface (Figure 2). At the head of the reservoir is a delta of gravel, sand, and silt of unknown thickness. The cracks are best developed on the silty surface of this delta below reservoir high water, forming a roughly rectangular network, parallel and perpendicular to the valley (Figure 3). The cracks are not straight, but meander somewhat. They are not associated with ridges, but appear on the otherwise flat alluvial surface. Fresh cracks are open to 1 inch (Figure 4). Sinkholes near the intersection of cracks are as much as 5 feet wide and 3 feet deep (Figure 5). Cracks and holes near the existing water surface are dry; the bottom of the big sinkhole (Figure 5) was dry 2 feet below reservoir level, suggesting that the contents of the reservoir are perched upon the silt blanket overlying a permeable substrate. Water fed into a sinkhole by hand digging a shallow channel from the reservoir required a flow of about 2 gpm to maintain a two-sq. foot puddle in the bottom of the hole for 5 minutes
