# LANDSLIDES IN THE BORAH PEAK, IDAHO EARTHQUAKE OF 1983

David K. Keefer, Raymond C. Wilson, Edwin L. Harp, and Elliott W. Lips  
U.S. Geological Survey  
Menlo Park, California

This report describes landslides and related ground-failure effects that were observed after the earthquake. Observations were made from a small fixed-wing aircraft on October 31 and November 8 and on the ground from October 30 to November 9. Ground-based field studies included automobile traverses over most roads in the epicentral region and traverses of selected areas on horseback or on foot.

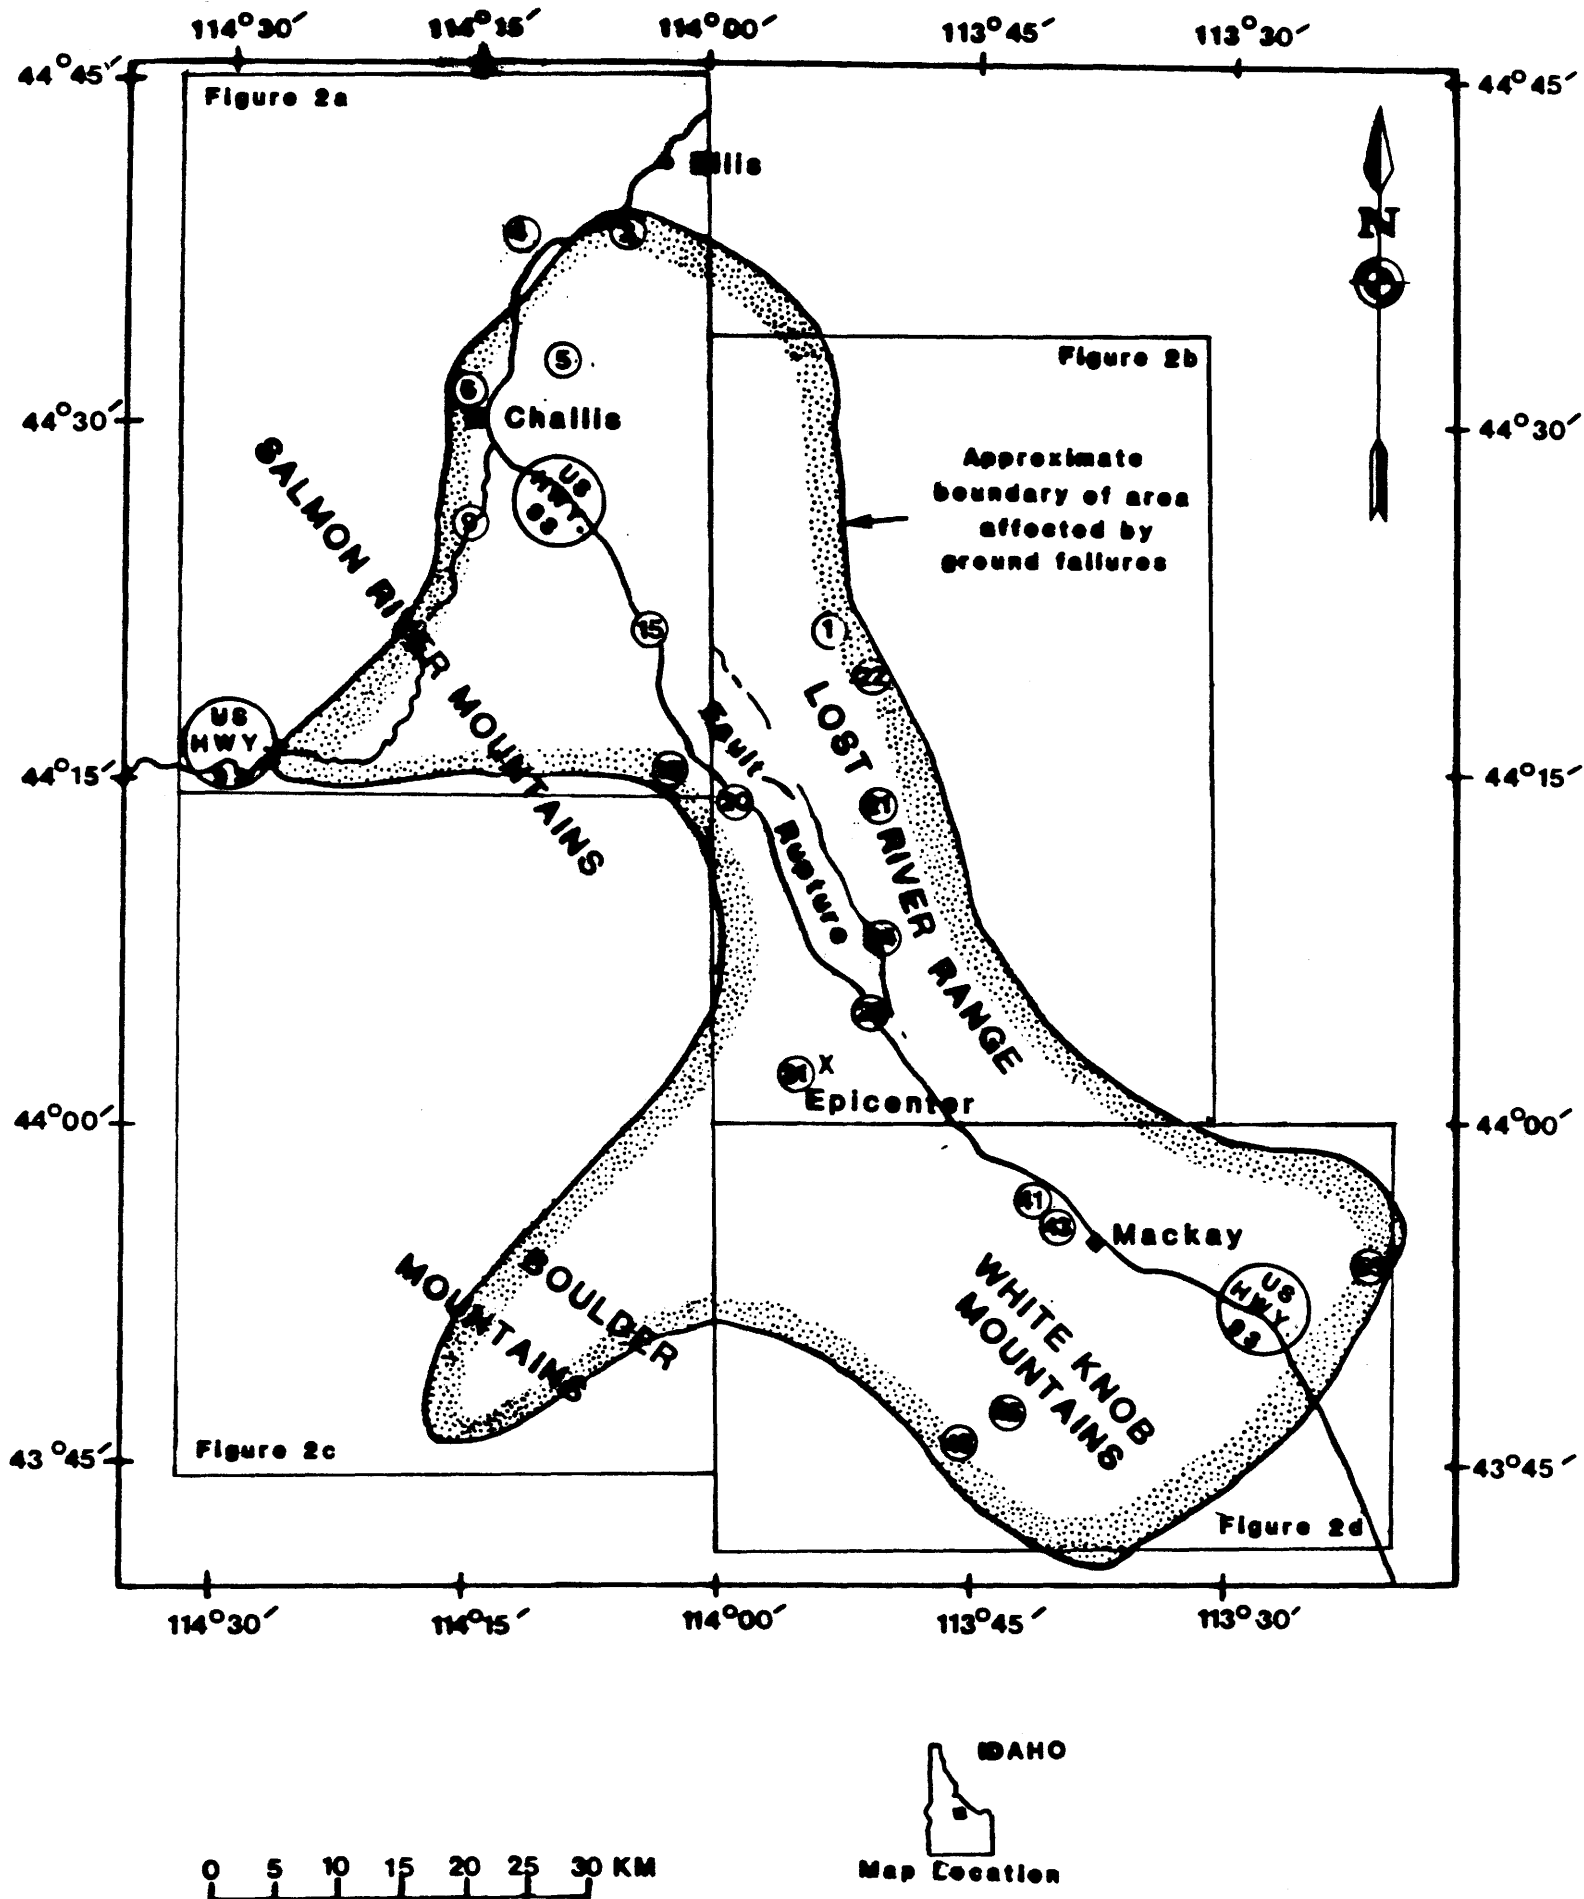
Figure 1. Index map showing areas of Figures 2a.-d., approximate boundary of area affected by earthquake-induced ground failures, major mountain ranges, epicenter, fault rupture, major Highway (U.S. 92), and localities described in text (numbered circles).

The earthquake caused landslides and other ground failures throughout an area of approximately 4200 km<sup>2</sup> (Fig. 1). Most landslides were rock falls or rock slides. From a fixed-wing aircraft we observed several dozen rock falls and rock slides on the eastern flank of Grouse Creek Mountain (Locality 1 in Figures 1 and 2b), several dozen more scattered through the central Lost River Range, and a few dozen more in volcanic rocks in the northern Lost River and eastern Salmon River Mountains. During ground-based studies we observed some of these in greater detail and discovered several additional rock falls and rock slides in the Boulder and White Knob Mountains. Rock falls caused significant damage in Challis (Locality 6 in Figures 1 and 2a).

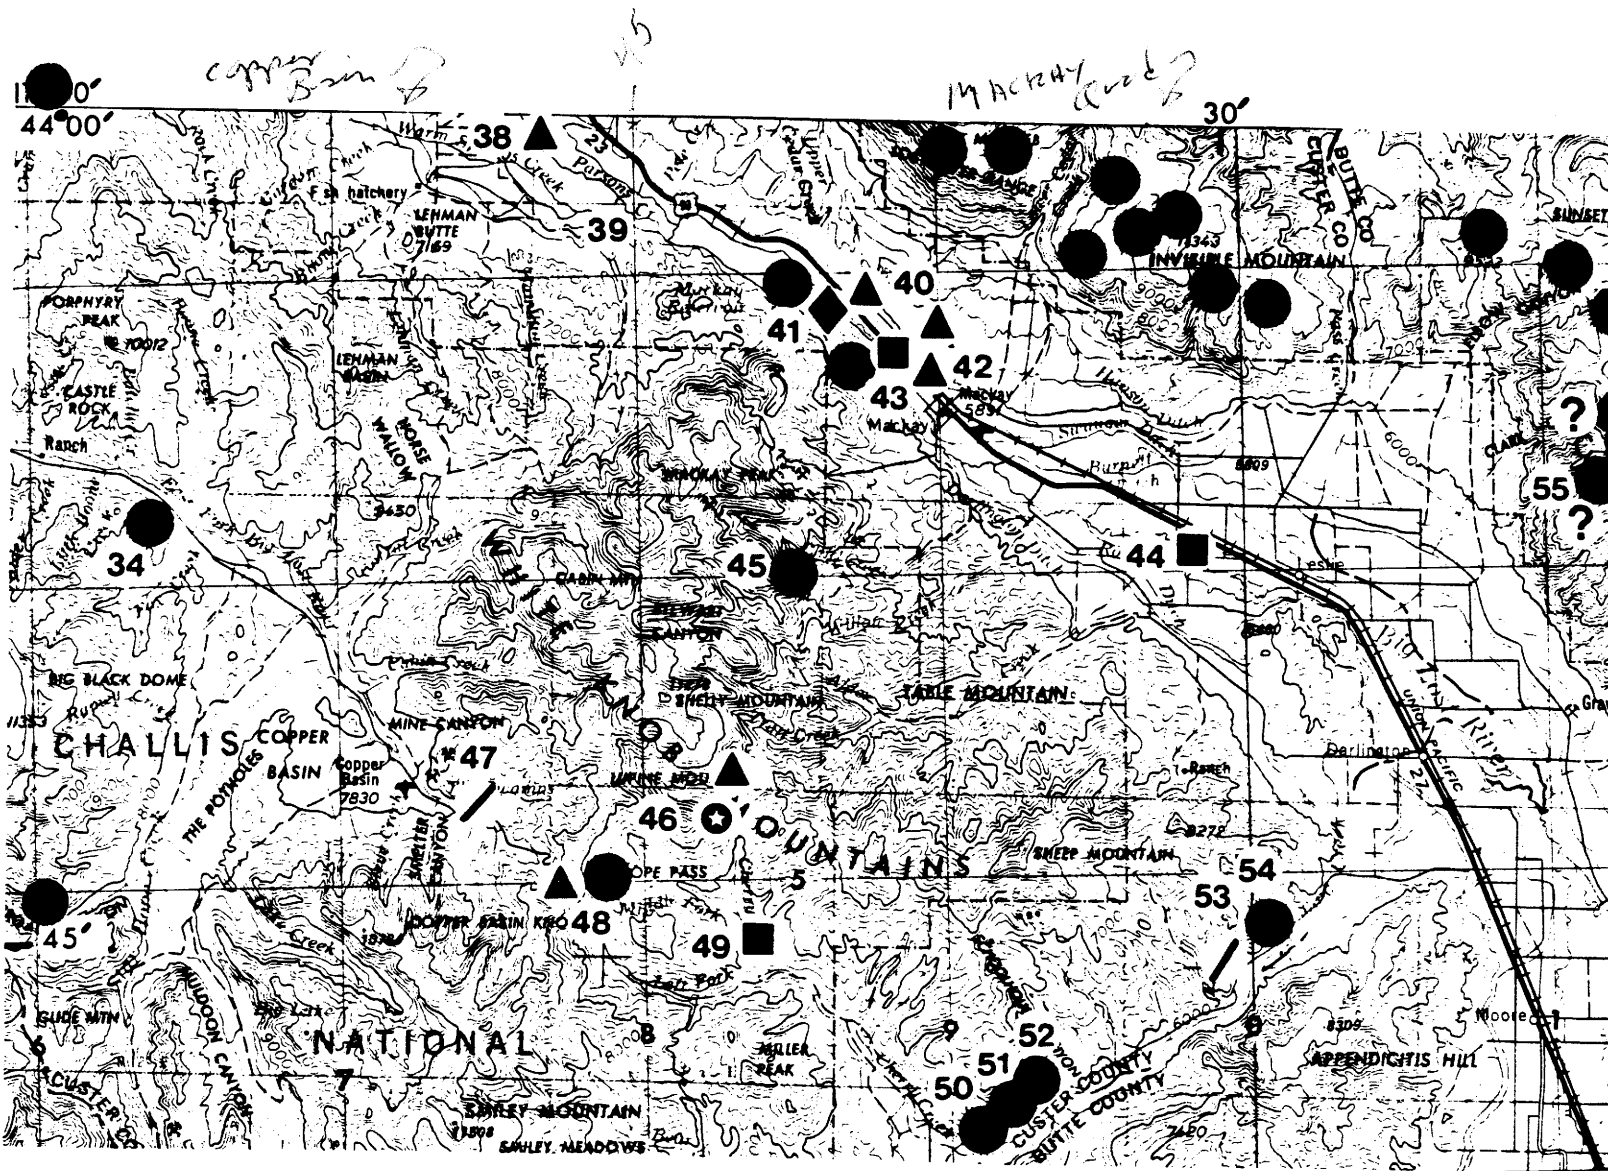
Figure 2d. Southeast part of affected area.

One complex mud flow and one complex debris flow were attributable to hydrologic changes caused by the earthquake. The debris flow, at Birch Springs (Locality 24 in Figures 1 and 2b), originated less than 200 m upslope from the fault scarp and probably occurred during or shortly after the ground shaking. The mud flow, in the Lupine Creek valley 29 km from the fault scarp (Locality 46 in Figures 1 and 2d), began at least 2 days after the earthquake.

Aerial observations north of the Salmon River (Locality 4 in Figure 2a) and south of Locality 55 (Fig. 2d) indicated that the earthquake had not triggered any landslides in either of these areas.
