Report No. UT-03.01

UTAH ROCKFALL HAZARDS INVENTORY Phase I

**By: Robert T. Pack, Ph.D., P.E.
Ken Boie**

**Utah Department of Transportation
Research Division**

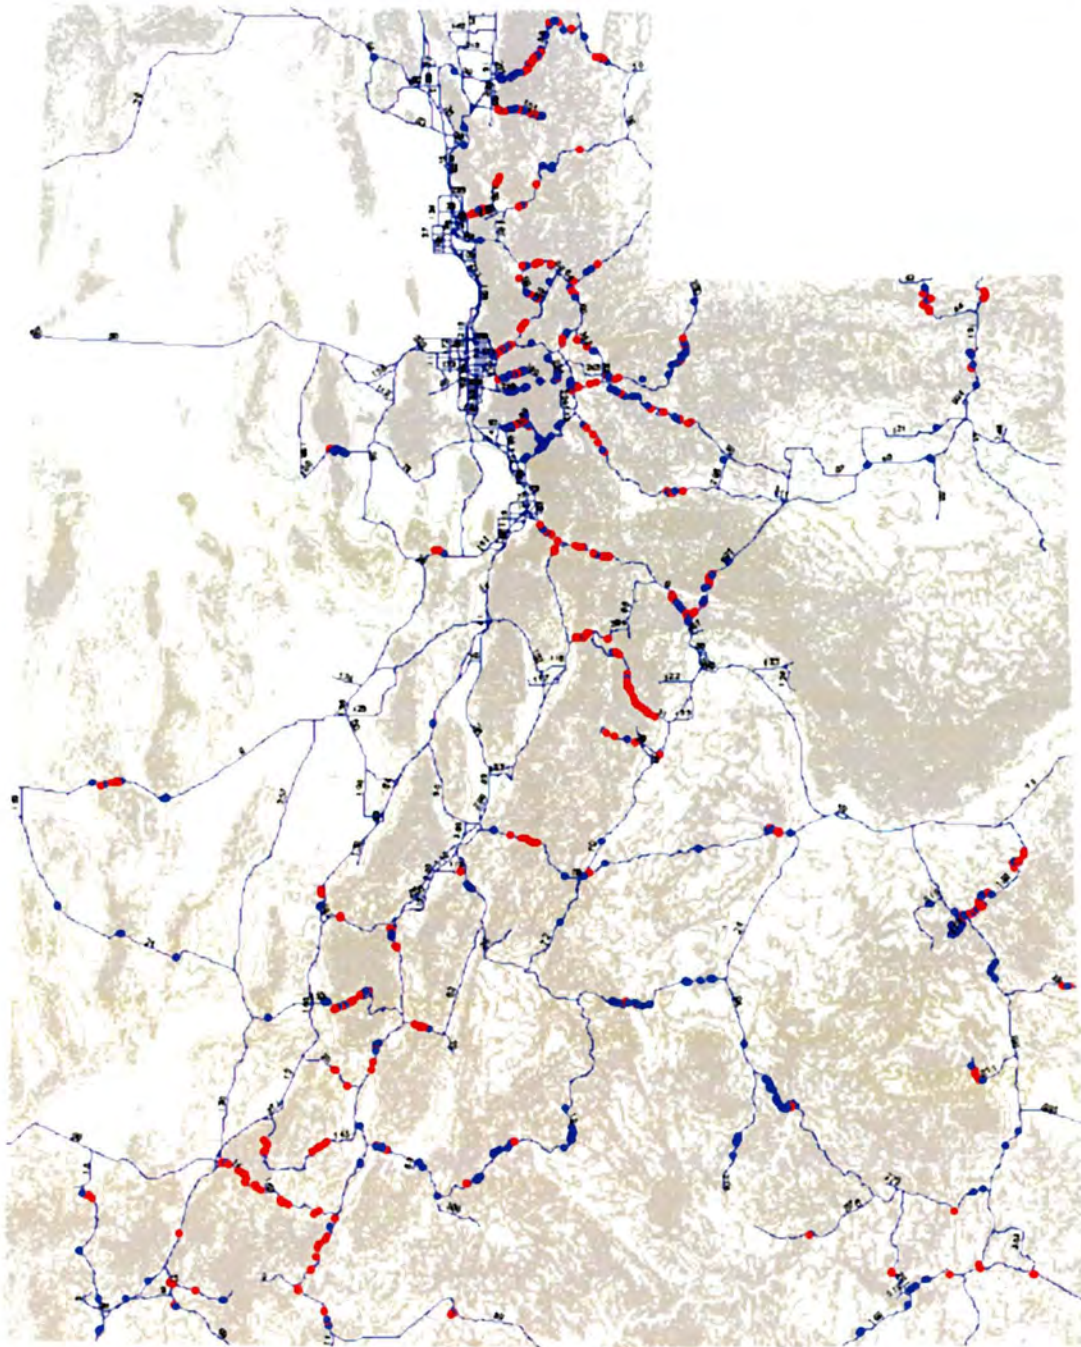
Figure 2. Distribution of rockfall sites classified as A (dots shown in red) and B (dots shown in blue).

roadside slopes classified as A is 134.8, as B is 155.3, and as C is 7.5 for a total of 297.7 kilometers (185 miles). It should be noted that sites classified as C are a very small subsample of sites in this category as they are essentially excluded from the inventory. As stated in the Section on methodology, C-rated slopes are considered low-risk and would add un-needed clutter to the database. However, a few have been included in order to get a feel for their nature and how they are distinguished for the A-rated and B-rated sites. Figure 2 shows the distribution of problem rockfall sites throughout Utah.
