**RECONNAISSANCE STUDY OF THE APRIL 12, 1995,
LANDSLIDE IN ZION CANYON,
ZION NATIONAL PARK, UTAH**

Robert L. Schuster and Gerald F. Wiczorek
Branch of Earthquake and Landslide Hazards
U.S. Geological Survey

U.S. Geological Survey Administrative Report

May 2, 1995

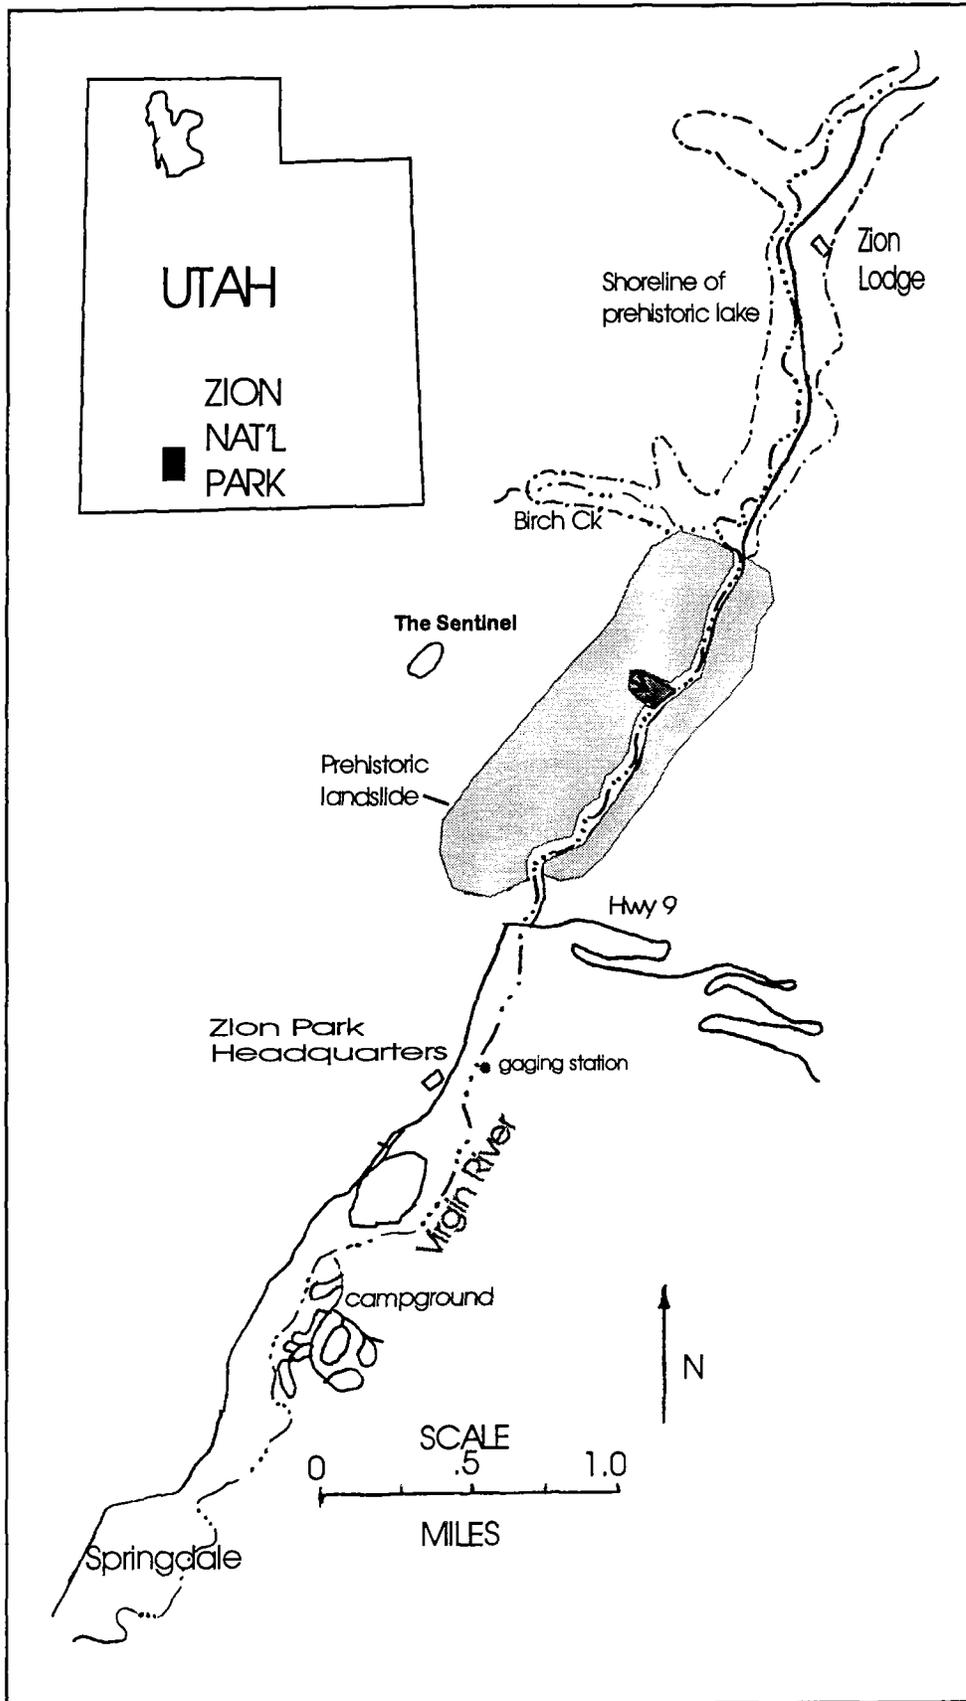
At about 9:00 p.m., April 12, 1995, a large landslide occurred on the west valley wall of Zion Canyon on the North Fork Virgin River, Zion National Park, Utah (fig. 1). The slide dammed the river, but the dam was soon overtopped. Erosion caused by the overflowing river caused partial failure of the dam, resulting in a local flood that destroyed about 600 ft of the National Park Service (NPS) highway in the canyon as well as parallel utility conduits. About 430 people were trapped at Zion Lodge, upstream from the landslide, until an emergency detour road was carved from the east wall of the canyon adjacent to the new course of the river.

The current landslide (figs. 3 and 4; volume approx. 300,000 yd³) seems to be similar to the 1923 and 1941 events. It occurred in broken-up rock (Navajo sandstone and Kayenta formation) at the edge of the old slide block that forms the west valley wall of Zion Canyon (fig. 1). It can be classified as a debris slide (Varnes, 1978). The slide consists of two blocks of debris separated by an intermediate scarp. The materials exposed in the flank of the upper main scarp are rock fragments in a sandy gravelly matrix (fig. 5) derived from the rock units disrupted by the prehistoric sliding. It measures about 700 ft along the river and approximately 900 ft (horizontal distance) from the head of the slide to its toe in the river. The elevation difference between the top of the headscarp and the toe of the slide at the river is about 550 ft.

Figure 1. Map of Zion Canyon and vicinity showing location of remnants (shaded) of the prehistoric slide from the flanks of The Sentinel and of the April 12, 1995, debris slide (arrow). Extent of the lake caused by the prehistoric landslide is indicated.

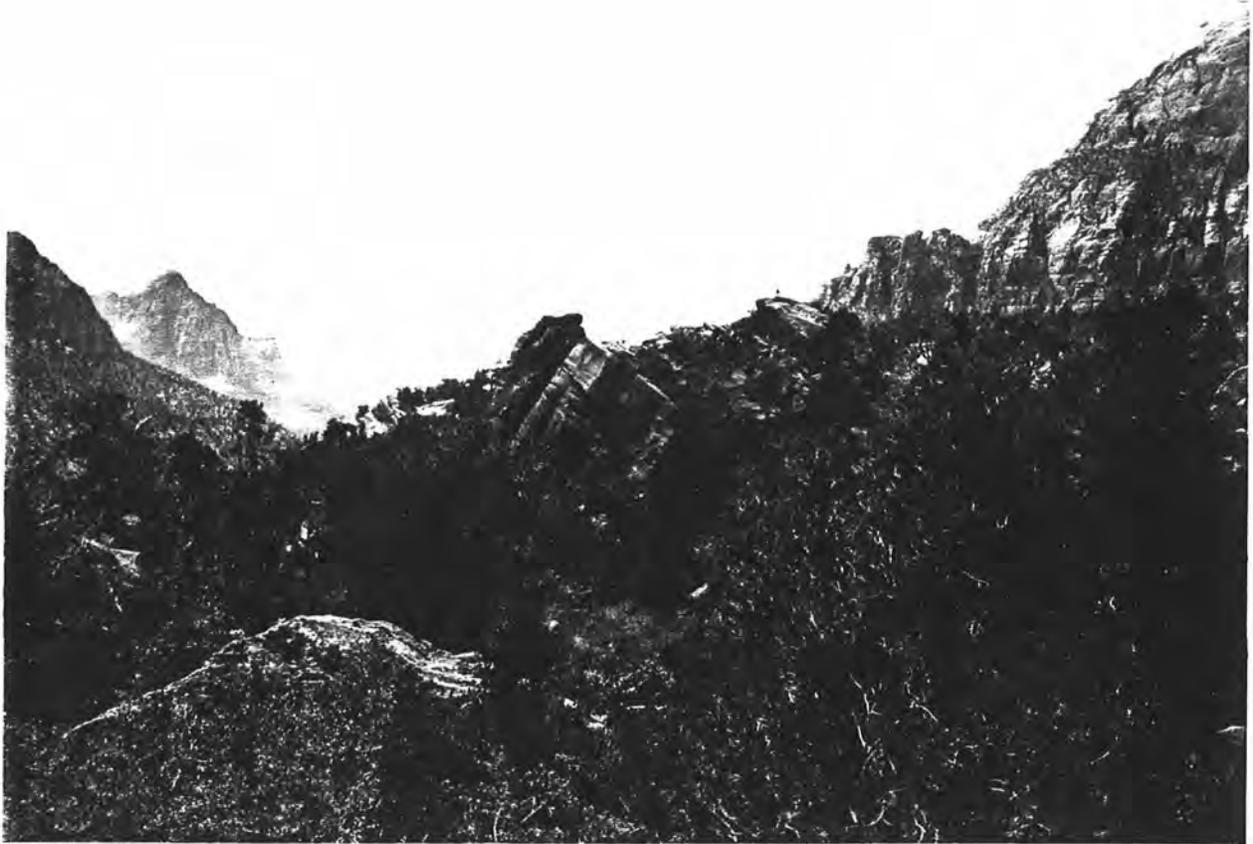
The North Fork Virgin River has eroded Zion Canyon into rocks of the Lower Jurassic Navajo sandstone and the Kayenta formation, the Upper Triassic (?) Moenave formation, and the Springdale member of the Upper Triassic Chinle formation (Grater, 1945; Hamilton, 1987, 1992). These units consist mainly of sandstone and siltstone. However, the Springdale member includes shale and mudstone, which when saturated, have a low shear strength and are susceptible to slope failure. About 4,000 yr ago, the river eroded down into the Springdale member which probably served as a failure surface when "a great slide from The Sentinel [fig.1; a 7,000-ft peak west of the canyon] blocked the mouth of the canyon" about 4,000 yr ago (Hamilton, 1992). This slide (fig. 2) can probably be classified as a Toreva block ("A slump block consisting essentially of a single large mass of unjostled material which, during descent, has undergone a backward rotation toward the parent cliff....." (Bates and Jackson, 1980)). The slide block dammed the river impounding a lake about 2 3/4 mi long (fig. 1). The original dimensions of this landslide were about 1 1/4 mi long (parallel to the valley) and 3/4 mi wide. About 3600±400 yr ago, the large natural dam breached, draining the lake and splitting the original slide block into two parts that are separated by the river (Grater, 1945; Hamilton, 1987, 1992). The larger remnant currently is about 1 mi long along the river and 1/2 mi wide; its top surface forms a ledge about 600 ft above the river on the west side of the canyon. The smaller remnant is a narrow strip of landslide material immediately east of the river. The channel cut into the landslide by erosion from the released impoundment and subsequent erosion by the river for about 3,600 yr forms the entrance to the present Zion Canyon.

Figure 2. View looking southward of back-rotated blocks of Navajo sandstone (center) displaced by the prehistoric landslide which moved from The Sentinel (right) to Zion Canyon (left) about 4,000 years ago.

This plan will necessitate moving the river from its current channel back to a position approximating that of the pre-landslide channel (fig. 2). This will require minor excavation into the toe of the current landslide to relocate the river. The cut slope should be analyzed
