LIQUEFACTION GENERATED BY THE 1983 MOUNT BORAH, IDAHO, EARTHQUAKE

T. L. Youd, E. L. Harp, D. K. Keefer, and R. C. Wilson

U.S. Geological Survey

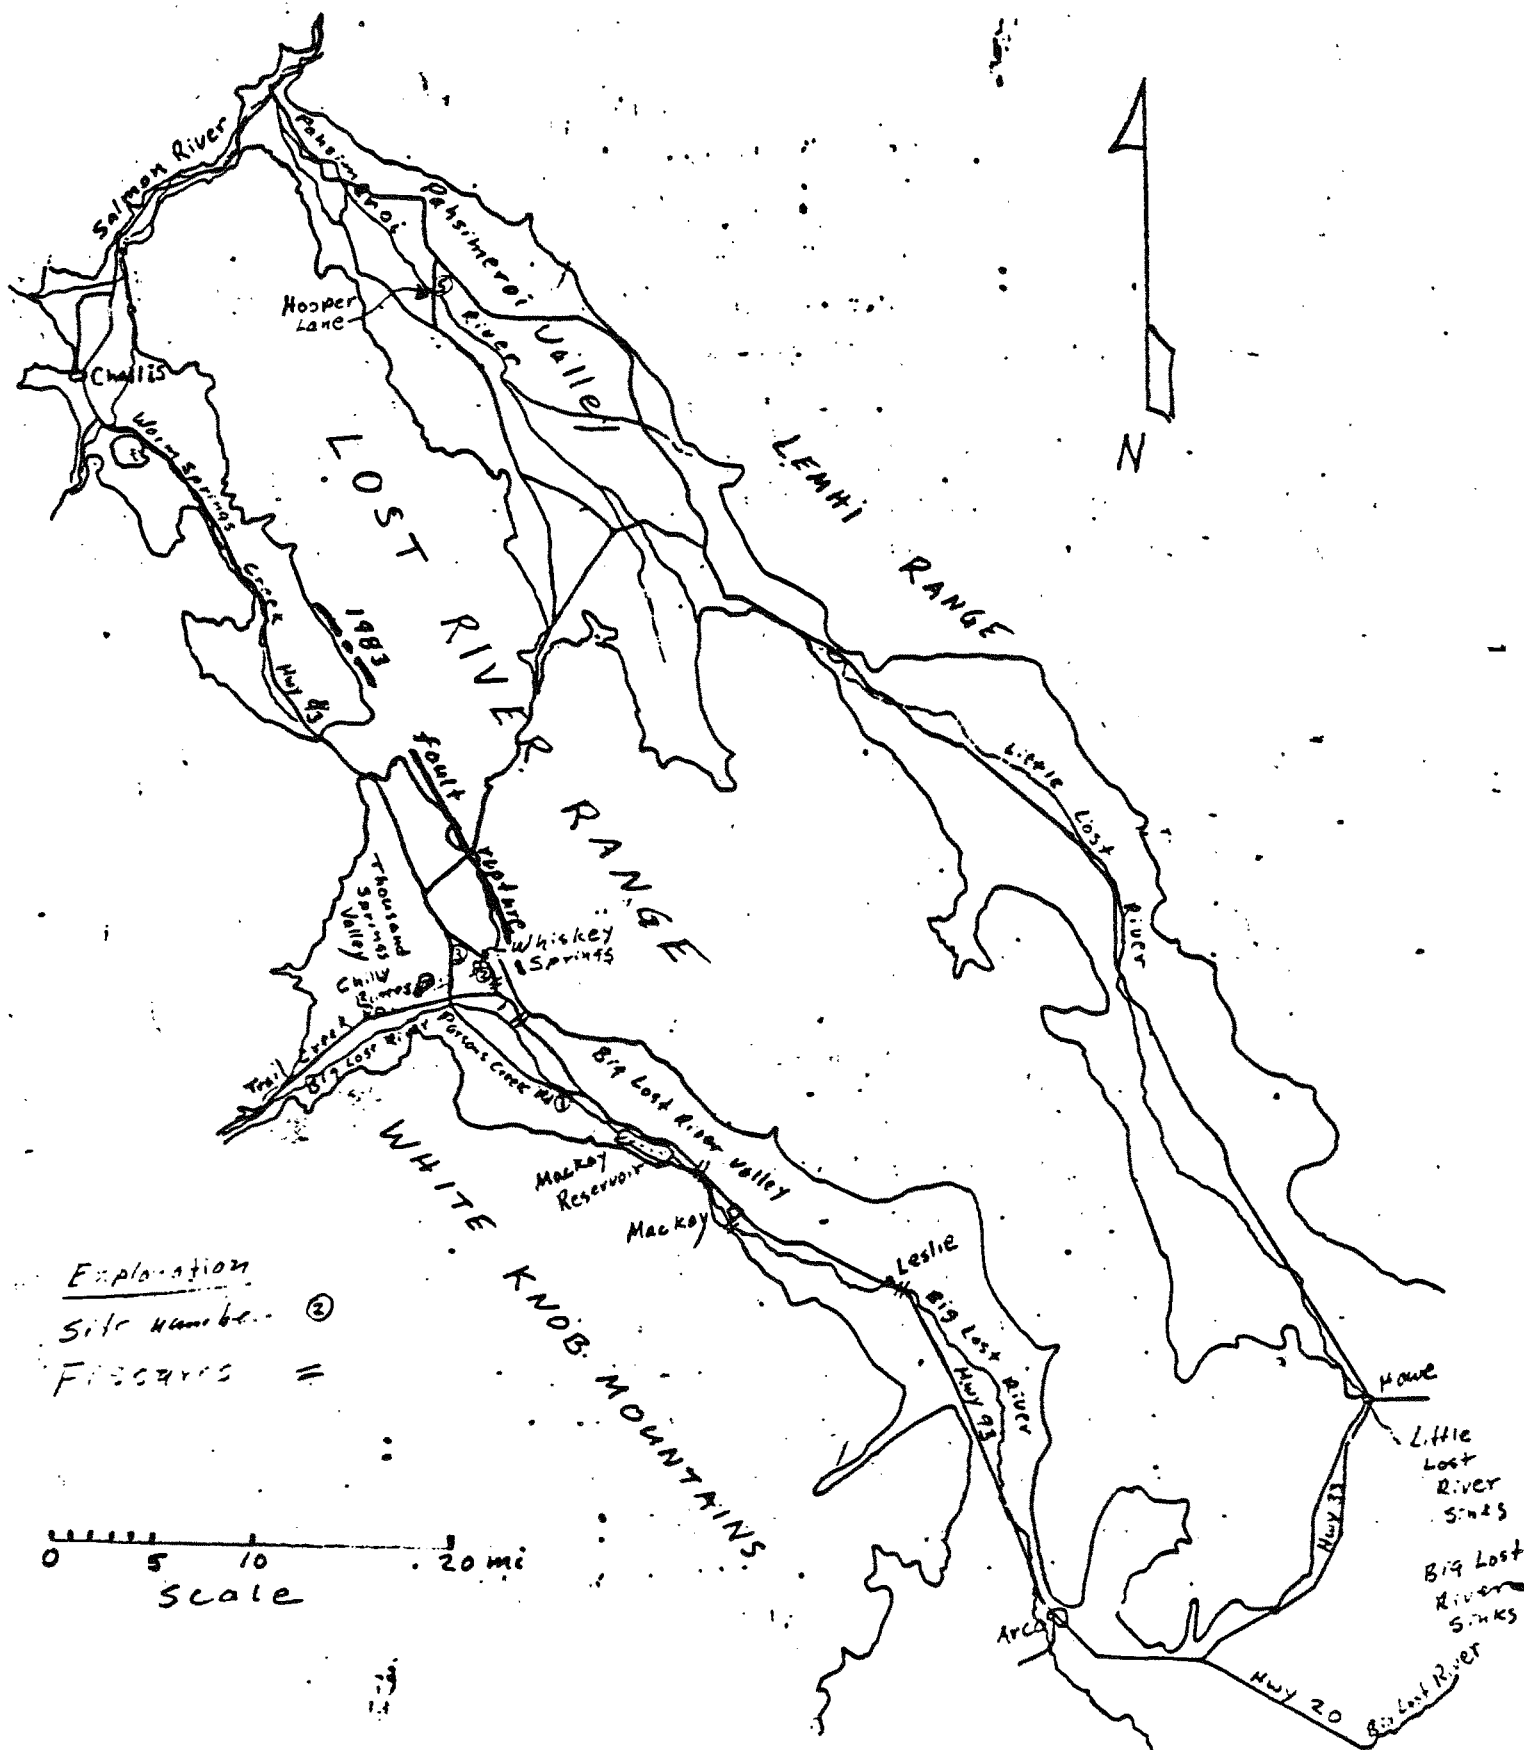
Fig. 1

Liquefaction effects generated by the 1983 earthquake developed only in the intermountain valleys surrounding the Lost River Range (Fig. 1). These valleys are filled with alluvial, fluvial, and glacial sediment to varying depths (McIntyre and Hobbs, 1978; Nelson and Ross, 1969; Rember and Bennett, 1979a, 1979b). The youngest sediment in the valleys are channel and floodplain deposits of late Holocene age. These young fluvial deposits lie along the courses of the many rivers and creeks that drain the intermountain

Fig. 1.--Map of region investigated showing geographic features and locations of effects associated with liquefaction.

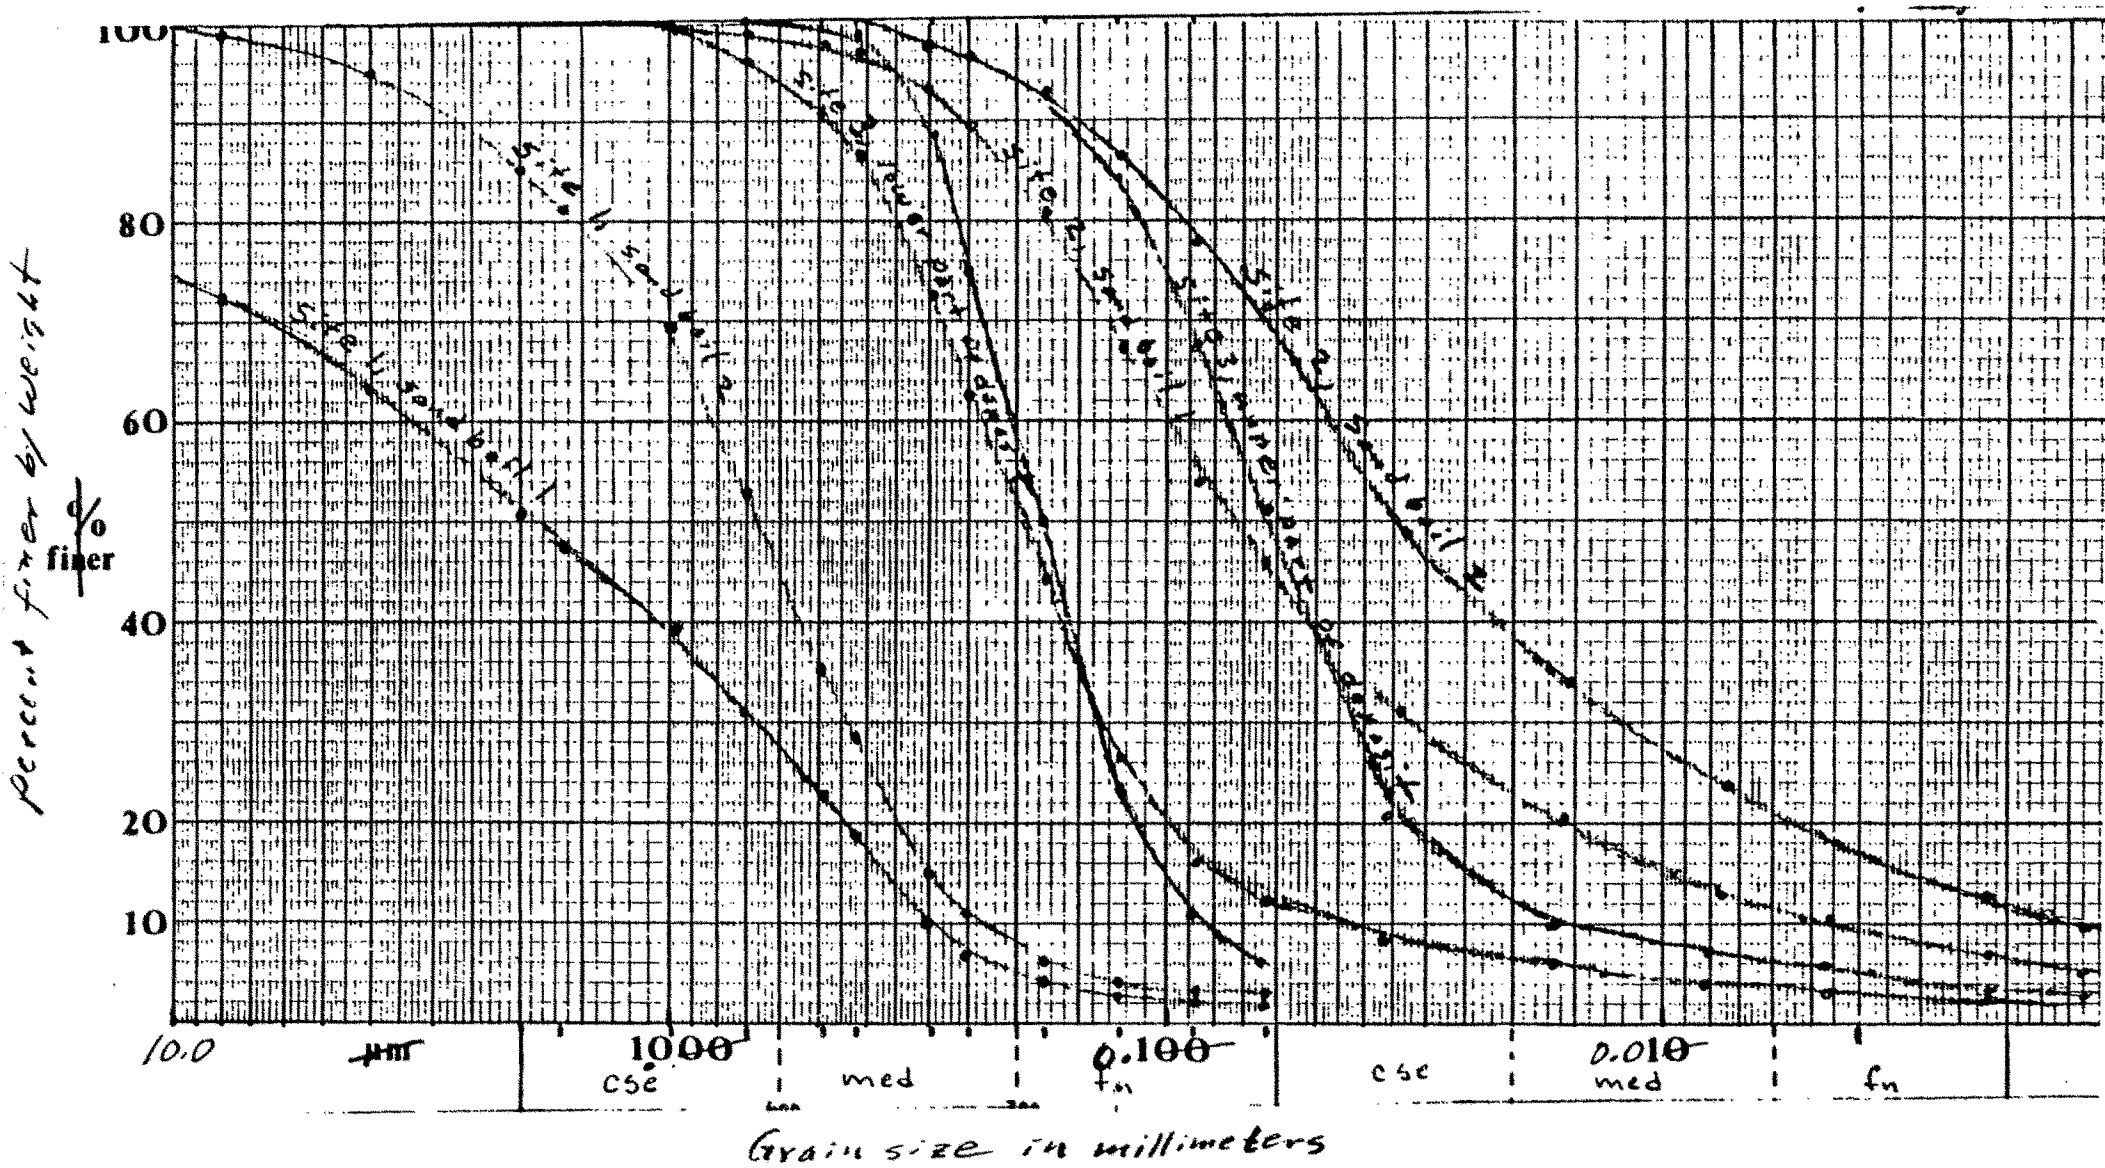
The apparent cause of the lateral spreading was liquefaction of a subsurface sediment layer. The eruption of sand boils at several places along the toe and on the spread are evidence of this phenomenon. The sediment deposited by the sand boils in all observed instances was silty fine sand (Fig. 3), indicating that the layer that liquefied is composed of approximately equally fine grained material. That material is finer grained and better sorted than the fan material exposed in fissures. The fan material is rather poorly sorted and contains both finer particles (clay-size) as well as coarser sand, gravel, and cobble size particles than the sand boil deposits.

Fig. 3.--Grain size distribution curves for samples taken from various sand boil deposits.

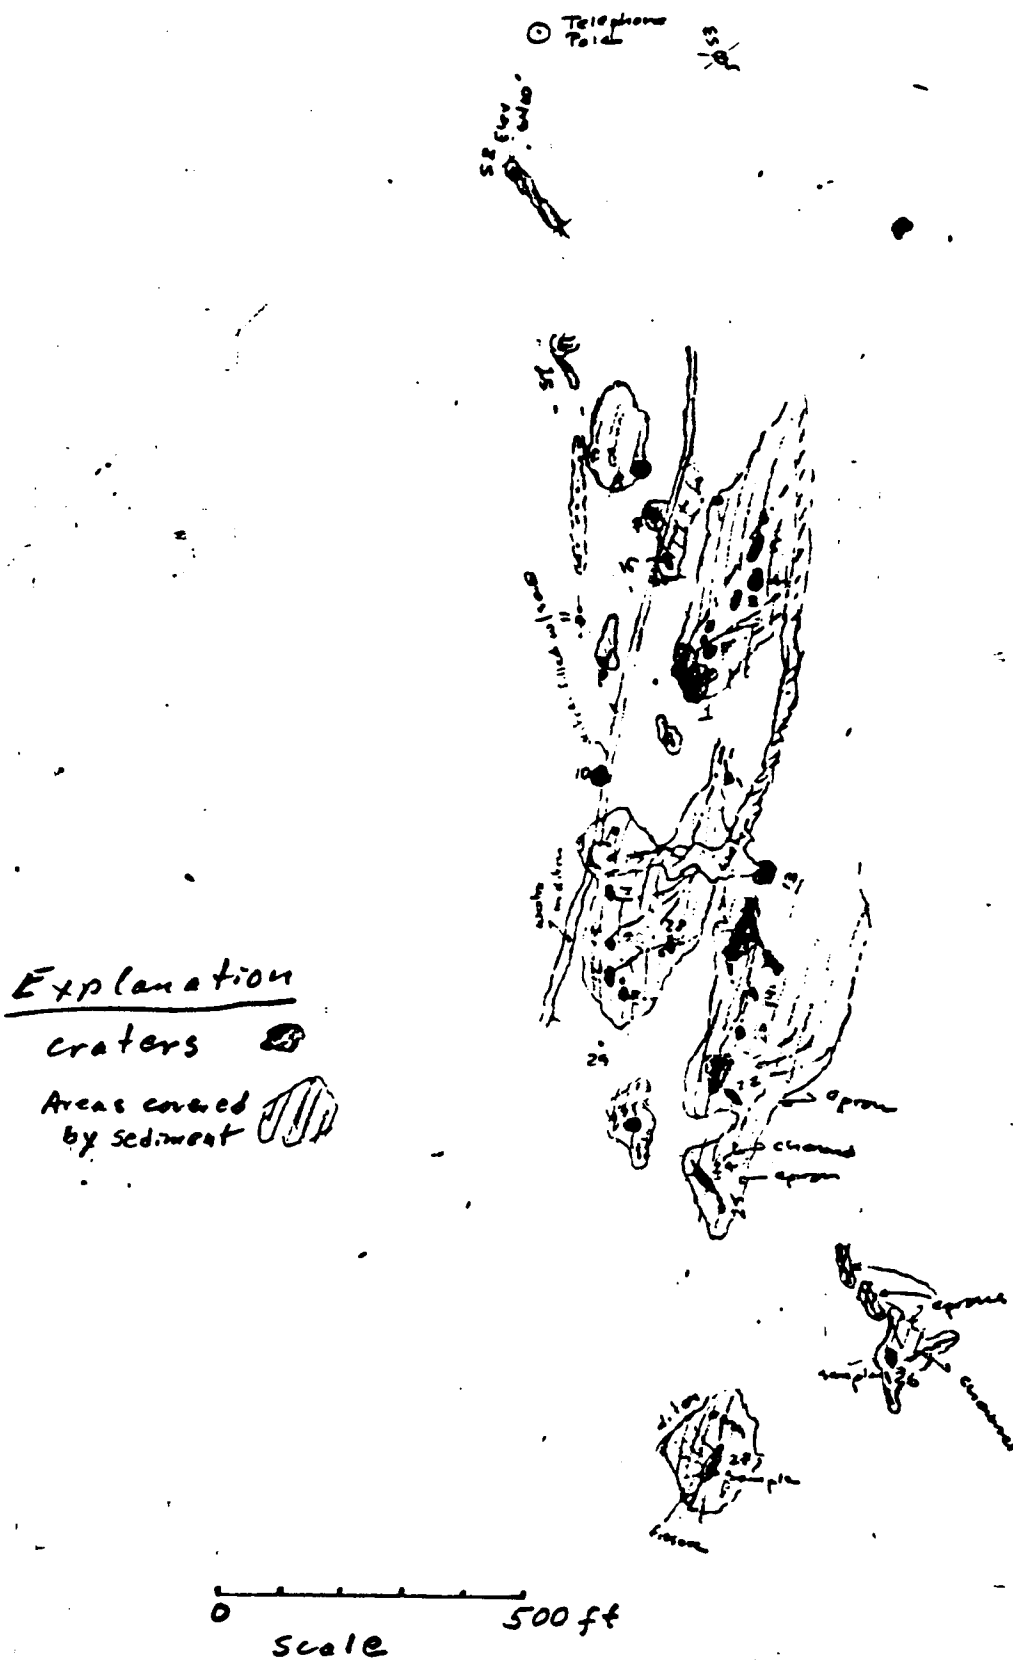
sediment (Fig. 12). They counted craters larger than 2 ft in diameter and measured 10 with diameters greater than 20 ft and depths greater than 5 ft. The largest crater had a diameter of 50 ft and a depth of 20 ft. (Dave and Ray correct the numbers given and fill in the blanks, or revise to better state what happened/ Les.) At least one crater existed before the earthquake and was deepened by the outburst of water during this event. That crater was apparently was created by a similar eruption of water during a previous earthquake, possibly the 1956 Hebgen Lake, Montana, event. The quantity of water expelled and the fact that eruptions developed high on the hillside of Chilley Butte indicate that the source for the water that flowed out of the boils and springs was a deep aquifer that was either pressurized or the confining cap fractured by earthquake actions. More information on the outbursts near Chilley Buttes and increases in spring flow in other parts of the Thousand Springs Valley is given in the chapter on Ground Water Hydrology in this report.

Fig. 12.--Map of Chilley Buttes area showing craters, areas covered by ejected sediment and flooded areas

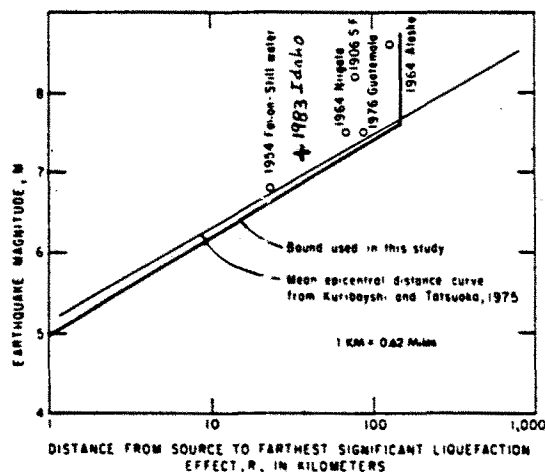
The distance from the fault rupture to the farthest localities where liquefaction occurred is much smaller for this earthquake than would be predicted from worldwide correlations. The fissures in Highway 93 near Leslie, 23.5 mi from the fault rupture, are the most distant effects attributable to liquefaction. That distance is only about half the possible maximum distance expected for M_s 7.3 earthquakes according to the curve given by Youd and Perkins (Fig. 14). This more rapid attenuation of liquefaction effects with distance, however, is consistent with Modified Mercalli Intensity which also decreased more rapidly with distance than would generally be expected.

Fig. 14.--Distance to farthest significant liquefaction effect versus earthquake magnitude (M_s) for past earthquakes (after Youd and Perkins, 1978) with data from 1983 Mt. Borah Idaho event.
