INDEPENDENT GEOTECHNICAL PEER REVIEW HOOVER SLIDE SECTION PROVO CANYON

US-189: WILDWOOD TO
DEER CREEK STATE PARK

JULY 18, 2001

**INDEPENDENT GEOTECHNICAL PEER REVIEW
SR-189 HOOVER SLIDE SECTION, PROVO CANYON
WILDWOOD TO DEER CREEK STATE PARK**

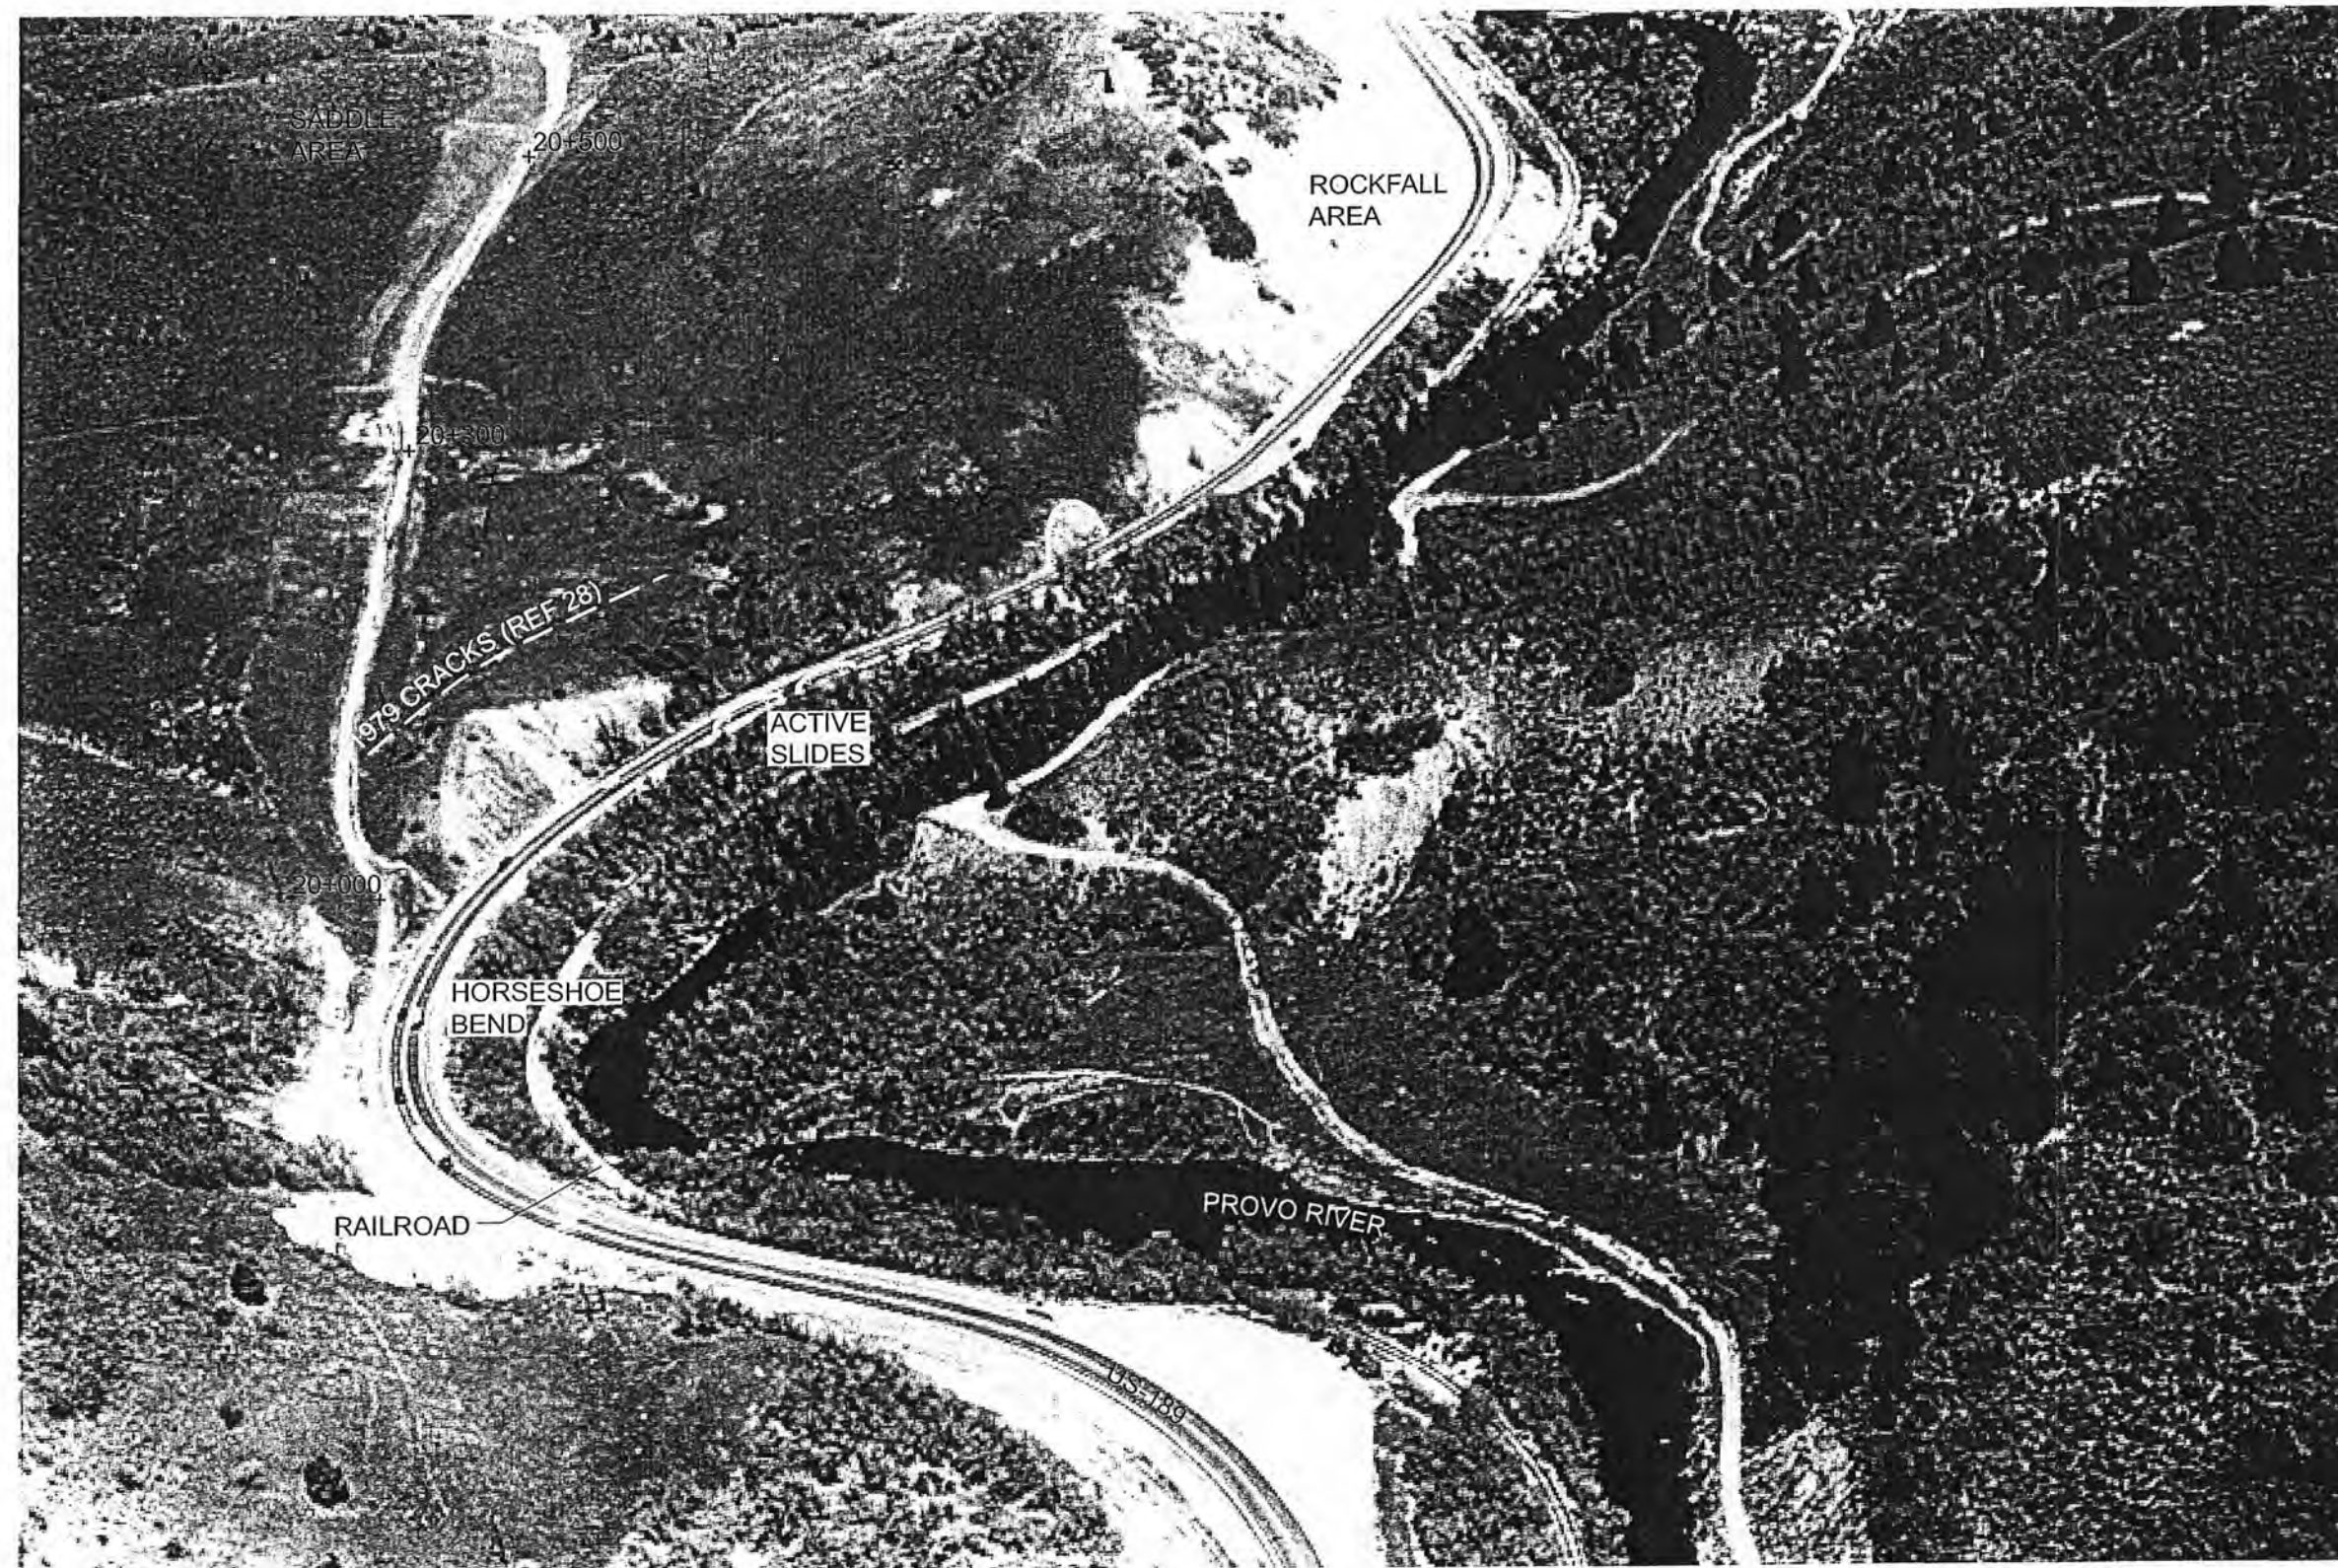
JUL 2001
PROJ. 1315
FIG. 1

Figures 1 through 4 present oblique air photos of the highway section across the Hoover Slide area. Approximate stationing is shown for the Preferred Alignment. Topographic features, facilities, and active slide areas are indicated on the air photos. For reference, Appendix A contains project site plans, showing topography, existing highway, Preferred Alignment (stationing), and preliminary design features.

VIEW LOOKING EAST

APPROXIMATE STATIONING SHOWN FOR PREFERRED ALIGNMENT, WHICH IS CLOSE TO HAUL ROAD.

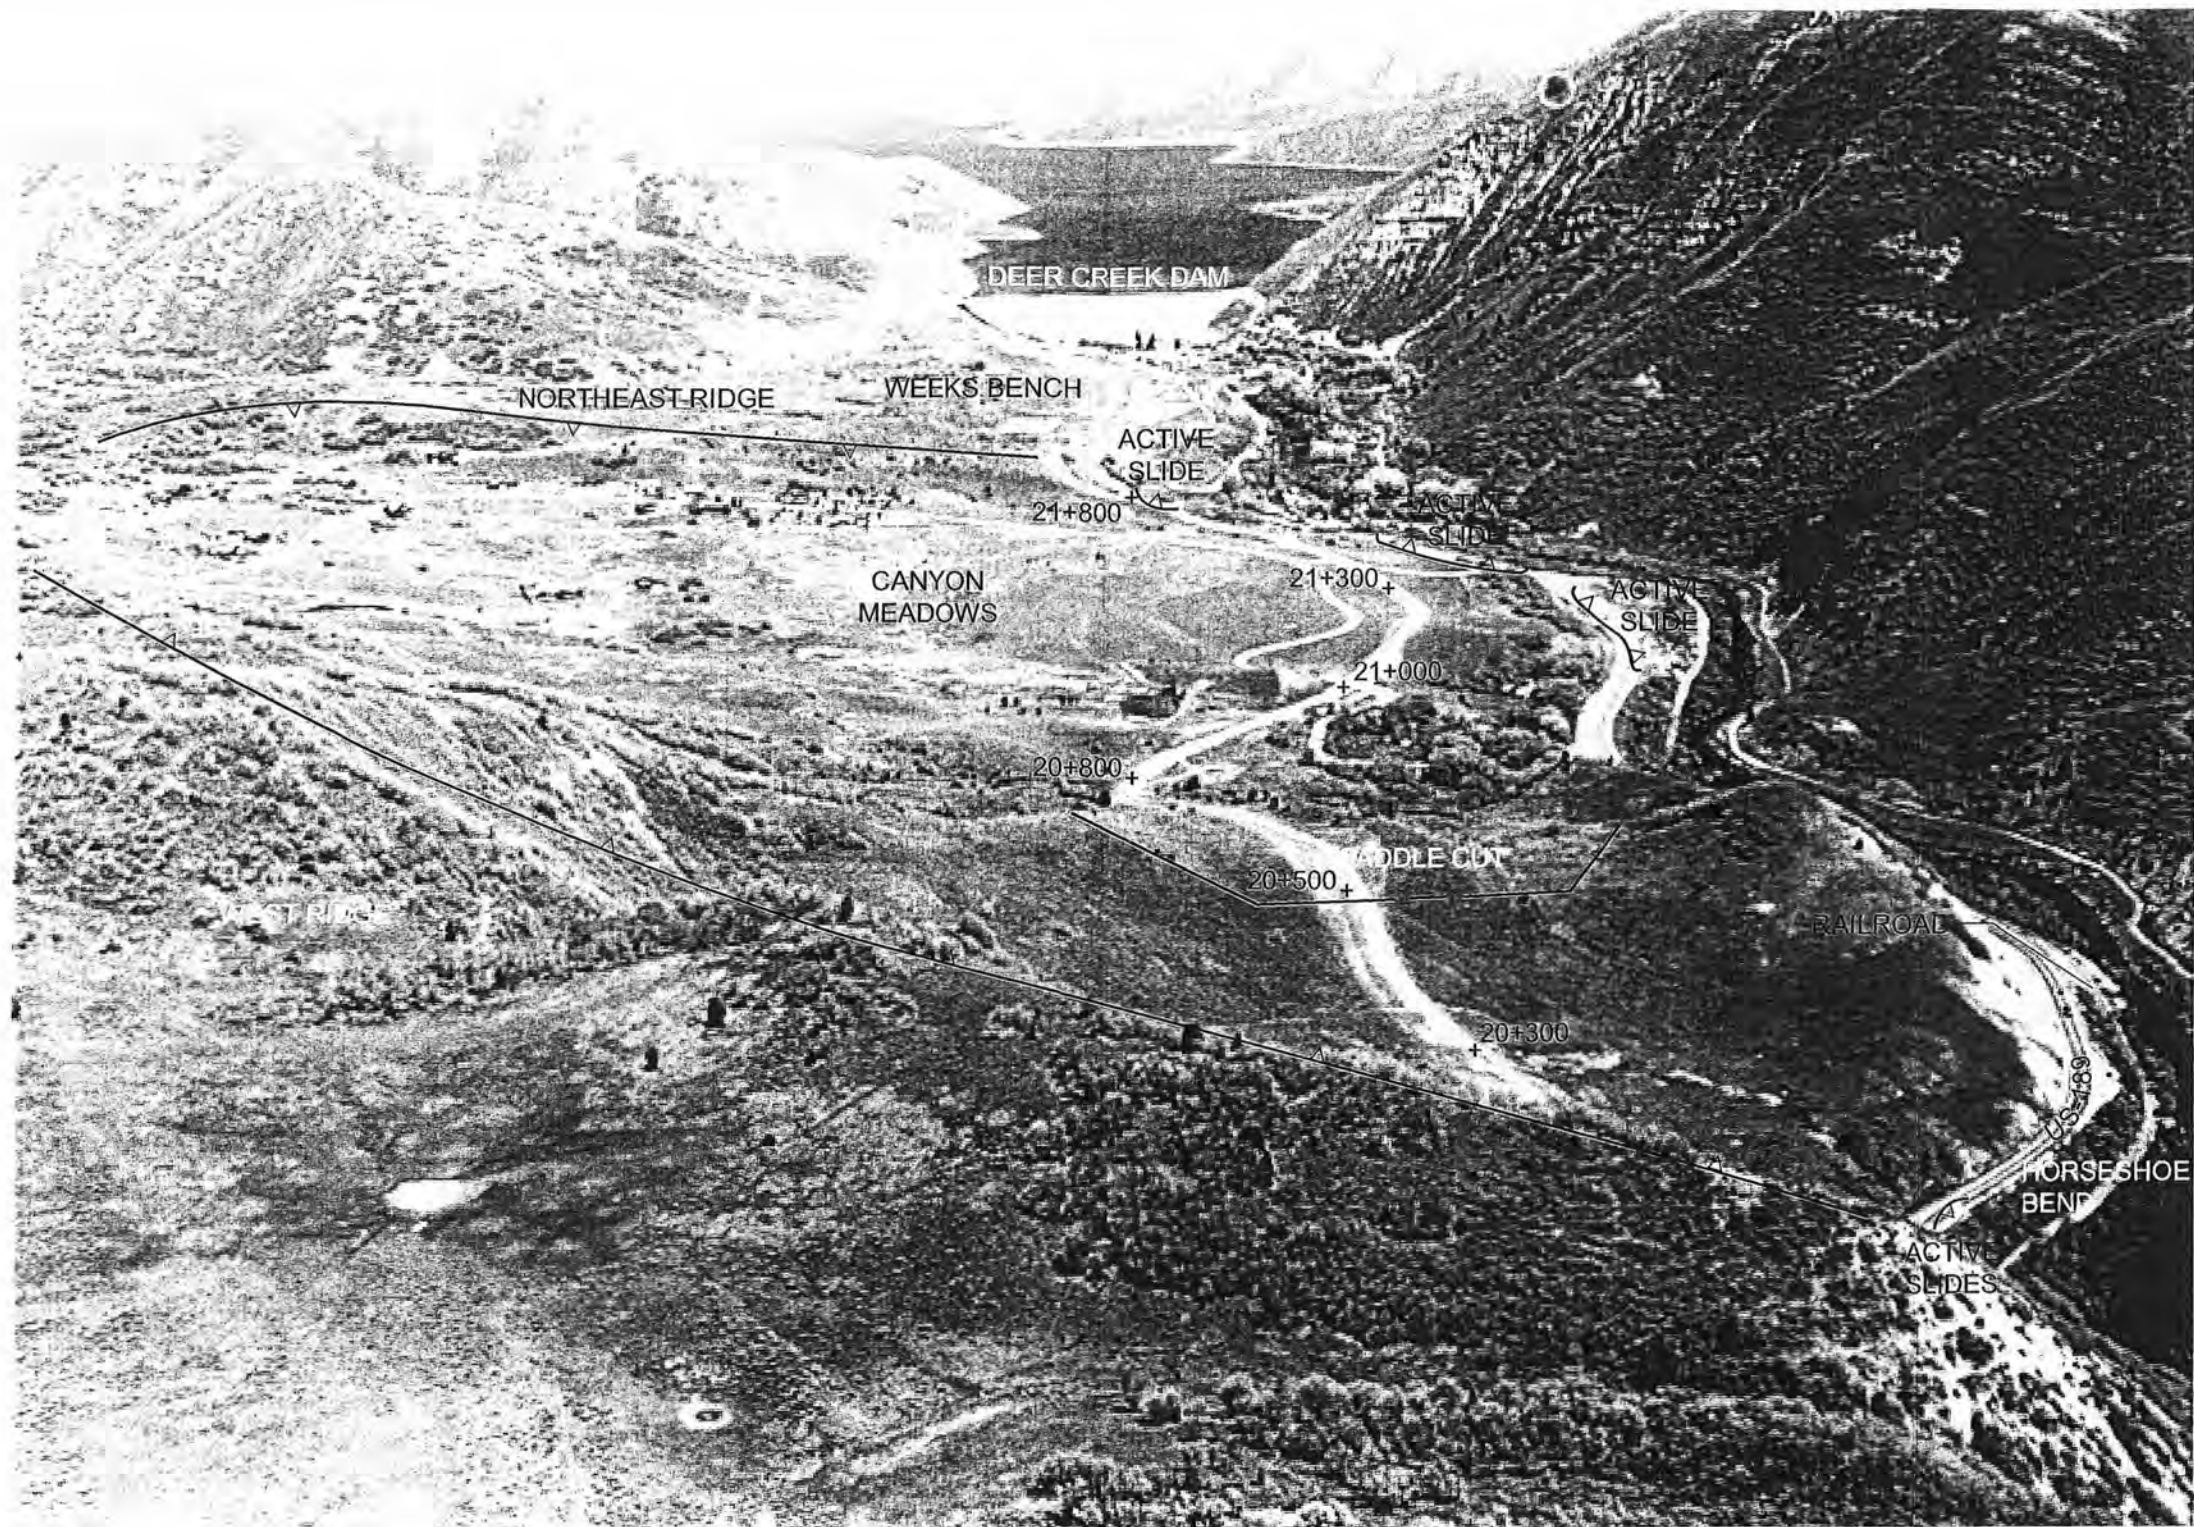
JUL 2001
PROJ. 1315
FIG. 2

VIEW LOOKING EAST

APPROXIMATE STATIONING SHOWN FOR PREFERRED ALIGNMENT, WHICH IS CLOSE TO HAUL ROAD

**OBLIQUE AERIAL
PHOTO LOOKING EAST (2)**
US-189 HOOVER SLIDE SECTION
WILDWOOD TO DEER CREEK STATE PARK

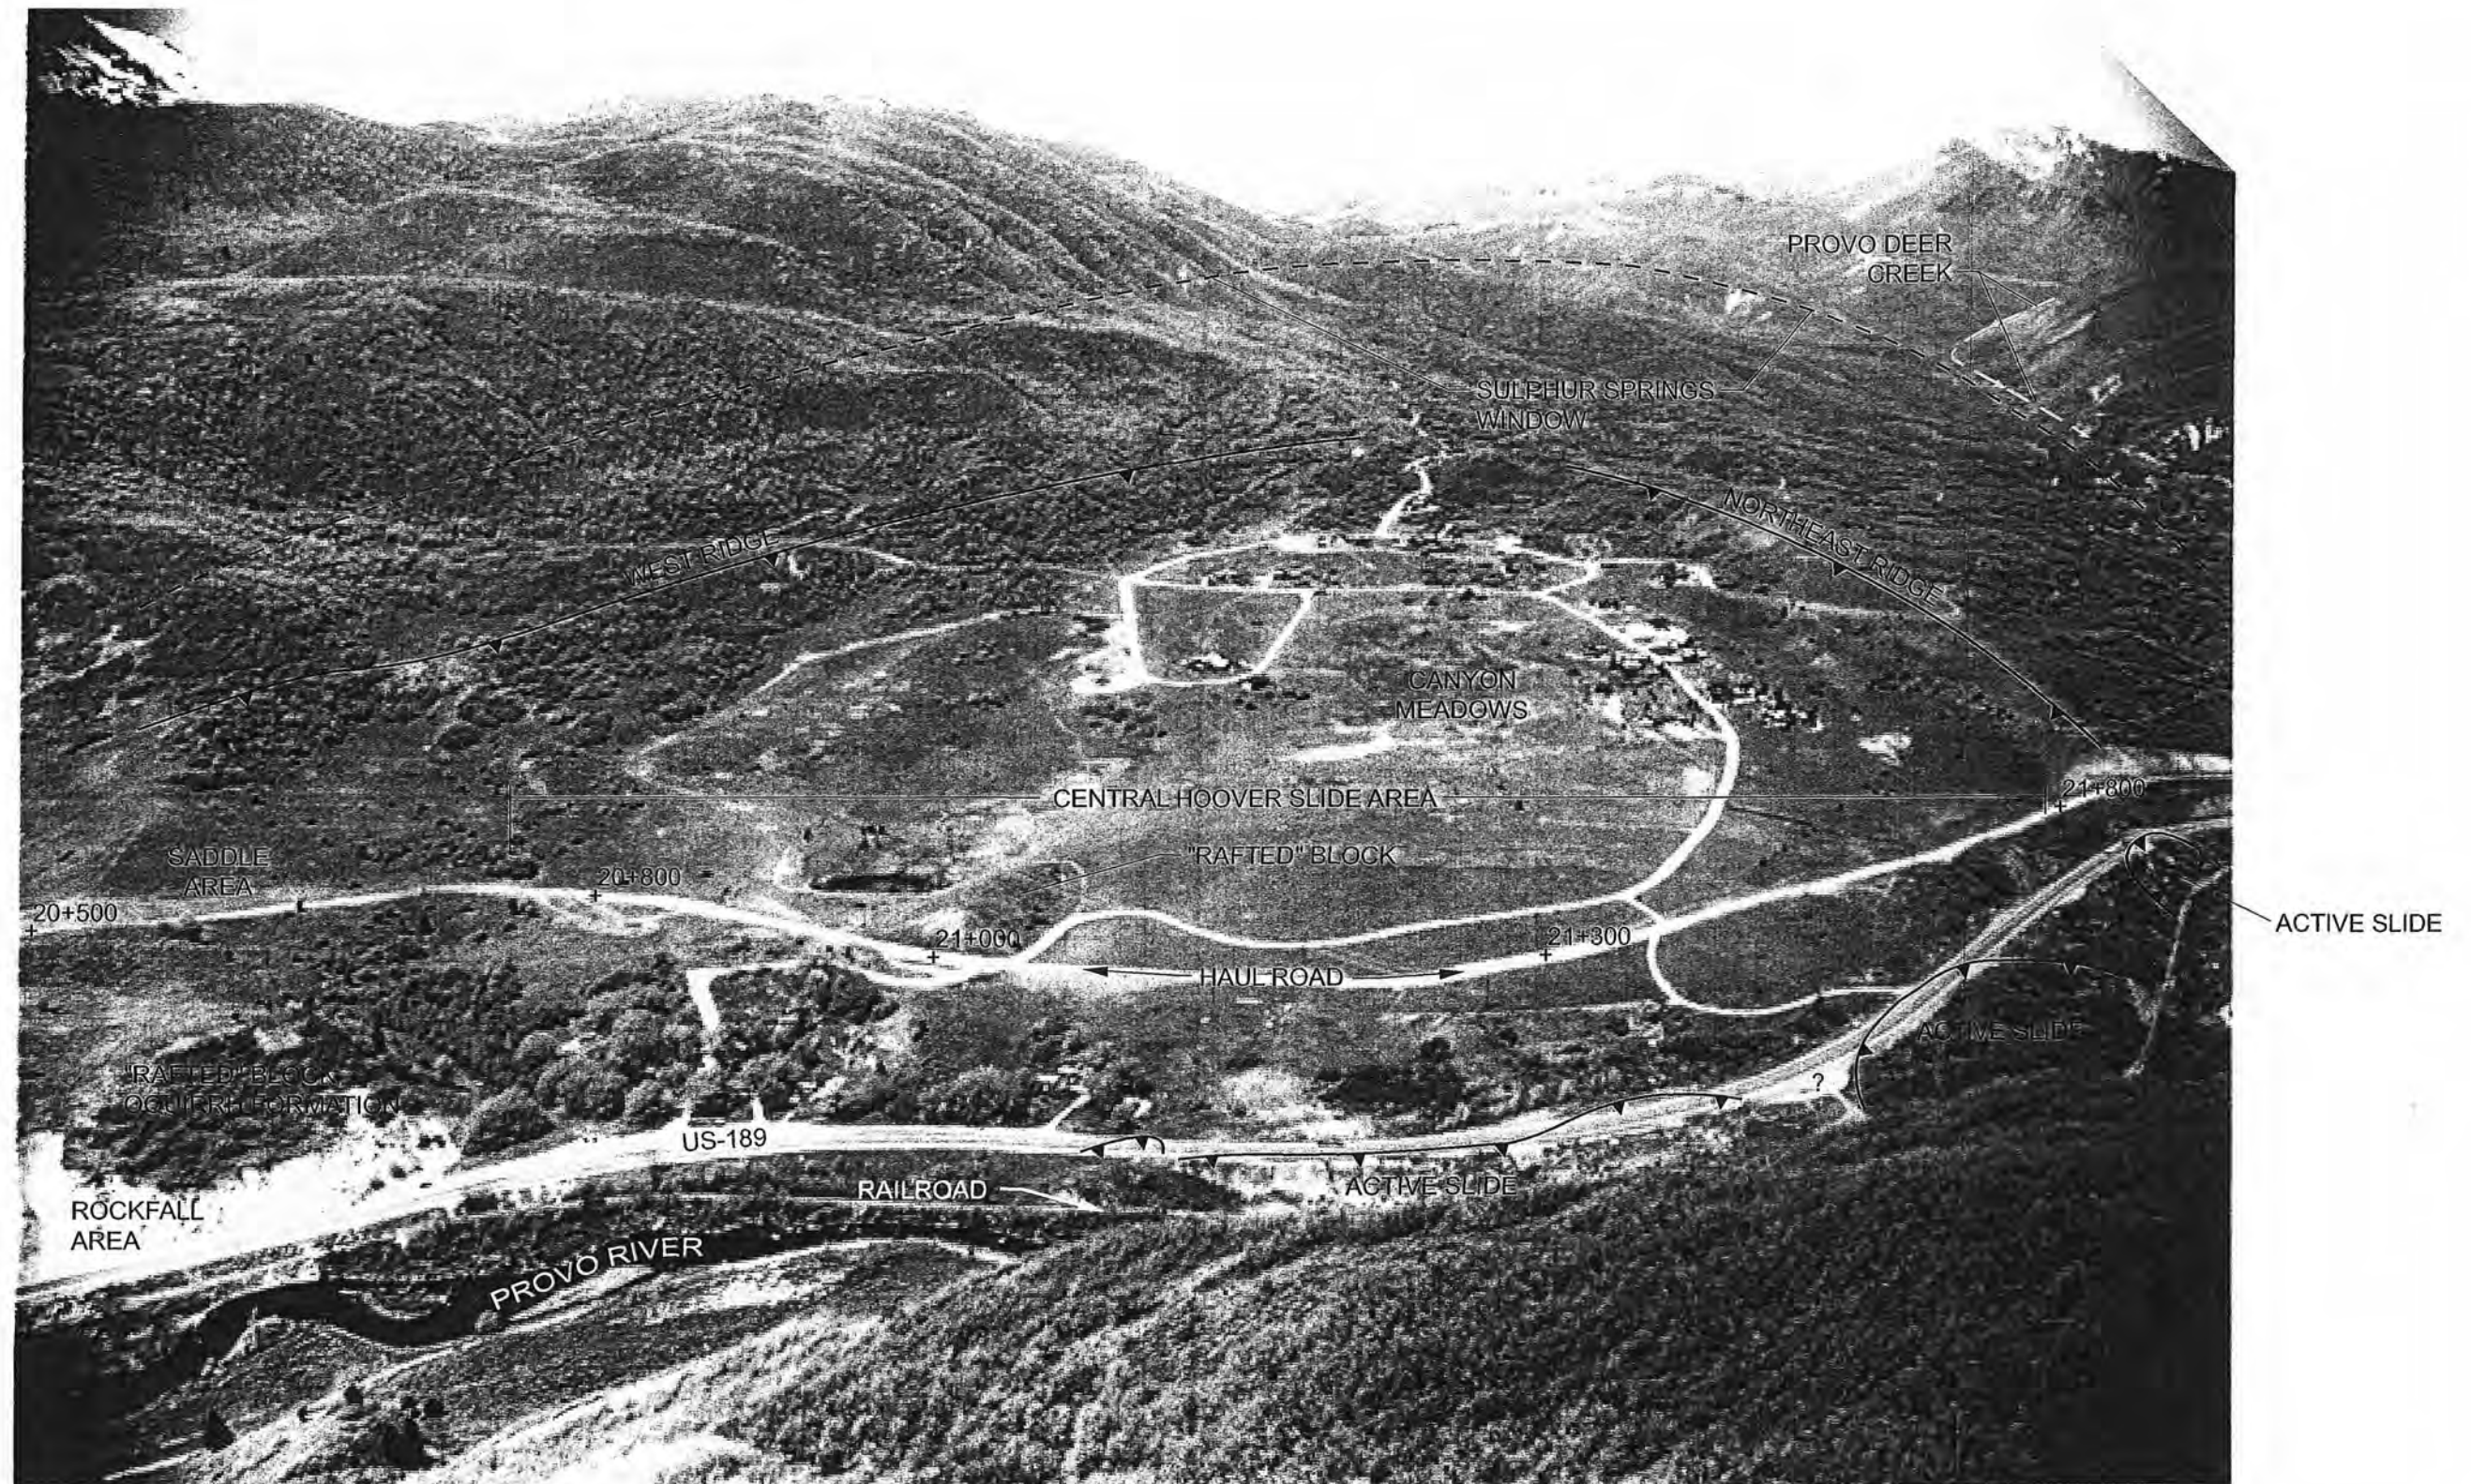
JUL 2001
PROJ. 1315
FIG. 3

VIEW LOOKING NORTH

APPROXIMATE STATIONING SHOWN FOR PREFERRED ALIGNMENT, WHICH IS CLOSE TO HAUL ROAD

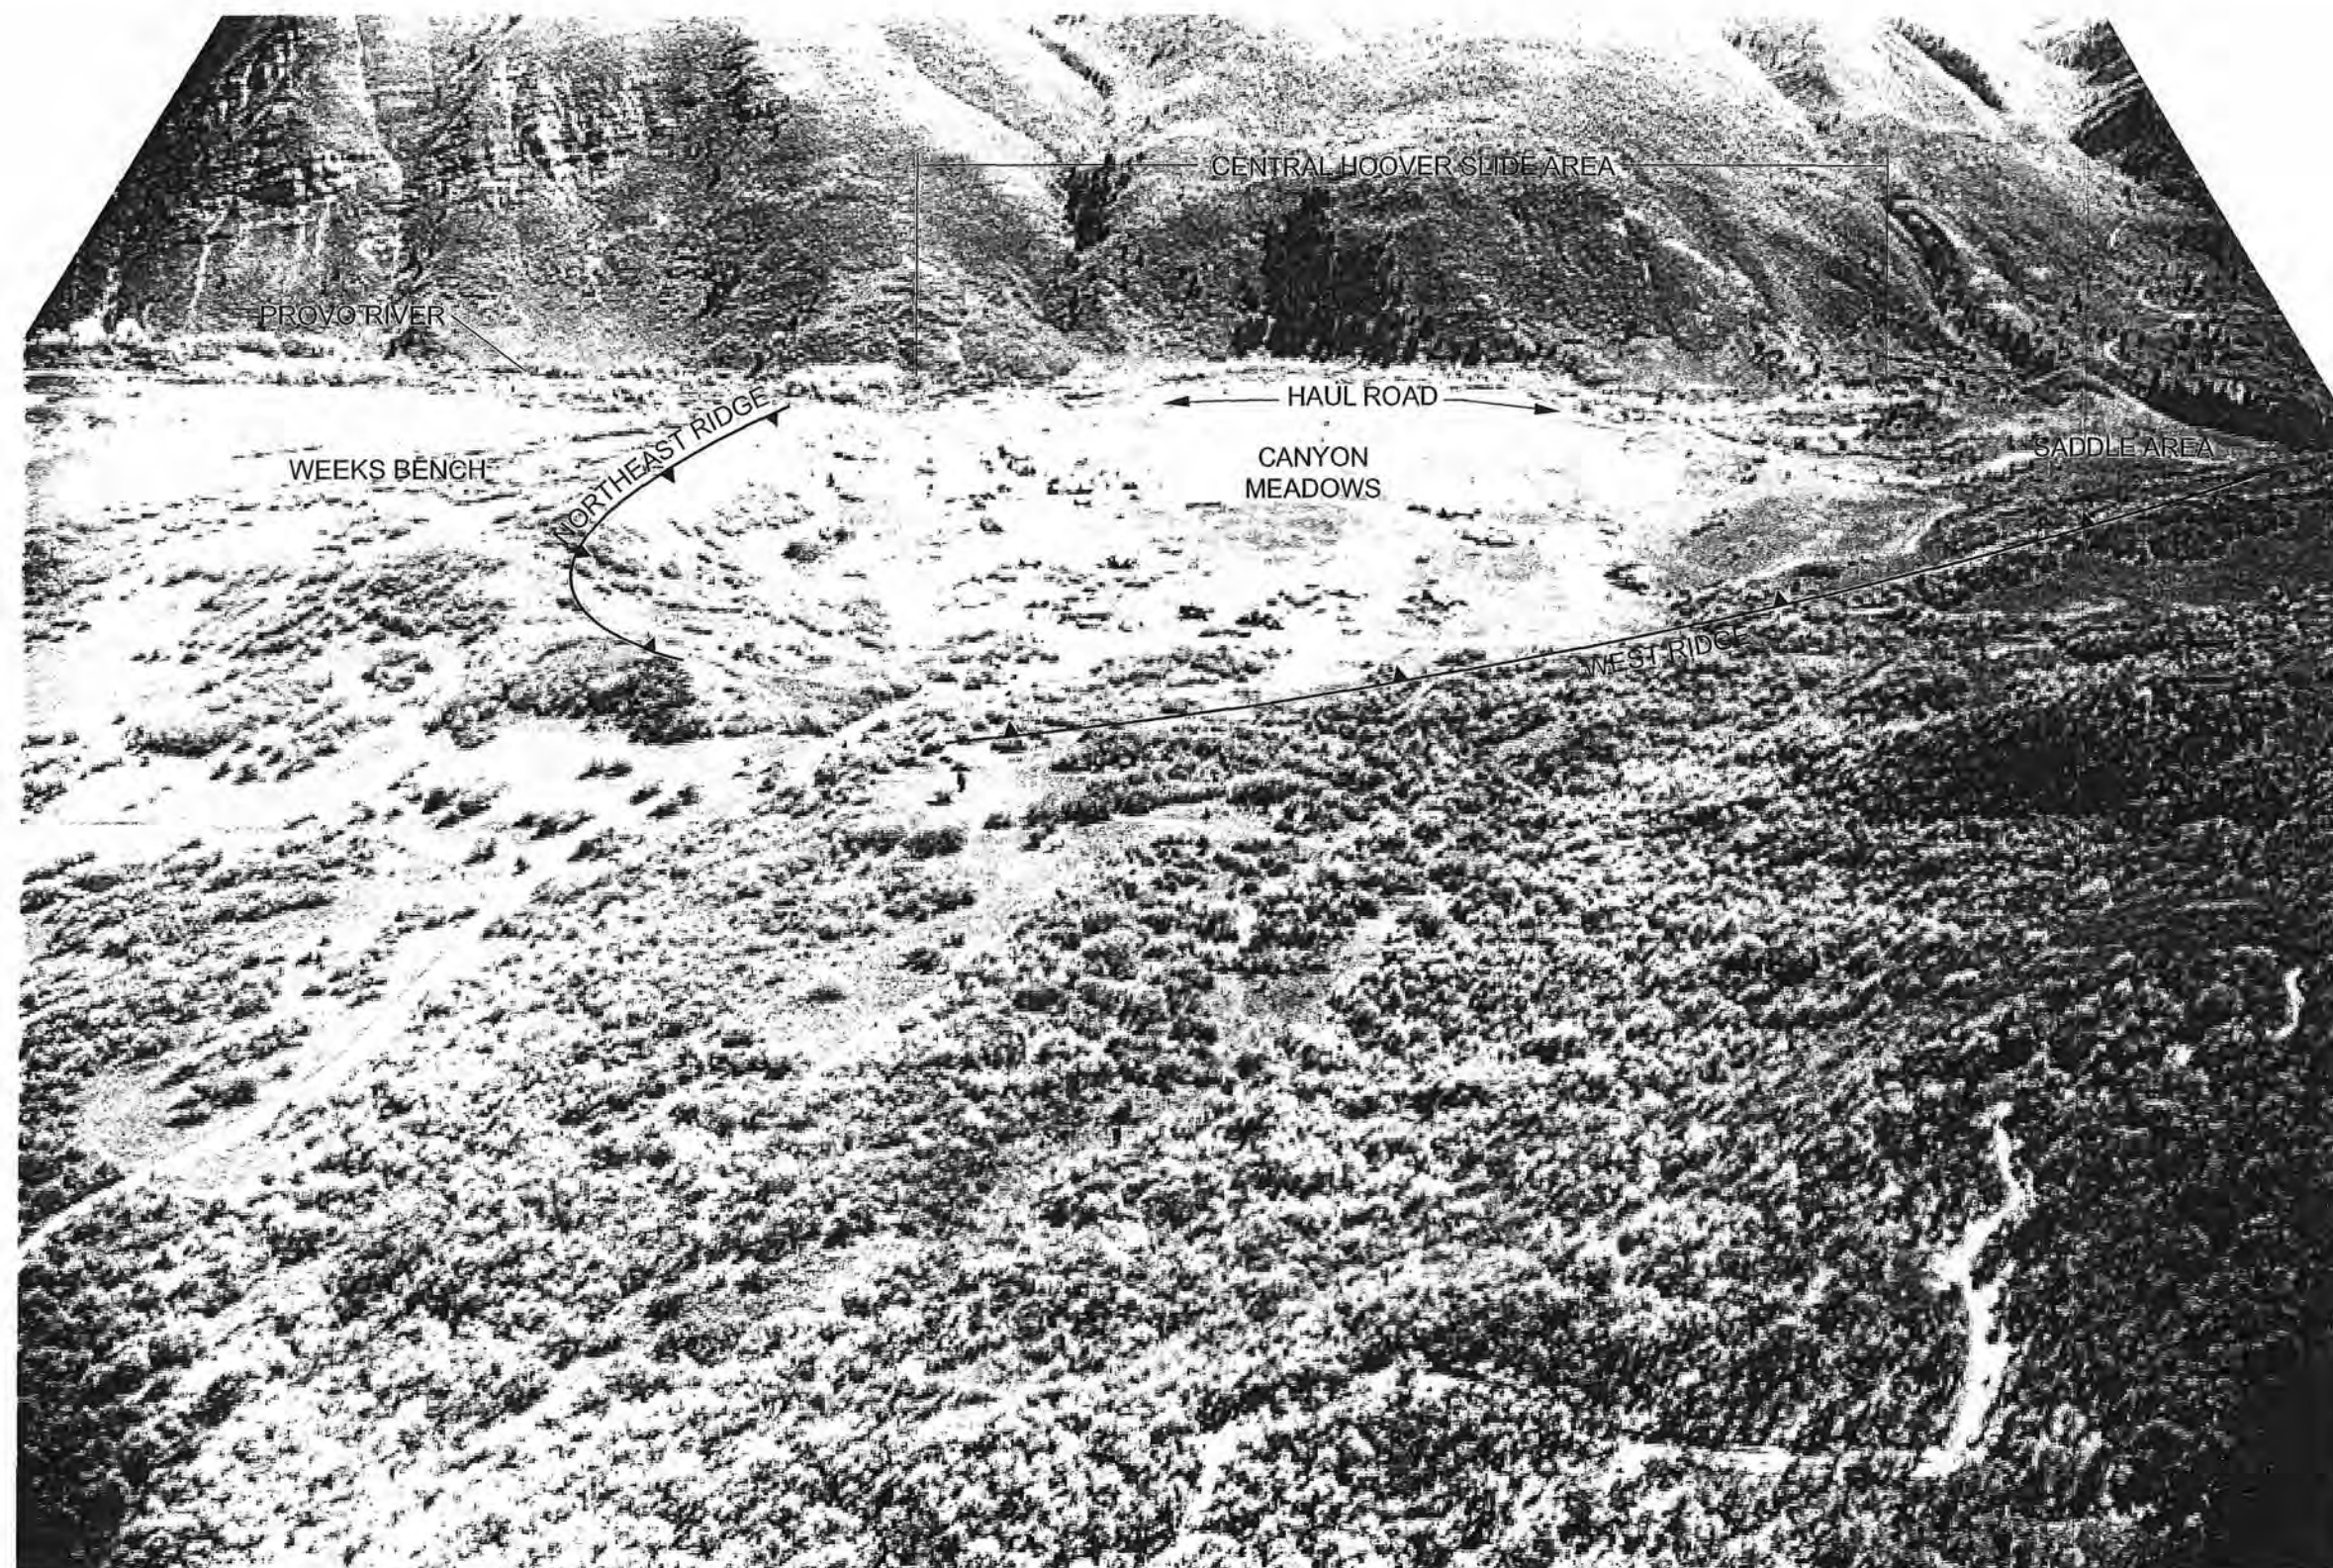
VIEW LOOKING SOUTH
