G-321
LANDSLIDE SURVEILLANCE
OF
LAKE POWELL

UPPER COLORADO REGION

DECEMBER 1980

Geology Report No. G-321
Field Work and Report
by D. Grundvig

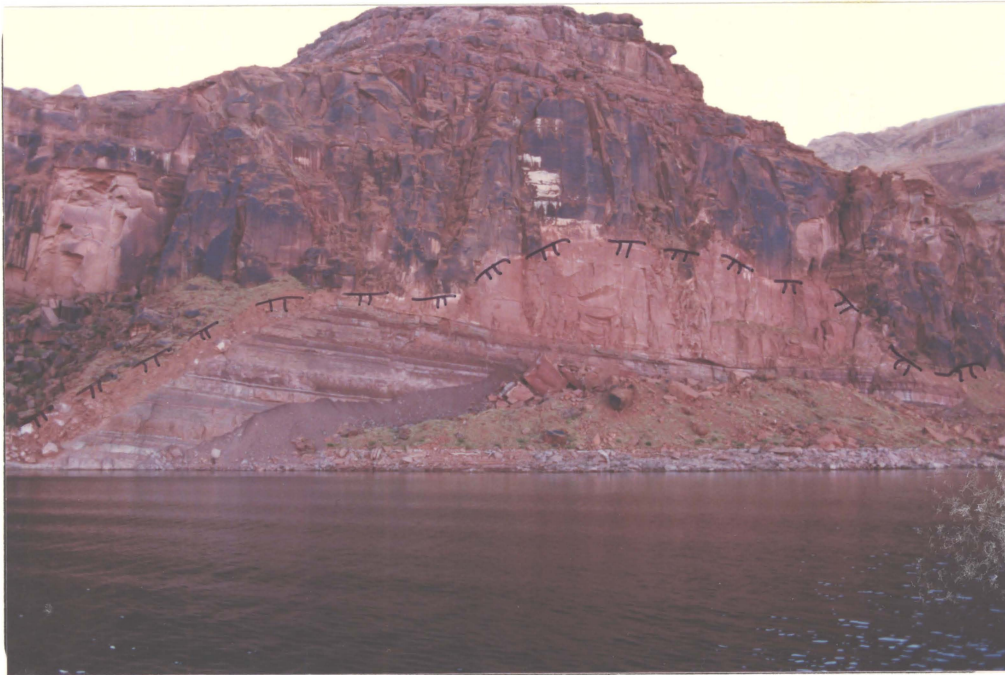
SITE 16

SITE 16: The sliding of talus into the reservoir has removed support from the base of the cliff (Wingate Sandstone) resulting in rockfall. Note the presence of the water line. Slide scarp is approximately 700 feet long and 90 feet high.

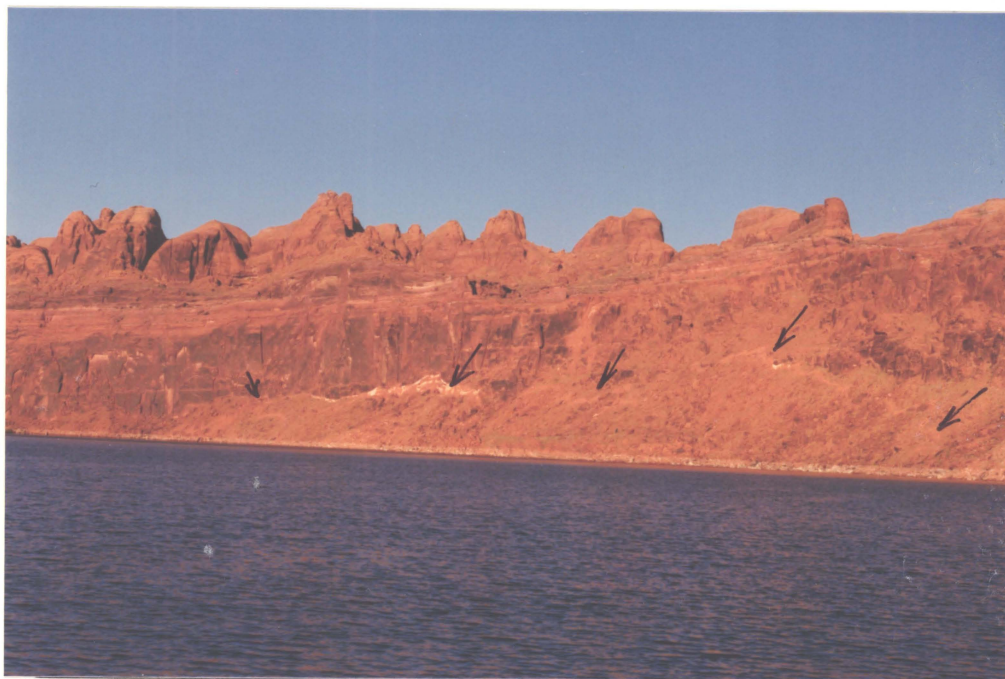
SITE 17

SITE 17: Sliding of talus down and away from cliff. Note presence of high water mark. Faint scarp outline is indicated by arrows. Slide is approximately 150 feet high and 1400 feet long. Entire mass appears to be moving as a unit.

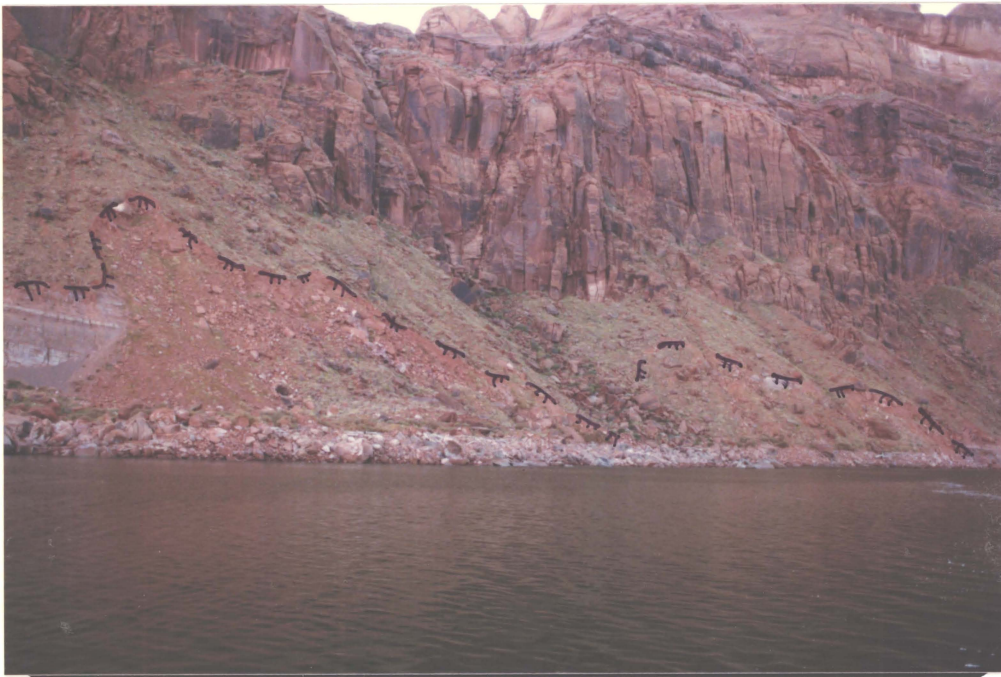
SITE 20

SITE 20: Talus slide located approximately $\frac{1}{2}$ mile west of Spencer Camp. Slide is approximately 100 feet high and 700 feet long. Chinle shale can be seen at the extreme left of the photo.

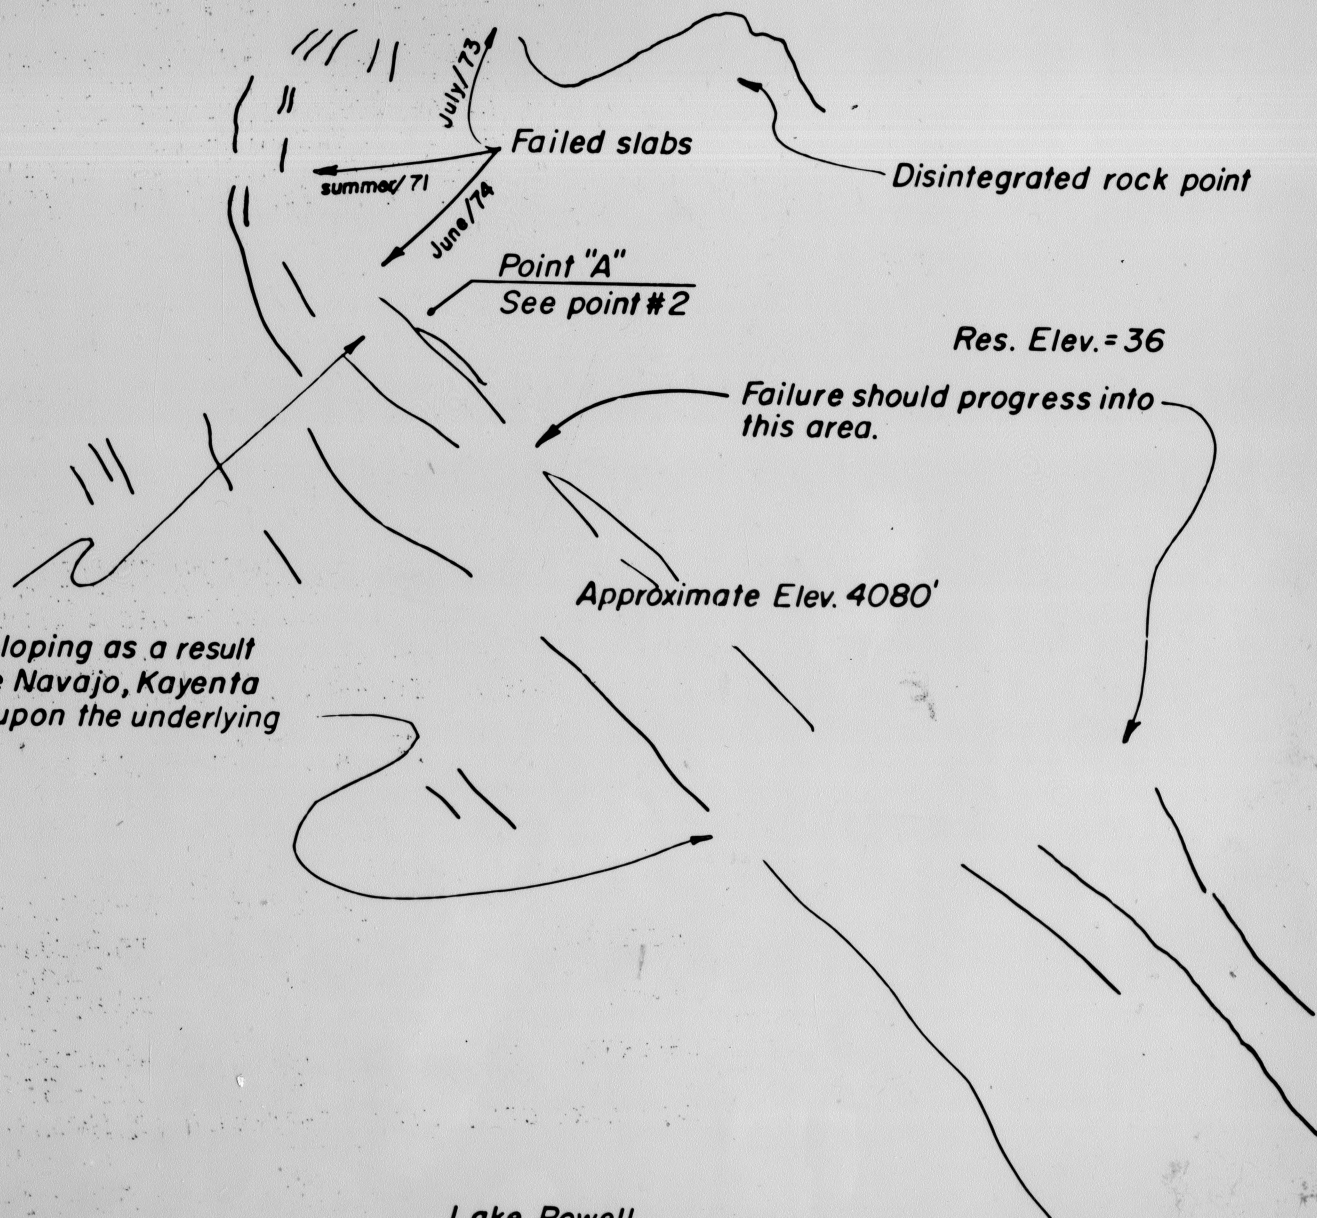
Photo # 1

Stress relief joints developing as a result of weight imposed by the Navajo, Kayenta and Wingate formations upon the underlying Chinle formation.

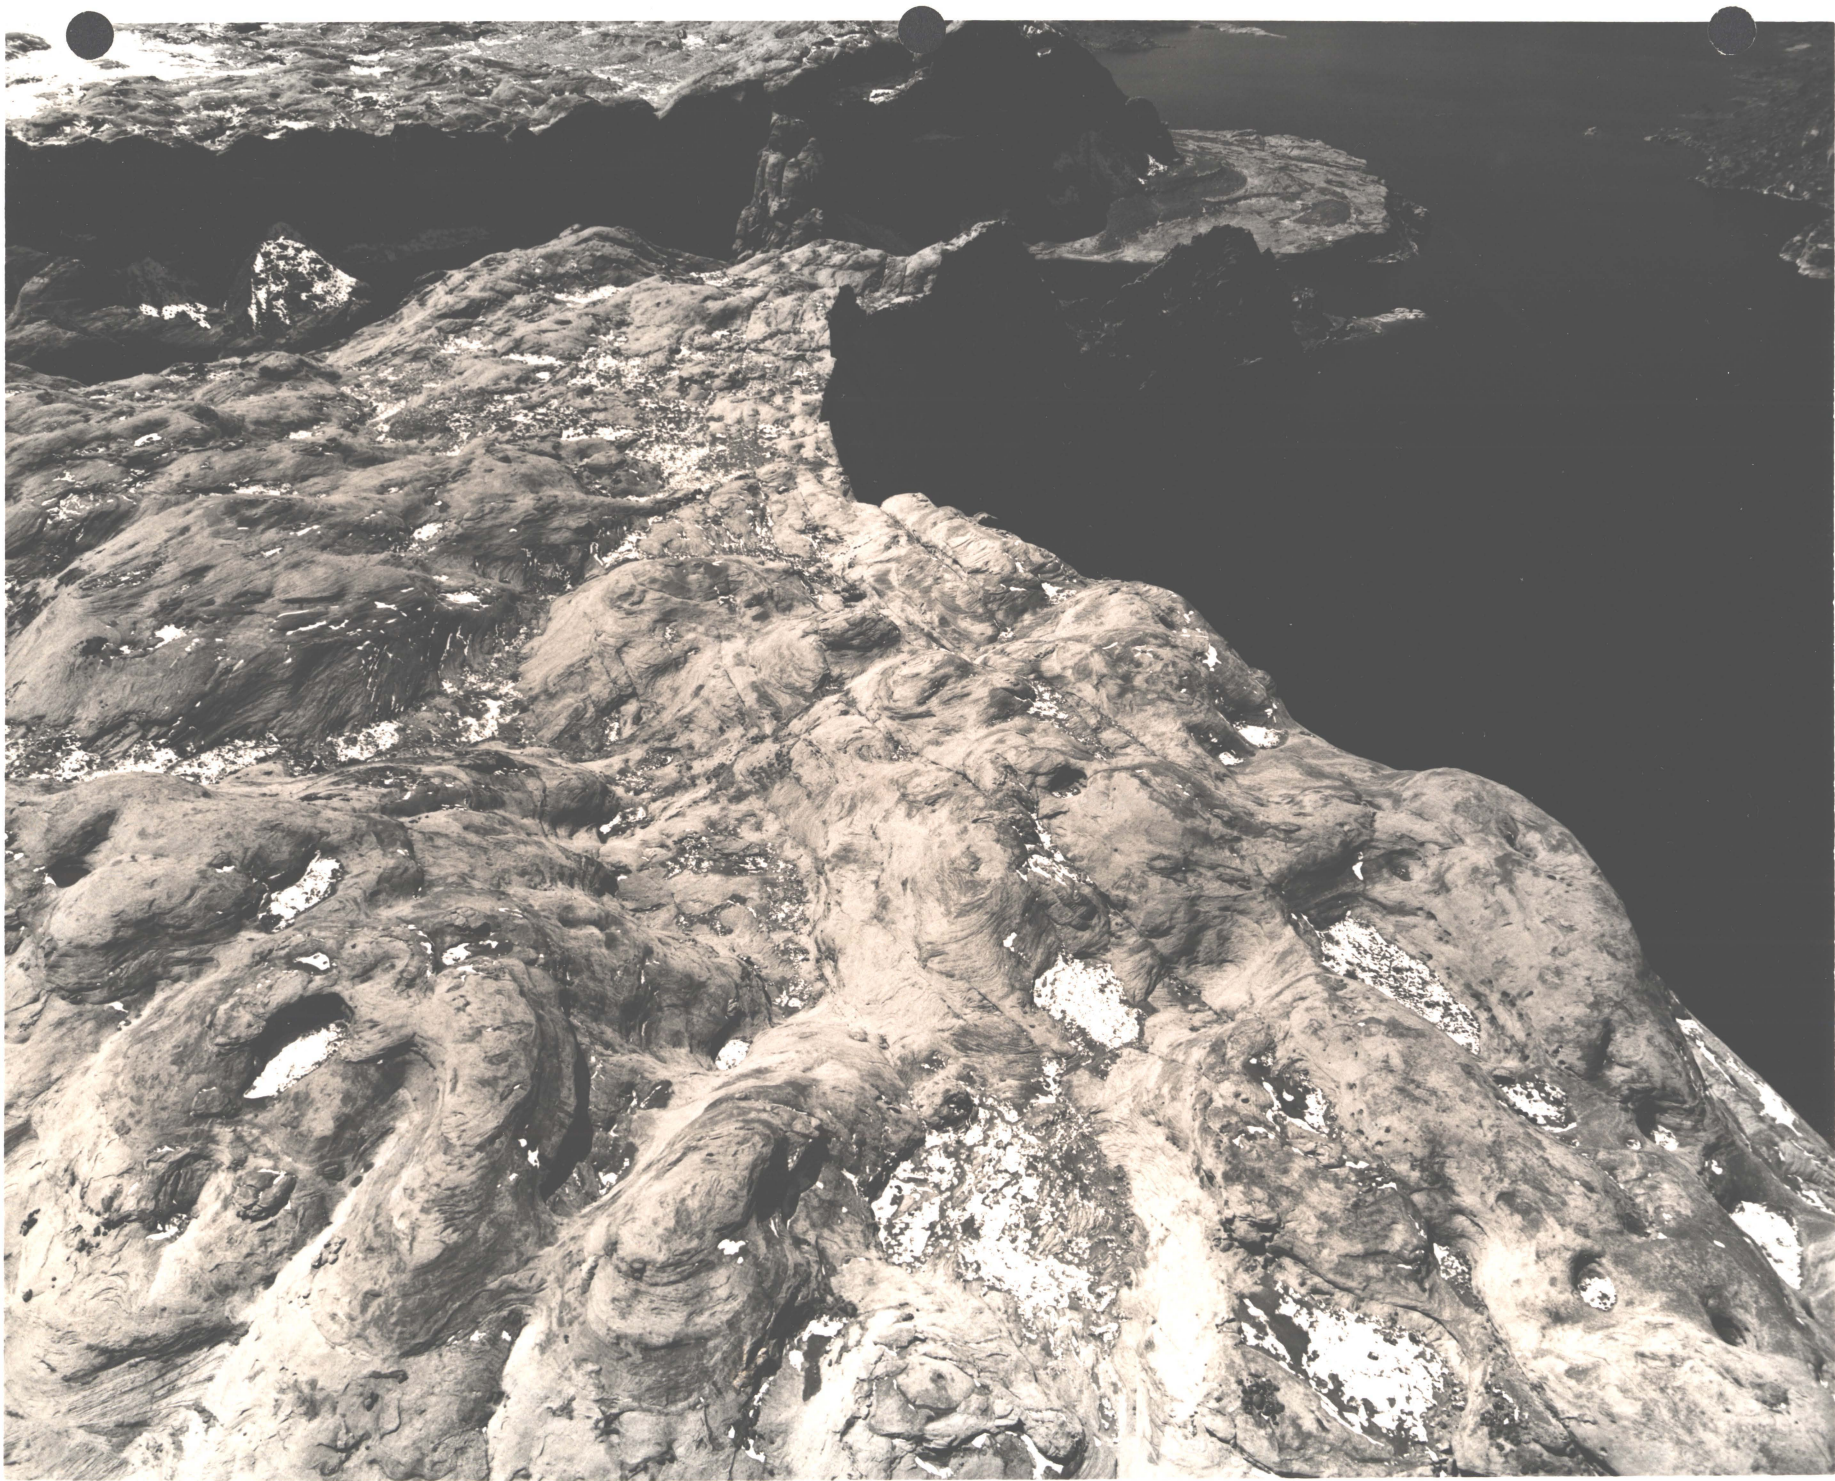
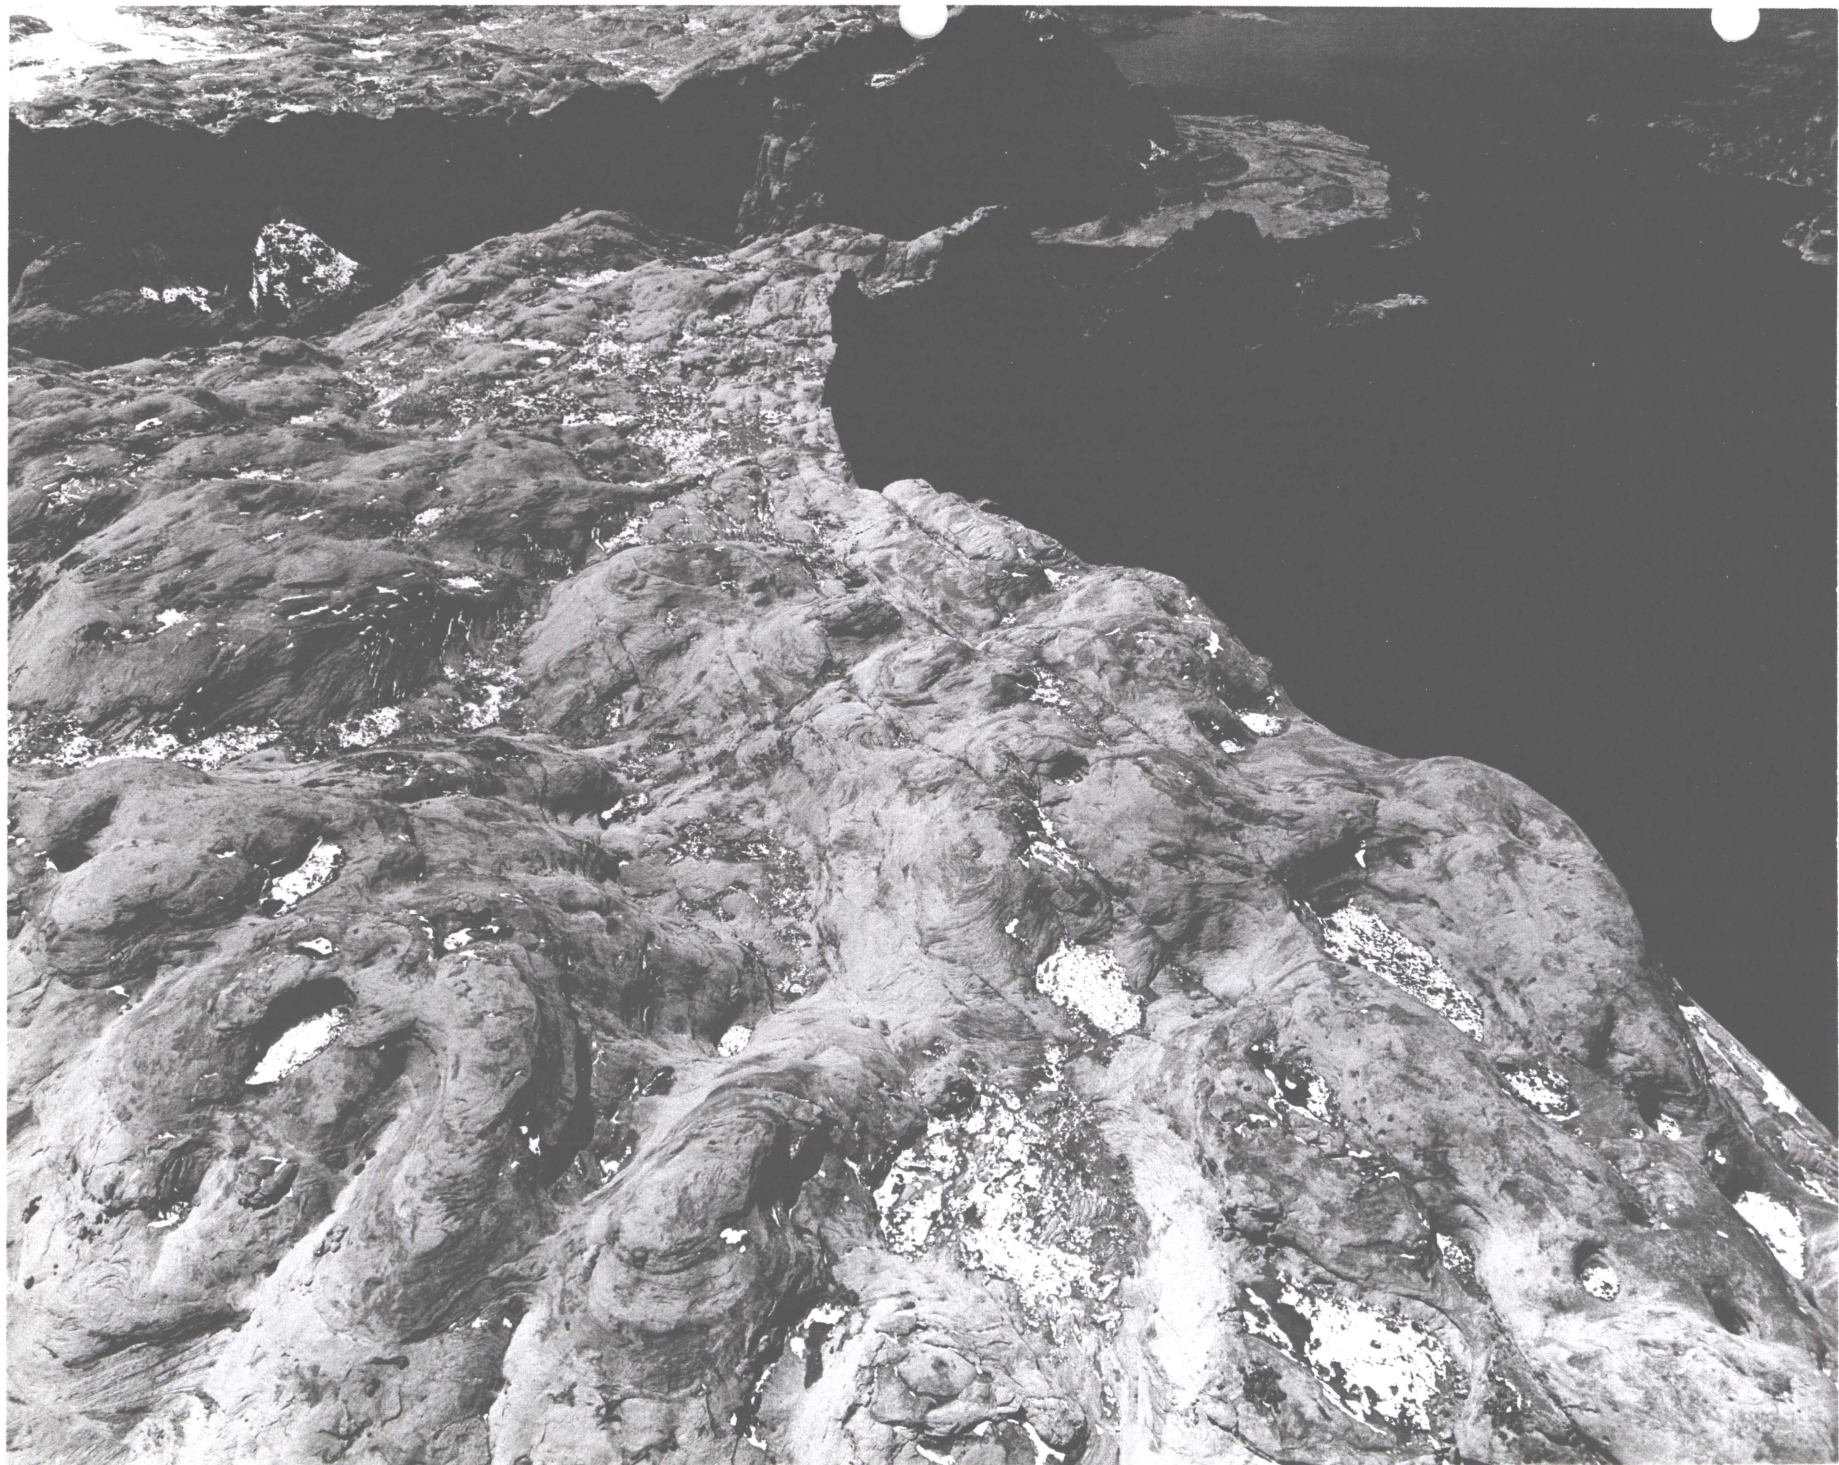
Photo # 1.

*Lake Powell
Iceberg Canyon Rockfall*

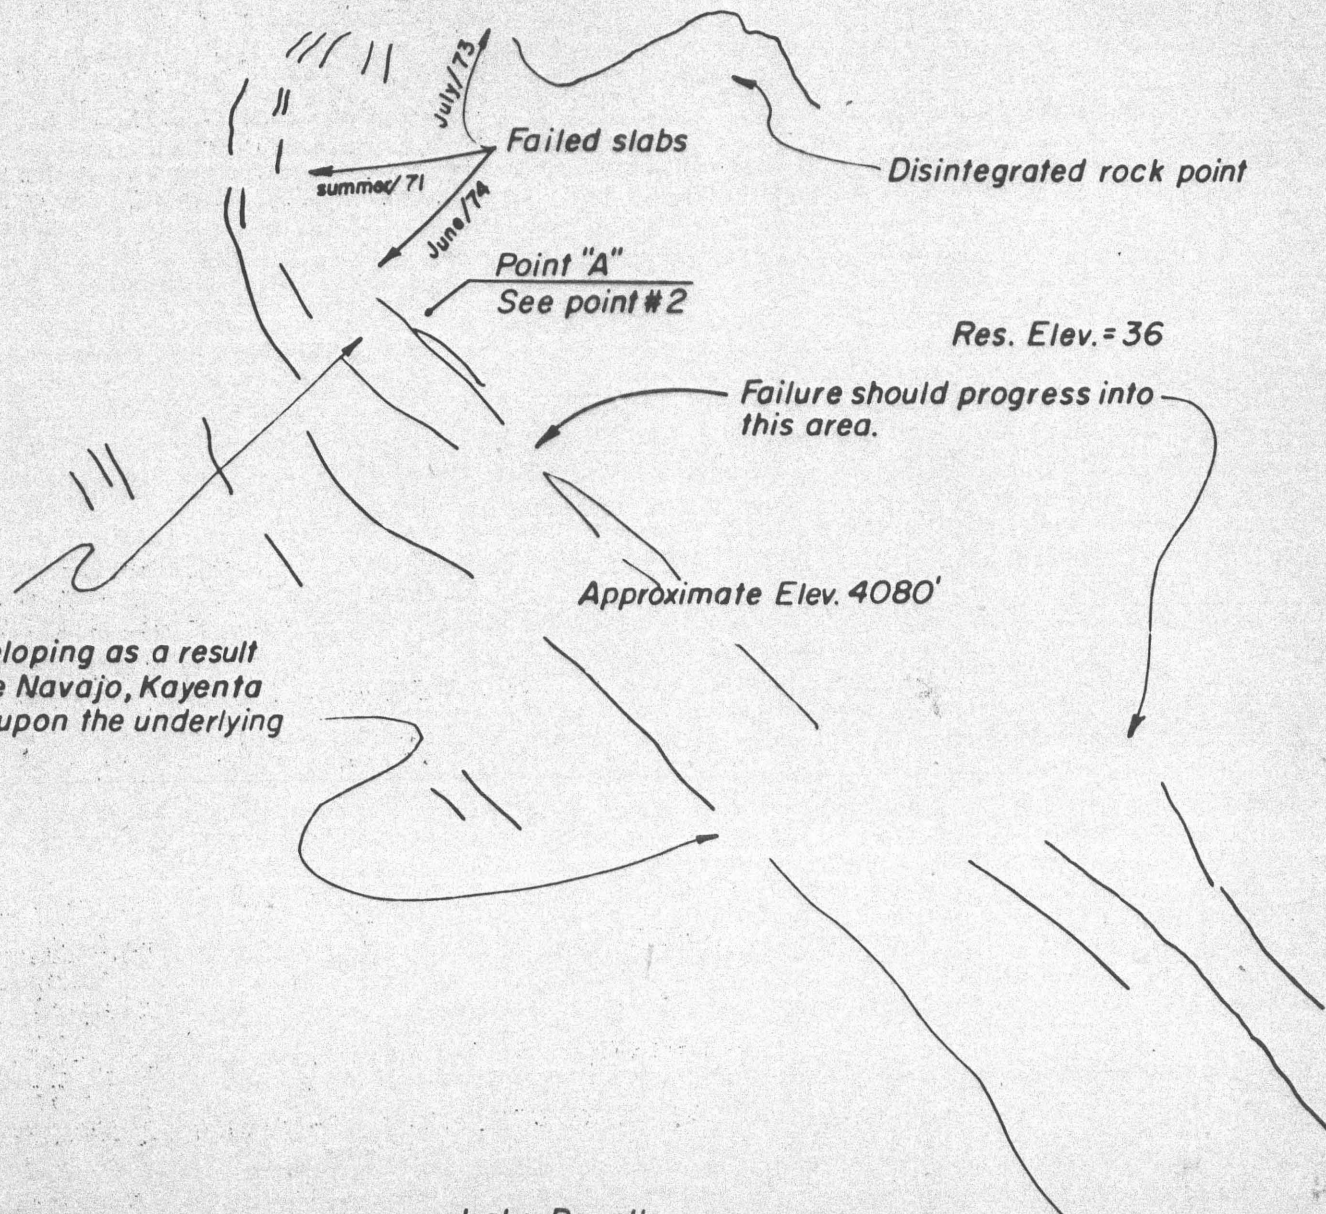
Stress relief joints developing as a result of weight imposed by the Navajo, Kayenta and Wingate formations upon the underlying Chinle formation.

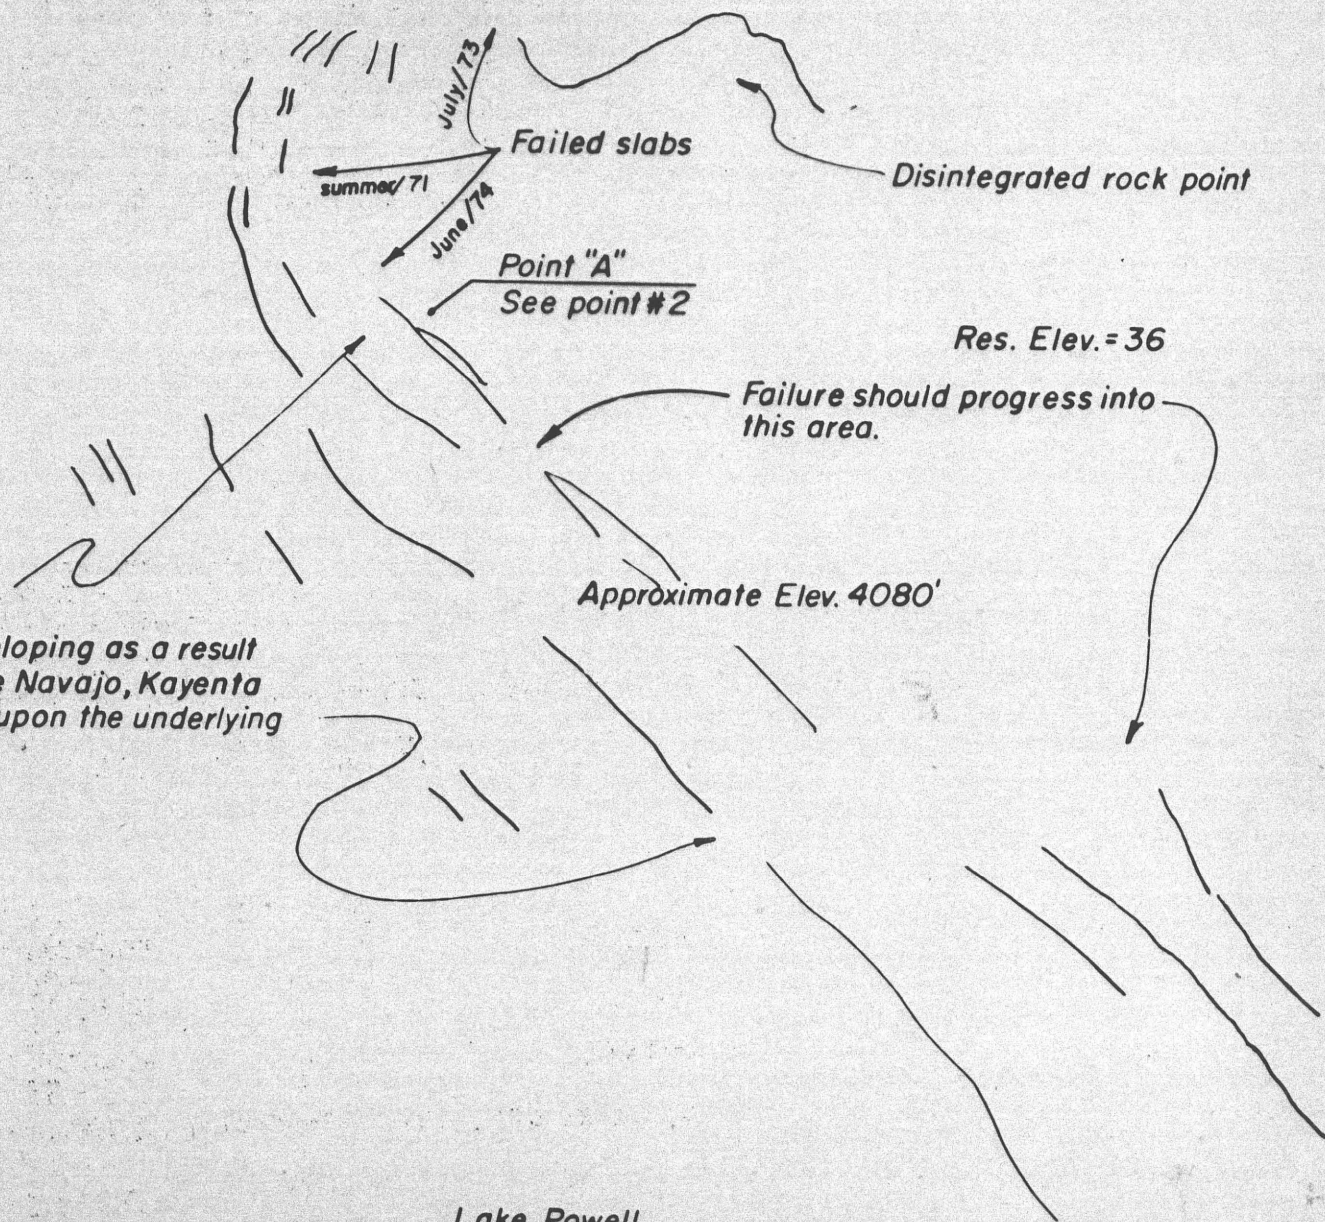
Stress relief joints developing as a result of weight imposed by the Navajo, Kayenta and Wingate formations upon the underlying Chinle formation.

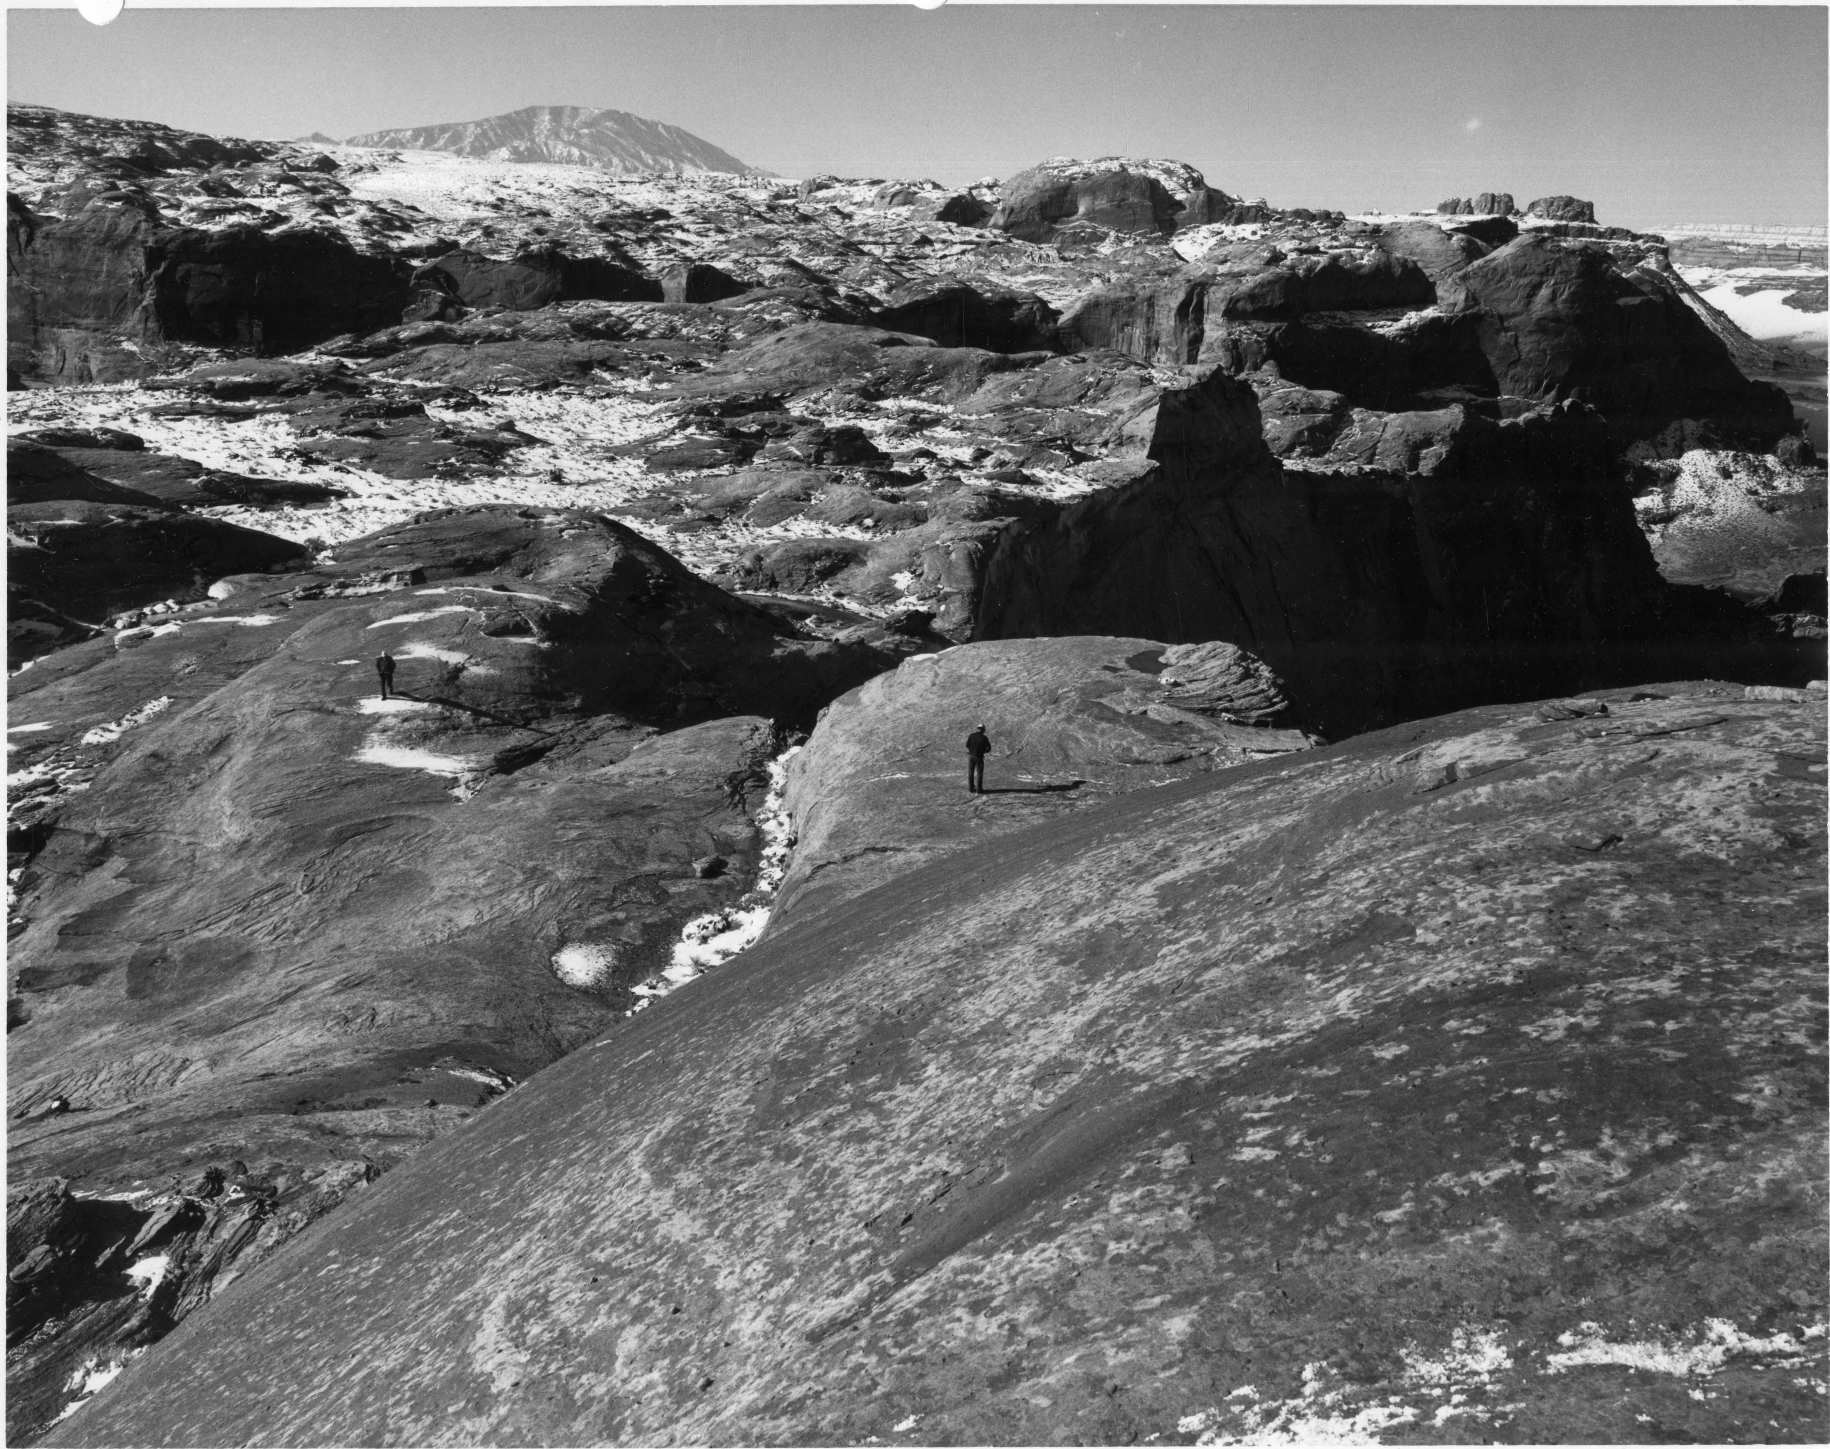
Photo #2

*Size comparison related to view in photo #1.
Some stress relief joints shown.*

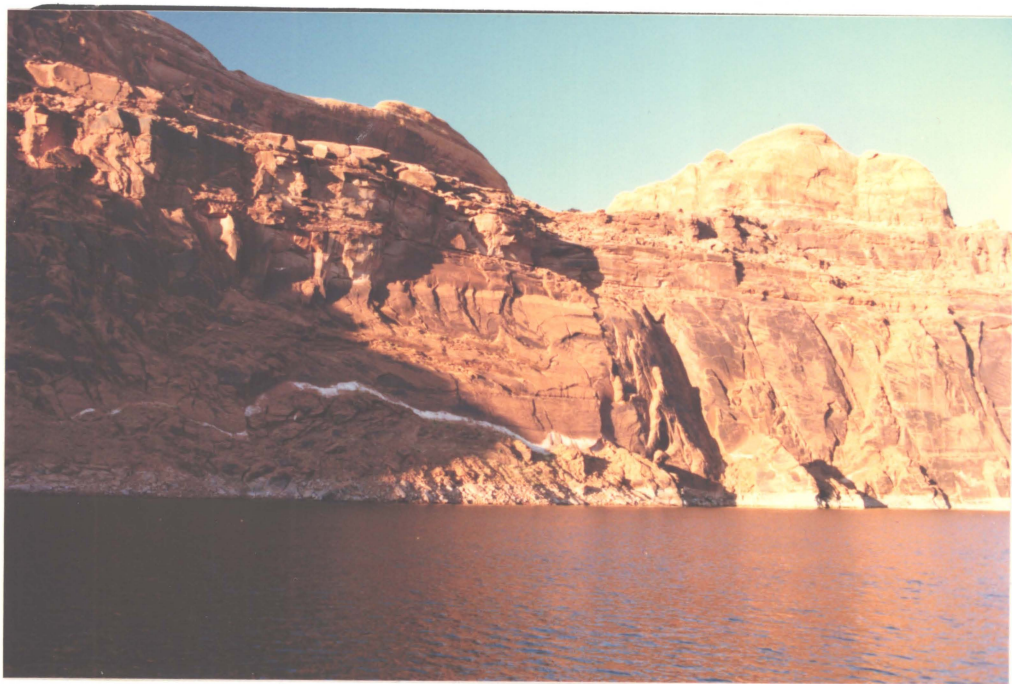
SITE 18

SITE 18: Initial stages of talus slide resulting from saturation and lubrication of shale surface below lake surface and erosion of toe of slope by wave action. Note the presence of a high water mark.

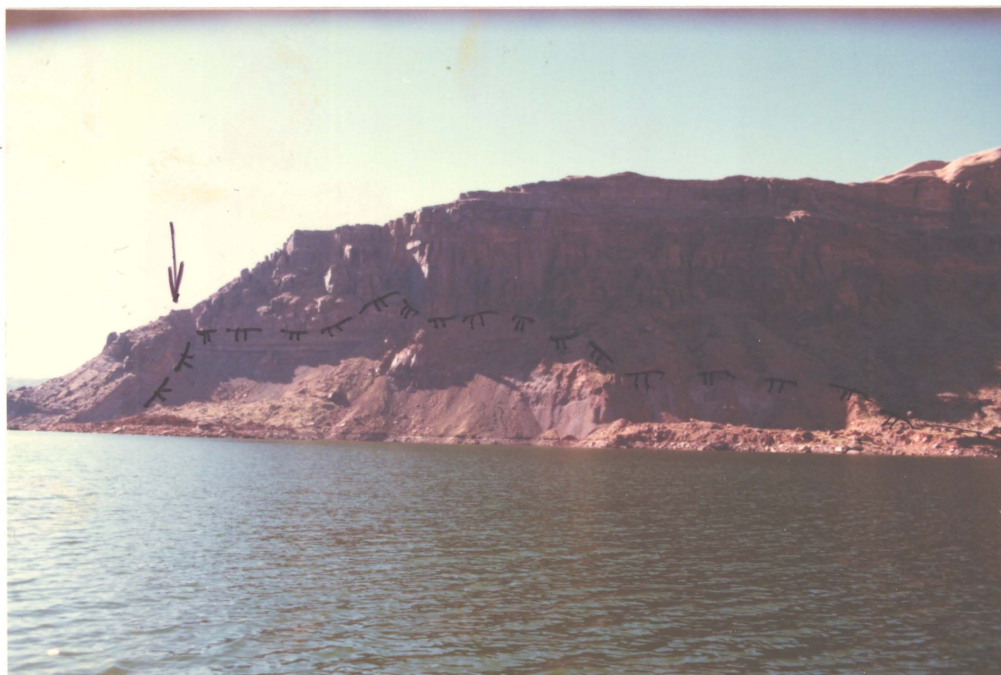
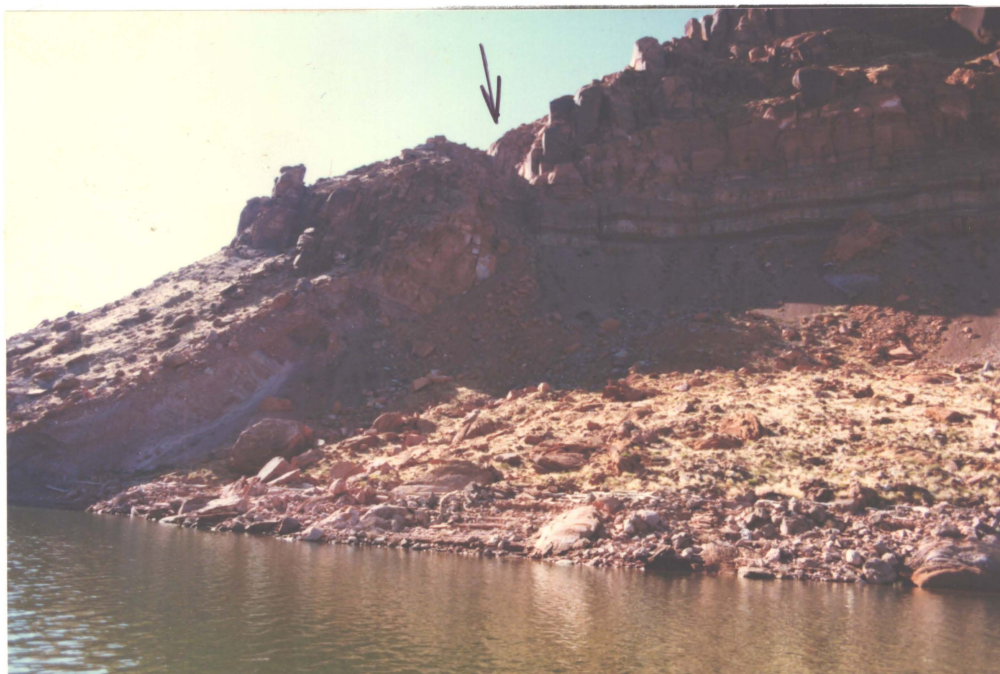
SITE 40

SITE 40: Slumping and sliding of shale beds in the Chinle Formation and overlying talus. Much of the sliding is renewed movement along old slide planes (indicated by arrow). Photo below is a closeup of the slump above.

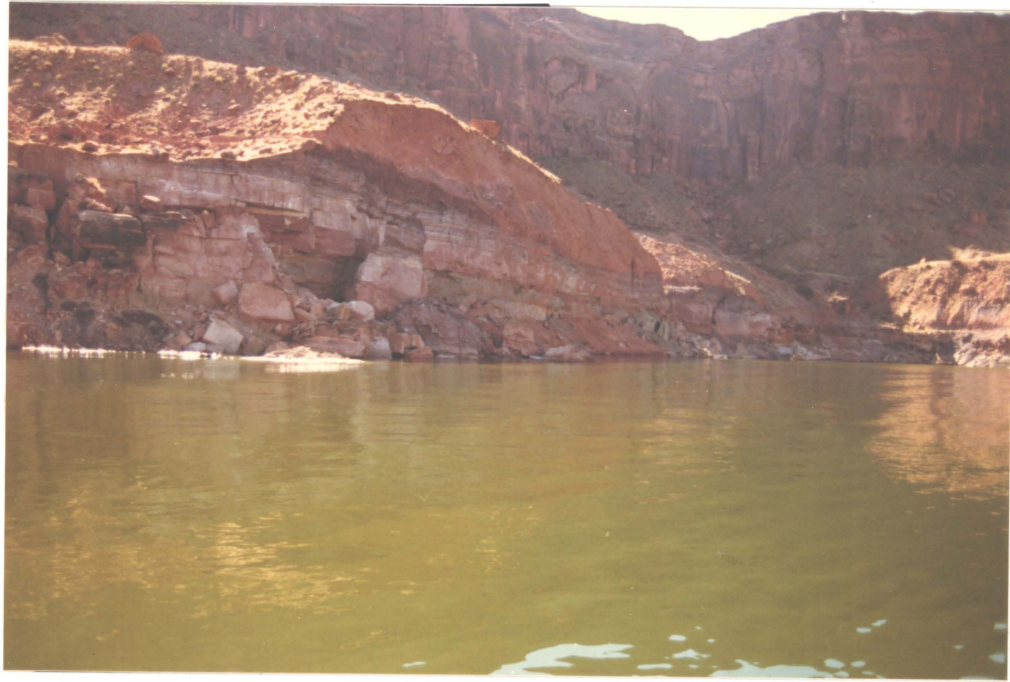
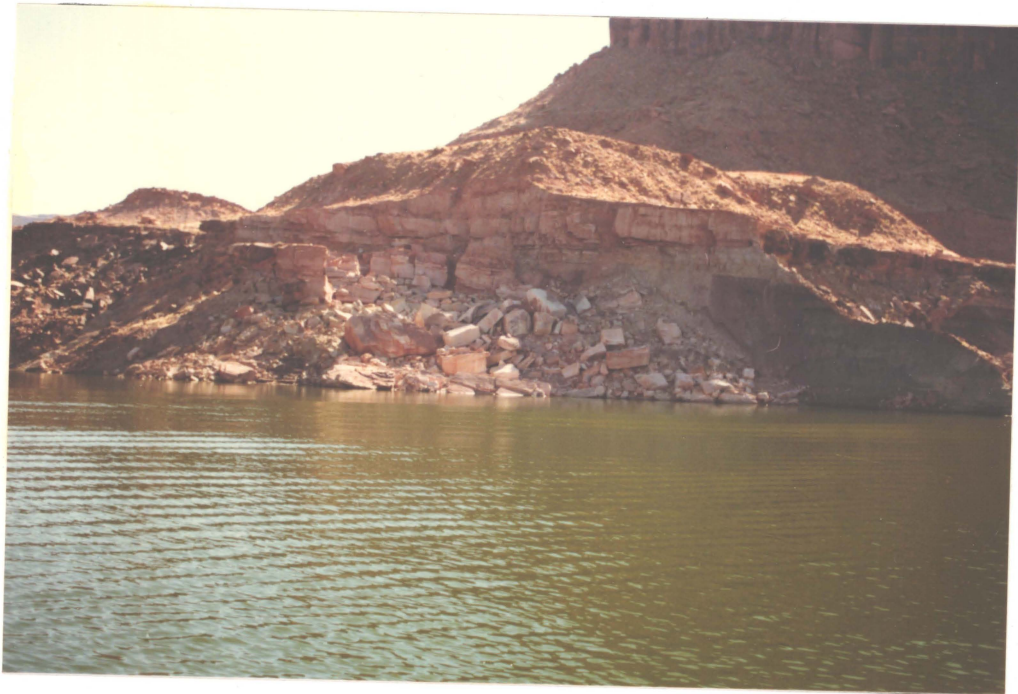
SITE 42

SITE 42: Rockfall and slumping of the Chinle Formation about 1 mile west of the Horn. Some areas present a high risk to boaters as the area has not as yet stabilized.

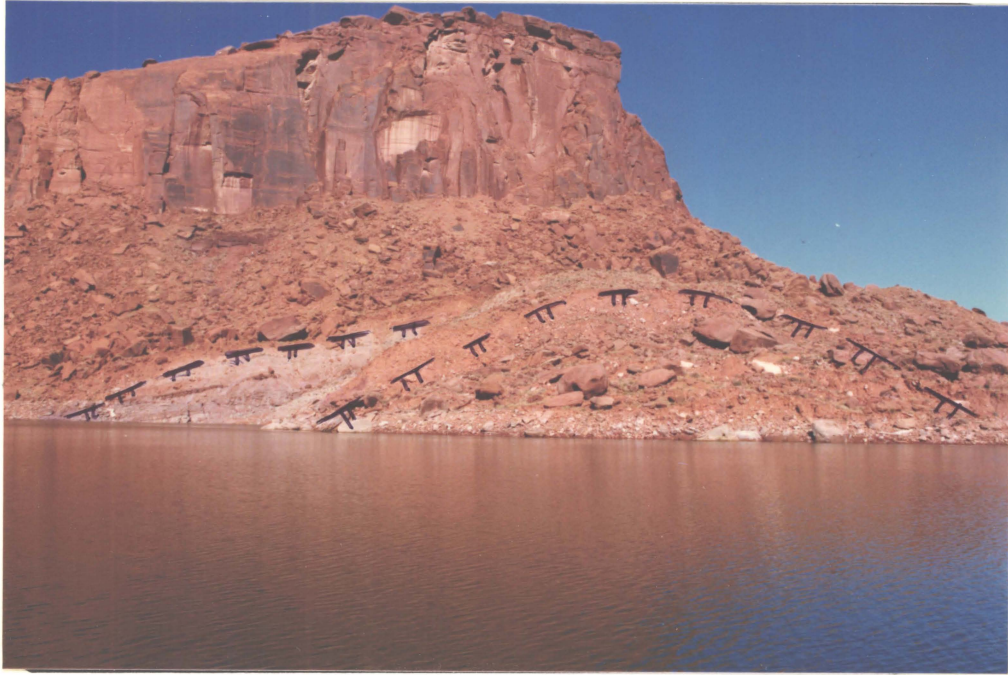
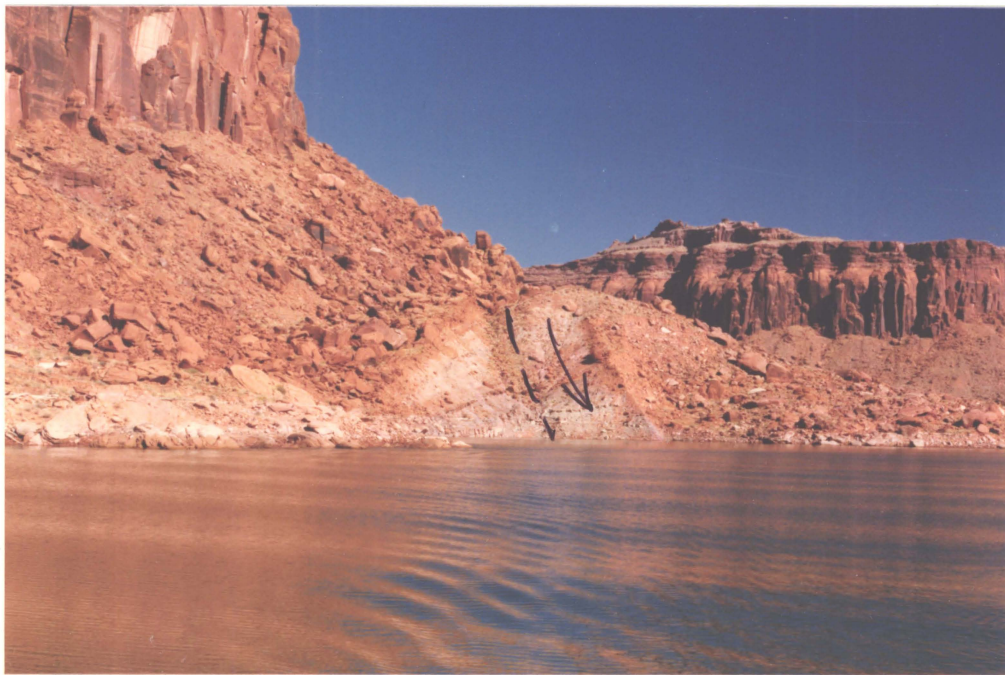
SITE 43

SITE 43: Renewed movement of old slump blocks in the Chinle Formation. Slides are located on north side of Four-mile Canyon. This particular slide is only one of numerous old slumps along this reach.

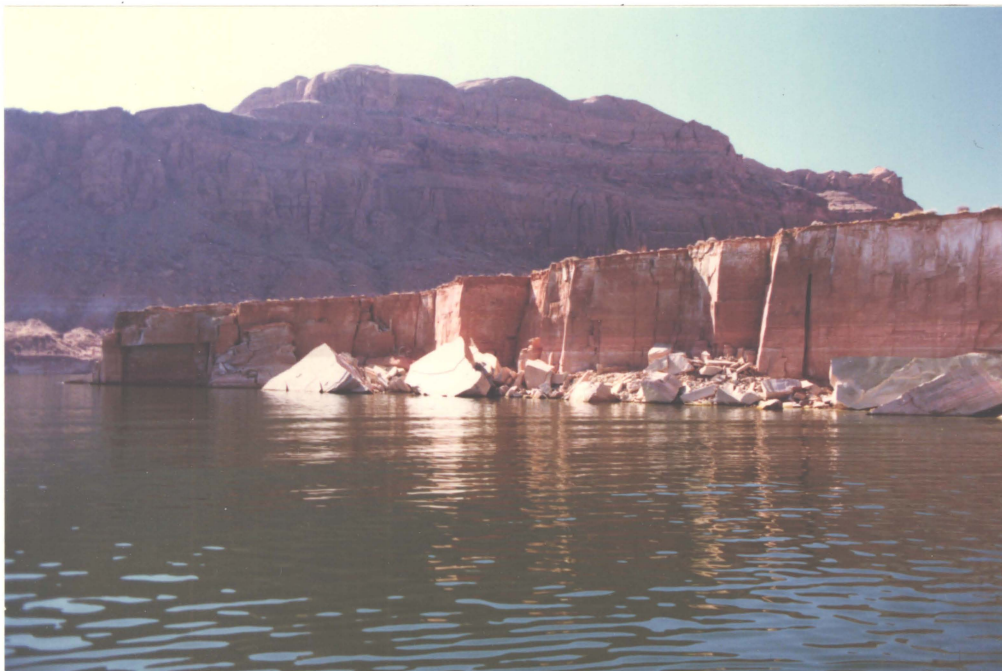
SITE 45: Extensive shoreline failure of sandstone units in the ^{Shinarump} Chinle Formation and overlying talus accumulations. Risk to boaters is high as rockfall continues and vertical slopes in the talus are created. Area is located about 1 mile north of Two-mile Canyon.

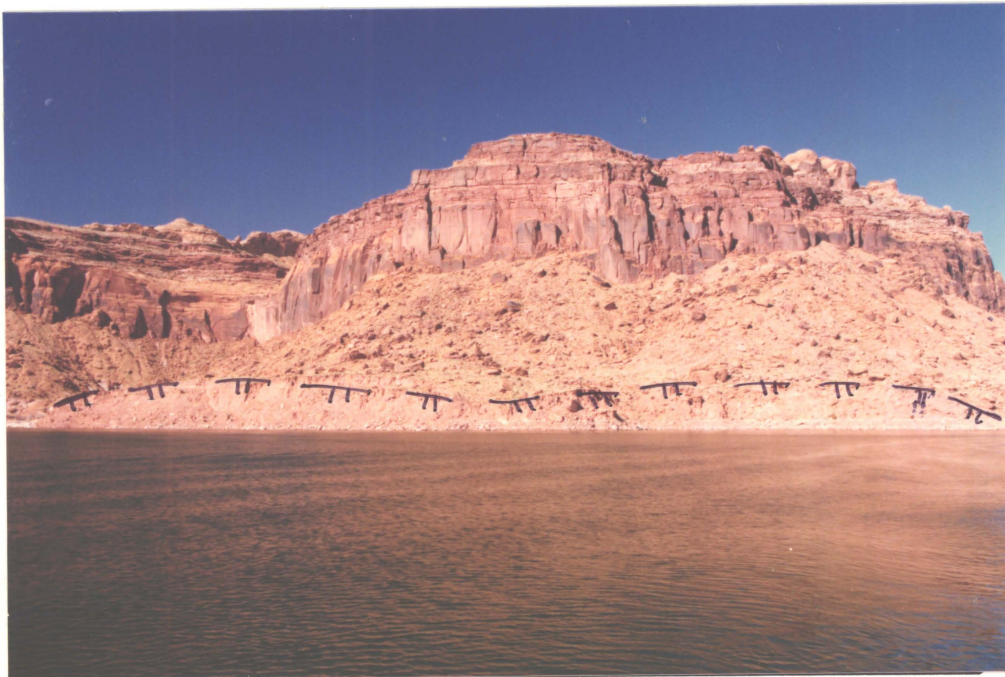
SITE 46

SITE 46: Sloughing of talus deposits probably resulting from wave action.
Site is located approximately 1 mile south of Trachyte Creek.

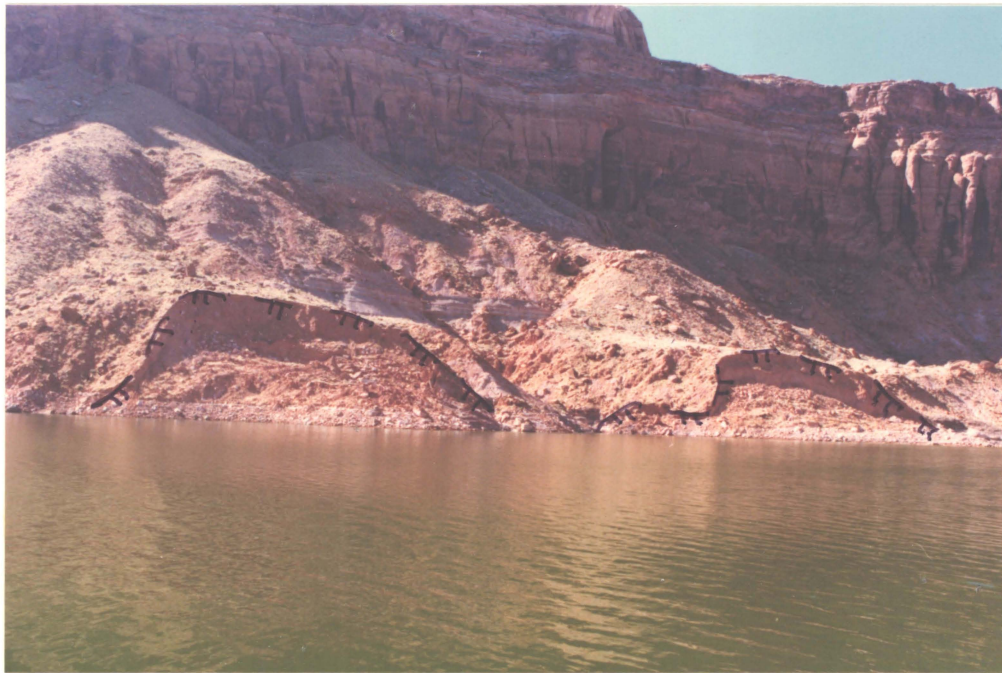
SITE 47

SITE 47: Slumps occurring in talus covered Chinle slopes on the south shore of Trachyte Creek. Slumps are approximately 50 to 60 feet high. Note the presence of the high water mark.

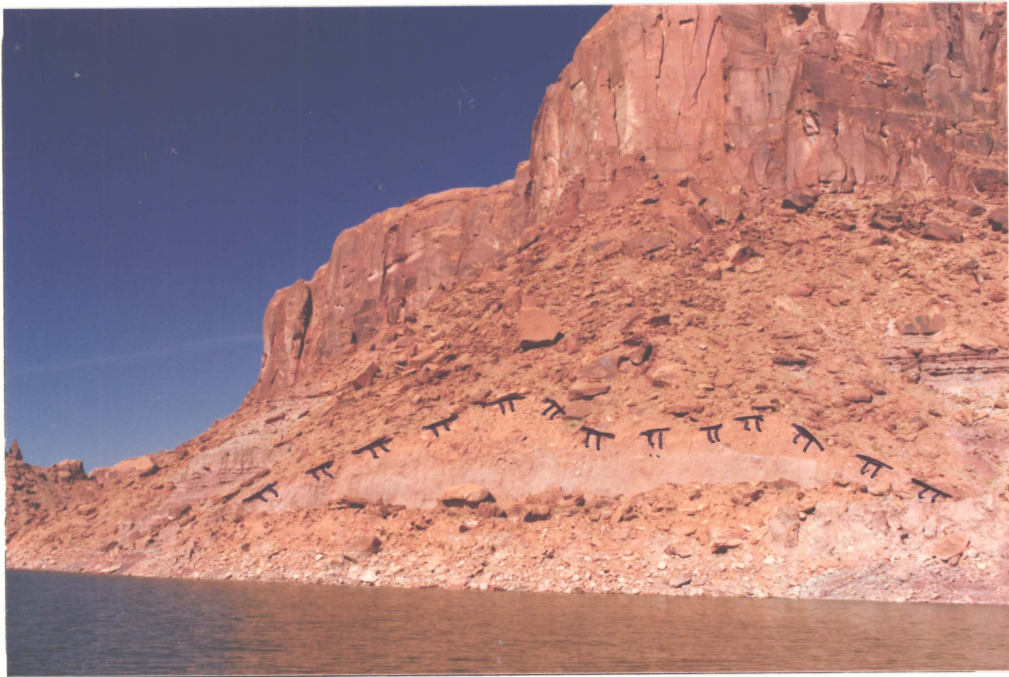
SITE 48

SITE 48: Slump in the Chinle Formation located on the north shore of Trachyte Creek. Slump is approximately 60 feet high and 200 feet long.
