G-321
LANDSLIDE SURVEILLANCE
OF
LAKE POWELL

UPPER COLORADO REGION

DECEMBER 1980

Geology Report No. G-321
Field Work and Report
by D. Grundvig

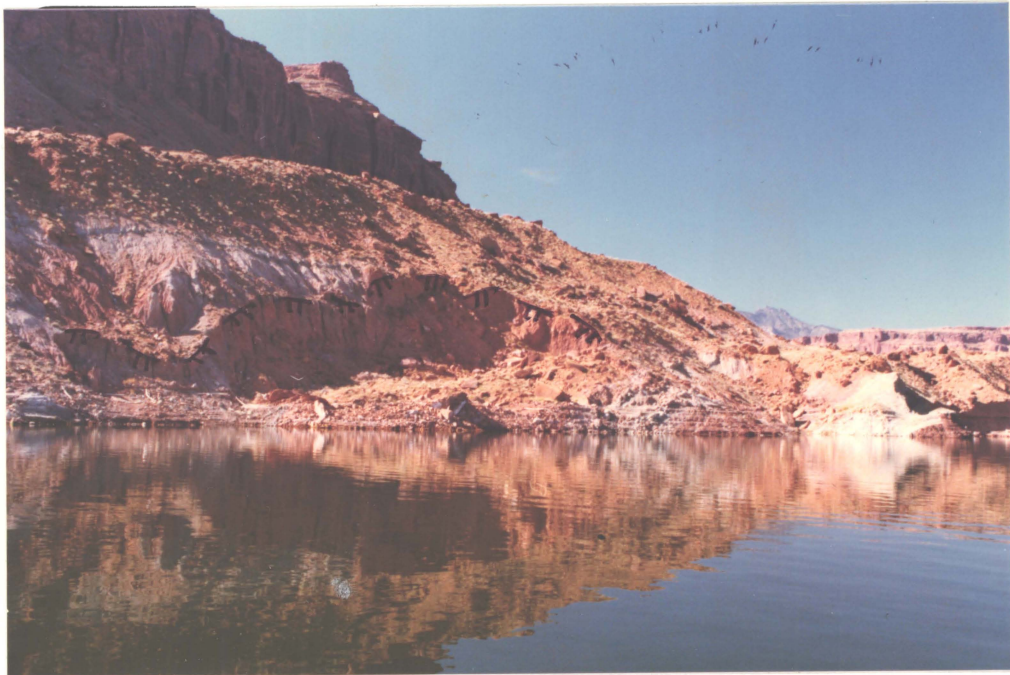
SITE 49

SITE 49: Renewed movement of old slide mass in the Chinle Formation. Slide is located approximately 1 mile west of the mouth of White Canyon.

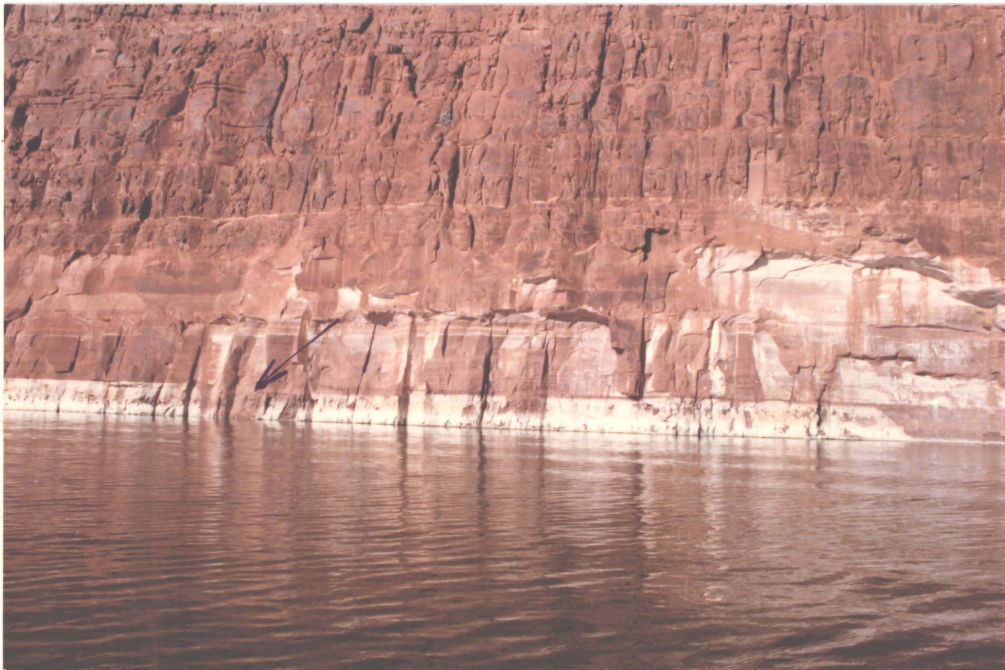
SITE 50

SITE 50: Recent rockfall has taken out the high water mark (indicated by the arrows in these two photos). Sandstone is the Organ Rock Tongue Member of the Cutler Formation. Photos were taken across the reservoir from Hite Marina.
