## INTERIM GEOTECHNICAL REPORT

● MANTI CANYON NORTH SLIDE  
STABILITY STUDIES

● DEBRIS DAM FOUNDATION  
INVESTIGATIONS

SEPTEMBER 1976

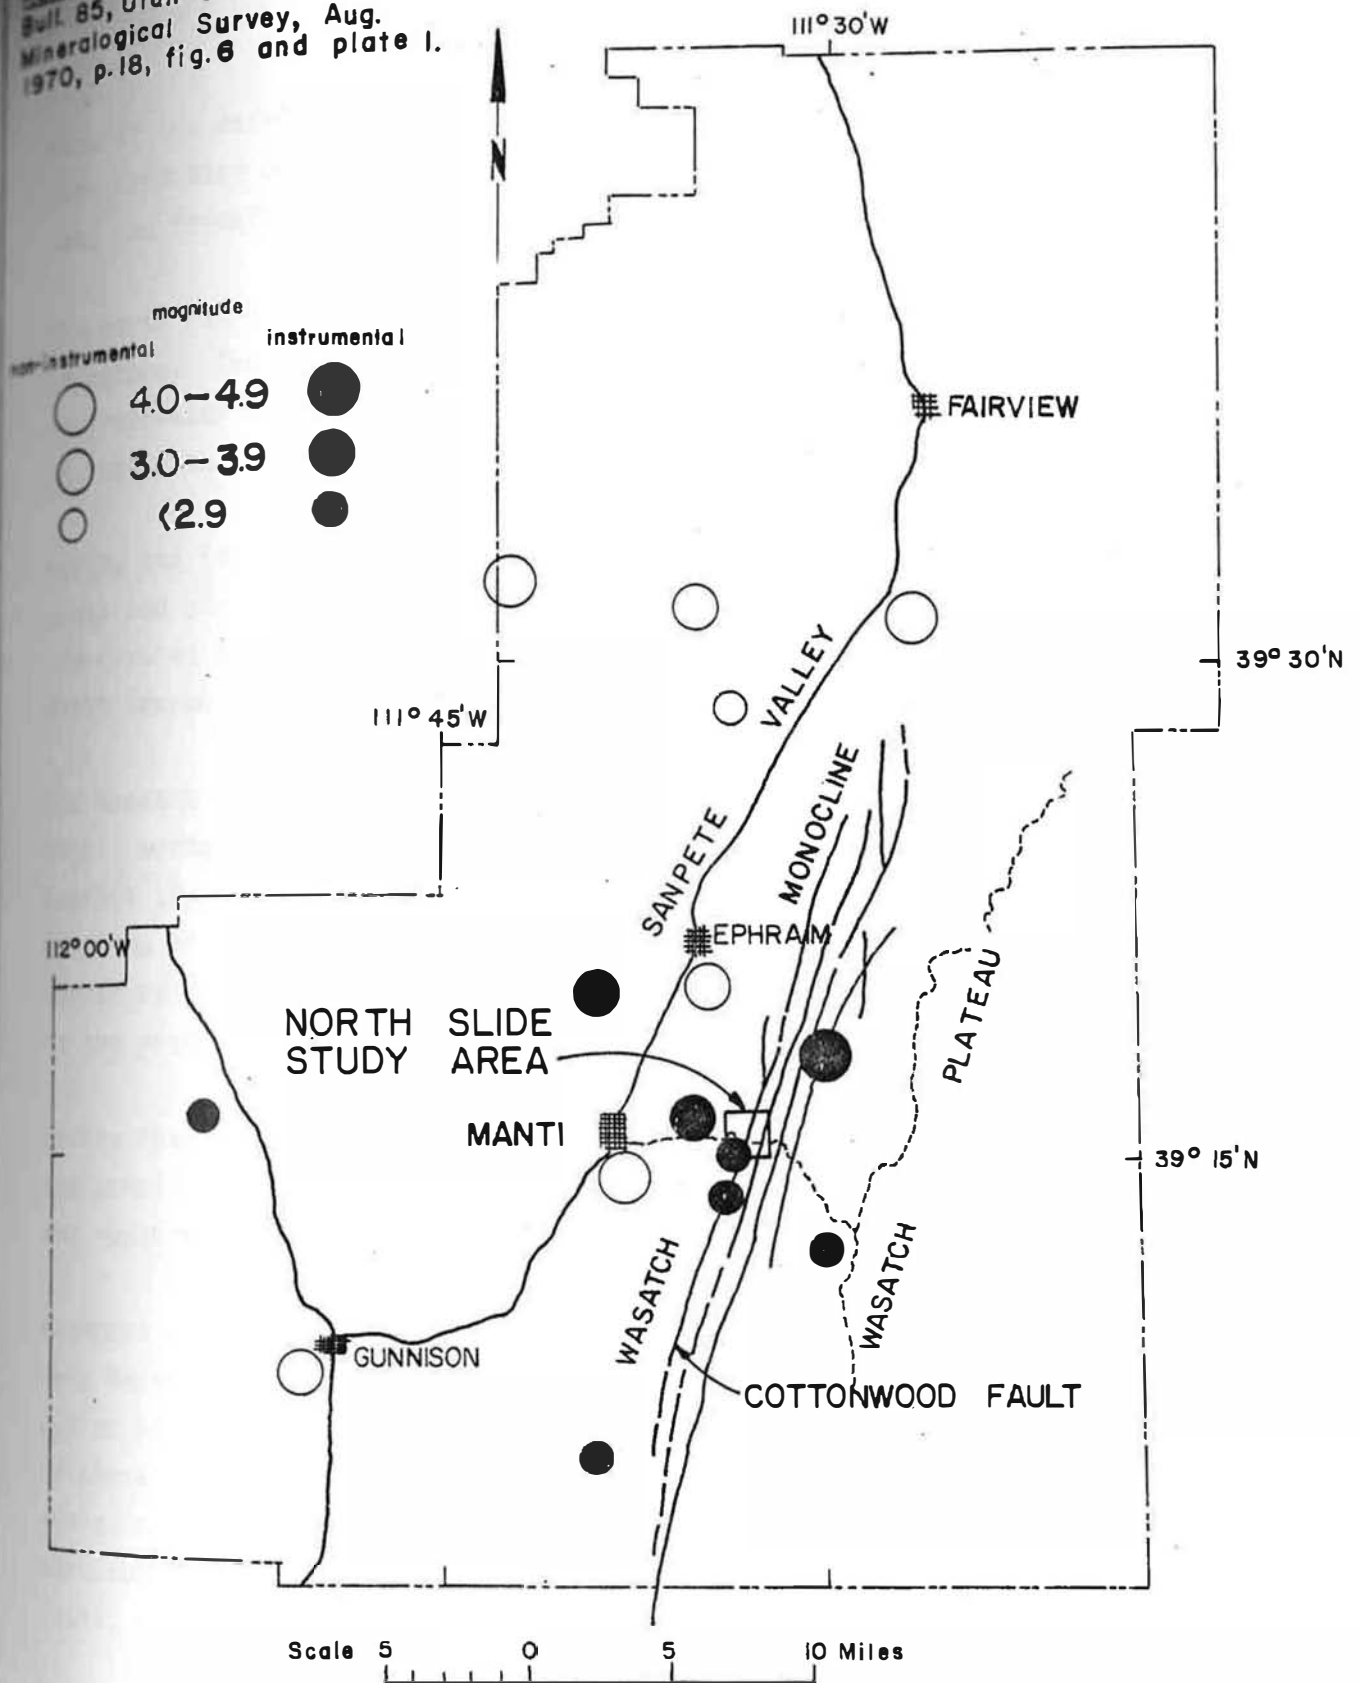
FIGURE 2-1 — EARTHQUAKE EPICENTERS IN SANPETE COUNTY, 1850-1964 AND MAJOR FAULTS ON AND ADJACENT TO STUDY AREA

The Wasatch Monocline was broken by major north-south trending, near-vertical, normal faults before and during the ice age (see Figure 2-1 and Exhibit 1). These faults strike from north-south to  $N20^{\circ}E$  and appear to cut some of the glacial till in Manti Canyon. The longitudinal blocks formed by the faulting have been variably uplifted and depressed, leading to the present sawtooth-like configuration on the canyon rims.

Movement on the faults in the Manti Canyon area appears to have continued into Recent time, and some of them are probably still active. Six earthquakes have occurred in the Manti Canyon area between 1850 and 1964. Two of these earthquakes had magnitudes of between 4.0 and 5.0 on the Richter scale, and several others had magnitudes of 3.0 or less. Two of the earthquakes with magnitudes of 3.0 or less occurred on the Cottonwood Fault, which passes directly through the study area (see Figure 2-1).

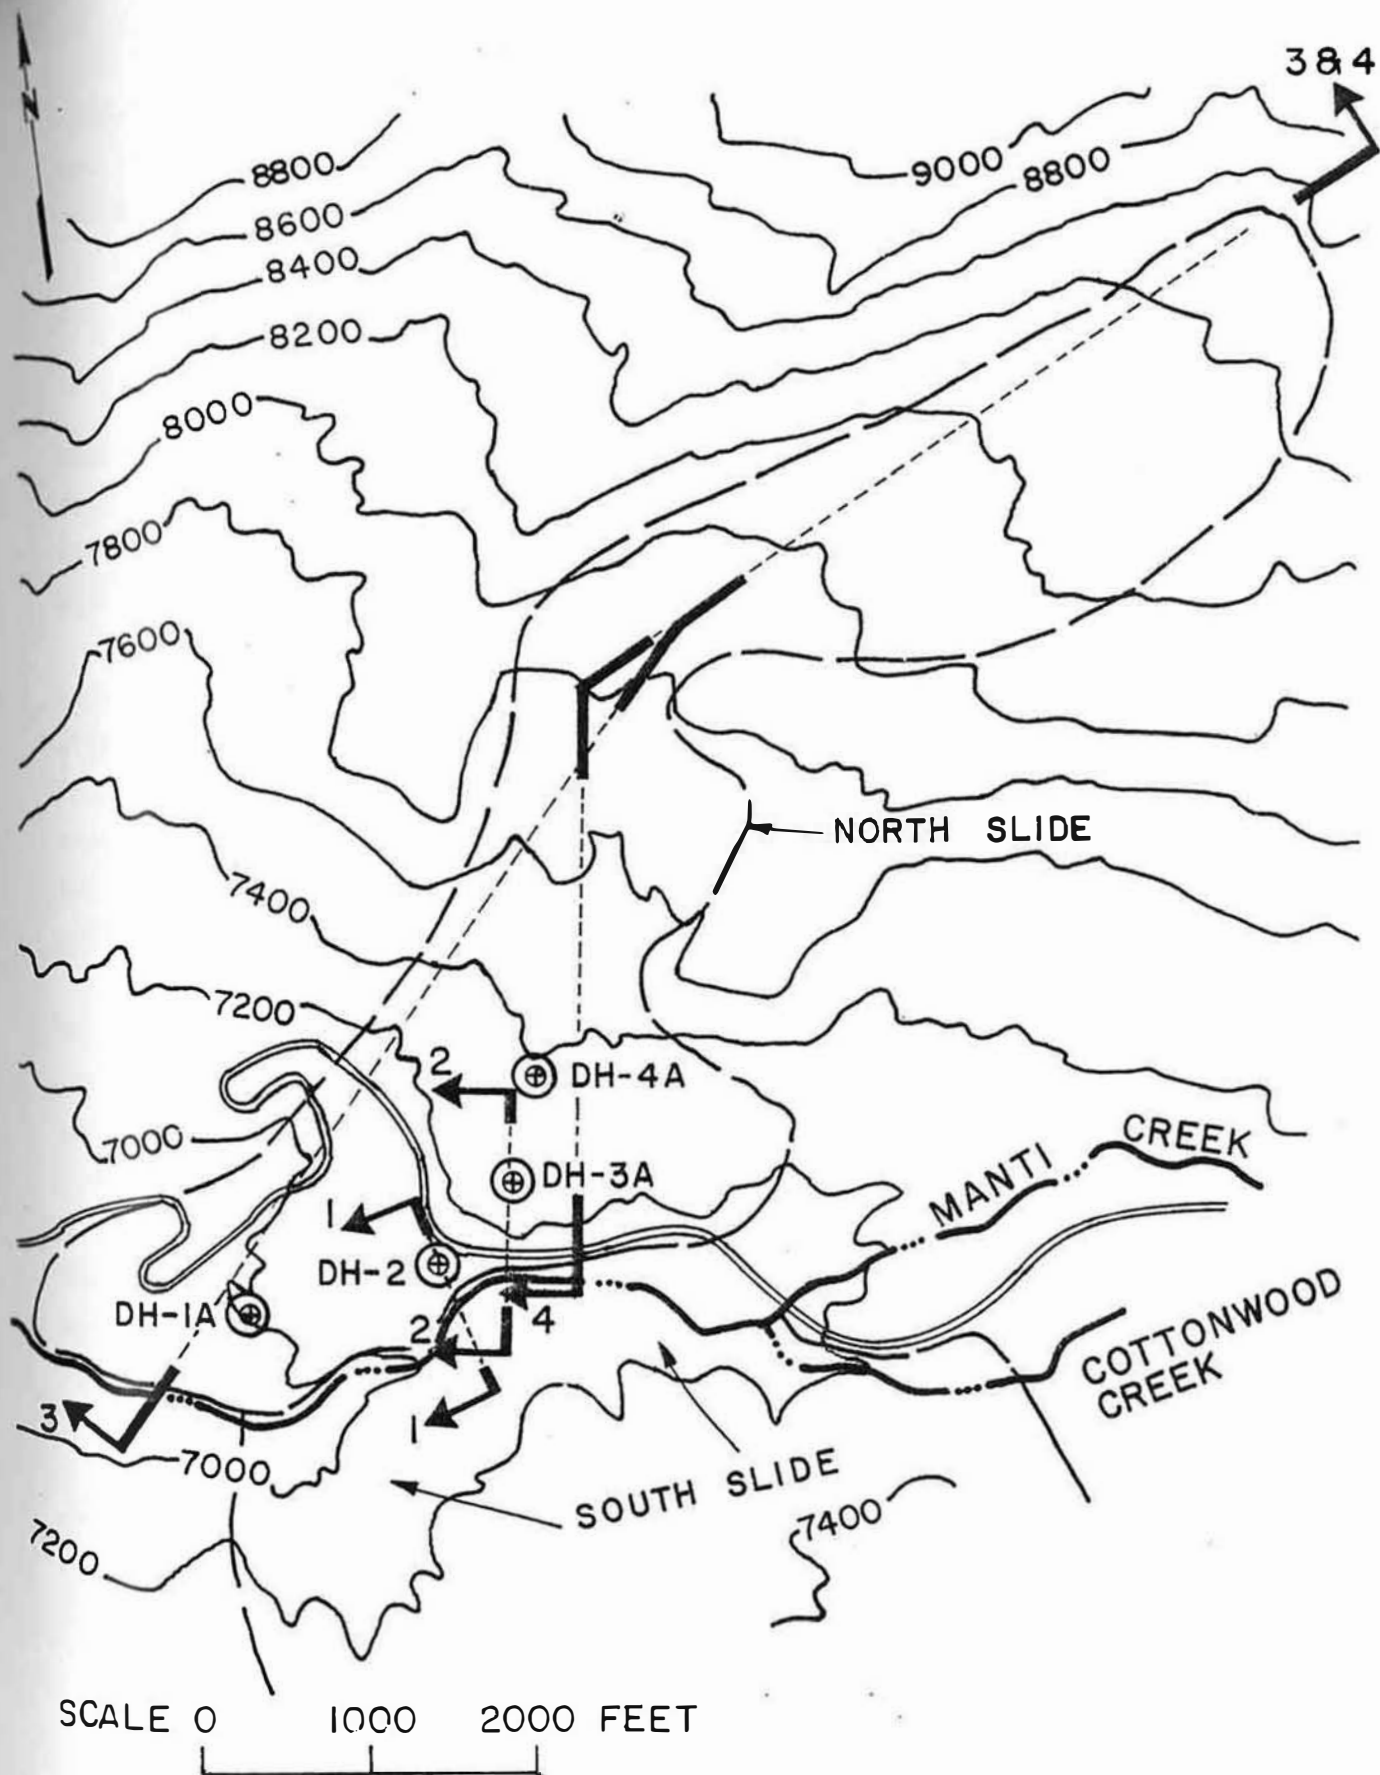
FIGURE 2-2 — LOCATION OF STABILITY ANALYSIS SECTIONS

2. Stability of Section 1 - Section 1 was chosen because of its steep bank slope and its high susceptibility to erosion and undercutting by Manti Creek (see Figure 2-2). A failure of this section would induce progressive failure up the slope and that would endanger the Forest Service access road and the proposed by-pass pipeline by erosion of toe support of the steep bank of Manti Creek (see Photo 6).

3. Stability of Section 4 - Section 4 begins at the base of the North slide, but is located further upstream than Section 3 (see Figure 2-2). As with Section 3 the failure plane was approximated from shear zones observed during field exploration. This assumed failure plane extends from the toe of the slope in Manti Creek to the top of the slide.

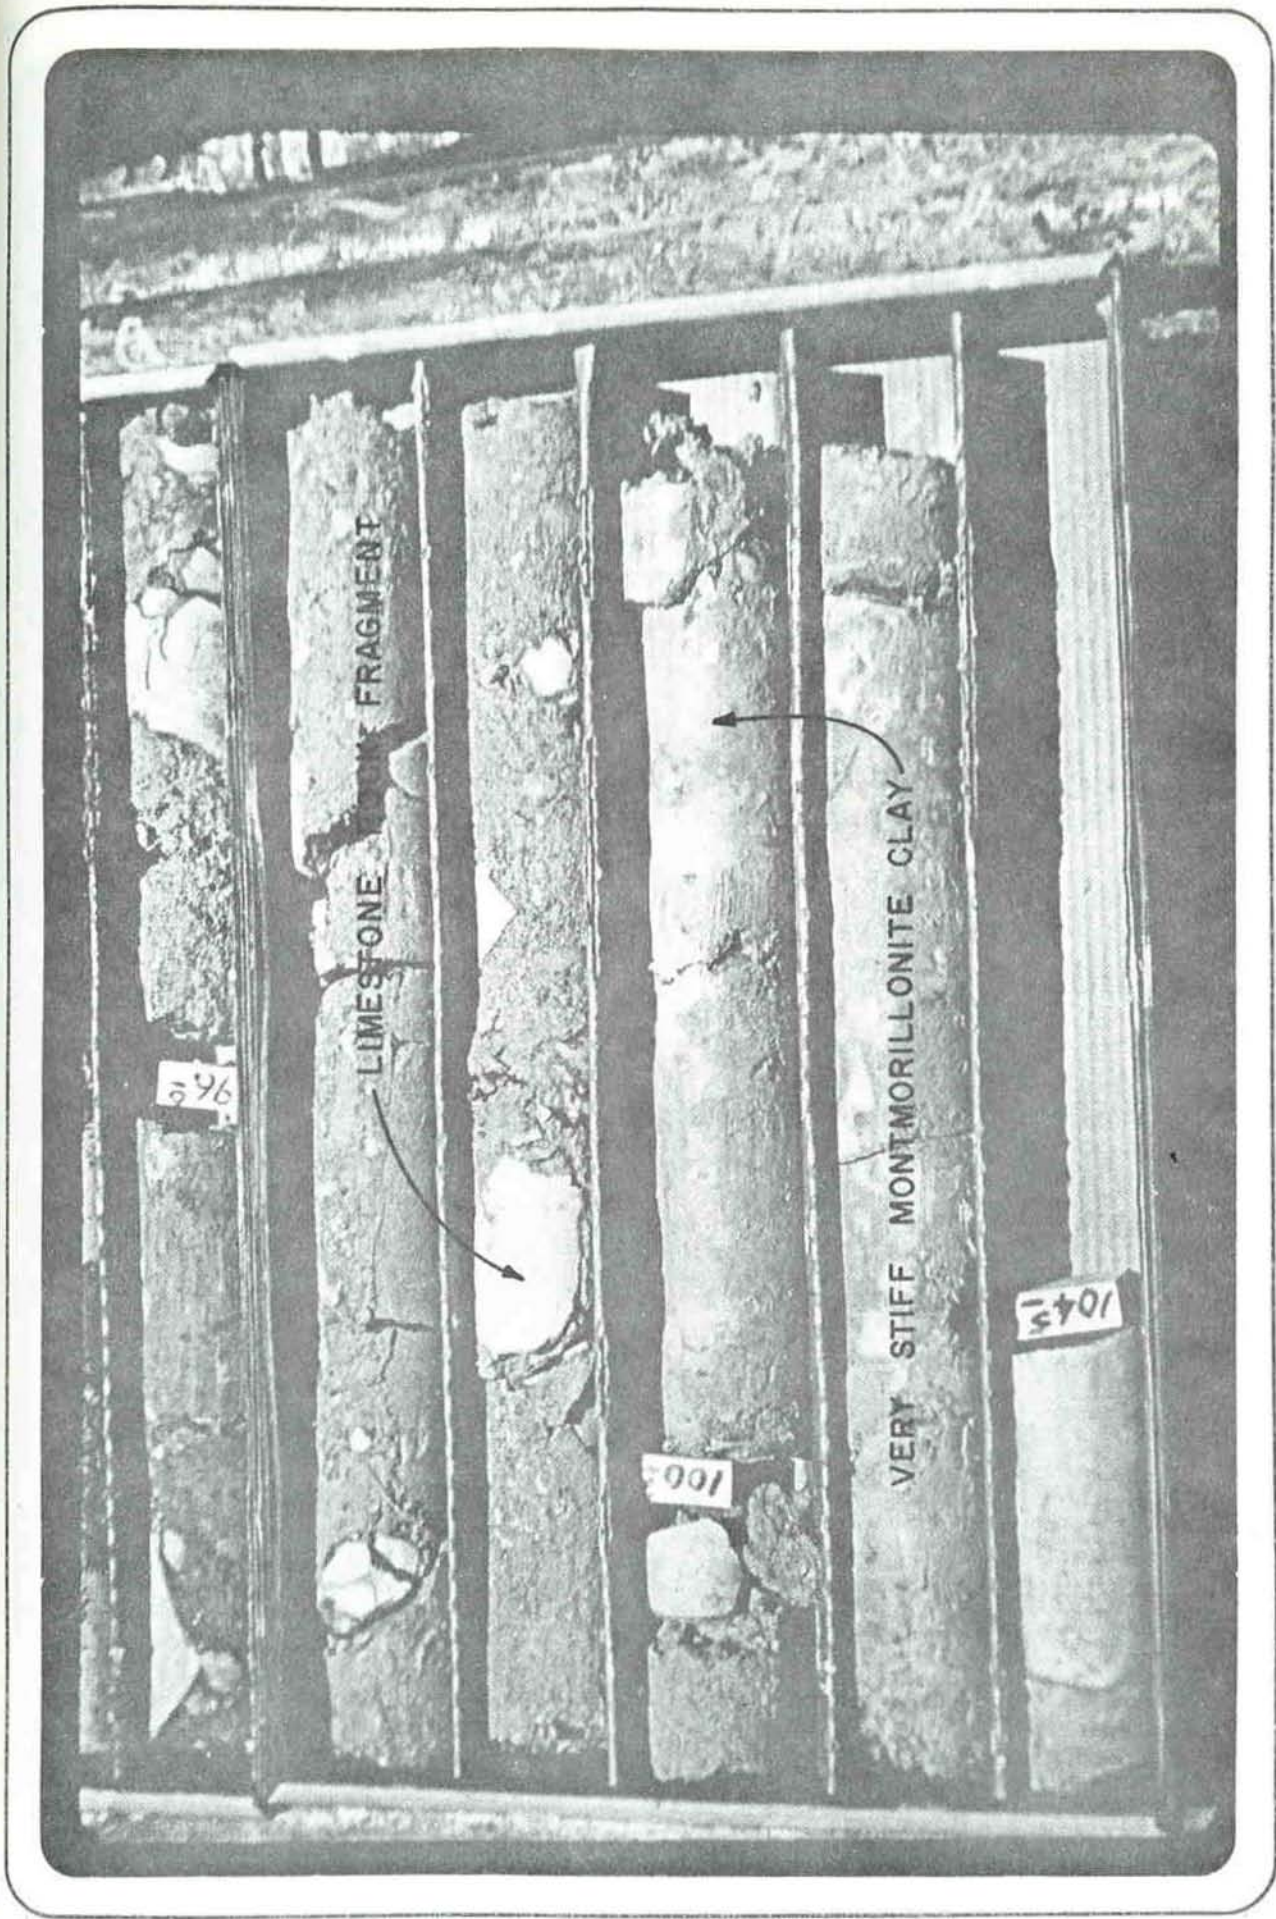
The glacial till between the upper layer and bedrock which was encountered in each of the four exploratory drill holes consists of dense clayey sandy gravels. These gravels are primarily subangular to subrounded fragments of sandstone and limestone with some fragments of shale (see Photo 2). The rock fragments are hard, and most are fresh, but some of them are slightly iron stained. They are contained in a matrix of very stiff slightly moist sandy clay, most of which is either brown or gray. The difference in color of the different parts of the till matrix may be due to changes in height in the groundwater table during periods of glaciation in the geologic past. The brown color resulted from oxidation of the till above the groundwater table and the gray till may have been predominantly below the groundwater table where reduction took place.

PHOTO 2 — TYPICAL DENSE GLACIAL TILL DH-1 95' TO 104'

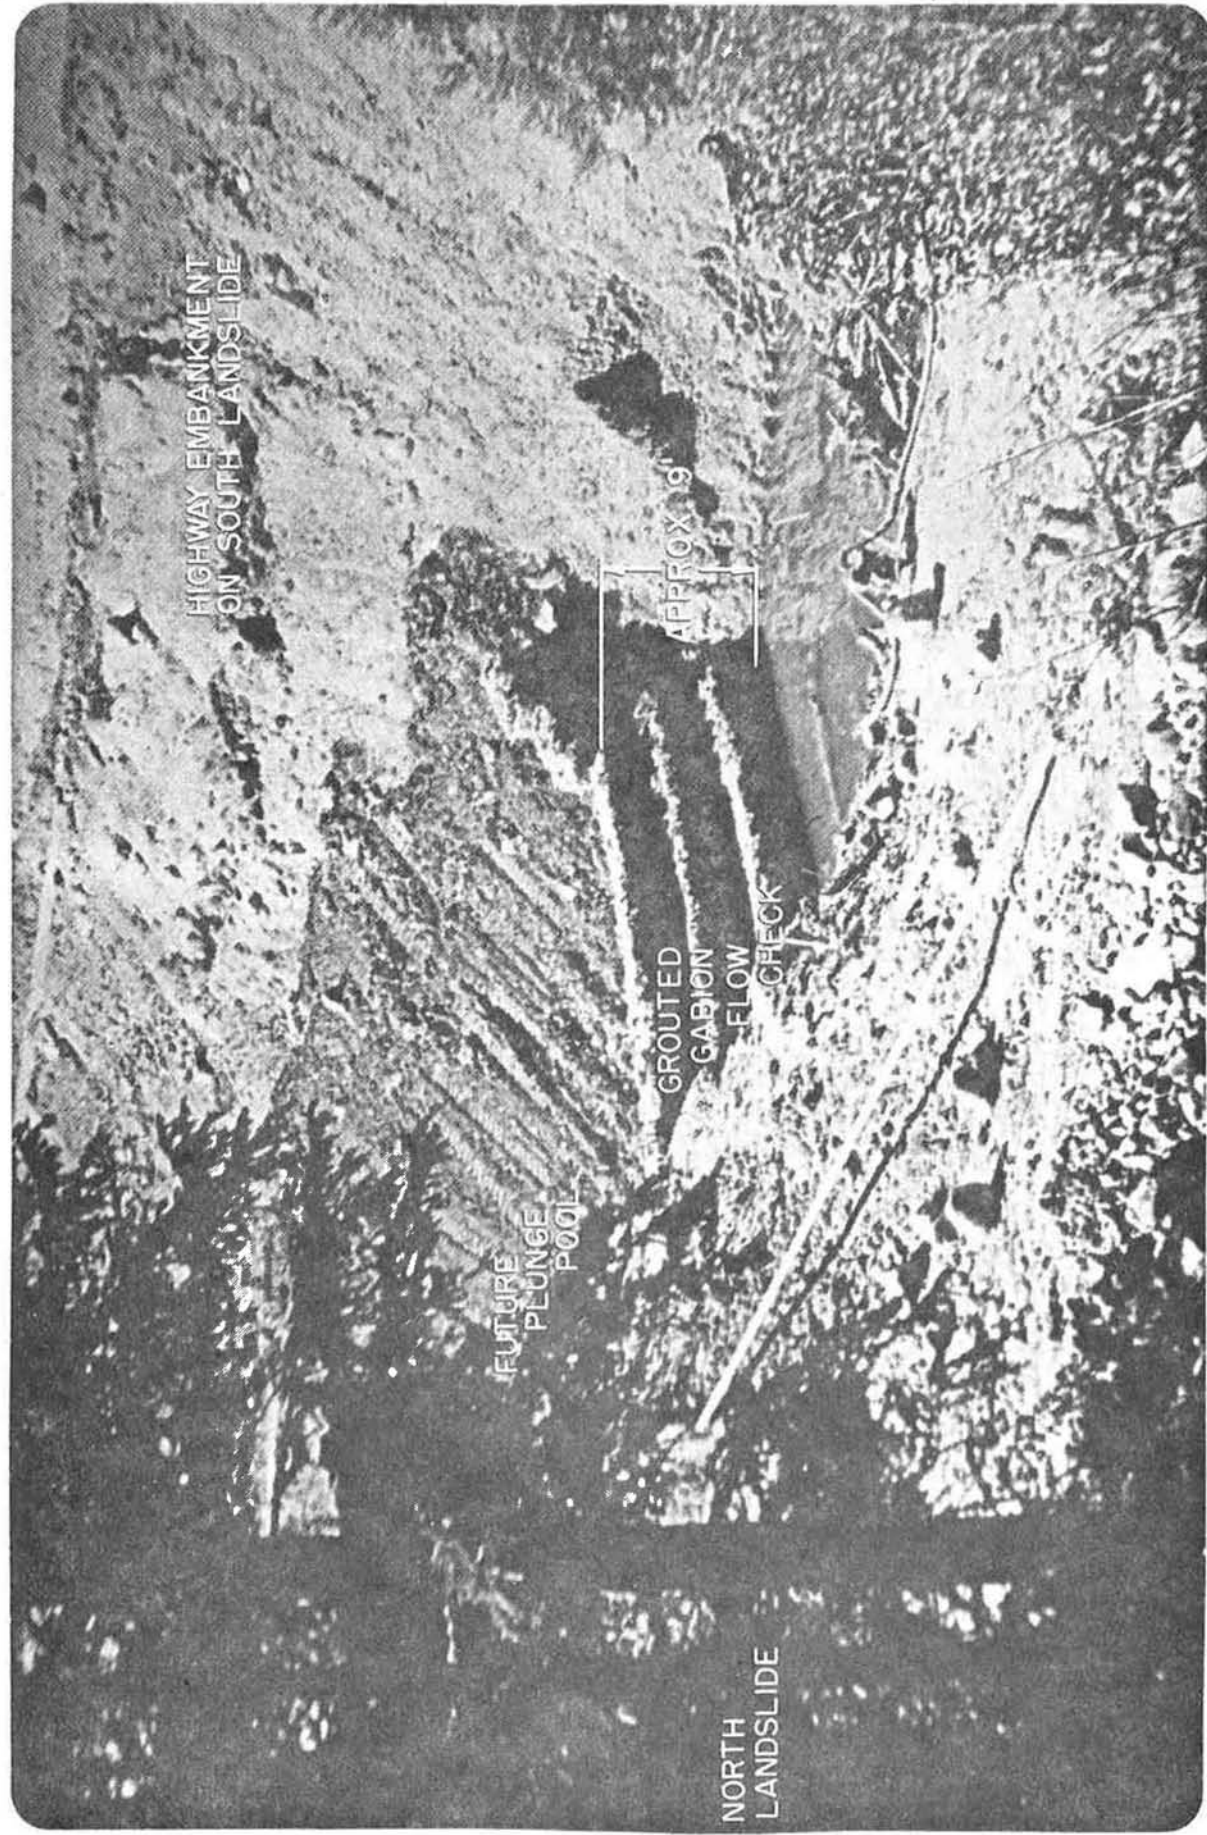
PHOTO 8 - CONSTRUCTION OF STABILIZED CHANNEL  
VAIL PASS, COLORADO

Placement of rockfill in the creek channel has been indicated as a possible means of improving stability (see Photos 8 and 9). This method has been successfully used by IECO for another project somewhat similar to Manti Creek. Numerous other methods for stabilization such as surface and subsurface drainage may also be appropriate.

It is recommended that a by-pass pipeline not be considered as a viable permanent solution for mitigating sedimentation erosion and landslide problems on Manti Creek. One possible alternative, of several, is control of Manti Creek streambed erosion in the critical toe areas of the North and South Slides. Erosion control might be implemented by rockfill-gabion structures as shown on Photos 8 and 9.

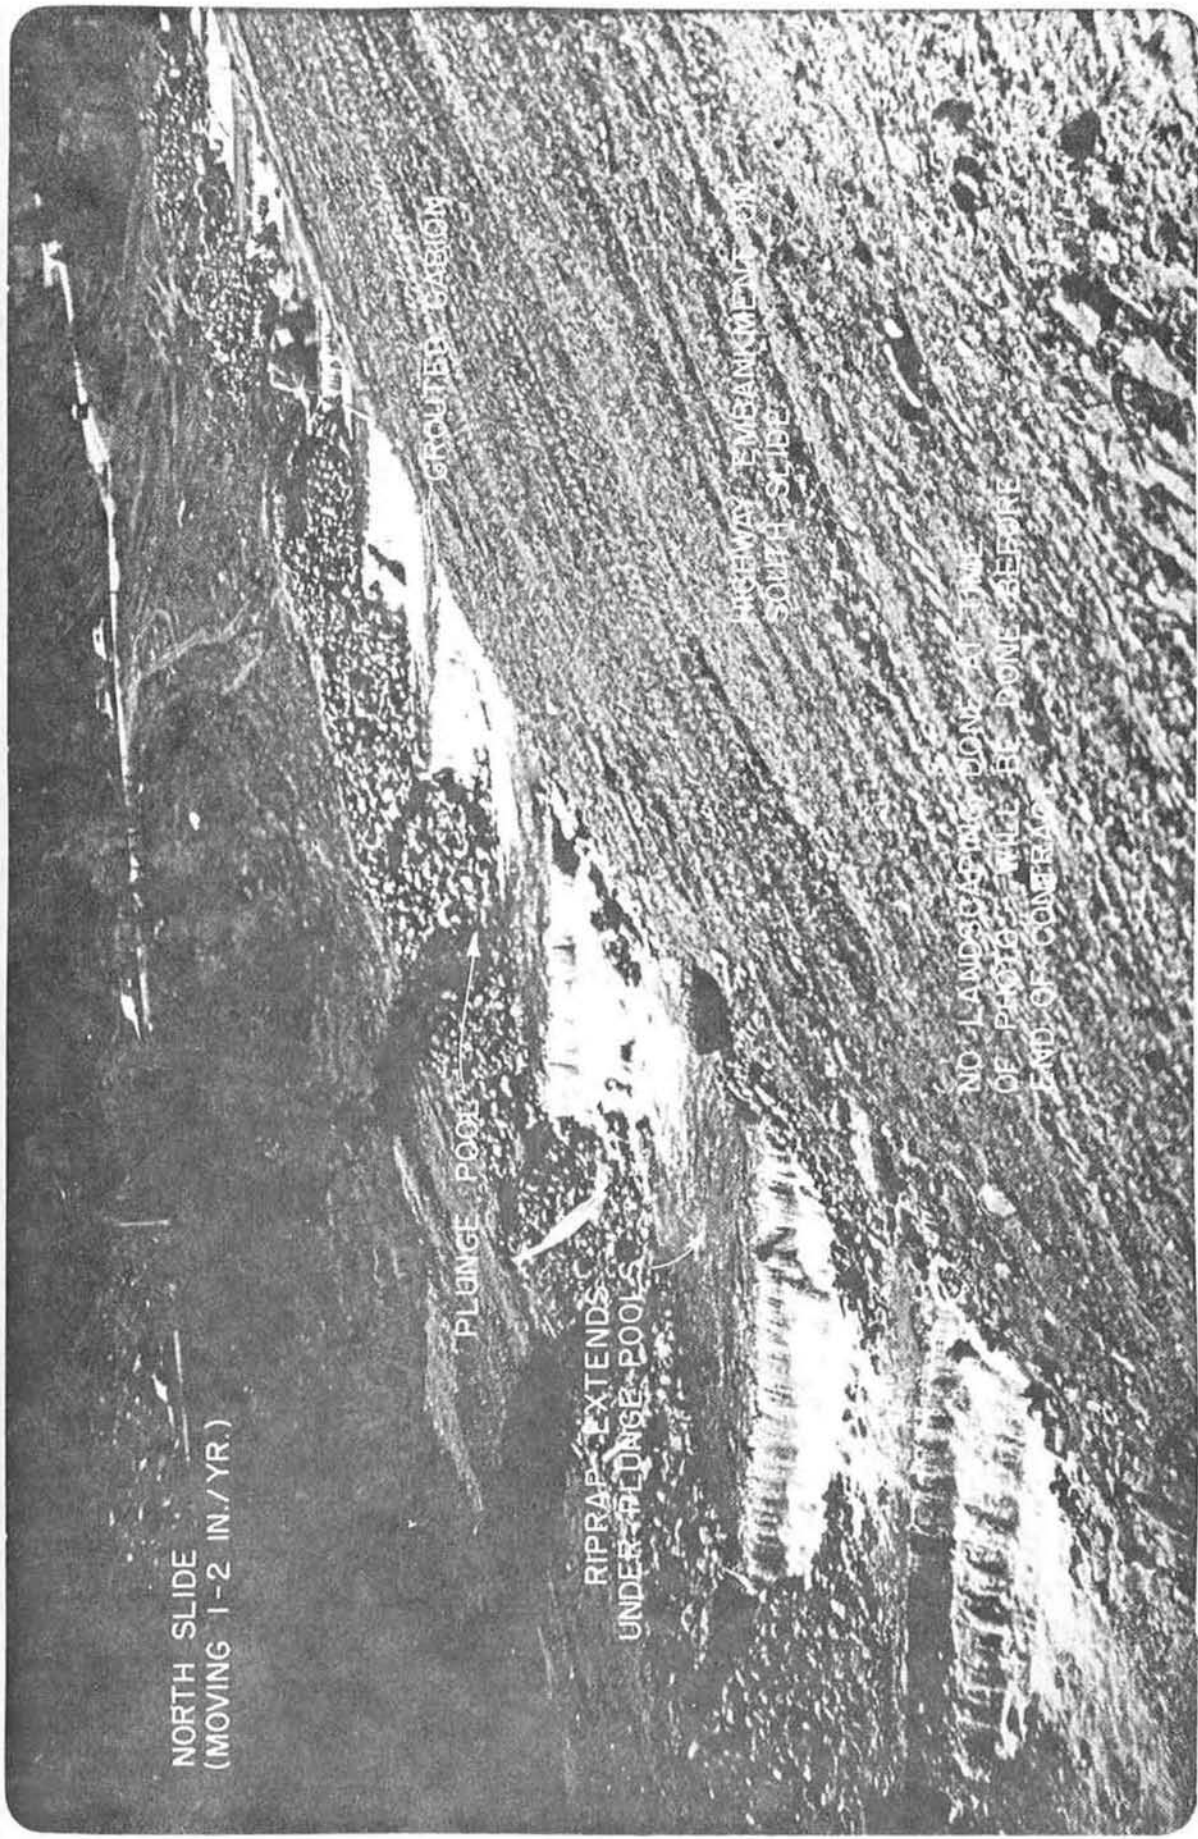
PHOTO 9 — COMPLETED STABILIZED CHANNEL ACROSS TWO LANDSLIDES  
VAIL PASS, COLORADO
