Reference: Review of *Geologic Hazard Investigation* for Leigh Hill reservoir in Cedar City, Iron County, Utah.

As per your request, the Utah Geological Survey (UGS) reviewed the report by GEM Engineering (GEM, 2007a) for Cedar City Corporation titled *Geologic Hazards Investigation, Leigh Hill Reservoir*. The report presents the results of a surface-fault-rupture-hazard investigation for the proposed reservoir site, which is at approximately 2000 West and 900 South in Cedar City (see attachment 1). The project site encompasses about 30 acres, of which the proposed 112-acre-foot reservoir and associated earth-fill embankment will occupy roughly 5 acres. The reservoir will provide storage for Cedar City Corporation's pressurized irrigation system. The purpose of our review was to determine whether the GEM Engineering report adequately addresses surface-fault-rupture hazards at the site. Our scope of work included a review of geologic literature (attachment 2) and aerial photographs, and three visits to the site with representatives of GEM Engineering and Cedar City Corporation; one visit was made prior to the start of the investigation, and two subsequent visits were made to inspec

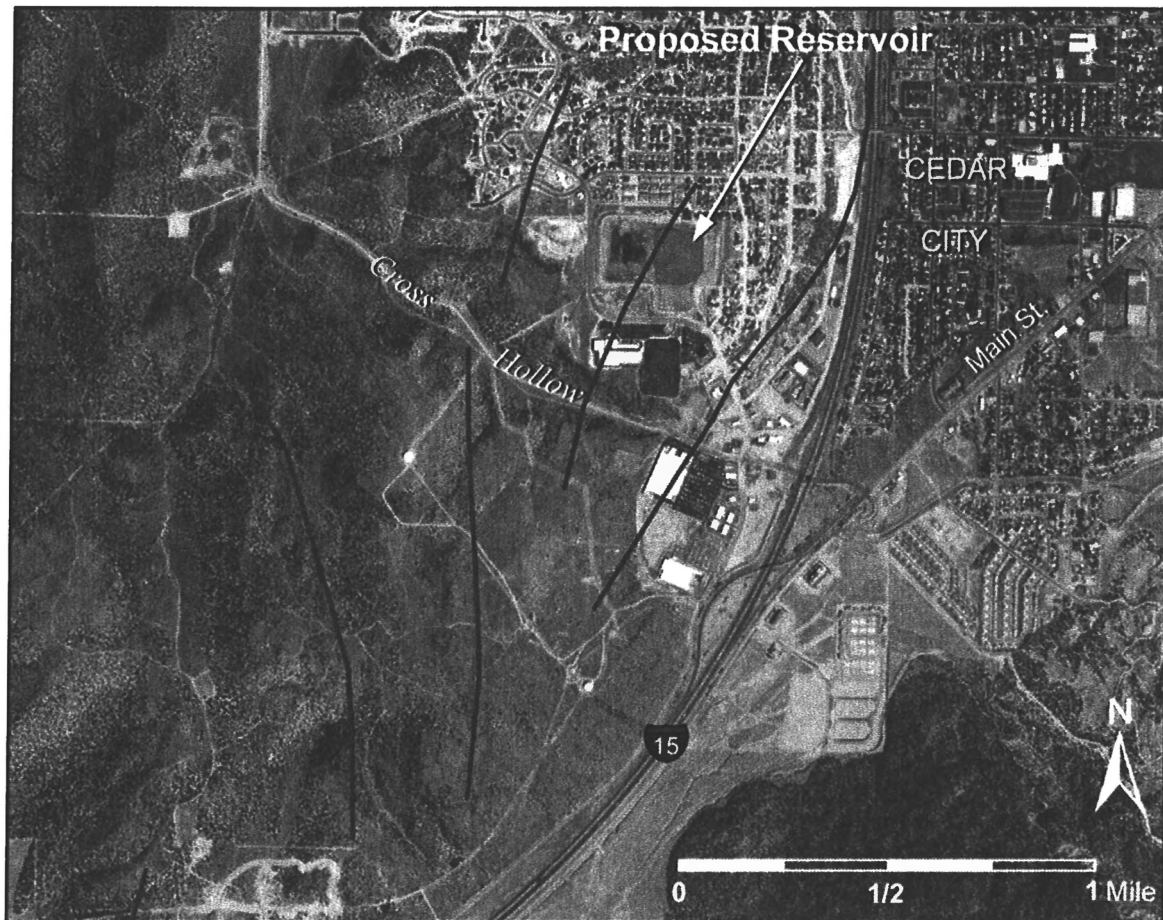
Attachment 1. Map showing the general proximity of the Cross Hollow Hills faults (red lines) to the proposed reservoir site. Fault locations are from the 1:500,000-scale *Quaternary Fault and Fold Database and Map of Utah* (Black and others, 2003) and should be considered approximate.
