Geologic Report
Soil Slumping below Swan Creek Irrigation Co., Canal
Rich County SCD, Utah
by
Daniel H. Griswold
November 25, 1962

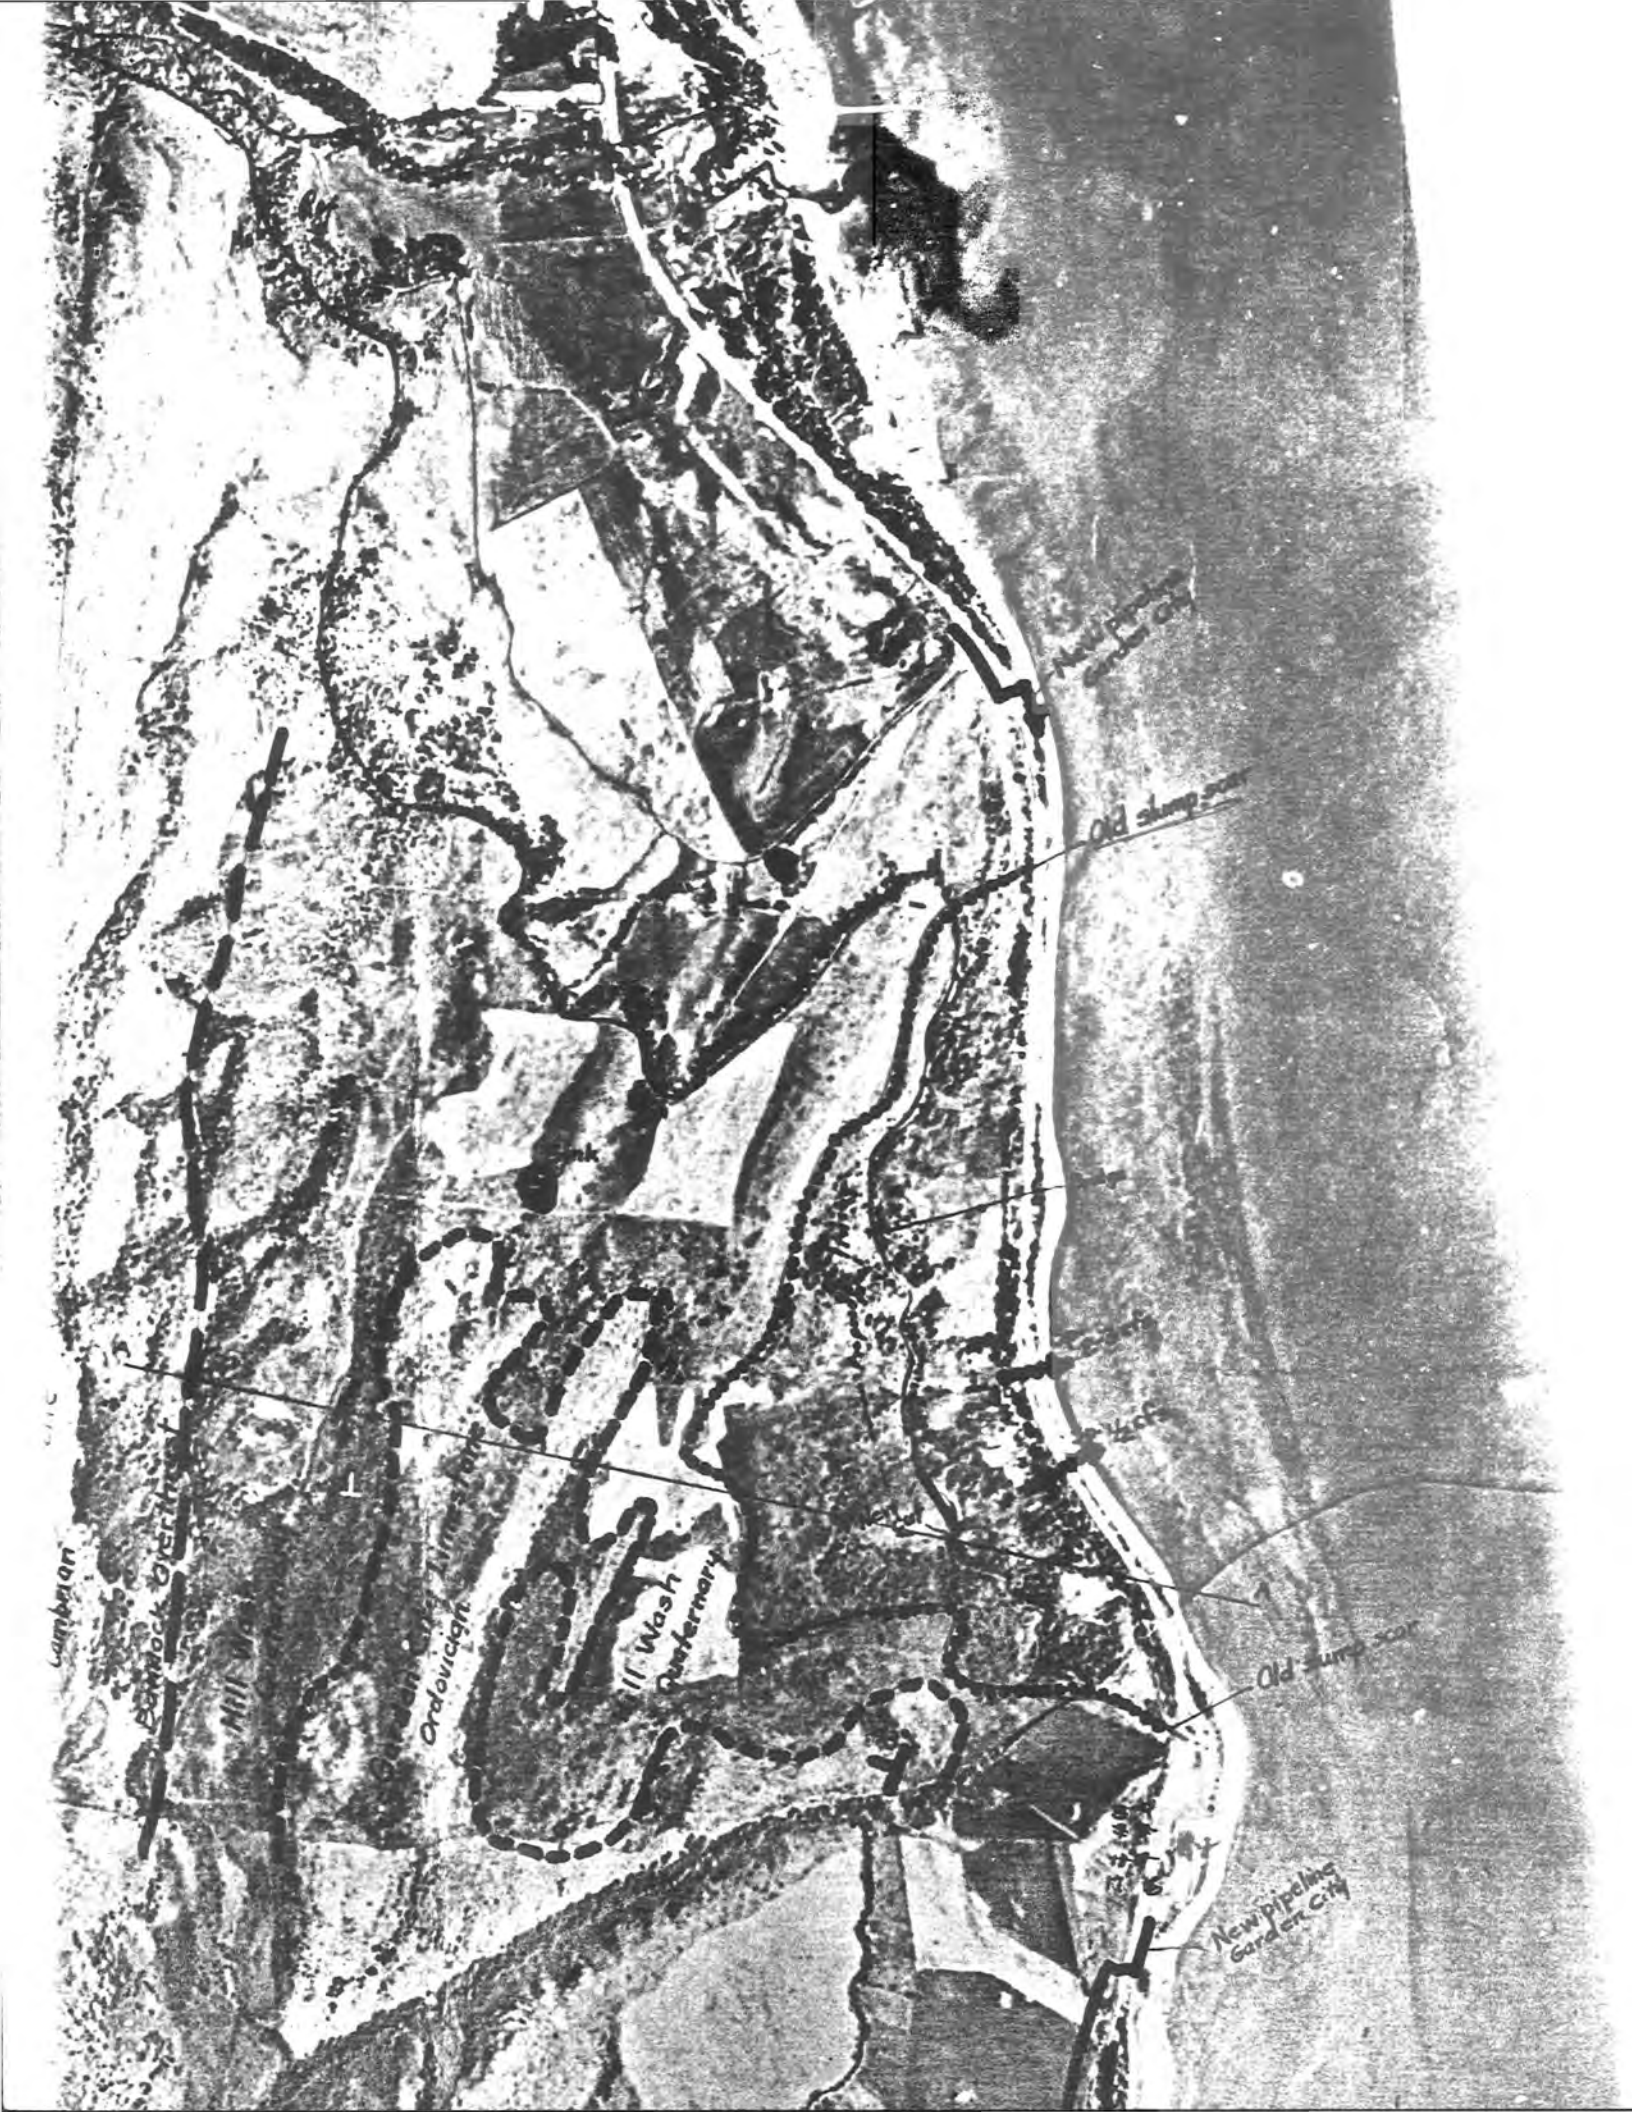
The canal crosses a slumped area for most of its length in the east half of Section 8, T. 14 N., R. 5 E., S14E4M. (Please see slump scar outlined on accompanying geologic map). The irrigation company has been troubled by frequent washouts in this reach, and wishes to stabilize the canal if possible. A geologic reconnaissance of the area was made in company with Delbert Hansen, WUC, and Dwayne Downs, Engineer, SCS, June 11-13, 1962. They assisted with information on springs, the recent relocation of the Garden City pipeline and accounts of difficulties in maintaining the canal. U. S. Geological Survey Bulletin 923, Geology and Mineral Resources of the Randolph Quadrangle, Utah-Wyoming, furnished by Bob Bridges, Geologist, SCS, was a valuable reference in the investigation. It is hoped the following observations will help to develop a method of treating the unstable section of the canal.
