**REVIEW REPORT
FAULT RUPTURE HAZARD/
GEOTECHNICAL EVALUATION
PROPOSED HIGHLANDS PUD
RESIDENTIAL DEVELOPMENT
APPROXIMATELY 2670 SOUTH HIGHLAND DRIVE
SALT LAKE COUNTY, UTAH**

**AGRA Earth & Environmental, Inc.
Salt Lake City, Utah**

June 12, 1995

Job No. E95-2196

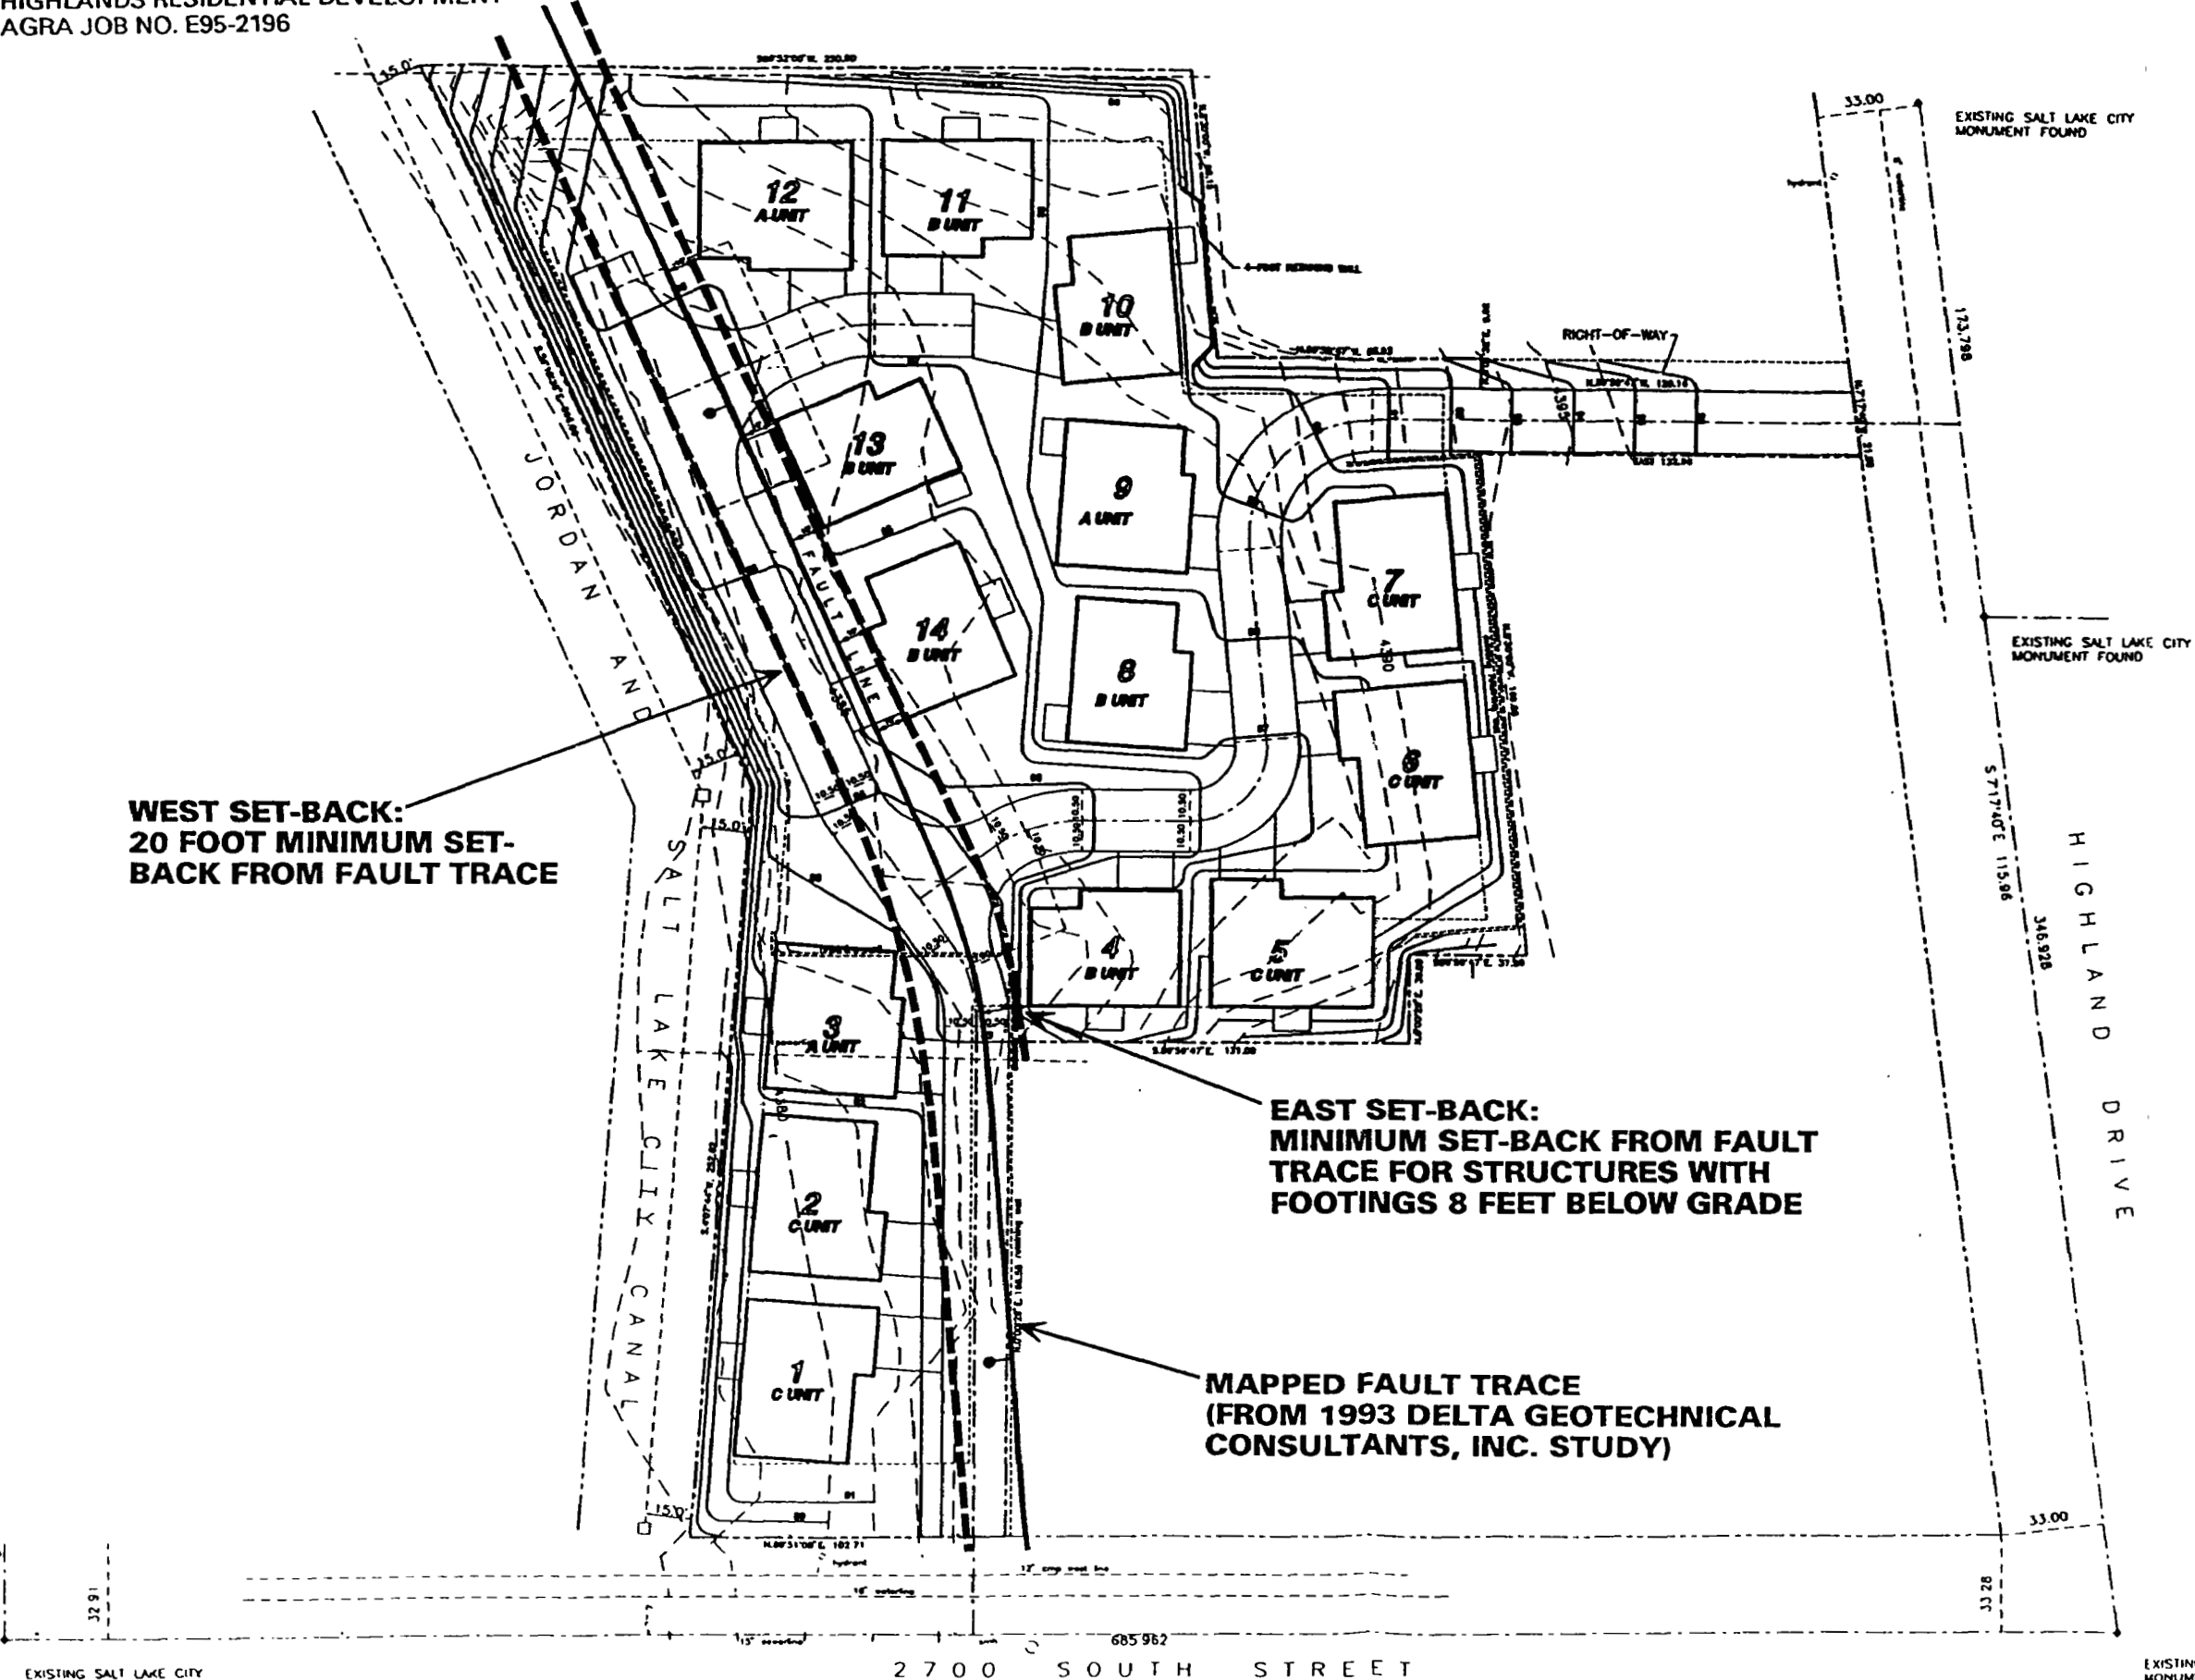
EXPLANATION

— MAPPED FAULT TRACE
