GEOLOGIC EVALUATION AND HAZARD POTENTIAL OF LIQUEFACTION-INDUCED LANDSLIDES ALONG THE WASATCH FRONT, UTAH

SPECIAL STUDY 104
UTAH GEOLOGICAL SURVEY
a division of
Utah Department of Natural Resources

Cover photograph of south view of the Harrisburg trench, by K.M. Harty

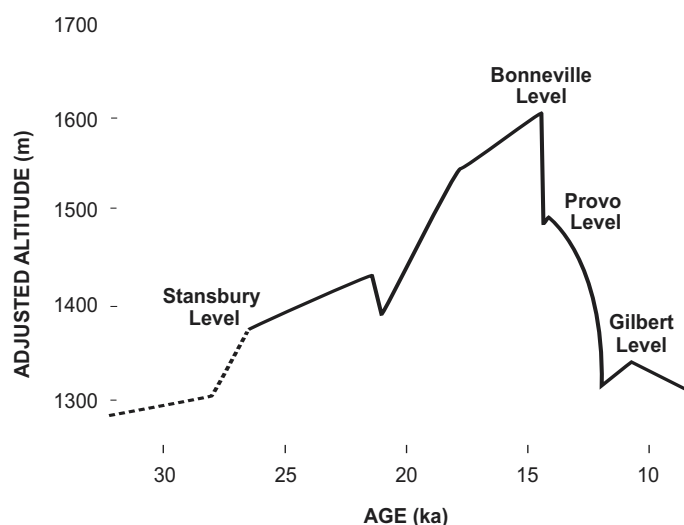
Figure 4. Hydrograph of Lake Bonneville and Great Salt Lake, 32,000 - ~10,000 years ago (modified from Oviatt and others, 1992; Oviatt, 1997).

Major shorelines associated with the transgressive (Stansbury and Bonneville shorelines) and regressive (Provo and Gilbert shorelines) phases of the Bonneville lake cycle provide a means of relative dating in the Lake Bonneville basin, as do the principal shorelines of the modern-day remnant of Lake Bonneville, Great Salt Lake (Currey, 1990; Oviatt and others, 1992; Oviatt, 1997). Figure 4 shows a time-elevation hydrograph of Lake Bonneville and early Great Salt Lake; table 1 provides data on ages and elevations of the four principal shorelines.

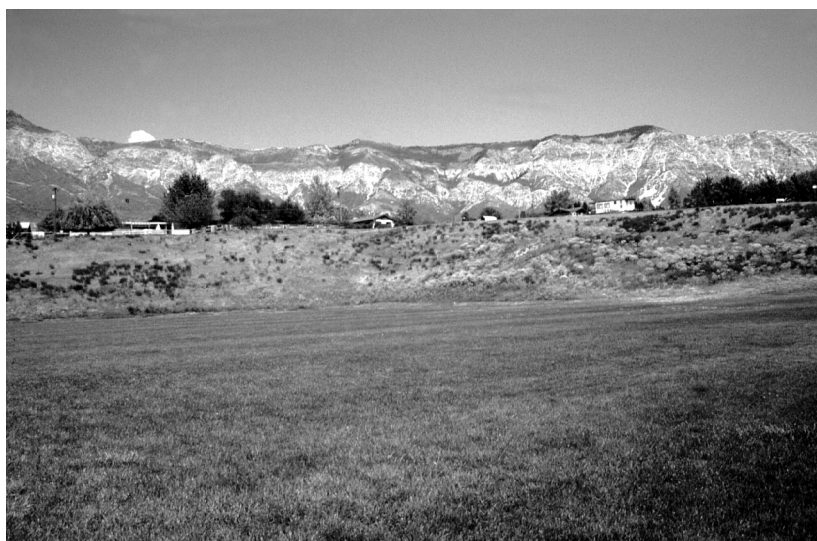
Figure 7. Northwest view of the main scarp of the North Ogden landslide complex as seen from Lomond View Park.

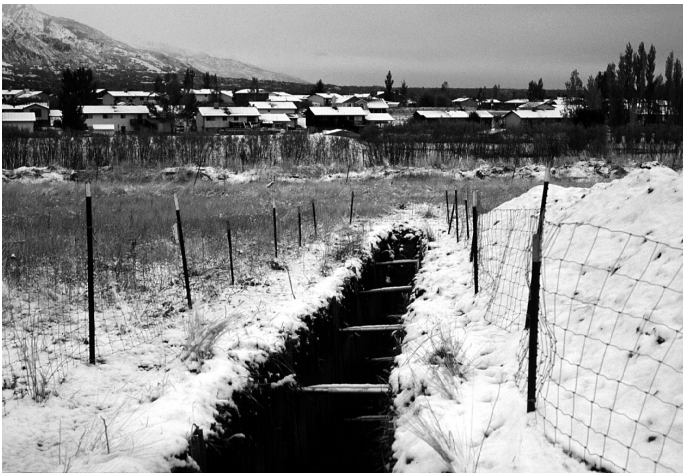
Figure 8. South (downslope) view of the Harrisville trench excavated on the flank of a hummock.

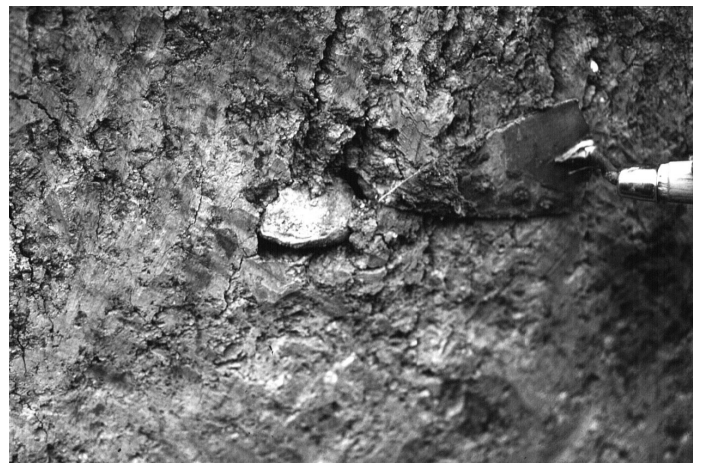
Figure 10. Harrisville trench flow-failure deposit (unit 2) containing subangular to subrounded gravel and cobbles.

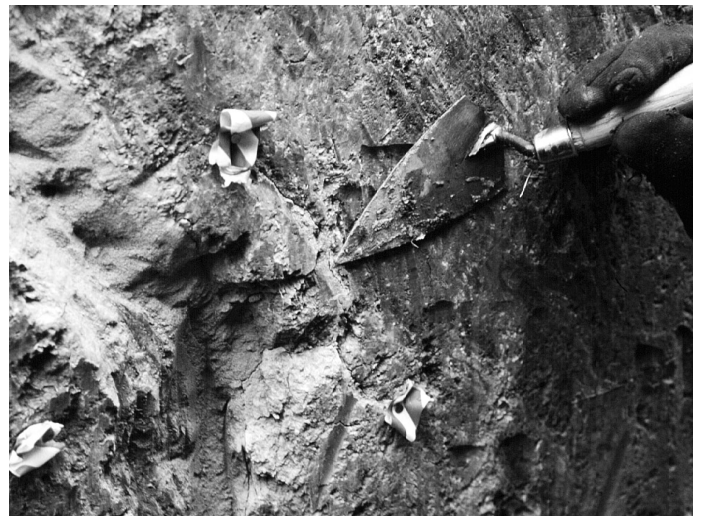
Figure 15. Sand-filled cracks (light-colored material at left and at point of trowel) in flow-failure (unit 5) along the west wall of the Harrisville trench (station 12 on plate 3).

Flow-failure units 2 and 5 both contain sand-filled fractures (unit 6) diagnostic of injection during earthquake-induced liquefaction (figure 15). The fractures are commonly less than 1 centimeter (0.4 in) wide, and many are only a few millimeters or less in width. The fractures contain unstratified, poorly graded fine sand. We could not find the source of this sand in the trench, nor in a core sample obtained from below the trench floor. As many of the injection features do not stem from the base of the trench, the source of the sand is likely at depth and lateral to the trench.

We found the sand-injection features only in units 2 (eastern [unlogged] side of trench) and 5. We believe that the injection features probably formed during one earthquake, and that injections likely penetrate intervening units S1 and 3 elsewhere in the subsurface. Injections of fine sand into unit 4 would likely disperse because of the lack of cohesiveness of unit 4 sand and its inability to maintain open fractures. No injection features extend into the modern soil (S2), but this does not preclude the possibility that the modern soil was present or forming when the liquefaction event occurred. None of the fractures is closer to the base of the modern soil than about 0.4 meters (1.3 ft), and perhaps the fracture network naturally dissipated at about this height above the source material.

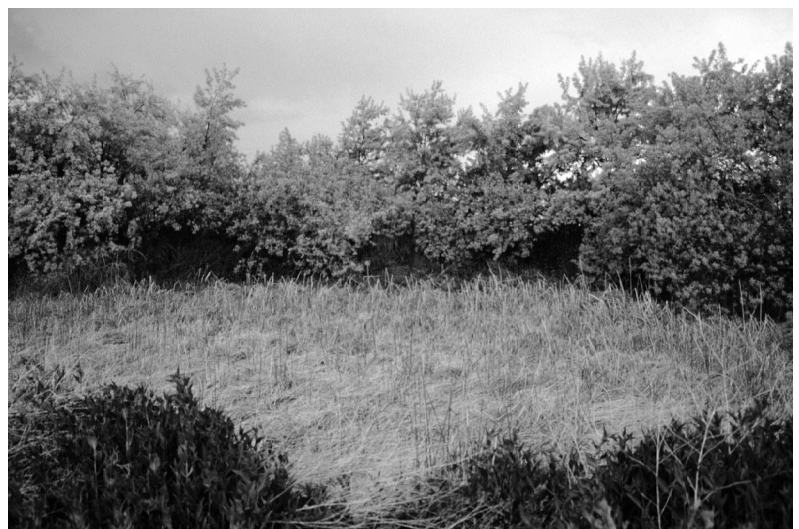
Figure 19. Vegetated, circular depression on the North Salt Lake northern landslide.
